**APPENDIX D**  
**PHOTOS OF CURRENT CONDITIONS**  
**Ironwood Forest National Monument**  
**Travel Management Plan**

Issues and concerns related to the current condition of the Monument roads and primitive roads are illustrated by the photographs in this Appendix. Current conditions are affecting the usability of the designated access roads and primitive roads, and present safety concerns for road users. Poor road conditions are also leading to damage of Monument objects from spreading vehicle use impacts.

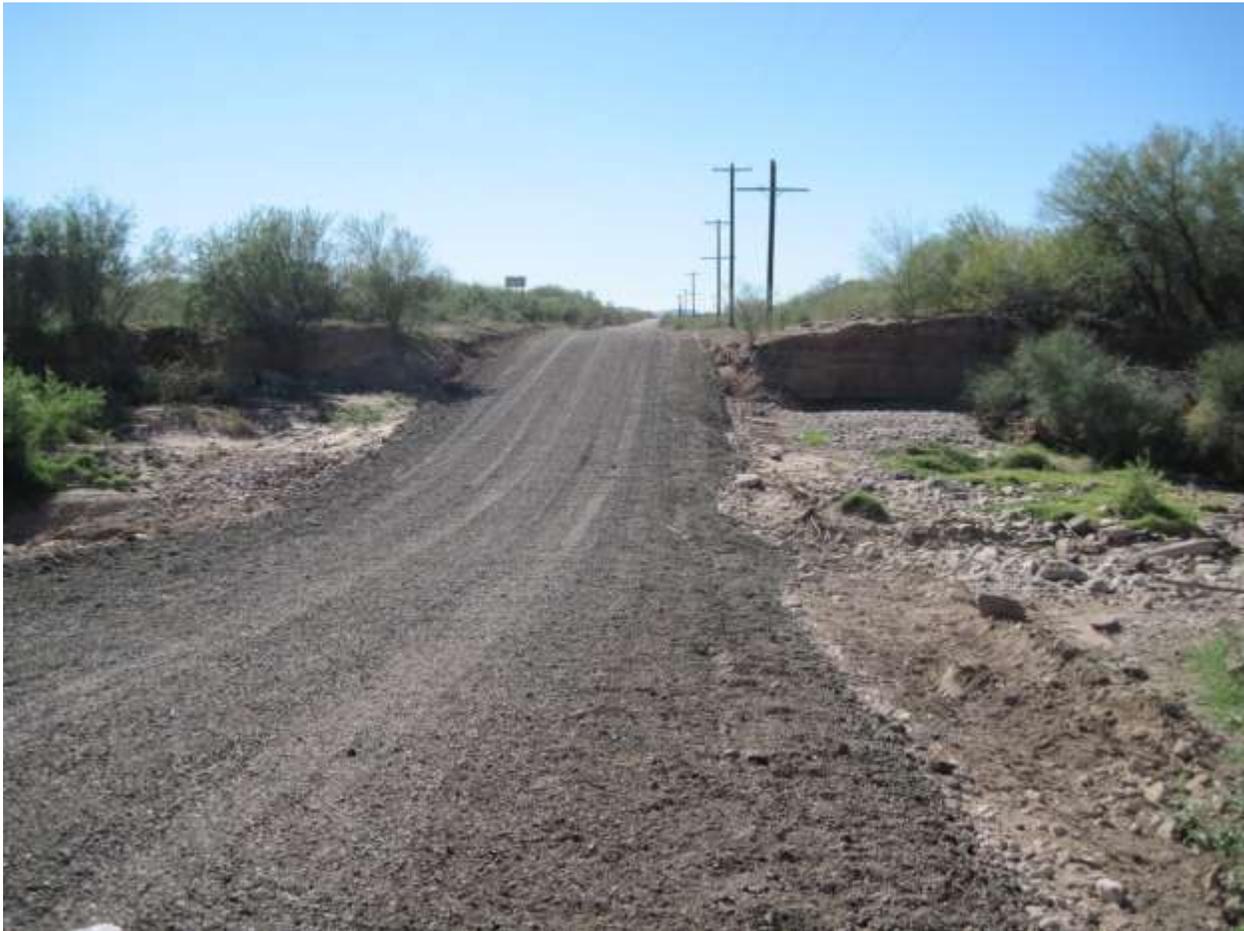
Figure D.1. Sasco Road River Crossing.

Proposed Monument Access Route connecting the IFNM to Interstate 8 at the Redrock Exit. Sasco Road partly uses the historic railroad grade to the Silverbell Mine. The remaining railroad grade separated from the road is planned in the IFNM RMP for a future trail connection to residential and other development in the Red Rock area. The low water crossings at the Santa Cruz River and Los Robles Wash become inundated and impassable by typical vehicles. Under proposed implementation strategy crossing and other road improvements will be pursued under the FLAP program with Pinal County.

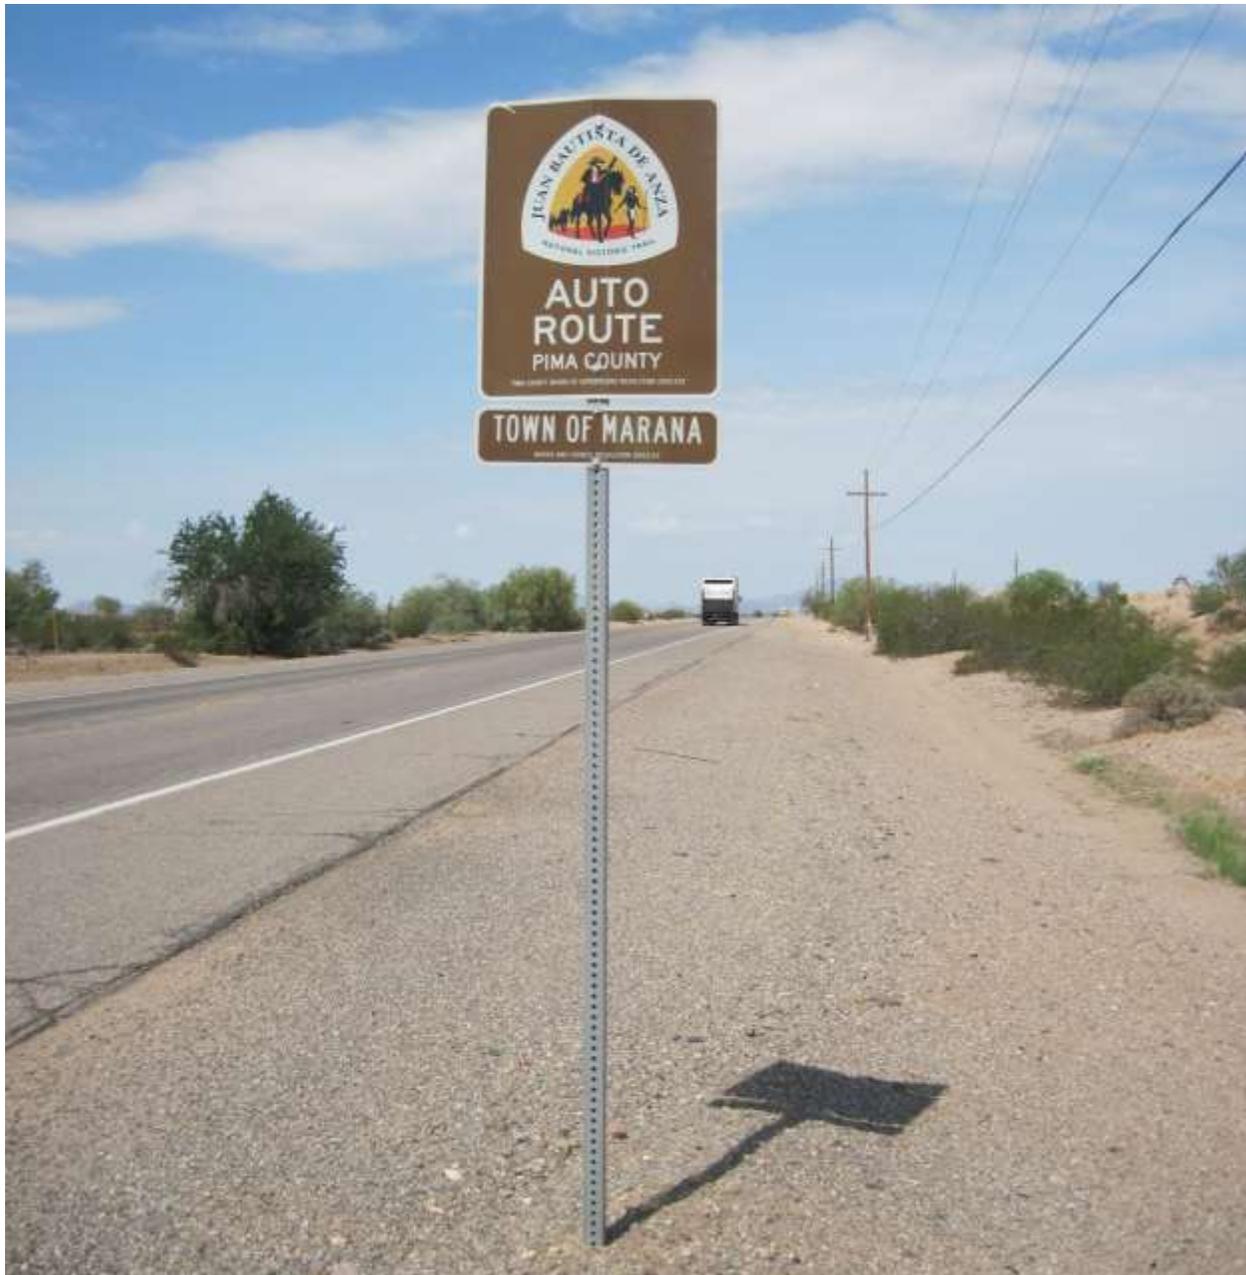
Figure D.2. Avra Valley Road across Monument private land inholding.

Primary purpose is haul road for trucks going to and out of the mine. Heaviest traffic, ADT is over 100 vehicles. The San Juan Bautista De Anza National Historic Trail Auto Route follows Silverbell Road and Avra Valley Road near the Monument.

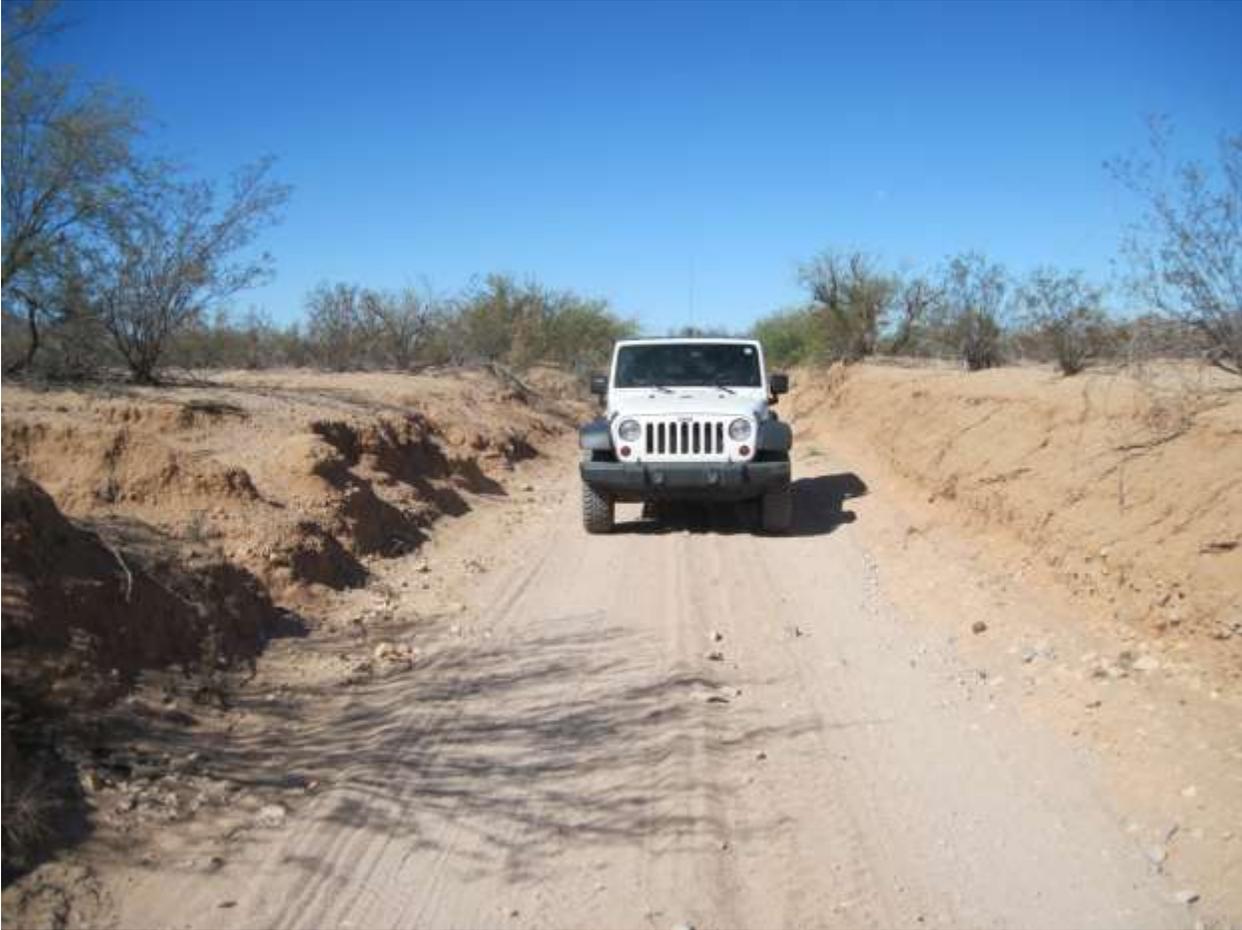
Figure D.3. Deeply entrenched road.

Agua Blanca Road, down cut by erosion over decades to approximately 4 to 5 ft below the prevailing elevation of adjacent ground, forming a deep canal. The roadway canal collects surface runoff and diverts it from natural drainage ways, concentrating the flow and continuing the erosion process that lowers the road grade and the gradient of adjacent drainages. The lowering of the gradient of side drainages is causing deep, steep sided gullies and stripping of topsoil from sheet erosion.

Cross drainages are undercut, and the road canal fills and ponds after storms, causing deposition of loose sand which makes passage difficult or treacherous and temporary loss of service.

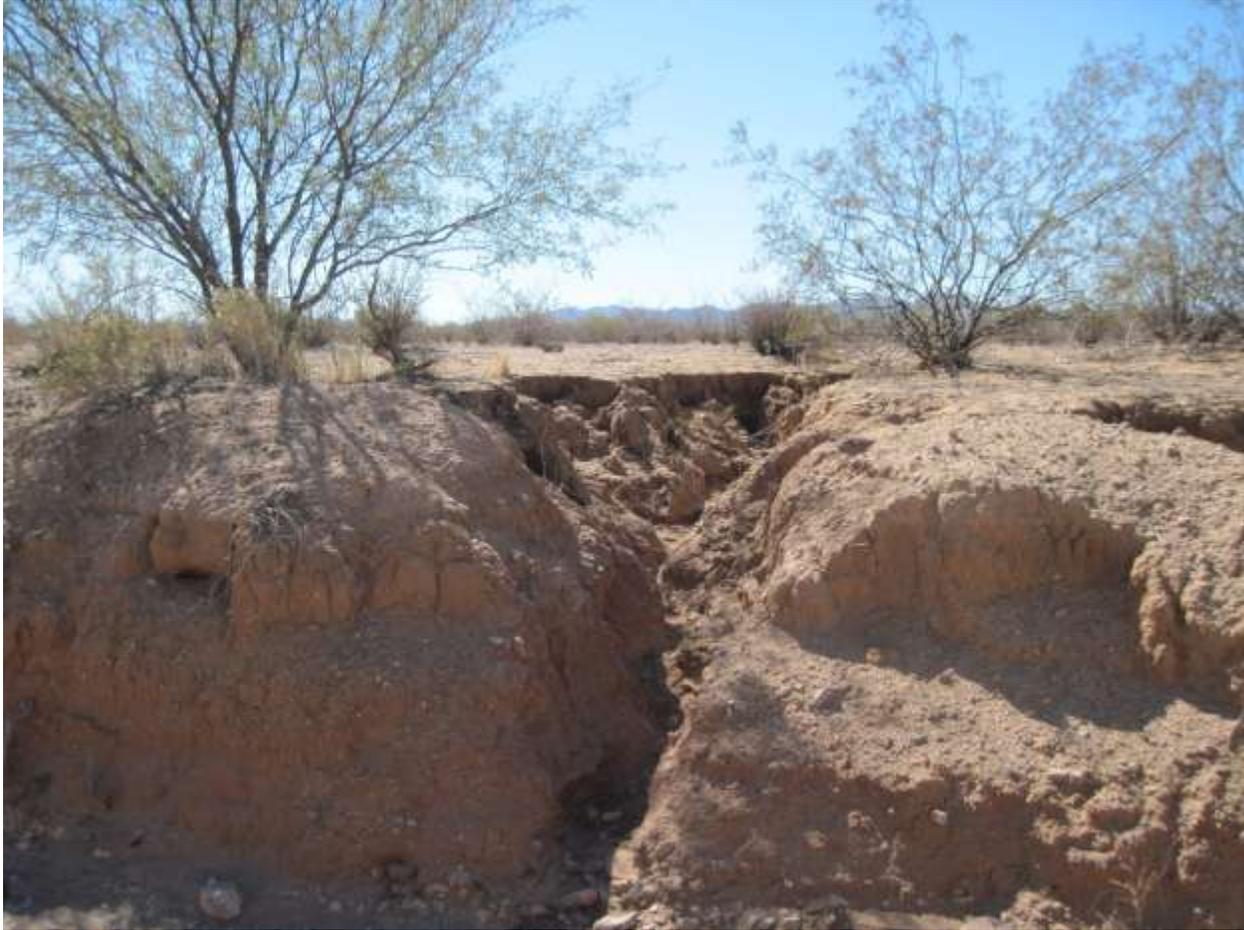
Figure D.4. Gully erosion along road cut bank.

Gully erosion is found along deeply trenched road sections (Agua Blanca Road) in highly erodible creosote flat soils; note topsoil erosion at the head of the gully. Ongoing erosion process strips the topsoil of adjacent land.

The proposed road maintenance will raise the road grade and keep the existing trenched section as a low basin to drain to. The basin will continue to pond and infiltrate runoff, support denser vegetation due to the concentrated moisture. The migrating gully erosion will be stabilized as part of road construction.

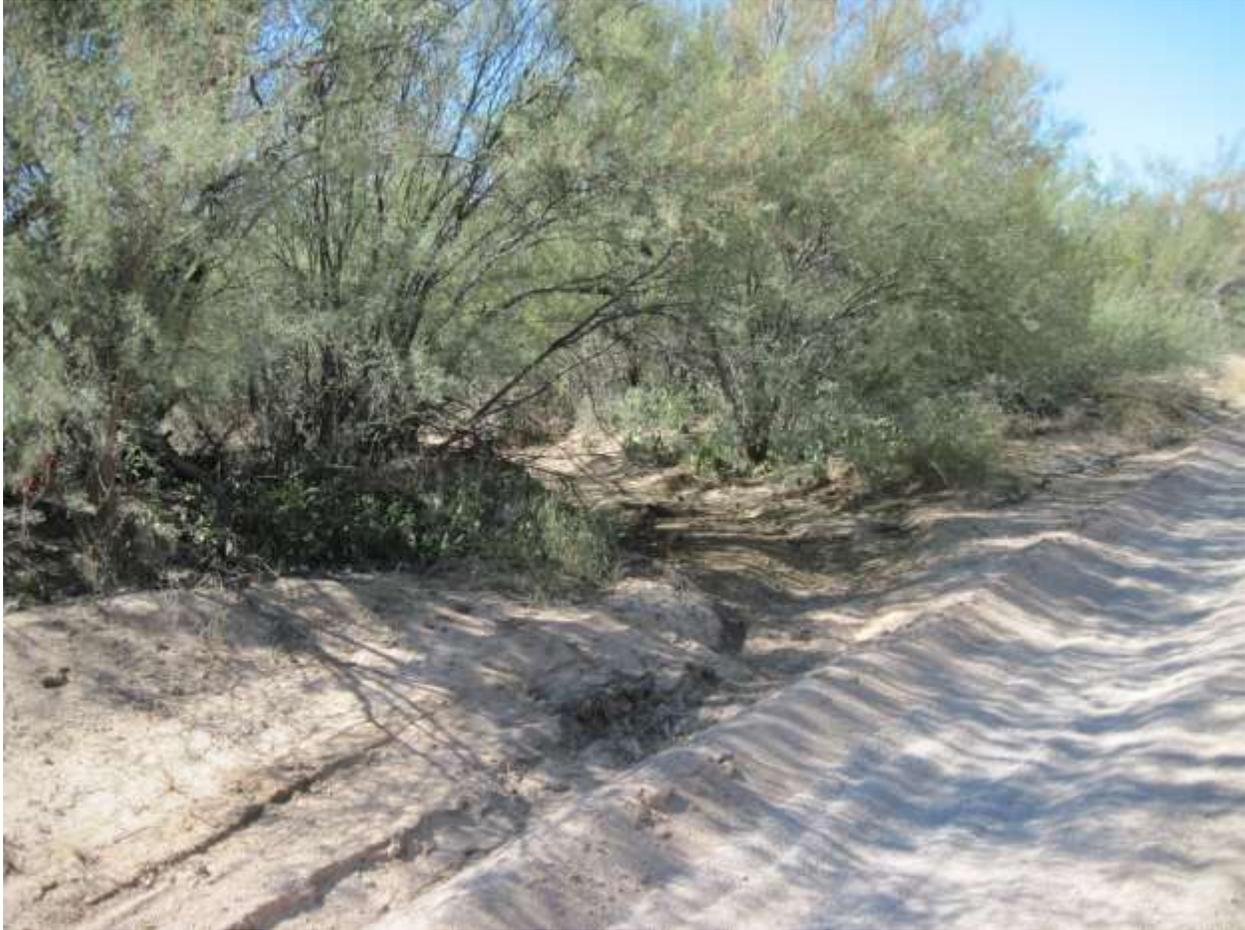
Figure D.5. Blocked and undercut drainage outlet.

Natural drainage crossing outlets are blocked in many places along roads. Sediment material displaced along the roads blocks outlets, along with obstructions by vegetation growth and debris, create ponding on the roadways before runoff spills out into natural drainage outlet.

Under the proposed road maintenance project, the road will be raised, the sand trap will be allowed to function as a wet area, and the road will be moved out of the green strip along the basin.

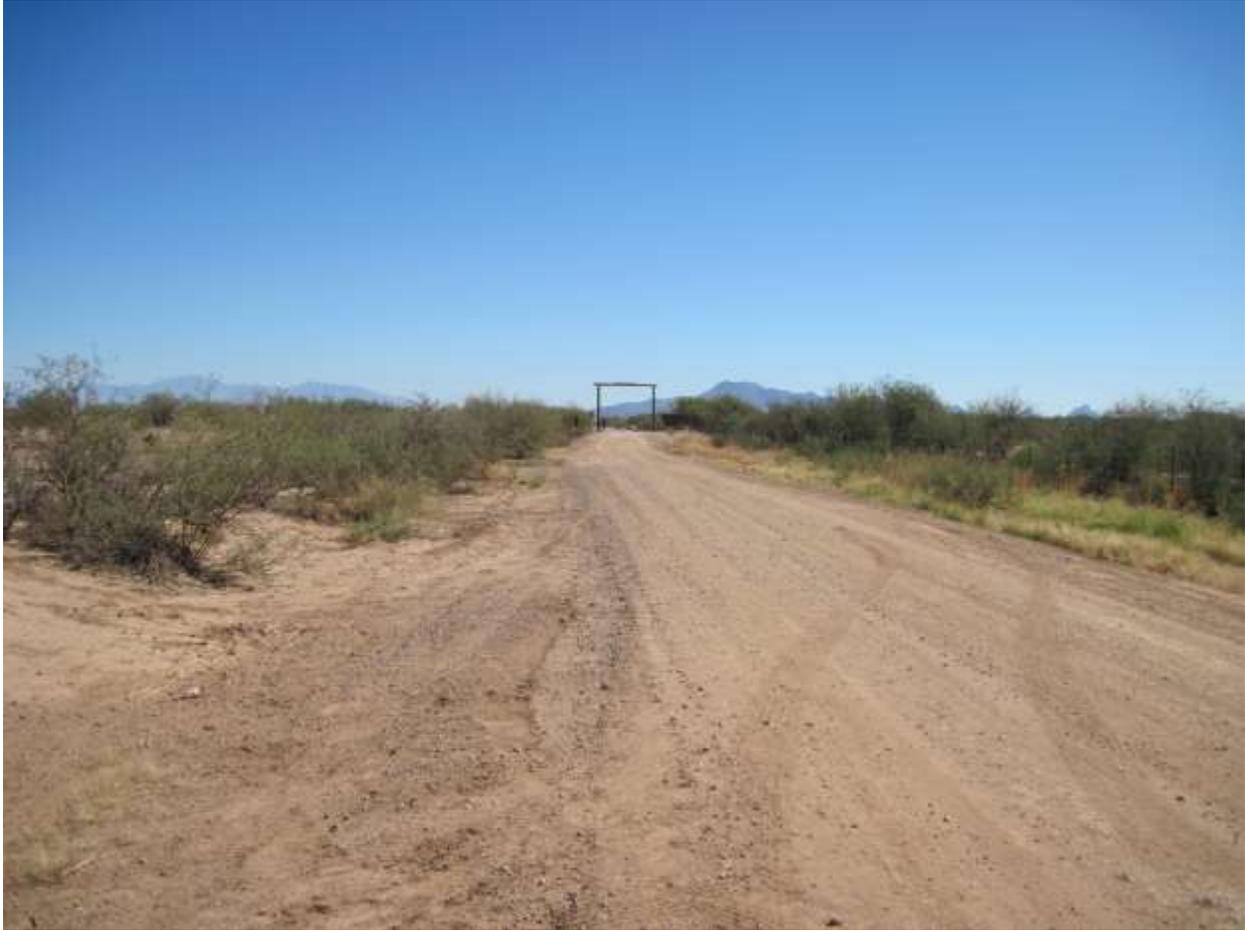
Figure D.6. Manville Road, unpaved section approach to Monument entrance.

This section of Manville Road west of Axtell is unpaved (view west toward Monument boundary at the entryway), and aggregate surfacing will be pursued to reduce fugitive dust in the residential area along the road. Manville Road provides access to Agua Blanca Road.

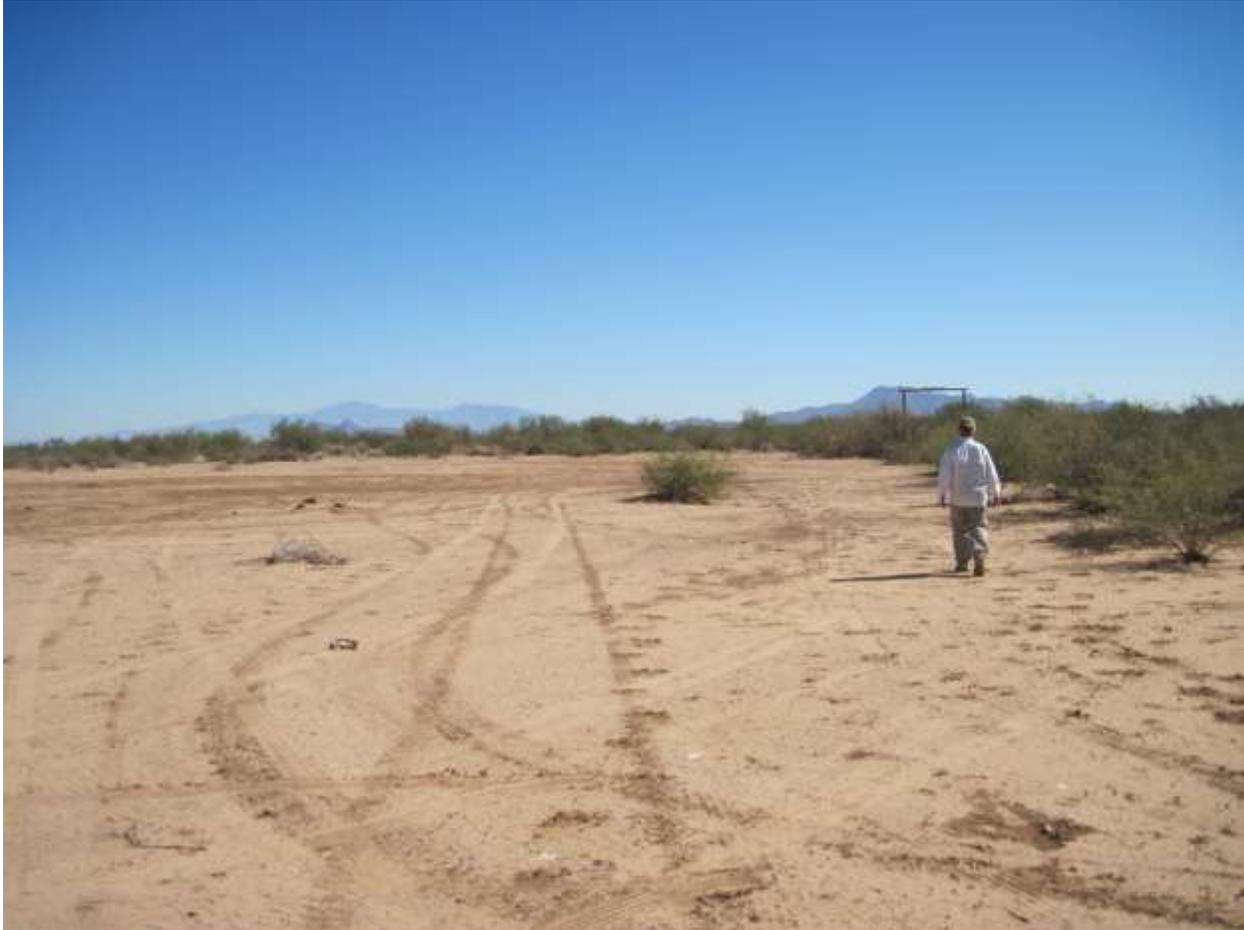
Figure D.7. Manville Monument Portal site.

The existing open, cleared flat area near the Agua Blanca Rd entrance (entryway in background) is proposed for a portal site and staging area. The site will be designed to provide a portal parking and staging area for public use, and to serve as the staging area for road maintenance equipment and materials. Site work will address drainage, fugitive dust and muddy soil conditions, and restoration of native vegetation cover.

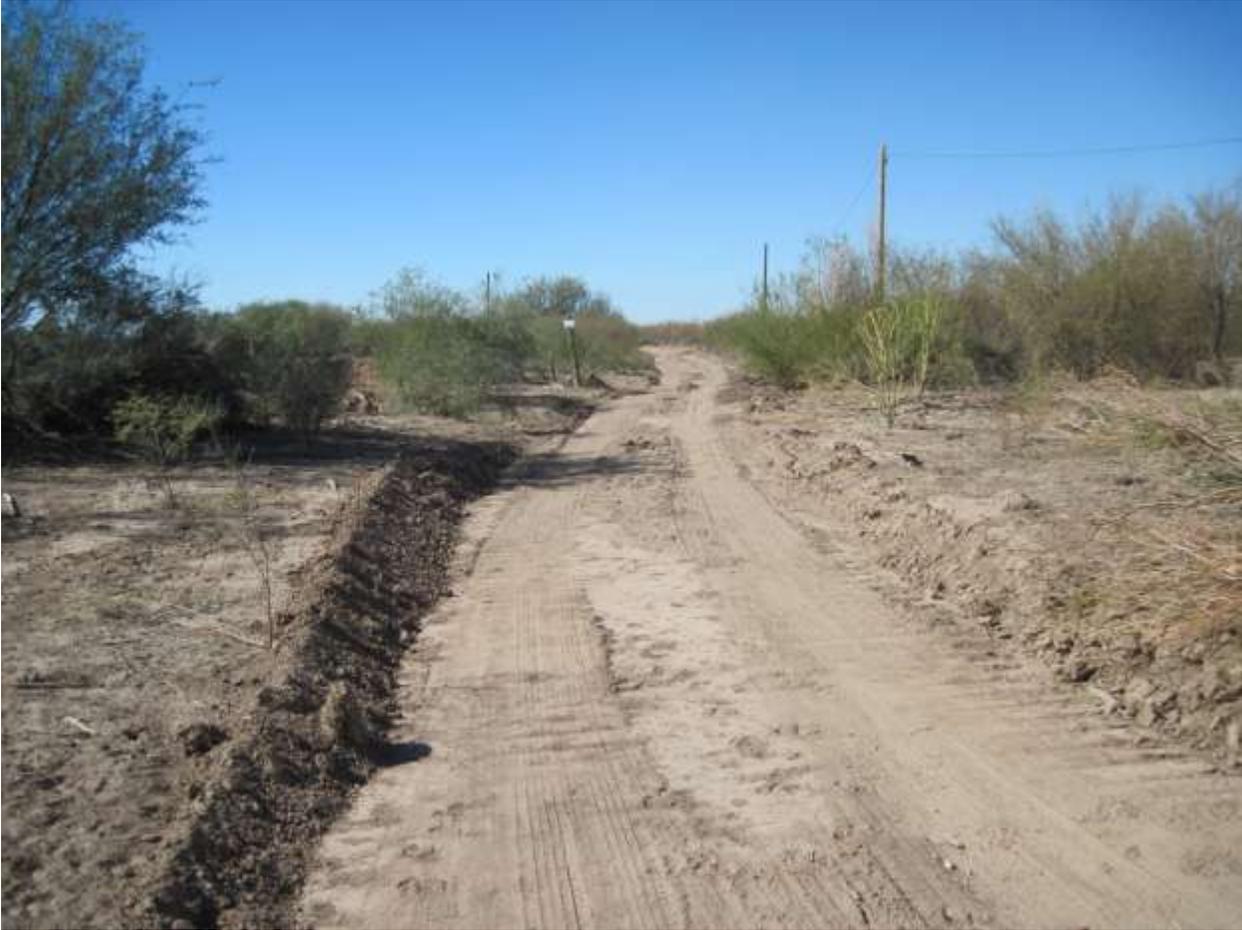
Figure D.8. Common road maintenance practices.

Road maintenance using motor graders or dozers over time down cuts the road grade, collecting surface runoff and creating flat bottom ditches with banks on both sides. This intercepts drainages and sheet runoff, disrupting natural drainage patterns and creating drainage and erosion problems. In places, the invert elevation of natural drainage crossing outlets is above road grade.

Road maintenance projects will be designed to restore or preserve natural drainage patterns by rolling the vertical alignment/grade, blocking the roadway with water bars, and directing drainage to runoff ditches or natural drainage outlets.

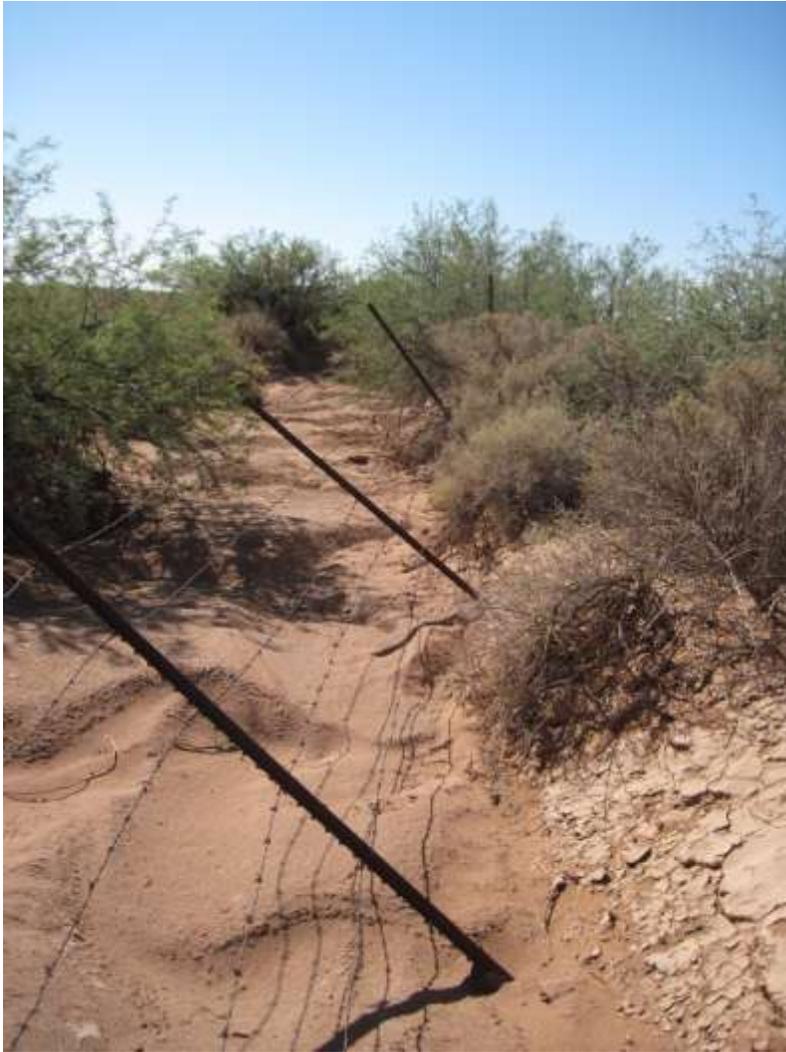
Figure D.9. Damaged fence from eroding access road.

Down cutting along fences from grubbing fence lines and road, maintenance has caused entrenchment along fences, undercutting fence posts and causing failure or collapse of the fence.

Proposed drainage improvements will restore intercepted runoff onto natural drainage channels or spread onto the adjacent flat soils to stabilize down cutting process, and worsening of erosion and related damage.

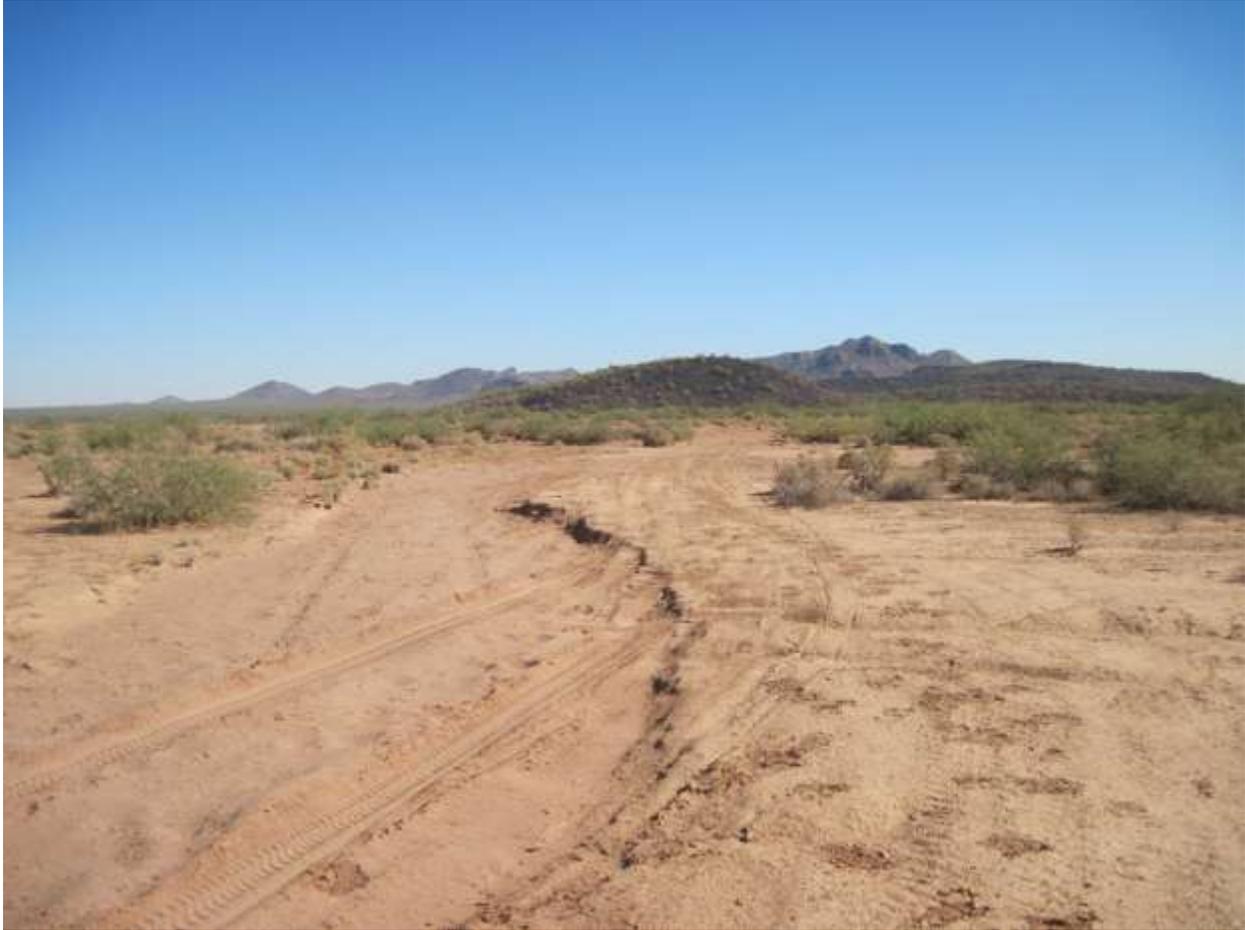
Figure D.10. Down cut roadway leading to travel way braiding.

Erosion makes road impassable on flat soils, causing road users to seek passage on higher ground, widening the impacts of a route in flat soil types, particularly in open areas with sparse, scattered vegetation cover.

Proposed maintenance will grade the roadway on higher ground using part of the existing road for balanced cut and fill, and low water crossings by rolling the grade's vertical alignment.

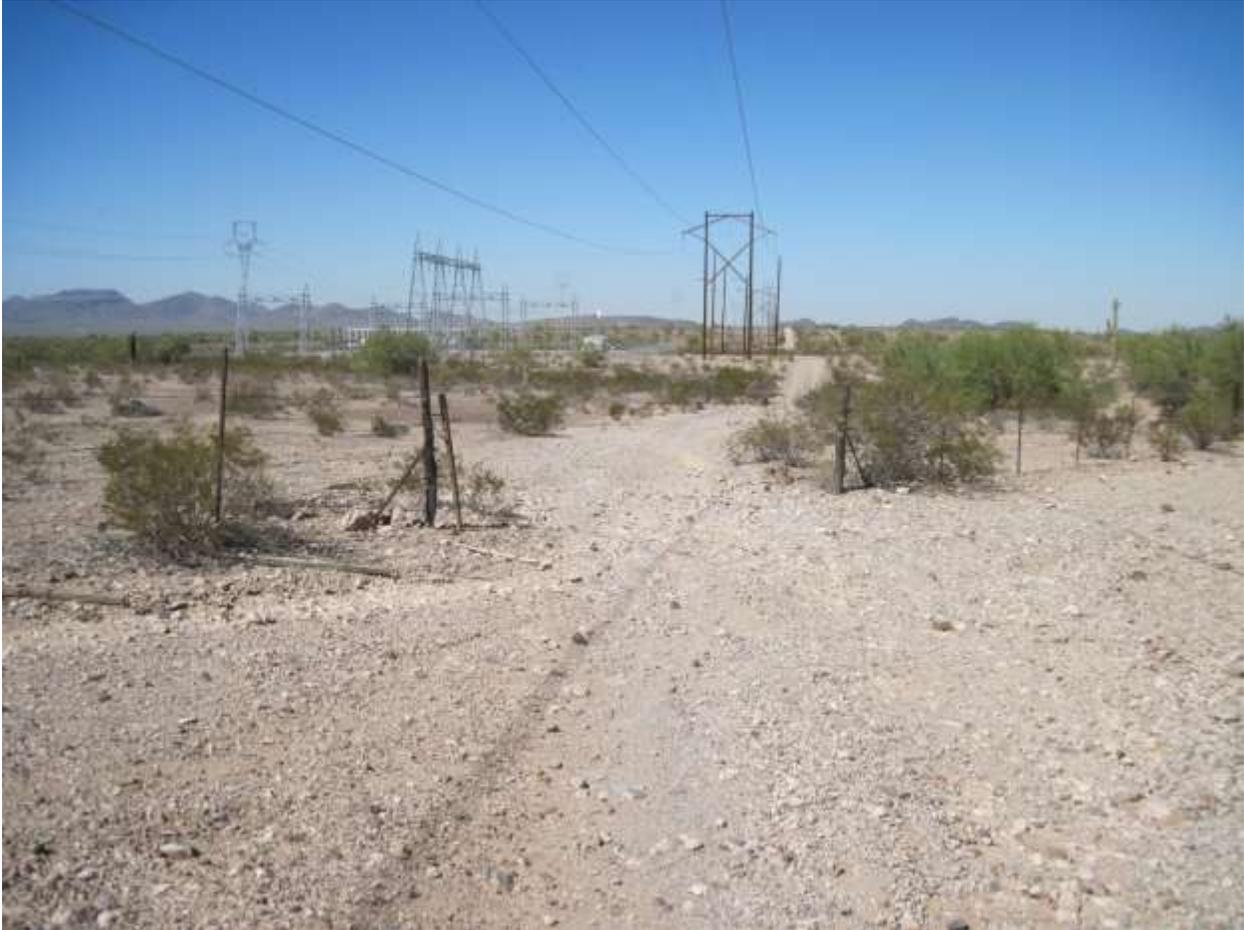
Figure D.11. Transmission lines in existing Right-of-Way service road.

Existing gate on Tohono O’odam Nation/IFNM boundary along the existing electric transmission lines across the Monument west of the Sawtooth Mountains prone to damage from errant vehicles, including traffic related to border zone smuggling activity. The fence is in poor condition and in need of replacement.

A proposed cattle guard will replace the wire gate to alleviate problems from the gate being left open or destroyed and livestock management. The IFNM will work with the Tohono O’odam Nation and grazing permittees on a fence maintenance and replacement project for the entire Monument boundary with the Tohono O’odam Nation.

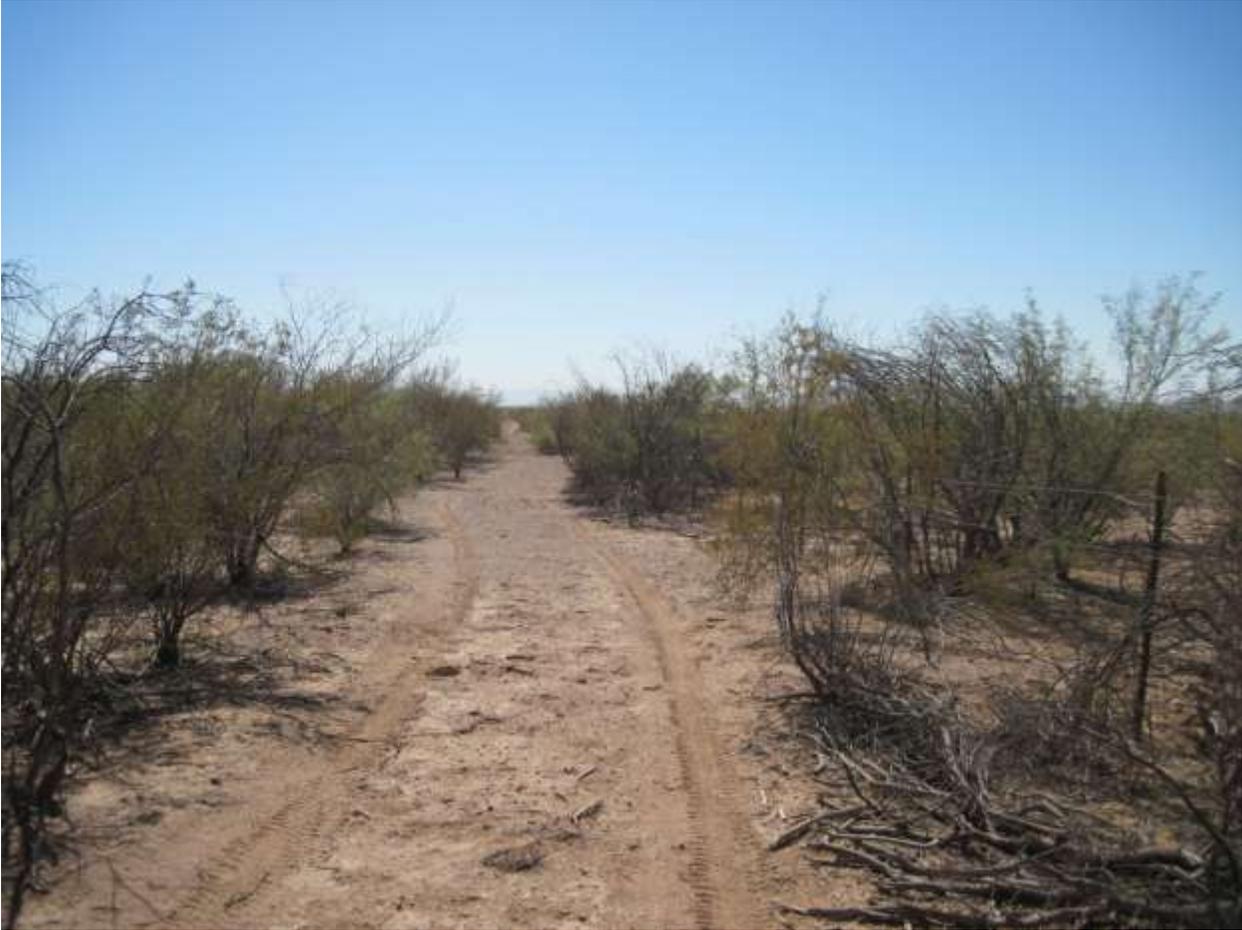
Figure D.12. Administrative vehicle access route along rangeland fence.

This type of access route receives very low volume and infrequent use for inspection, maintenance or repair. At these use levels the route and its use has little impact on soils, and natural drainage patterns, and vegetation is present in the roadway in many cases. This type of route can attract increased traffic and related impacts.

This type of access route may not have been identified on the physical access route inventory, unless it was receiving vehicle traffic at the time the Monument was established in 2000. Multiple purposes will generally be blocked and signed to prevent attracting increasing traffic, and consequent impact on soils, drainage and other Monument resources along the route. Most fence lines require infrequent access for inspection, maintenance or repair. Such access will be accommodated.

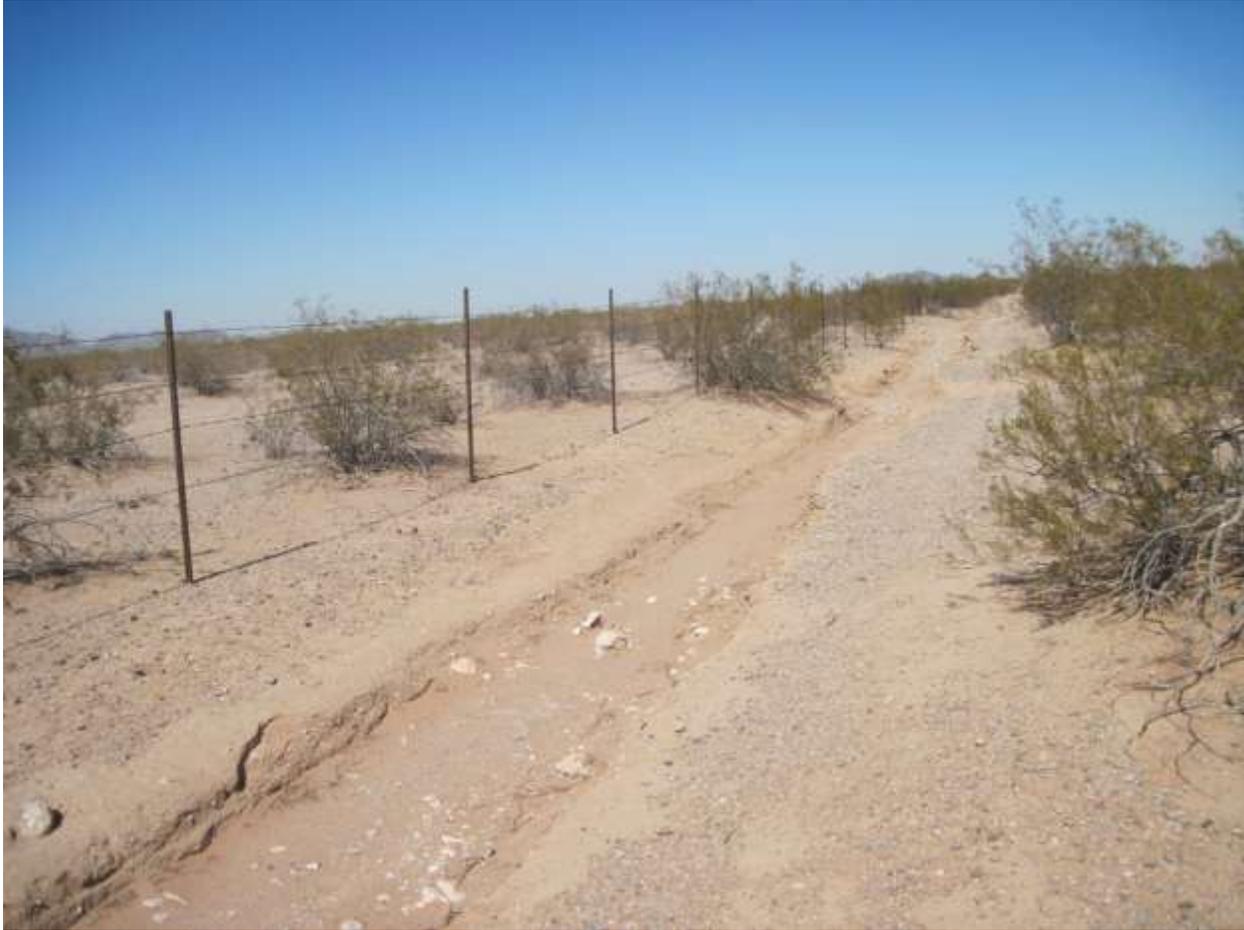
Figure D.13. Existing fence line access route erosion.

Erosion by surface runoff collected and concentrated by the route has formed a ditch that strips topsoil and causes traffic to use adjacent ground, widening the impacts of the access routes and potentially causing damage to Monument objects (hidden cultural resource values, vegetation, soil), and disrupting natural drainage patterns. Ditch formation is common on routes aligned across the prevailing contours on bajada and mountain slopes.

Ditch formation will be stabilized by redirecting runoff to natural drainages, and treatments at head cut and rill eroding fronts. Existing ditches will be blocked with water bars, particularly at undershot natural drainage crossing outlets. Conditions predisposing routes to ditch erosion will be prevented by rolling the vertical alignment of the route's to prevent a continuous grade line for extended distances, depending on the soil type and grade.

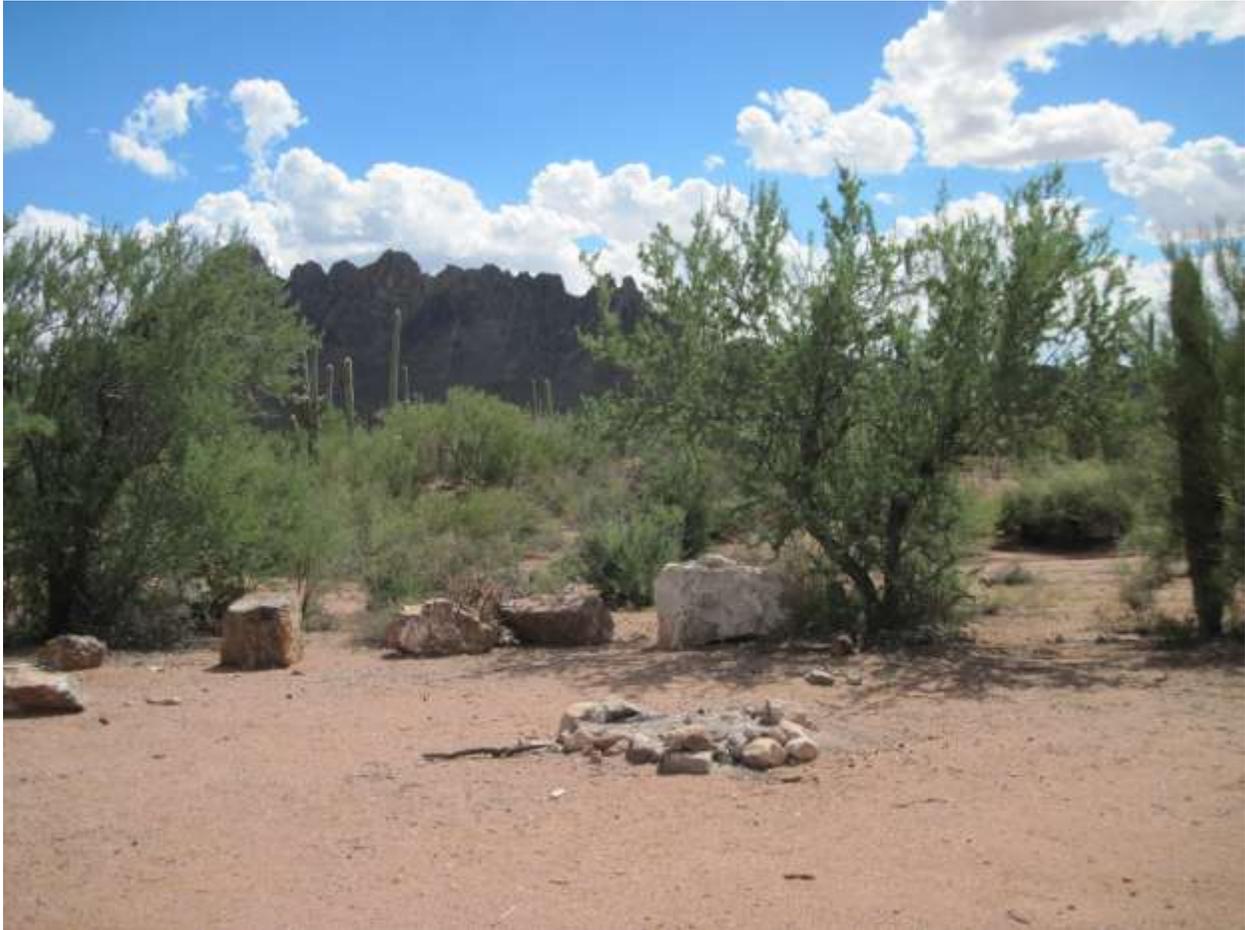
Figure D.14. Silverbell Group Site.

Existing group site along Silverbell Road north of Ragged Top. Rock bordered parking areas and driveway were installed into prevent sprawling vehicle use. This area has capacity for approximately 10 vehicles, with overflow parking along Silverbell Road. The site is used for educational programs, organized group activities, camping and picnicking.

Under the proposed plan future expansion of the site to the west will be considered to increase capacity to two groups at one time (approx. 20 vehicles at one time) capacity. The site would be maintained to semi primitive standards, with no facility development other than parking, driveways, signing, and fire rings. Temporary sanitation facilities will be required for organized group use.

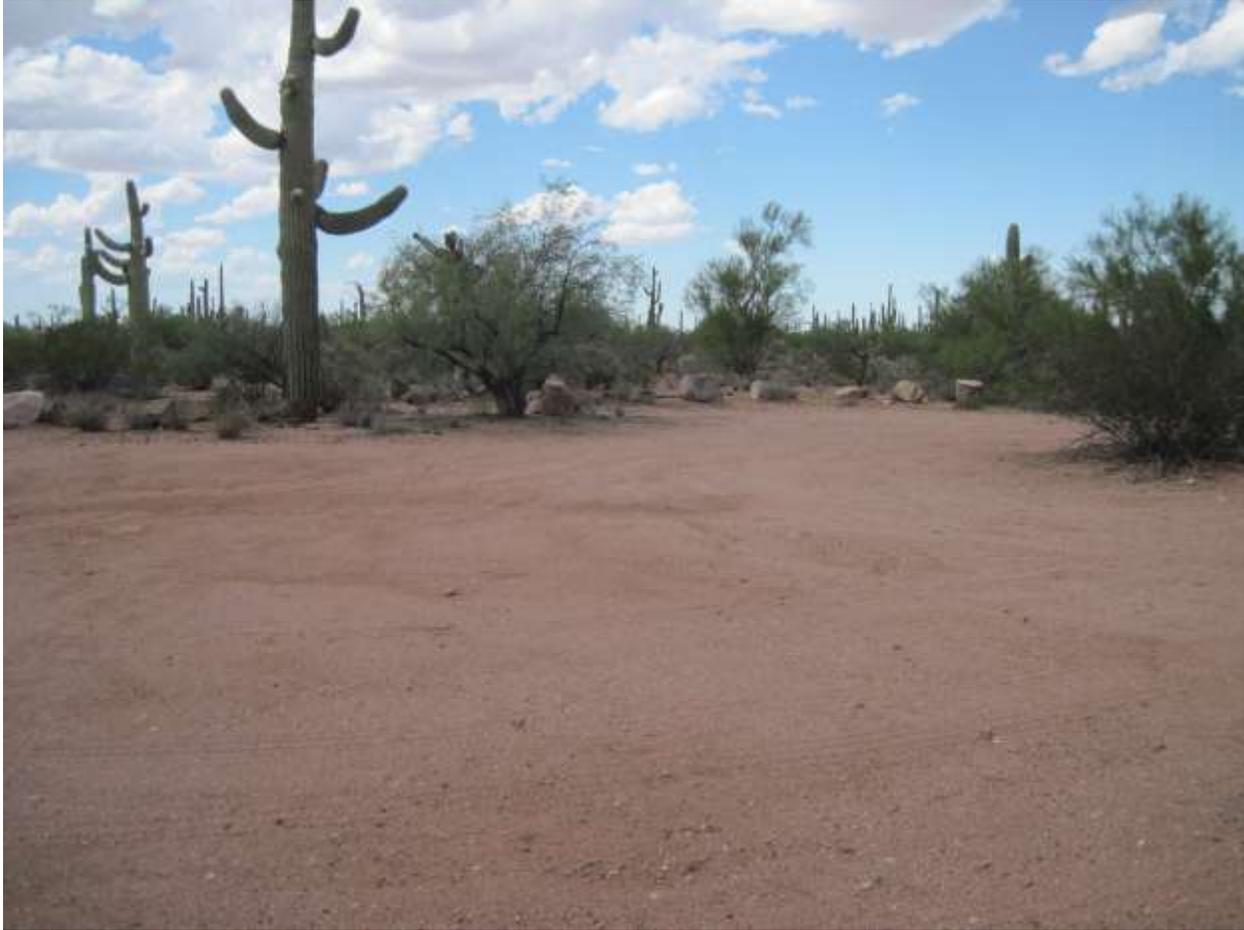
Figure D.15. Proposed Silverbell Group Site expansion area, view west.

Existing boulders define the western parking and driveway perimeter of the group site.

Under the proposed implementation plan, construction of a new driveway will be considered from the existing driveway to a second ingress/egress point approximately 800 feet west along Silverbell Road.

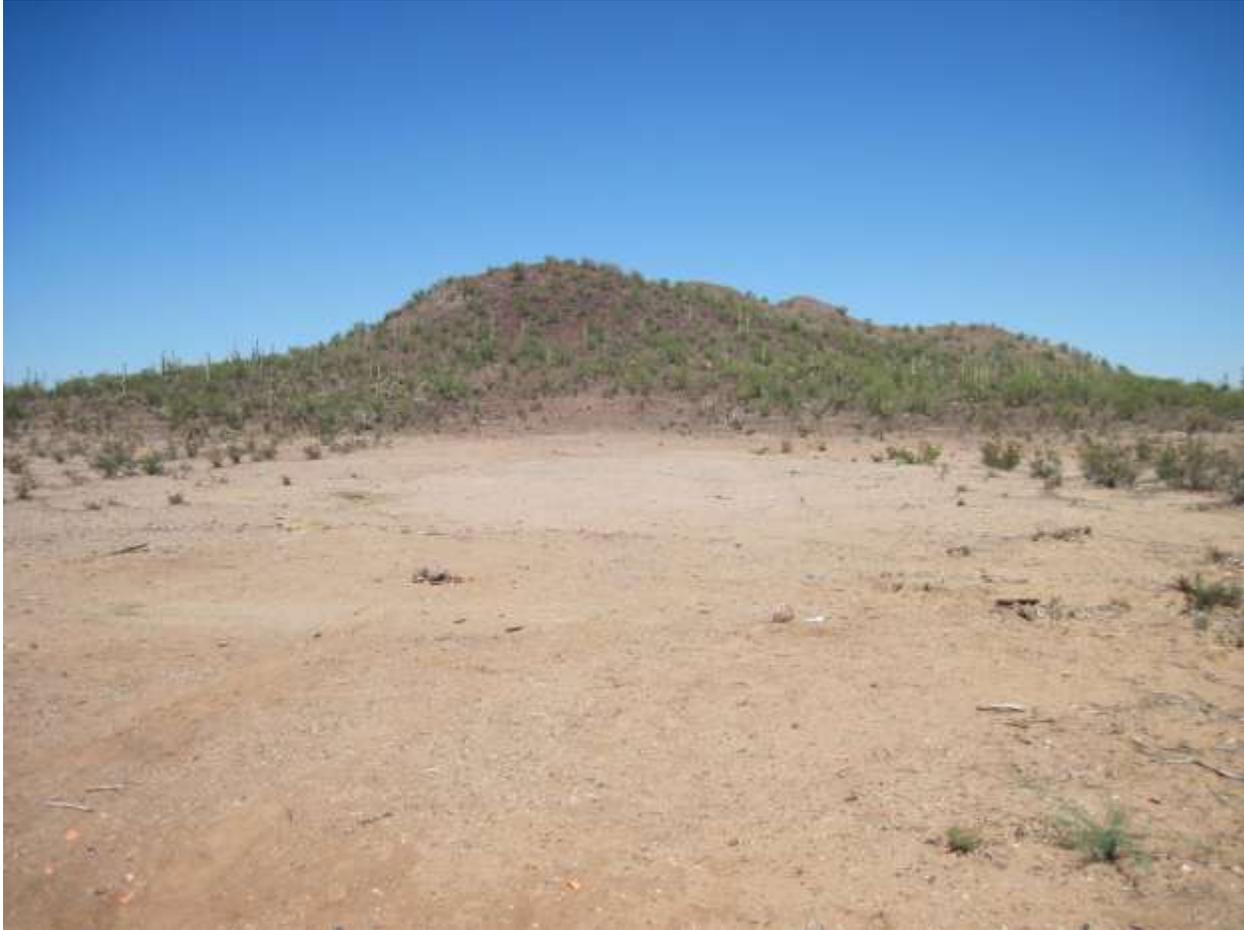
Figure D.16. Avra Hill restoration site.

Existing disturbed area created by intensive recreational use and intensive target shooting activity since the Monument was established along Avra Valley Road.

Highly disturbed sites will be cleaned up and treatments will be applied to restore the sites to natural conditions as much as possible. Impacts to be addressed in restoration efforts include: blocking access by vehicles to preventing further impacts, soil compaction, vegetation cover, invasive plants, and visual contrast.

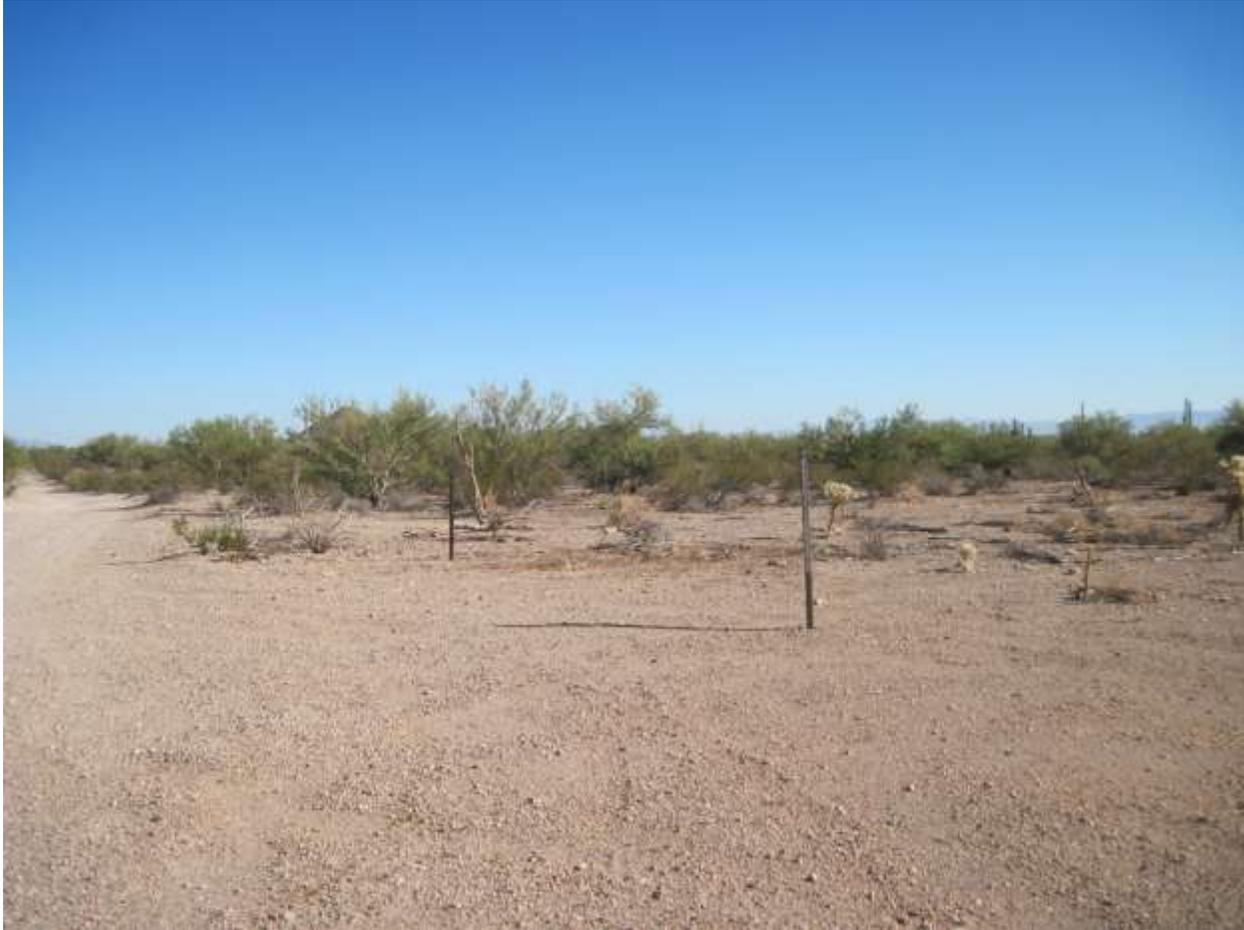
Figure D.17. Typical restoration treatment.

Disturbed area heavily disturbed by intensive vehicle use and recreation activity after restoration treatments, and signing to prevent continued traffic. Treatments applied here included clean-up of trash and debris, removal of hot fire remains, trimming of cacti cuttings and standing dead wood, persistent woody ground litter, raking ruts to disguise the area and prevent attracting additional use. Work usually done using hand crews and hand tools.

Restored areas will be monitored for compliance with temporary use/occupancy restrictions, and success in restoring normal soil function including vegetation cover.
