## **Draft Standards Determination Document**

### **Marys River Complex**

#### **Appendix L – Lentic Proper Functioning Condition and Water Resources Inventory Data**

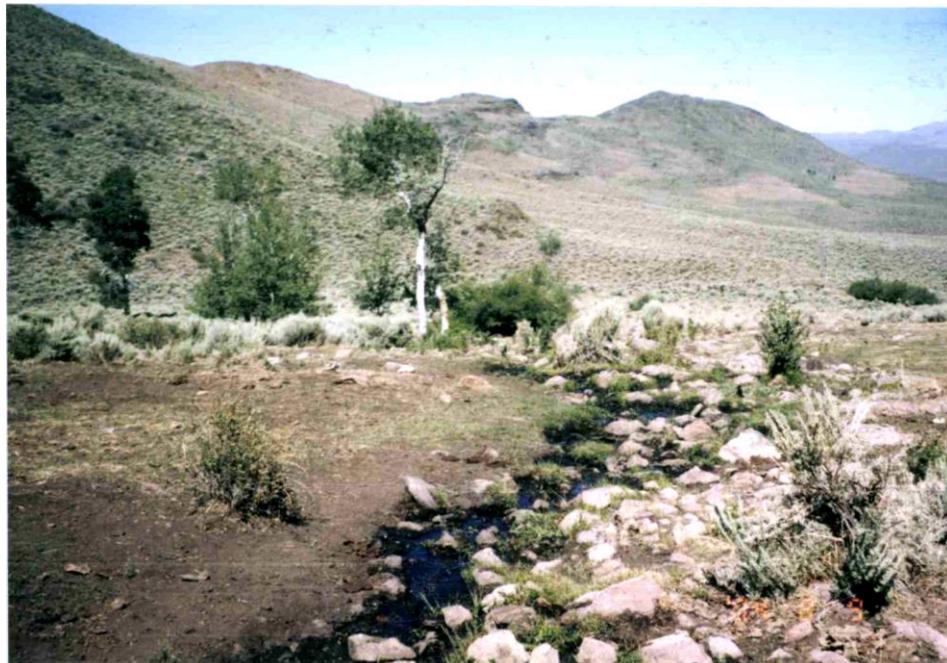
Riparian area is about 0.12 acres in size and is supported by several spring sources. Two of these sources have measurable overland flow for a total of 2.8 gallons per minute (gpm). The springs are within an approximately 15 acre liberty pipe enclosure which has been in place since about 2006. Lentic assessments in 2004 and 2013 both rated the riparian area nonfunctional (NF). Assessment teams observed that in the past this spring complex had supported a much larger riparian area as evidenced by adjacent soils and vegetation along with the dependable high rate of flow from the spring. Long term grazing at this site has resulted in narrowing of the riparian area due to erosion of riparian soils and channelization of the spring outflow. This has resulted in a substantial loss in ability of the riparian area to retain water during periods of higher flow. The presence of riparian soils and vegetation is well below potential due to these hydrologic impacts along with long term effects of persistent grazing and hoof action. The site has shown some improvement due to installation of the enclosure, but riparian vegetation recovery has been slow due to heavy past impacts. In addition, the liberty pipe enclosure has been breached on occasion and cattle have not been completely excluded from the site.

Photo 1 - Riparian area assessed for the 2004 Stag Mountain 42 assessment. Large areas of bare soil are present along with little riparian vegetation.

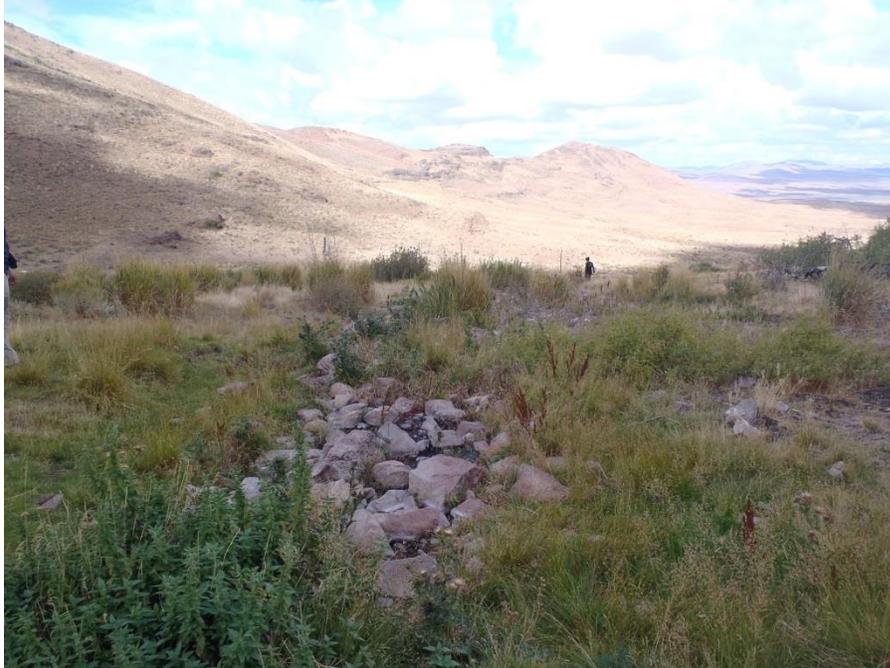
Photo 2 – Repeat of Photo 1 taken as part of the 2013 Stag Mountain 42 assessment. More vegetation is present, but most of the vegetation seen is not riparian and therefore site stability is only minimally improved. Development of riparian vegetation and soils, and lateral expansion of the riparian area will take considerable time.

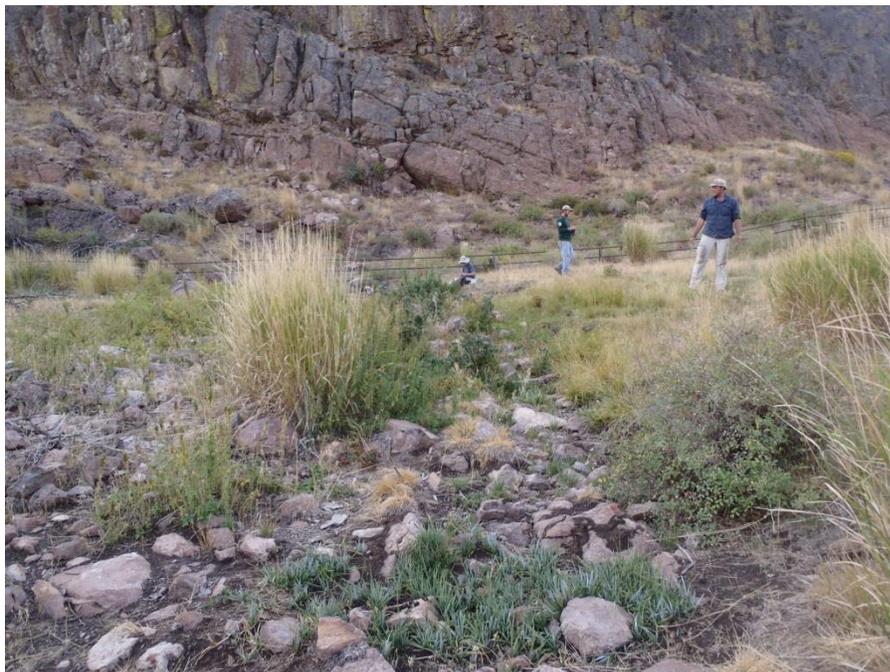
Photo 3 – Looking upstream at one of the spring sources during the 2013 Stag Mountain 42 assessment. The liberty pipe enclosure can be seen at the base of the cliff.

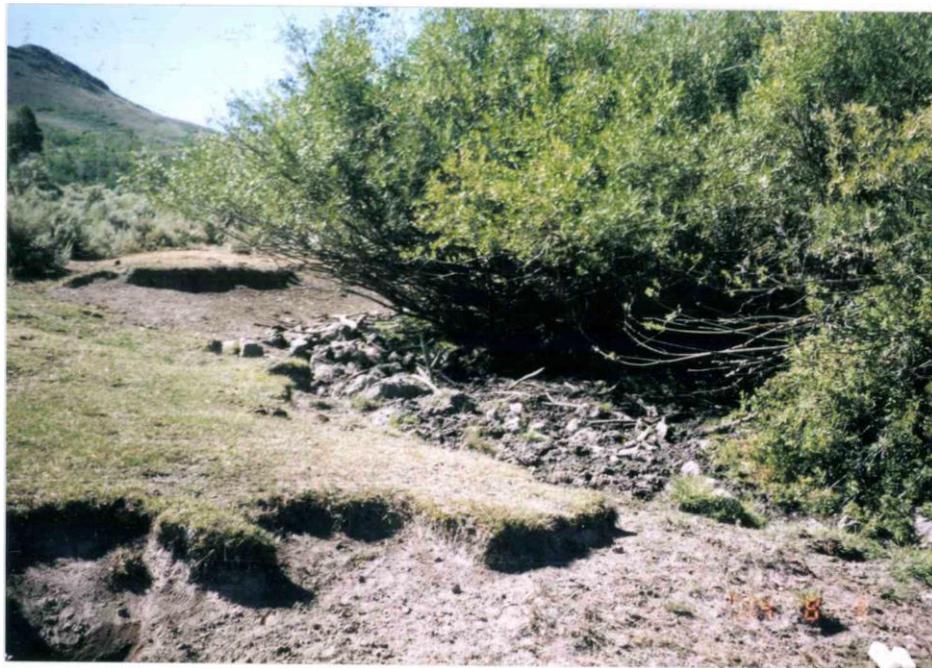
Riparian area is about 0.25 acres in size and is supported by a spring source which flows six gpm. Flow from Stag Mountain 42 may be resurfacing at Stag Mountain 41. The spring is in the same liberty pipe enclosure as Stag Mountain 42. This site was rated NF in 2004 but the 2013 team rated it as FARU. Heavy livestock impacts had resulted in large areas of bare soil in 2004, but not all of the riparian soils had eroded, and some stabilizing willows and herbaceous riparian plants remained. Following installation of the liberty pipe enclosure enough riparian vegetation returned to the site that the 2013 assessment team thought the site retained sufficient functionality to be rated as FAR.

Photo 4 - Riparian Area Assessed for the 2004 Stag Mountain 41 assessment. Large areas of bare soil are present due to cattle grazing and hoof action.

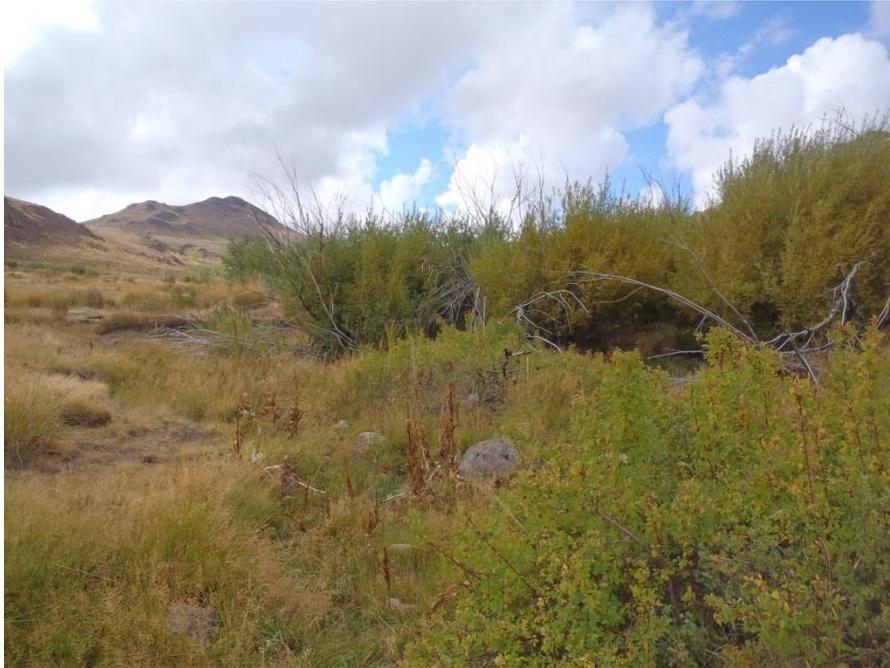
Photo 5 -Repeat of Photo 4 taken as part of the 2013 Stag Mountain 41 assessment. Much of the additional vegetation is not riparian, however riparian vegetation has improved sufficiently enough to improve site stability and reverse erosion.

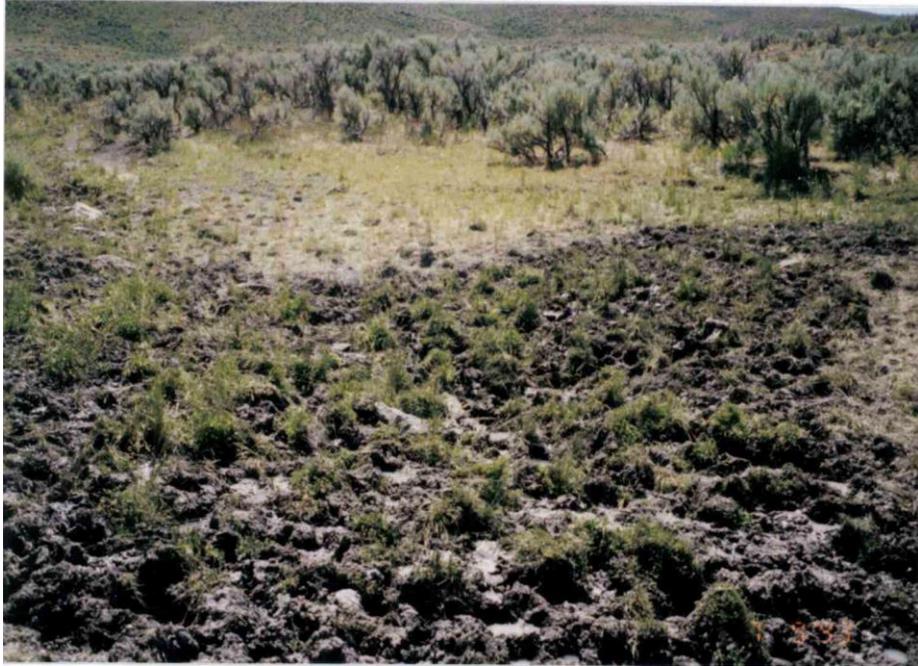
The area assessed is about 0.18 acres in size and is supported by an intermittent spring that was dry in 1980 and 2012, but flowed 0.03 gpm in 1993. This area is not likely riparian, but the team assessed it anyway because it has produced water in the past, and is mapped by the USGS as a spring. There are many other spring sources and riparian areas included in the Stag Mountain assessment with similar characteristics. This area was rated as FARNA because cattle have impacted the site in the past and may have impacted the riparian productivity of the site. This site could have easily been rated PFC, and several similar sites are rated as PFC because they are at or near their capability as a riparian site. Presence or absence of cattle or other activities within the control of the BLM appear to have little impact on the functionality of this and other similar sites with low riparian capability.

Photo 6 – Spring area N40 E57 02ACC inventoried in 1993 showing presence of some water but lack of riparian vegetation and considerable impacts from grazing and hoof action.

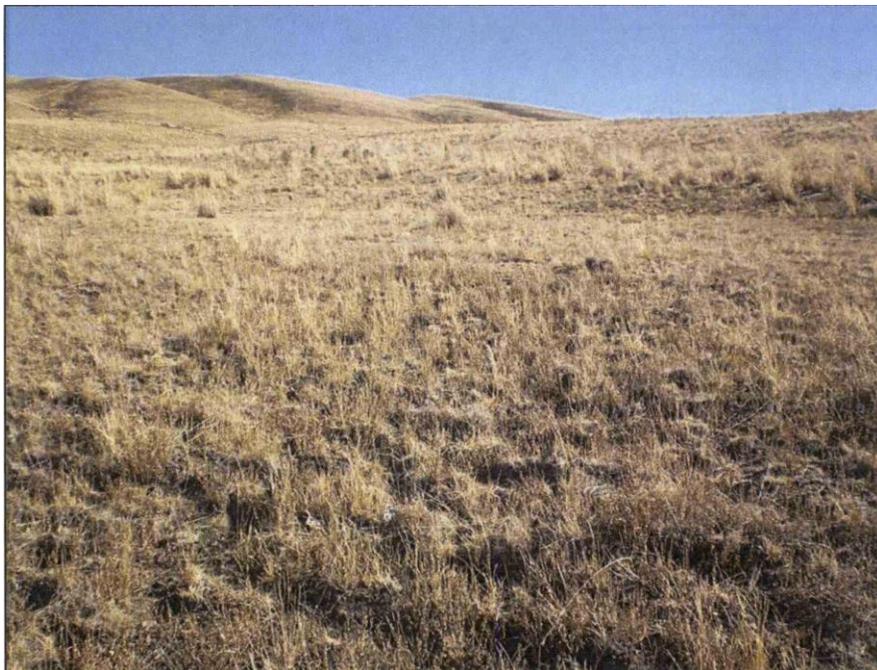
Photo 7 – Repeat of photo 5 showing area assessed for the 2012 Stag Mountain 81 assessment. Soils are completely dry and there is no riparian vegetation.

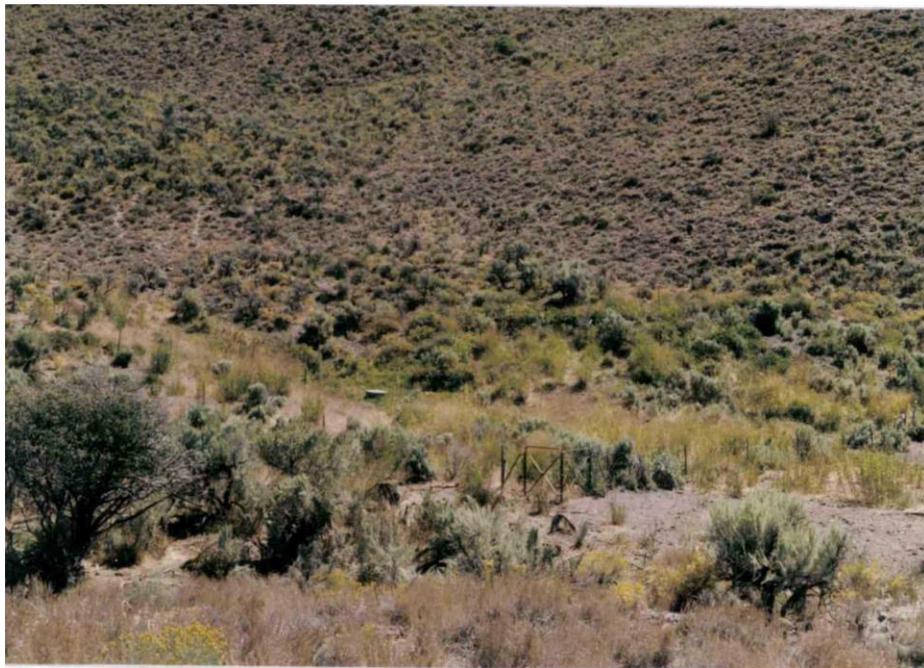
Riparian area is about 0.02 acres in size and is supported by a spring source that flows about two gpm. The spring is within a livestock exclosure and a portion of water produced by the spring is diverted into troughs outside the exclosure. The riparian area had been impacted heavily in the past but the assessment team indicated there was some new establishment of riparian vegetation of banks and rated the site FARU. It is possible that riparian area might be more extensive and the site might be more stable in the absence of the diversion, but this site has retained its functionality and is improving due to the livestock exclosure.

Photo 8– Spring area N40 E57 12 DDD inventoried in 1993 showing water diversion and exclosure.

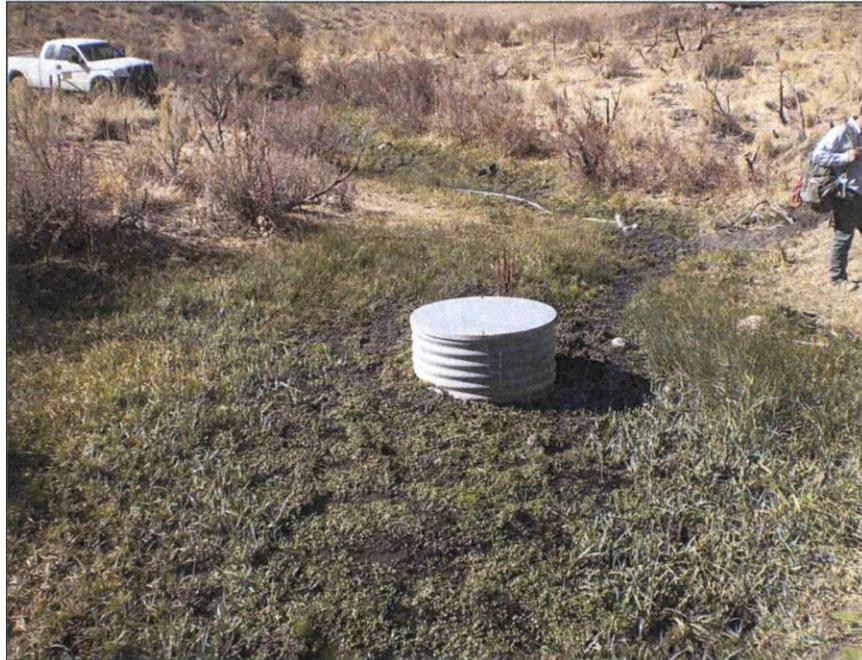
Photo 9 – Area assessed for the 2012 Stag Mountain 82 assessment taken in the same general area as photo 8. Riparian vegetation and revegetation of banks is shown.

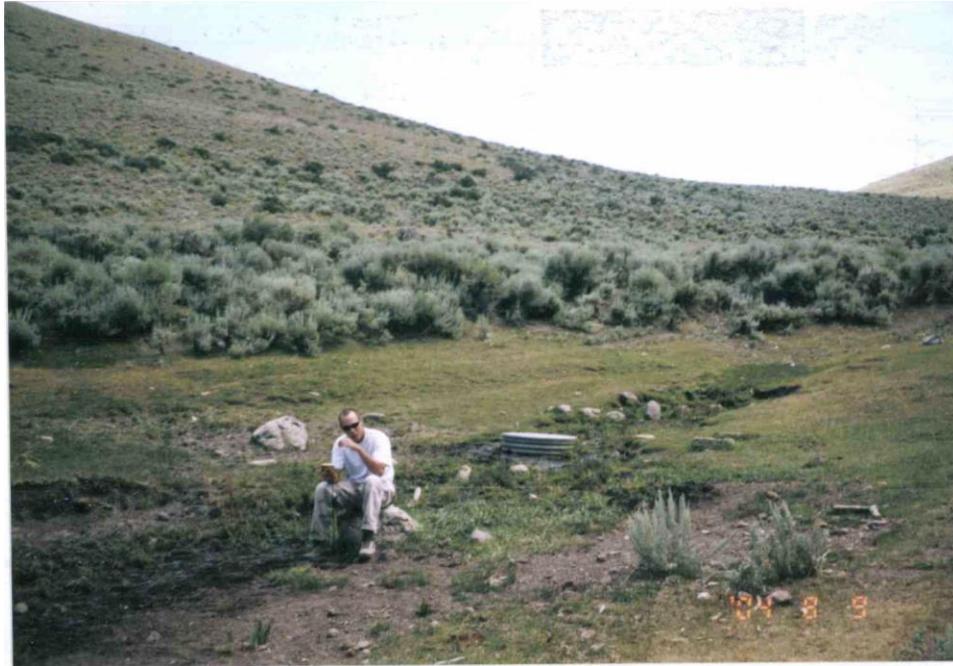
Riparian area is about 0.11 acres in size and is supported by a spring source that flows about one gpm. A portion of water produced by the spring is diverted into a storage tank and livestock watering trough adjacent to the spring. This is an area of livestock concentration and therefore grazing and hoof action have affected riparian functionality. The site was rated as FARD in 2004 and NF in 2012. Large areas of bare ground are present, and sufficient vegetative diversity, composition, and vigor are not present. Notes recorded in 1980 indicate that the diversion and trough were present, and that livestock trampling was heavy, but that vegetation was still in good condition.

Photo 10 - Riparian Area Assessed for the 2004 Stag Mountain 48 assessment. Riparian soils in the area around the spring source have been eroded and compacted.

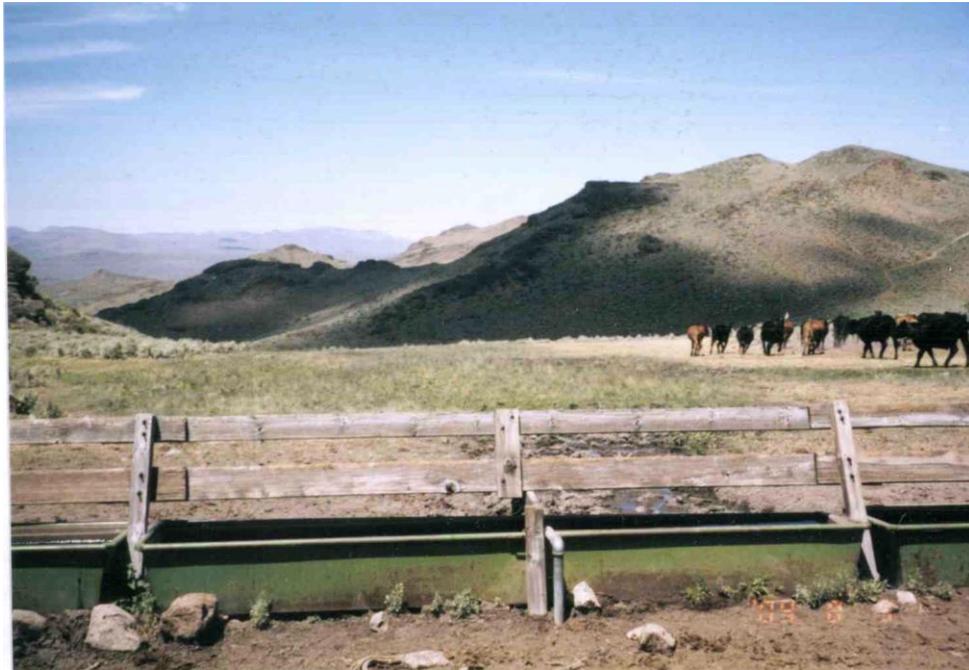
Photo 11 - Riparian Area Assessed for the 2004 Stag Mountain 48 assessment. Large areas of bare ground or upland vegetation are observed adjacent to the livestock watering troughs in areas that may have been riparian area in the distant past.

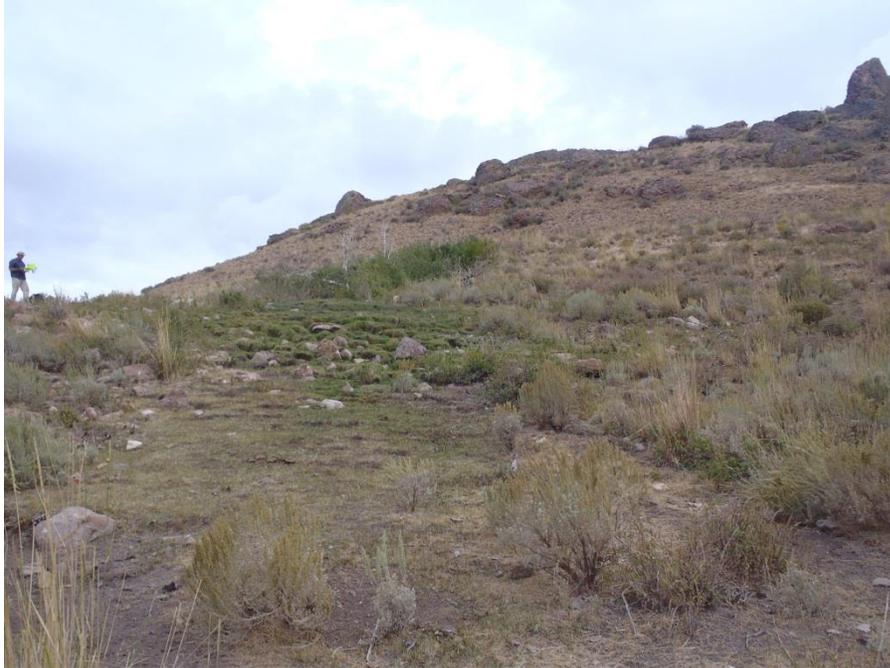
Riparian area is about 2.9 acres in size and is supported by several spring sources with a combined flow of about two gpm. The lentic assessments in 2004 divided the site into three separate areas and rated two of the sites FARS and one of the sites NF. The 2013 assessment combined the area and rated it FARN. Assessment teams observed that in the past this spring complex had supported a much larger riparian area as evidenced by adjacent soils and vegetation along with the dependable high rate of flow from the spring. Long term grazing at this site has resulted in narrowing of the riparian area due to erosion of riparian soils and channelization of the spring outflow. This has resulted in a substantial loss in ability of the riparian area to retain water during periods of higher flow. The presence of riparian soils and vegetation is well below potential due to these hydrologic impacts along with long term effects of persistent grazing and hoof action. In each of the assessments the team was unable to determine a trend in functionality and it appears that the woody vegetation and rock at the site is preventing further degradation, but the continued impacts are high enough that recovery is not occurring. It appears that sheep use at this site is heavy which is common at several riparian sites at high elevations within the allotment. It appears that sheep are not only using these sites for watering, but are spending considerable time at the sites causing soil compaction and altering flow patterns.

Photo 12 - Riparian Area Assessed for the 2013 Stag Mountain 45 assessment. Stressed riparian vegetation and hoof action have destabilized and eroded riparian soils resulting in exposed rock at the surface. As a result, water is no longer stored and potential riparian area on the lower margins is no longer wet during dry periods.

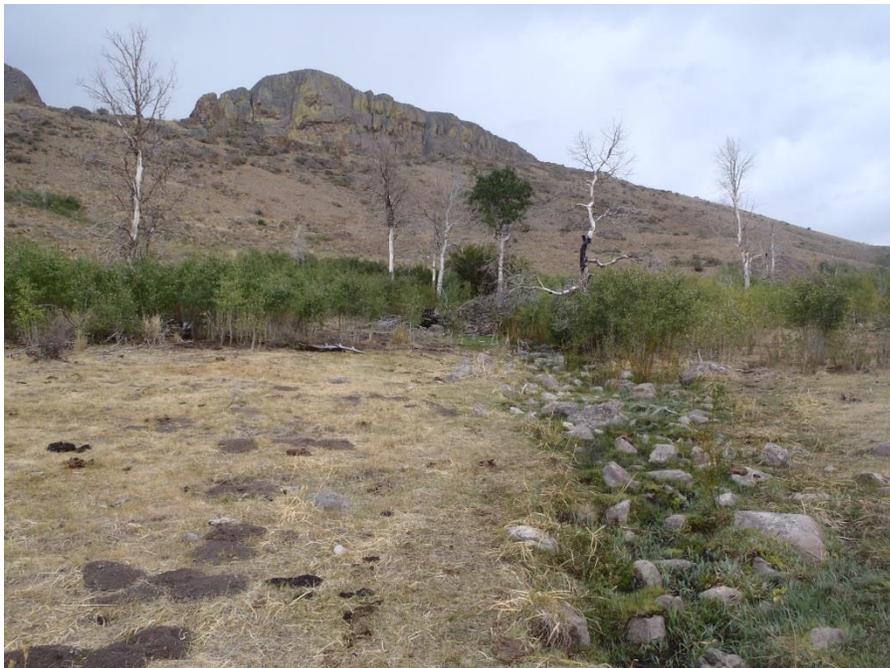
Photo 13 - Riparian Area Assessed for the 2013 Stag Mountain 45 assessment. Stressed riparian vegetation and hoof action have destabilized and eroded riparian soils resulting in exposed rock at the surface. Instead of flowing laterally and watering a wide riparian area, water flows down the channel and may infiltrate into the ground more rapidly. Soils adjacent to the channel are dry and less stable than riparian soils.

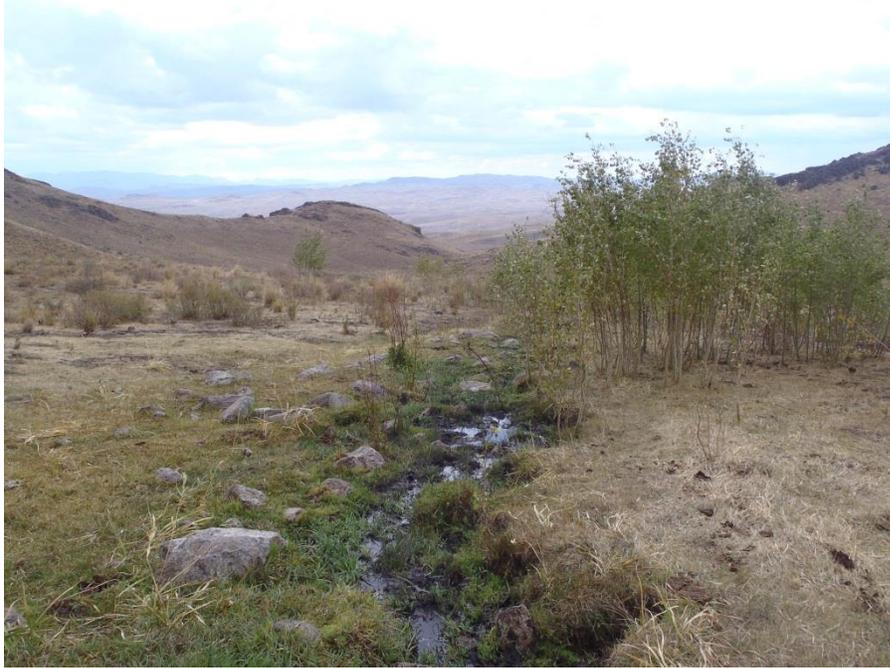
Photo 14 – See comments for photo 13. Sheep use is seen clearly as aspens are devoid of leaves in the lower areas of their trunks.

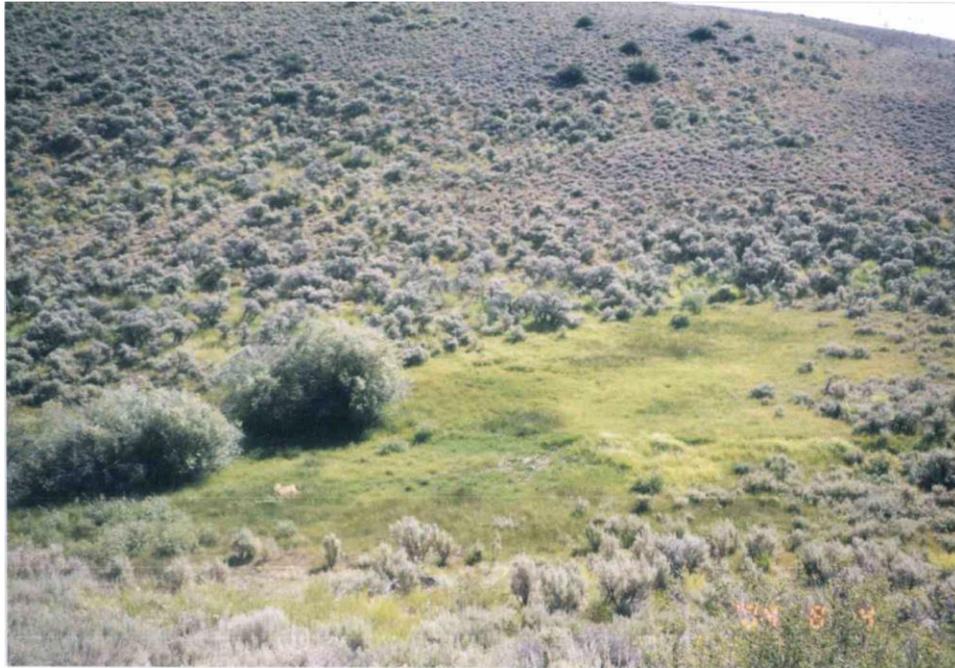
Photo 15 – Riparian area assessed for the 2004 Stag Mountain 19 assessment.

The riparian area consists of a small herbaceous meadow of about 0.62 acres in size. The spring source which feeds this meadow then trickles into a stream channel where it supports a string of willows. The riparian area was assessed in 2004 and rated as being in PFC. Vegetation is vigorous at the site and there was no record of gullyng or livestock related impacts.

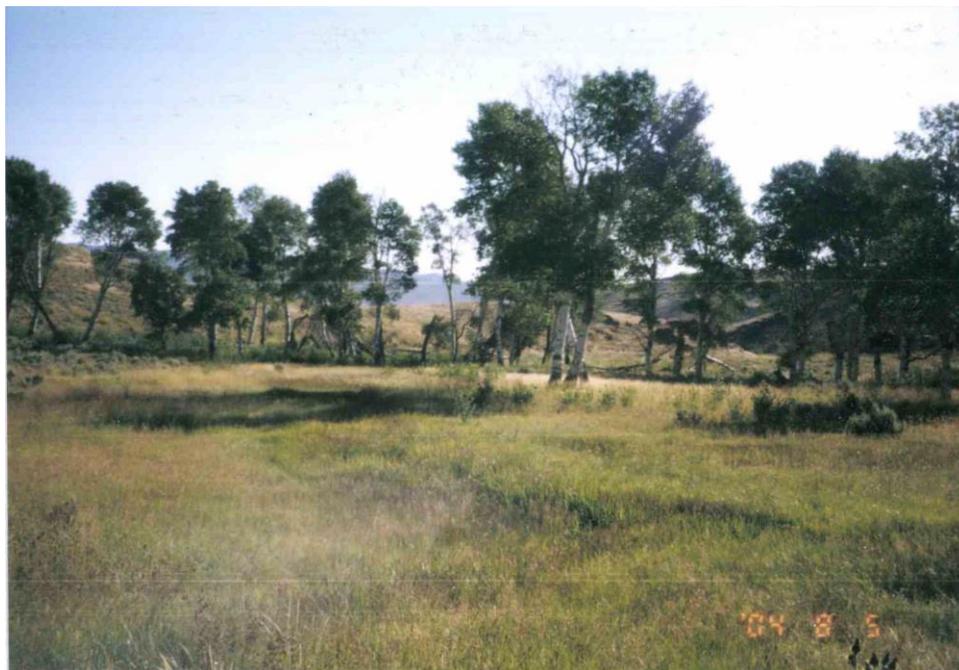
Photo 16 – Riparian area assessed for the 2004 Stag Mountain 32 assessment.

Riparian area is about 0.6 acres in size and is supported by a spring source that flows about 0.5 gpm. Vegetation consists of aspen and herbaceous riparian vegetation. Observers did not record any livestock related impacts and rated the area as being in properly functioning condition in 2004.

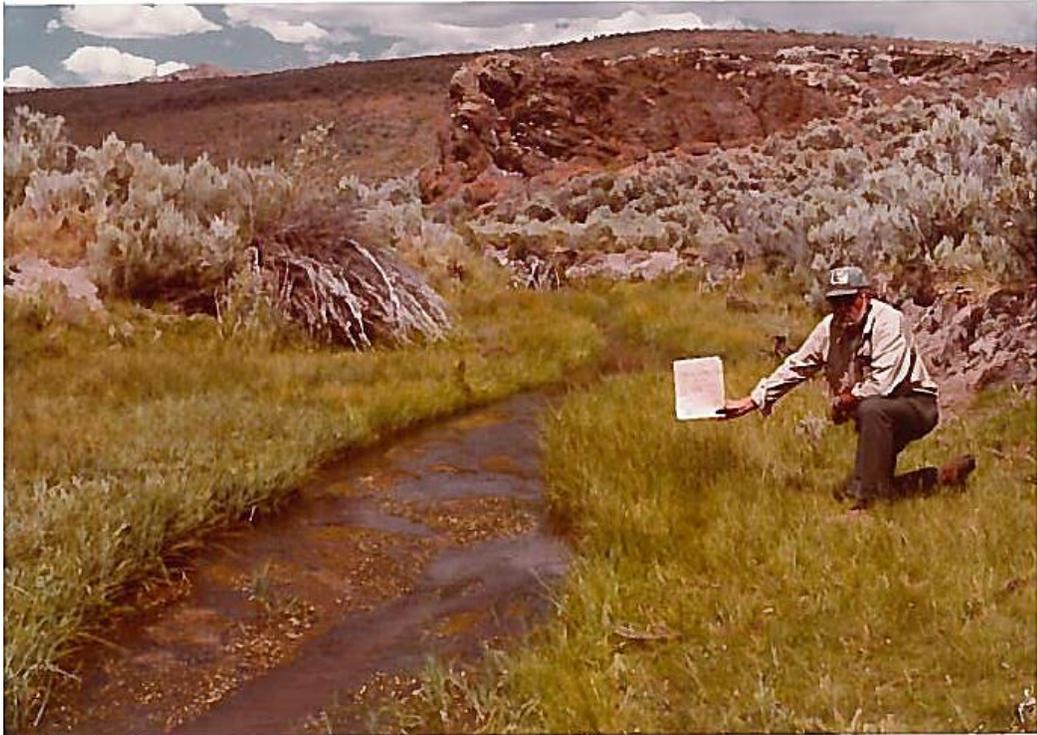
**Photo 18** – Downstream view from East Fork Beaver Creek station 14. Area assessed in 1978.

East Fork Beaver Creek is a perennial system. The Riparian Condition Indices for station 14 was 44 % (fair) for 1978 and 63% (good) in 2009.

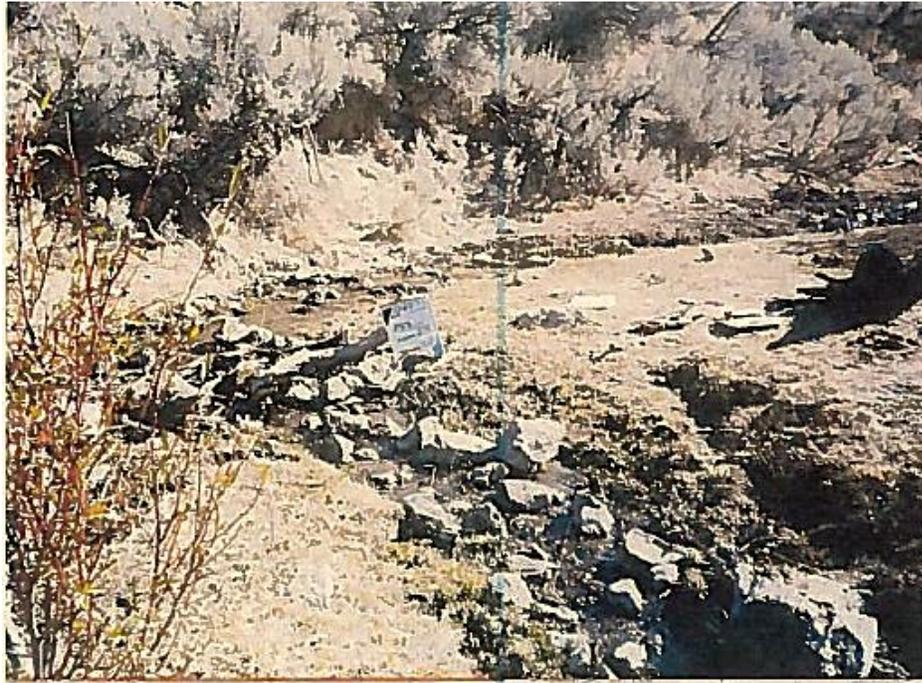
**Photo 20** – Upstream view from Cabin Creek Station 4. Area assessed in 1999.

East Fork Beaver Creek is a perennial system. The Riparian Condition Indices for station 4 was 55 % (fair) for 1978 and 62% (good) in 2010.
