Coronado National Forest Desired Conditions & Fire Recovery

Michele Girard

Watershed Program Manager

Watershed Condition Framework

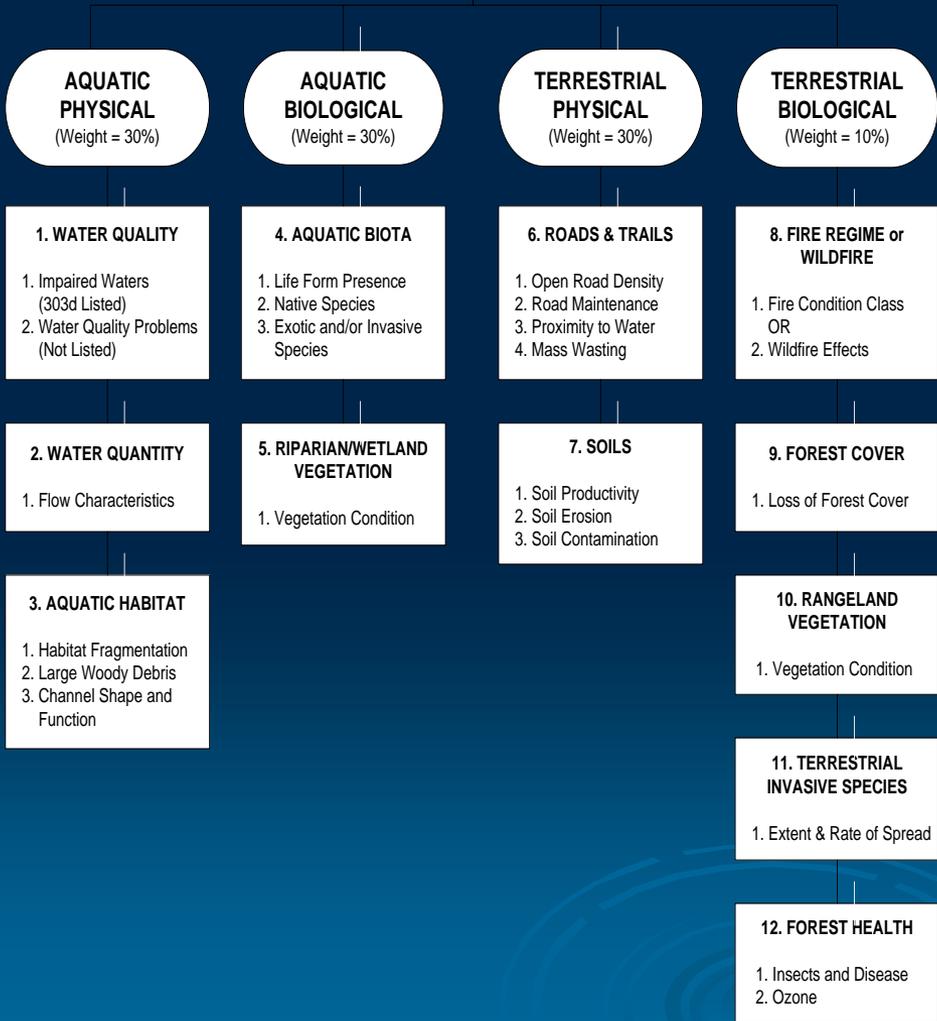
WATERSHED CONDITION INDICATORS (12 Indicator Model)

1. Water Quality
2. Water Quantity
3. Aquatic Habitat
4. Aquatic Biota
5. Riparian/Wetland Vegetation
6. Roads and Trails
7. Soils
8. Fire Regime or Wildfire
9. Forest Cover
10. Rangeland Vegetation
11. Terrestrial Invasive Species
12. Forest Health

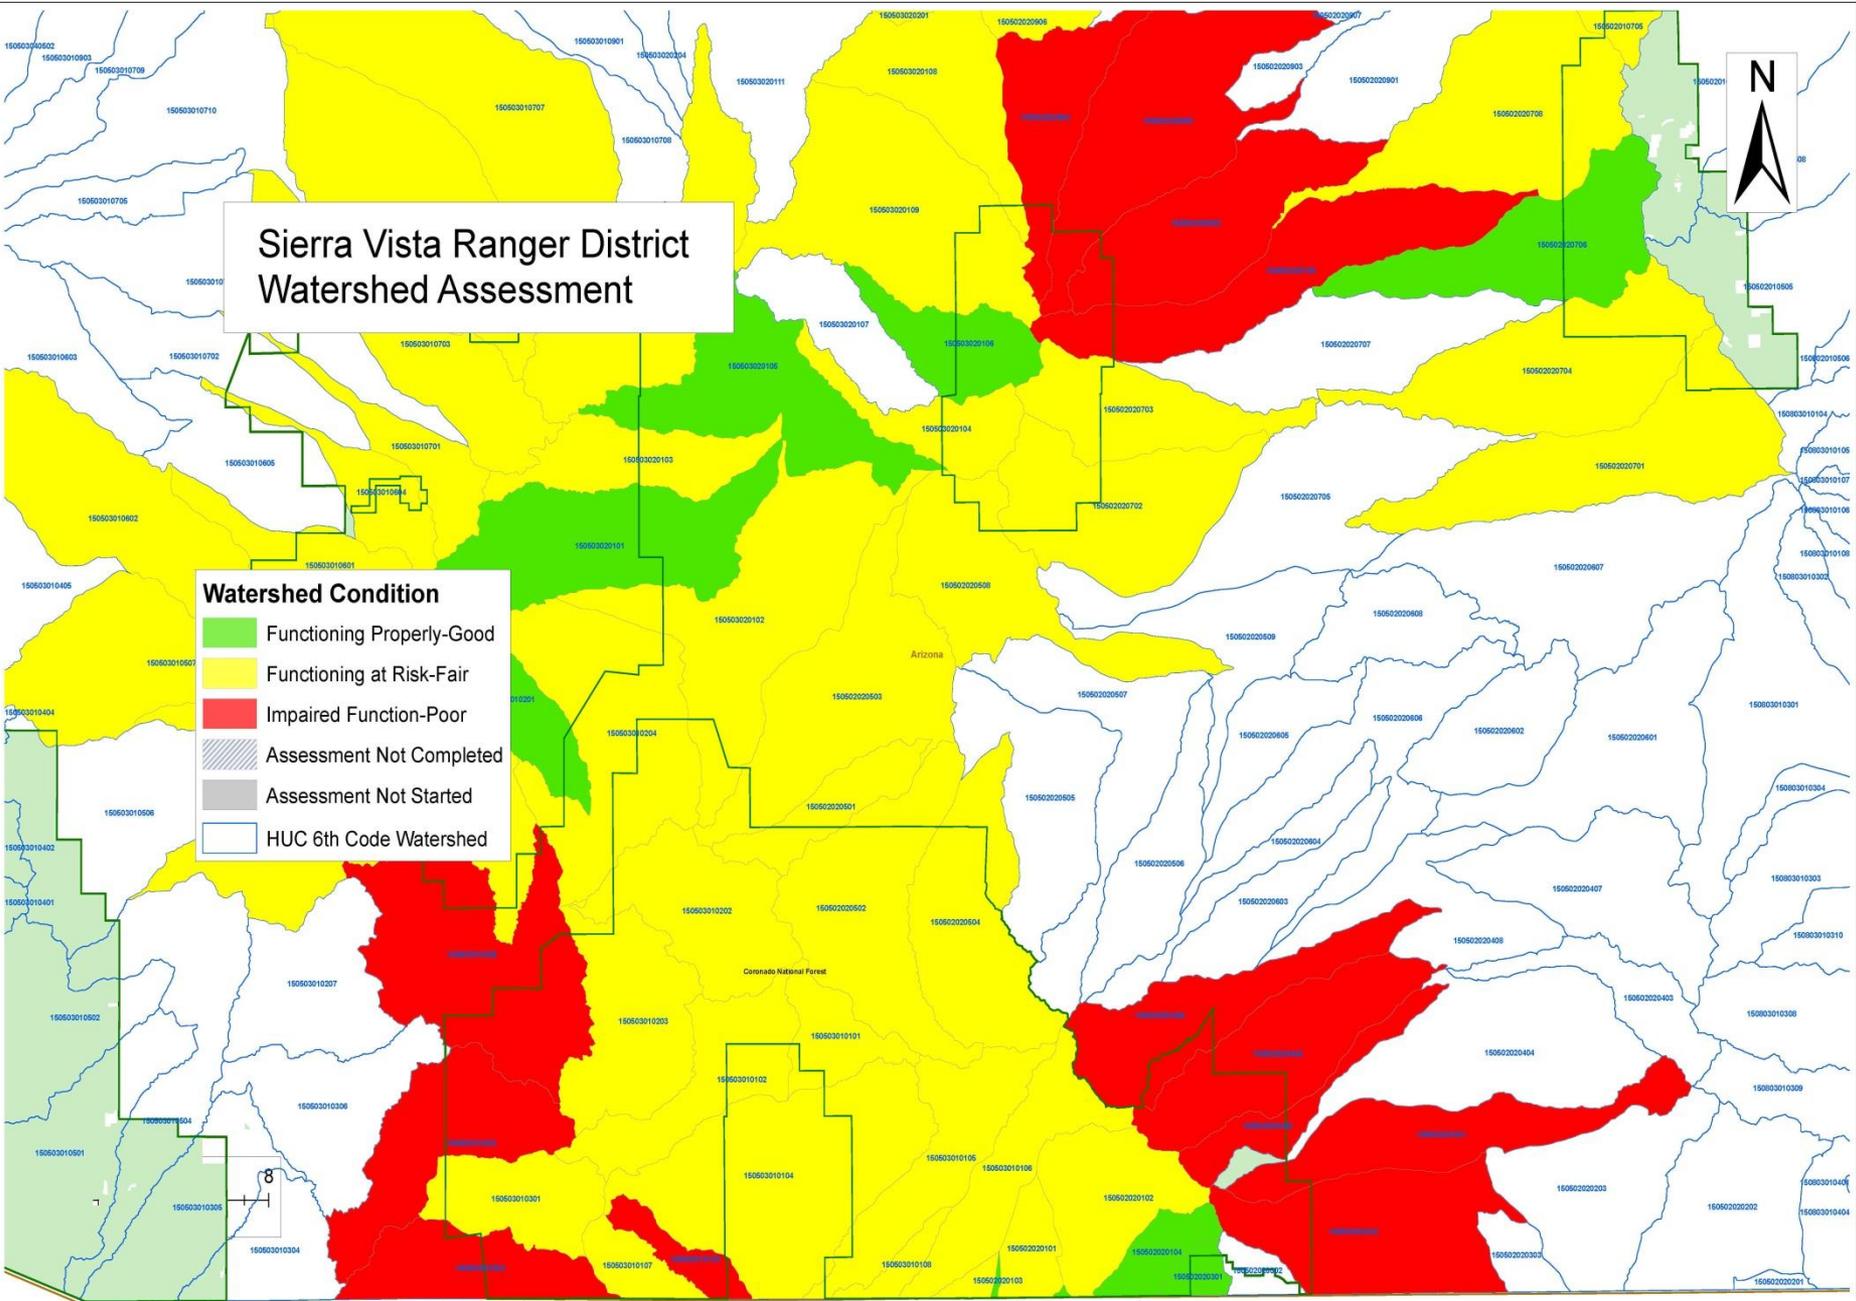
Sierra Vista Ranger District Watershed Assessment

Watershed Condition Issues in Miller Canyon 6th Code

- Fragmentation
 - Habitat
 - Drainages
- Urban development
- Road density and maintenance
- Fire condition class
- Invasive species

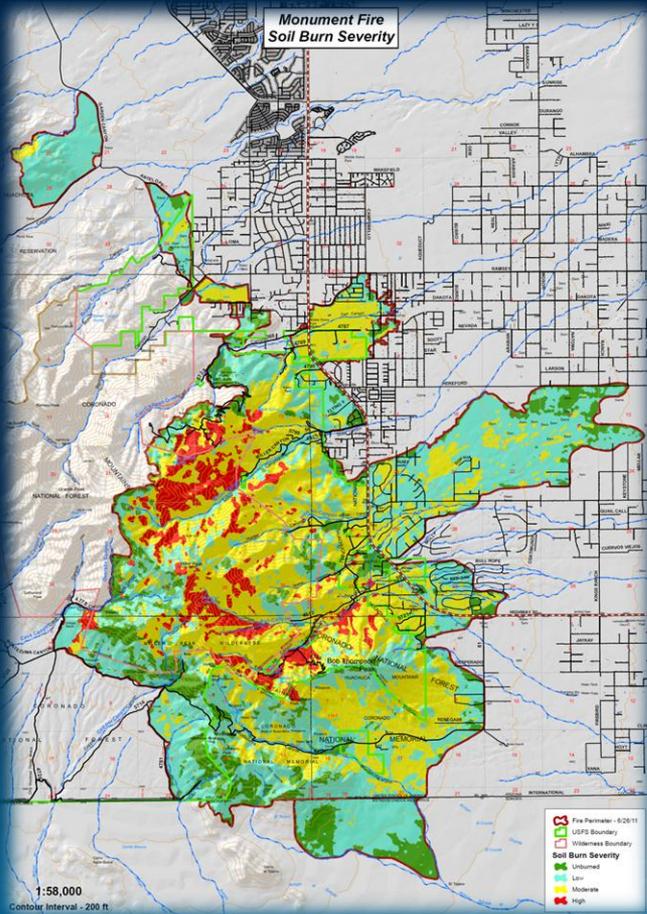
Monument Fire

Soil Burn Severity	Acres	Percent
High	2318	7.3%
Moderate	12493	39.0%
Low	12946	40.0%
Unburned	4317	13.7%
Total	32,074

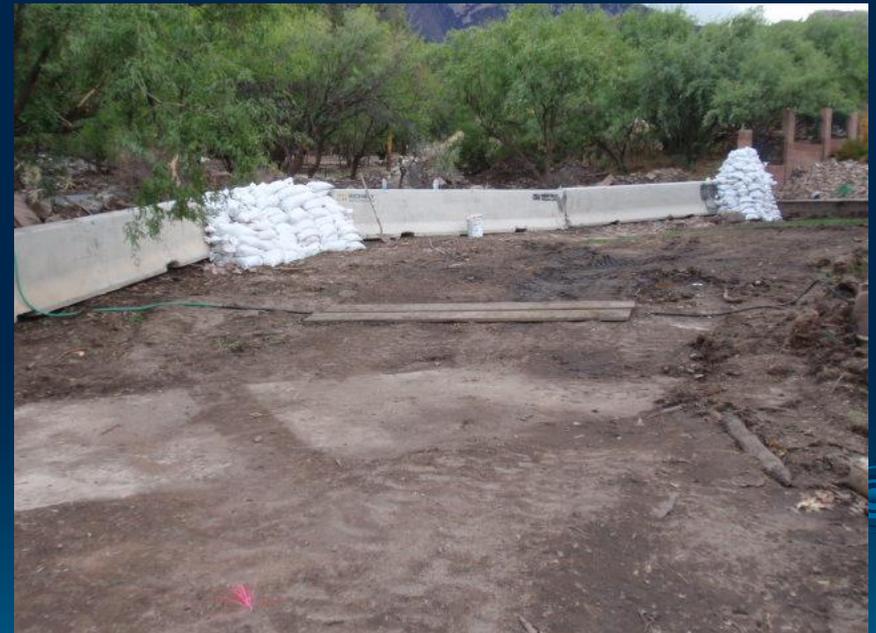
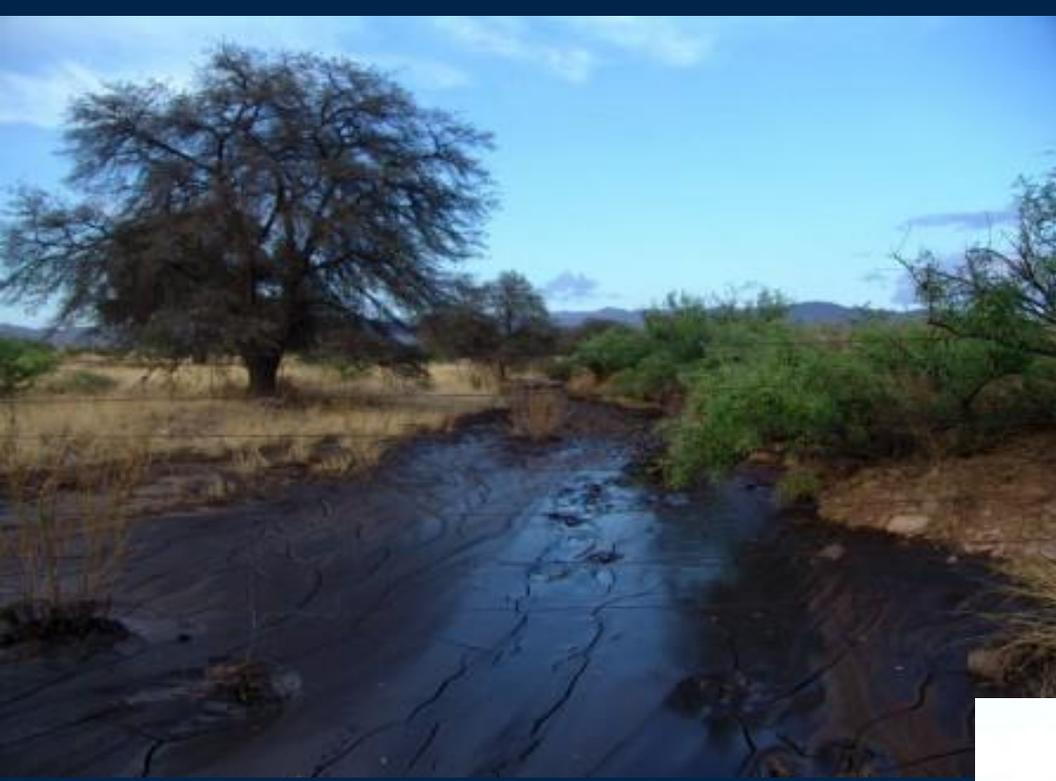
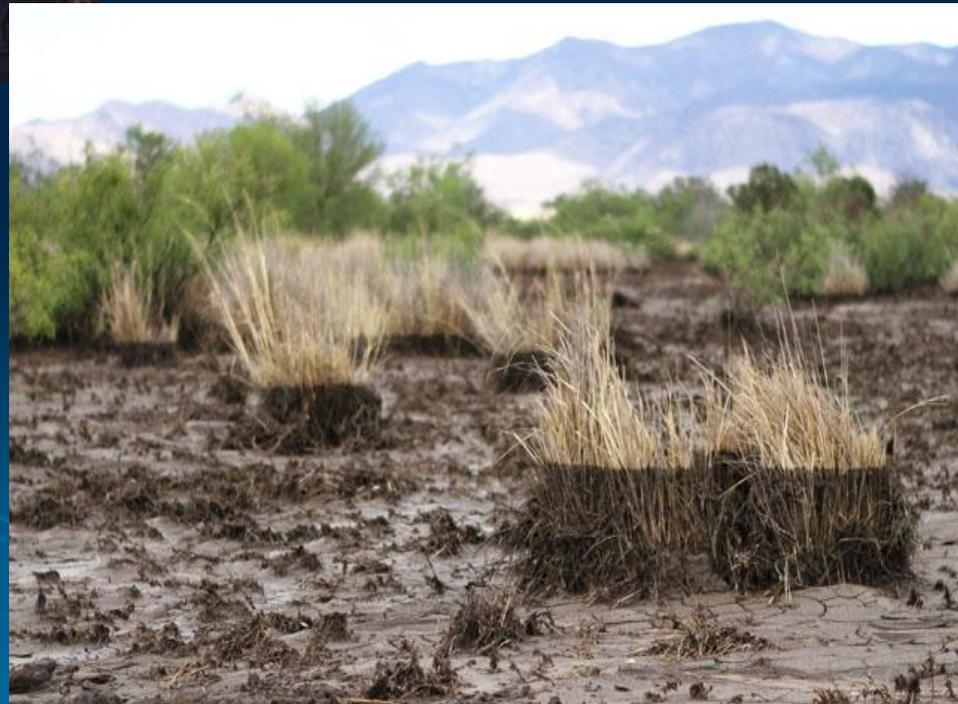
BAER Treatments

- Seeding
- Heli-mulching
- Sand bagging
- Clear drainages
- Road maintenance
- Fence repair
- Flood warning systems
- Invasive species treatment & monitoring
