Summary of Analysis*

Area Unique Identifier: UT-C010-117A, B, C & D-The Toad

Current Conditions: Presence or Absence of Wilderness Characteristics (Form 2)

WILDERNESS CHARACTERISTICS INVENTORY
APPENDIX C – ROUTE ANALYSIS¹

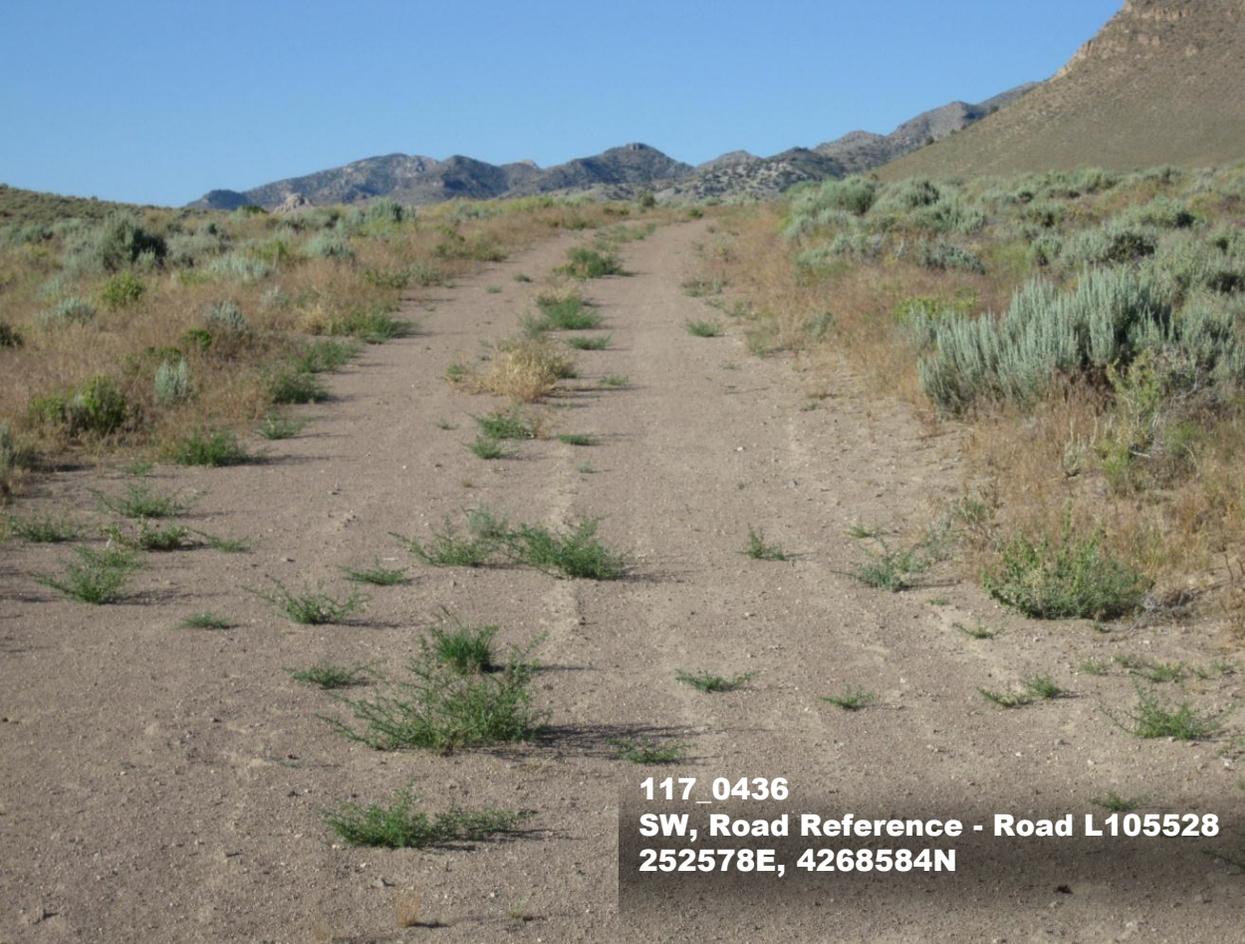
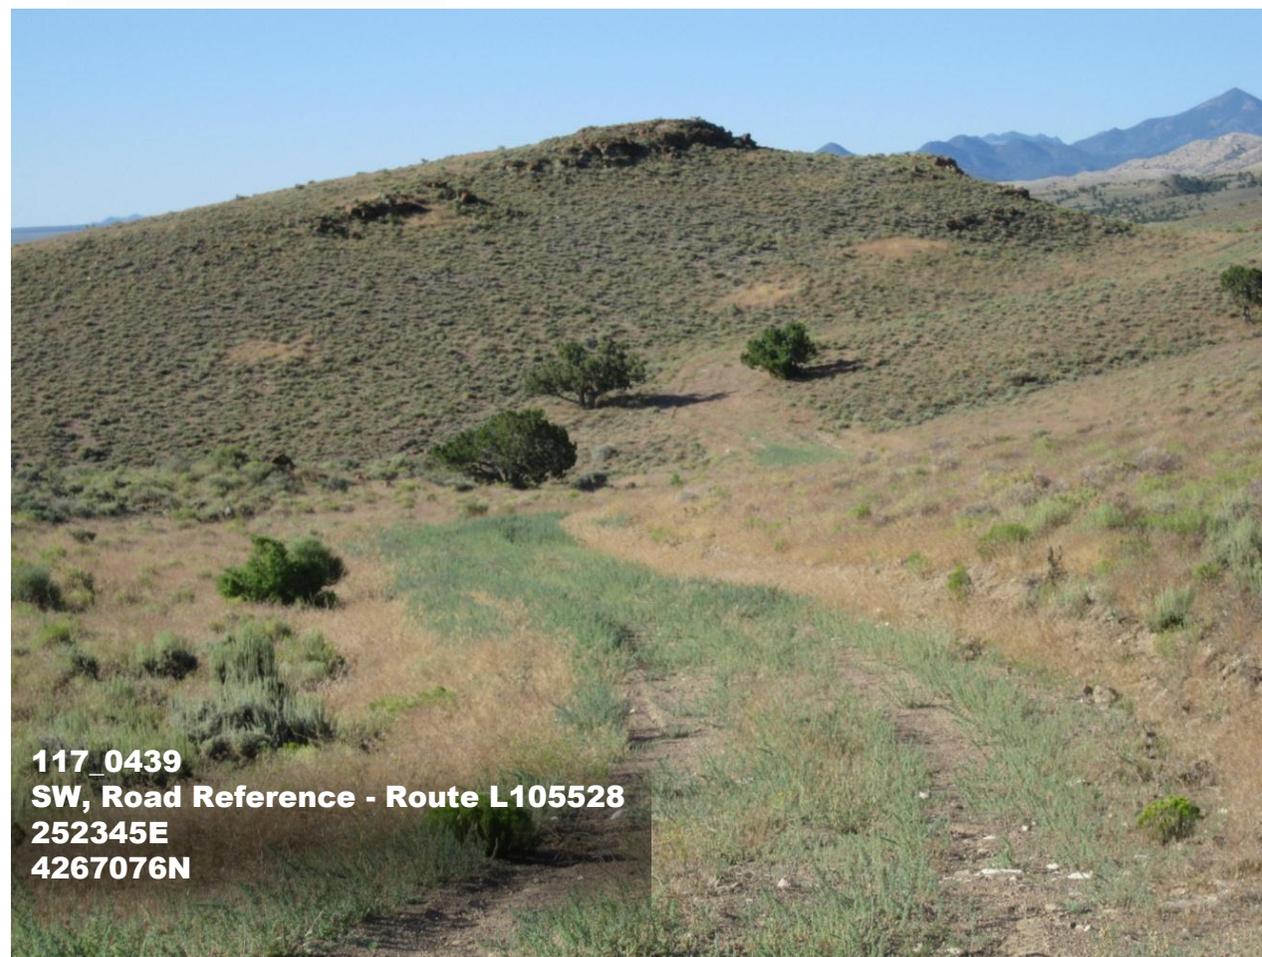
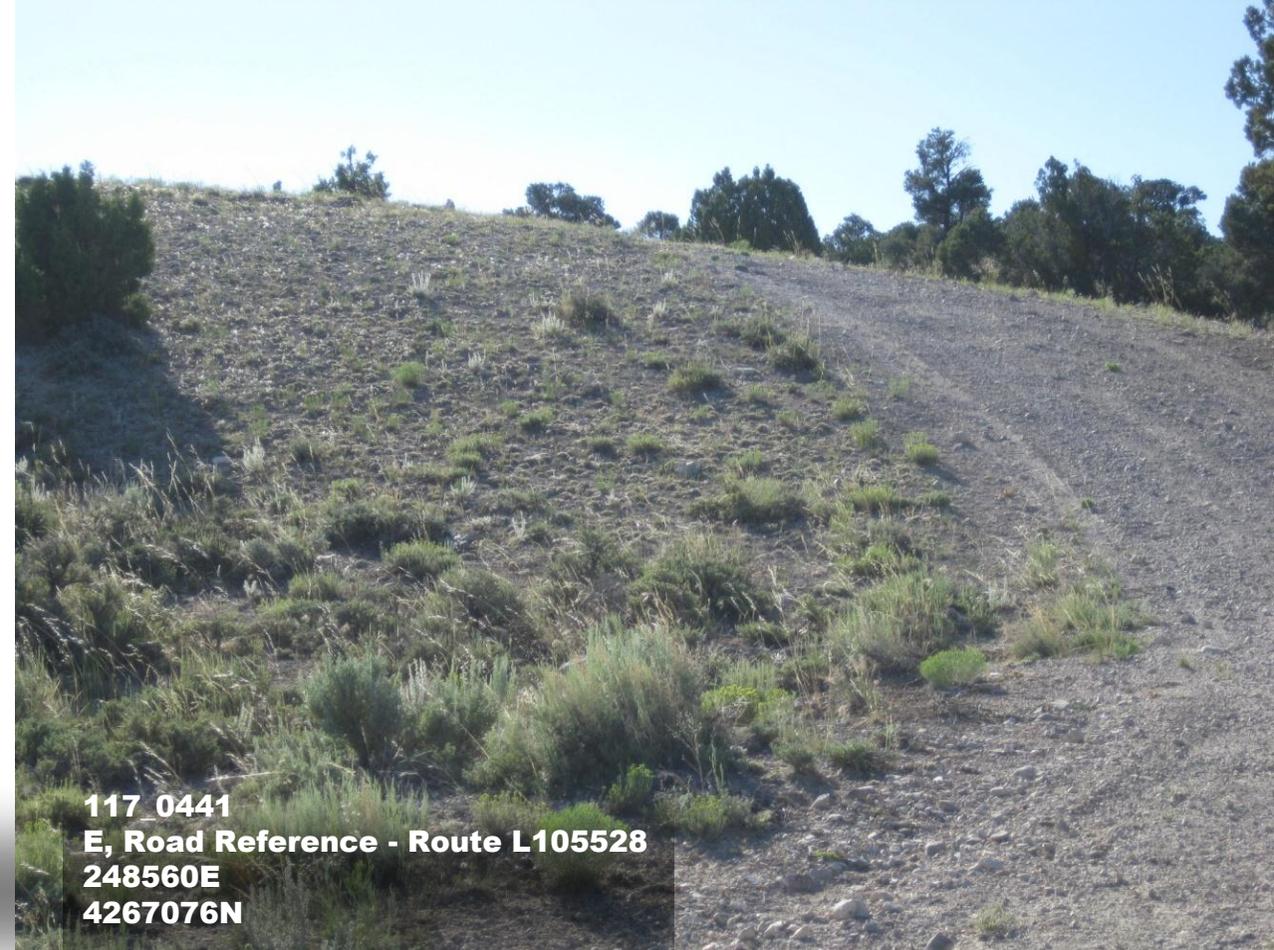
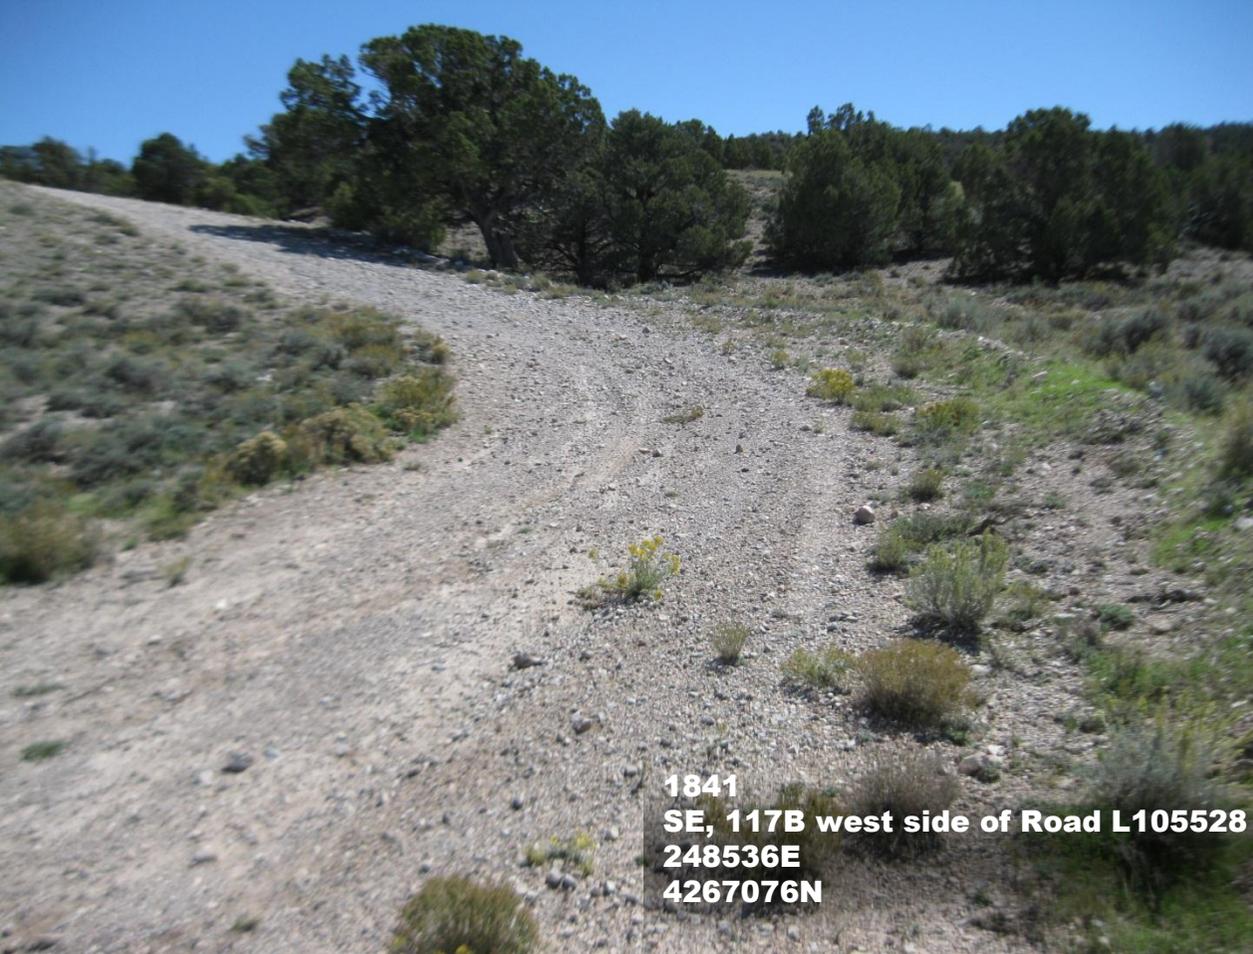
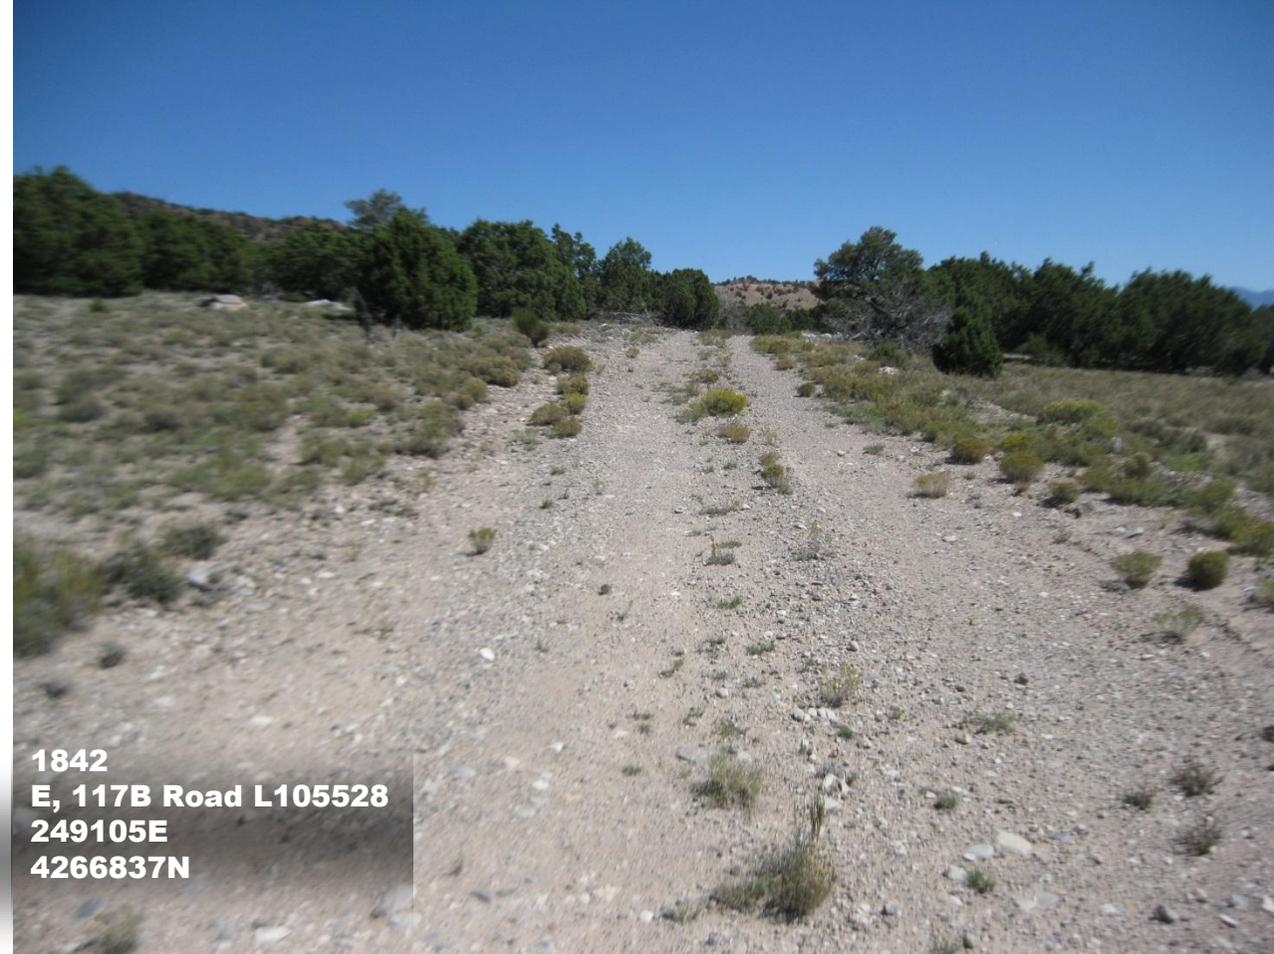
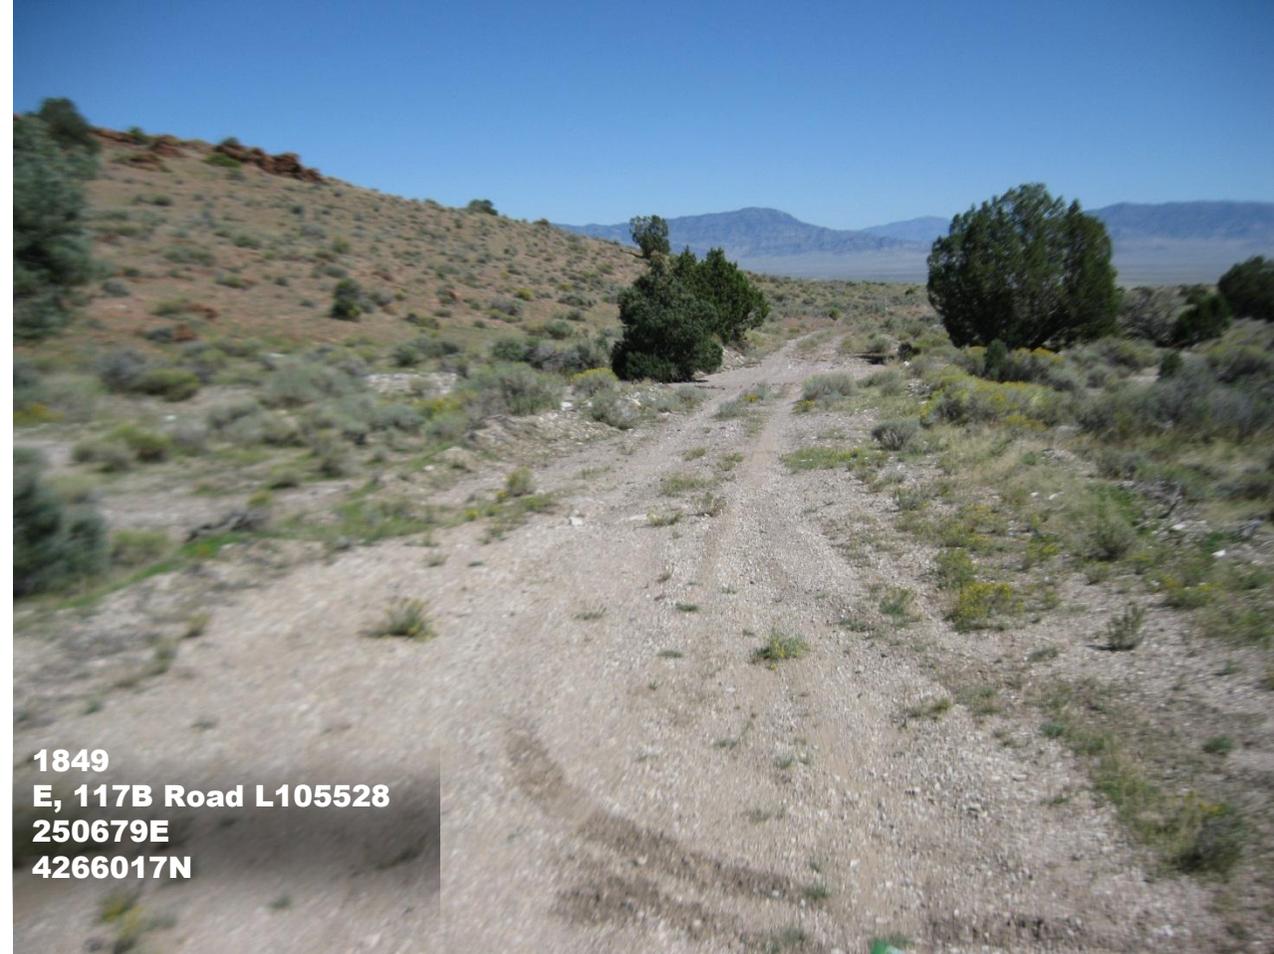
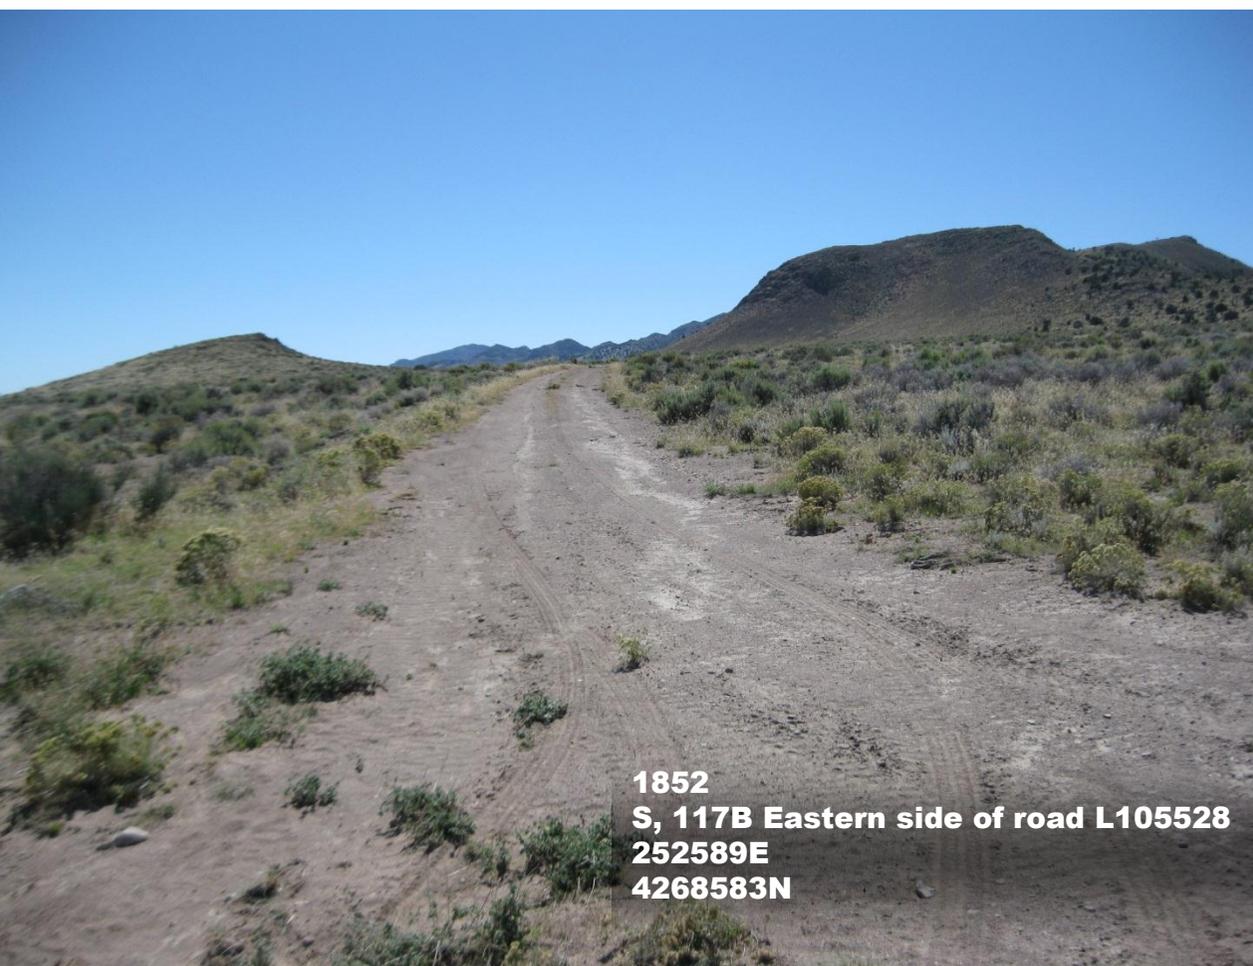
117_0436
SW, Road Reference - Road L105528
252578E, 4268584N

117_0439
SW, Road Reference - Route L105528
252345E
4267076N

117_0441
E, Road Reference - Route L105528
248560E
4267076N

1841
SE, 117B west side of Road L105528
248536E
4267076N

1842
E, 117B Road L105528
249105E
4266837N

1849
E, 117B Road L105528
250679E
4266017N

1852
S, 117B Eastern side of road L105528
252589E
4268583N

Describe: This is a very wide bladed road

Describe: There are large berms on the side of the road and it has been bladed.

Explain: The road has been bladed in the recent past since there is little vegetation on the road bed.

Describe: Vehicle tracks on the route and the vegetation in the middle of the route is significantly smaller than vegetation adjacent to the route.

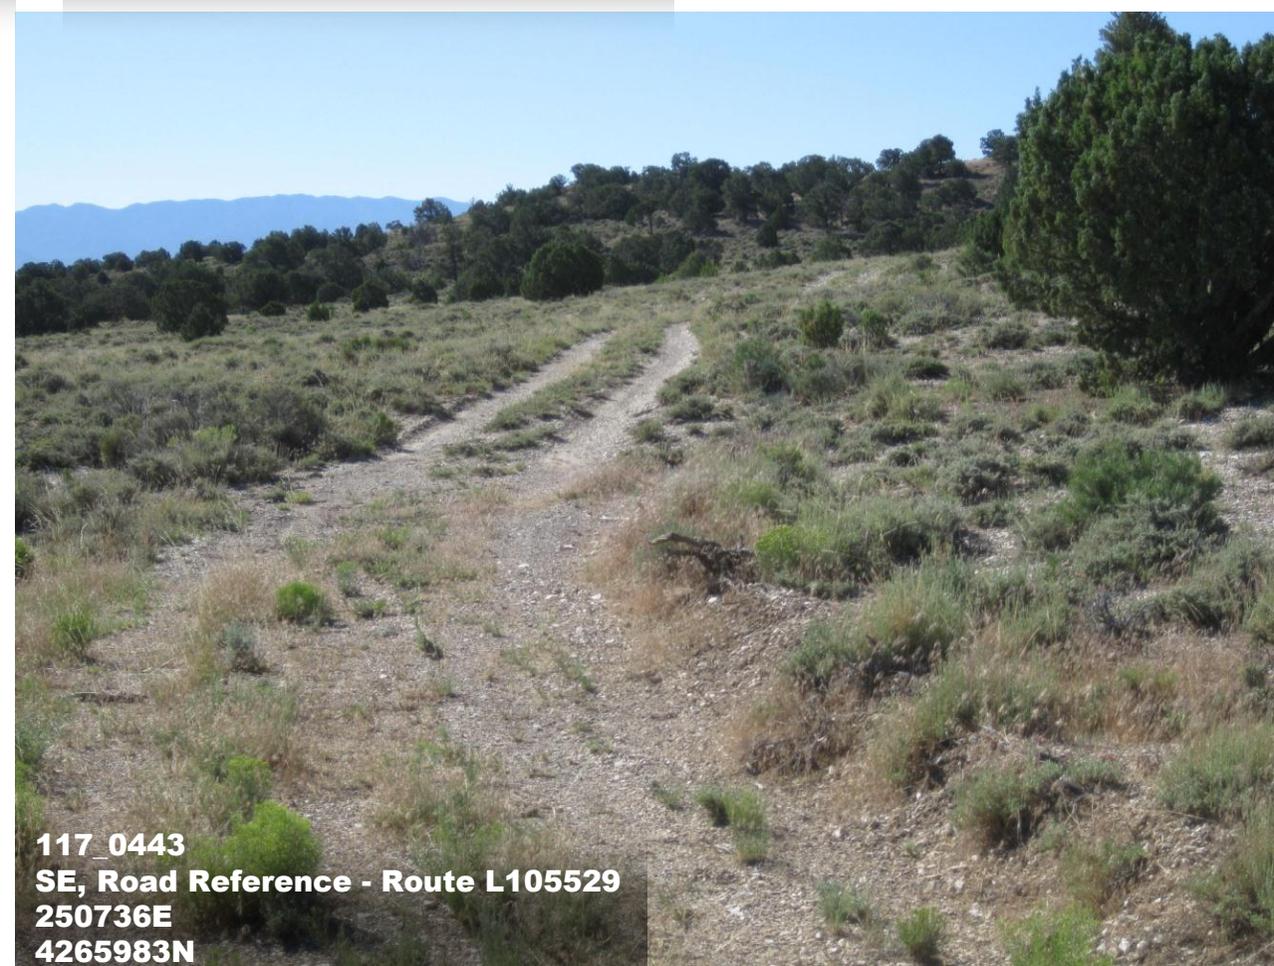
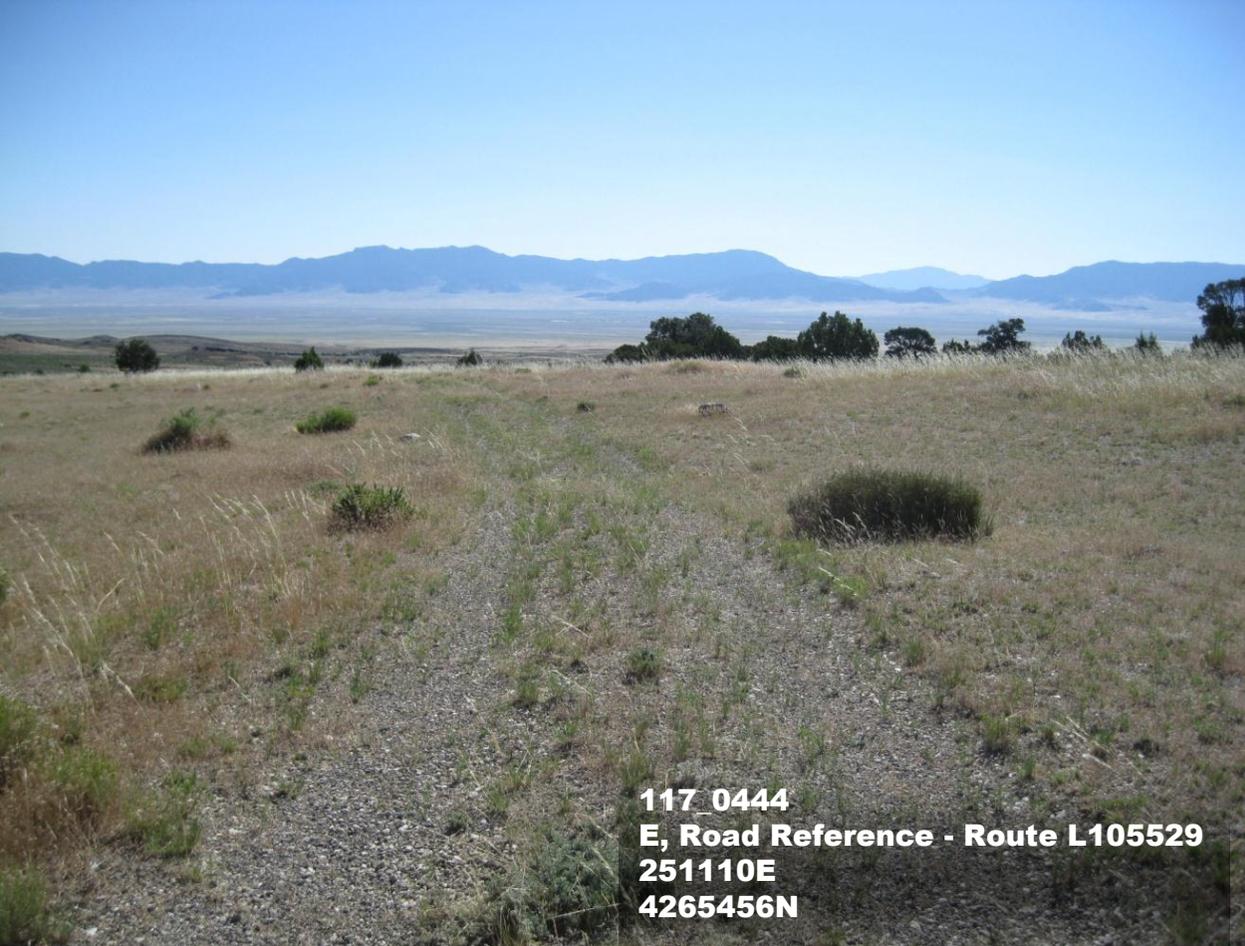
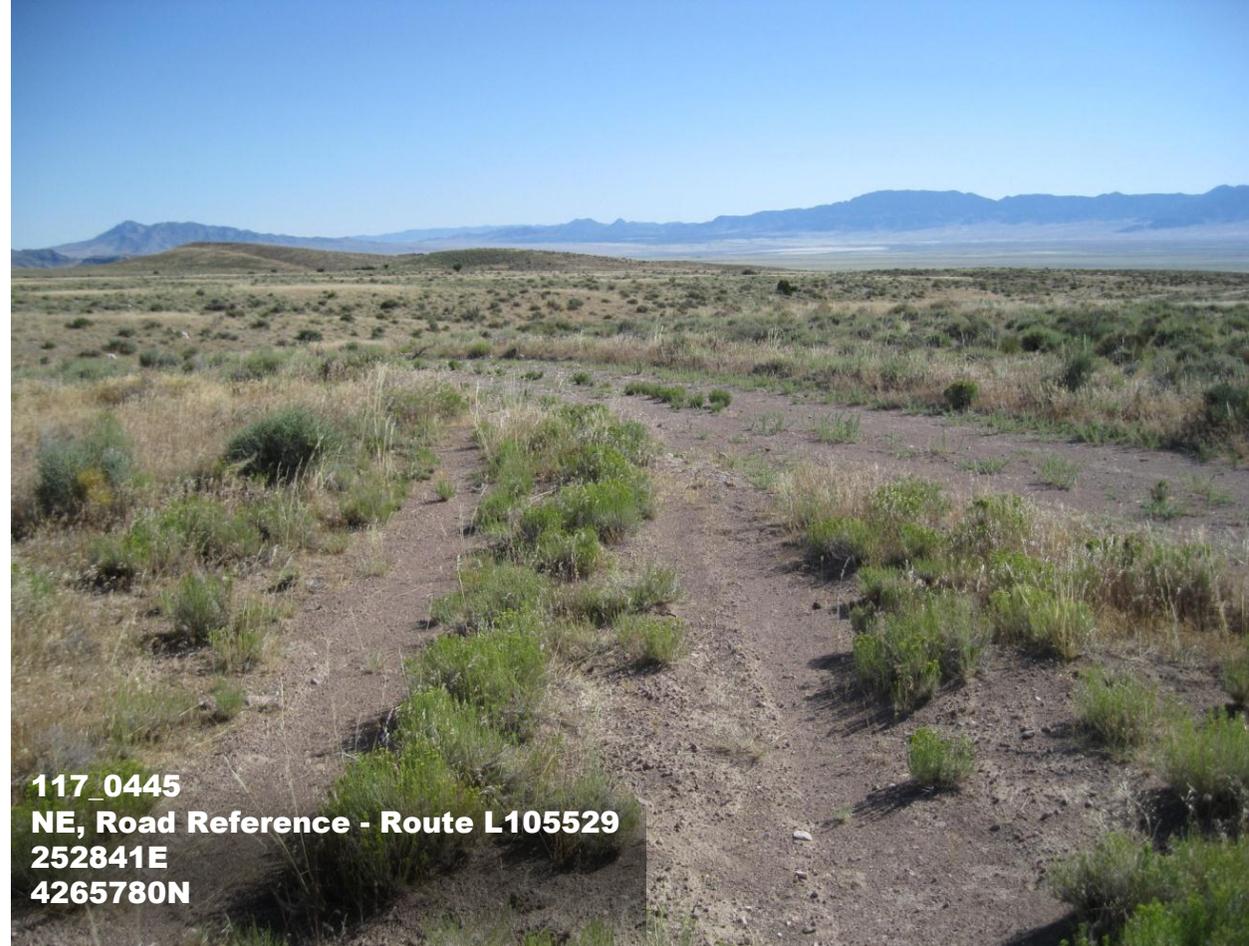
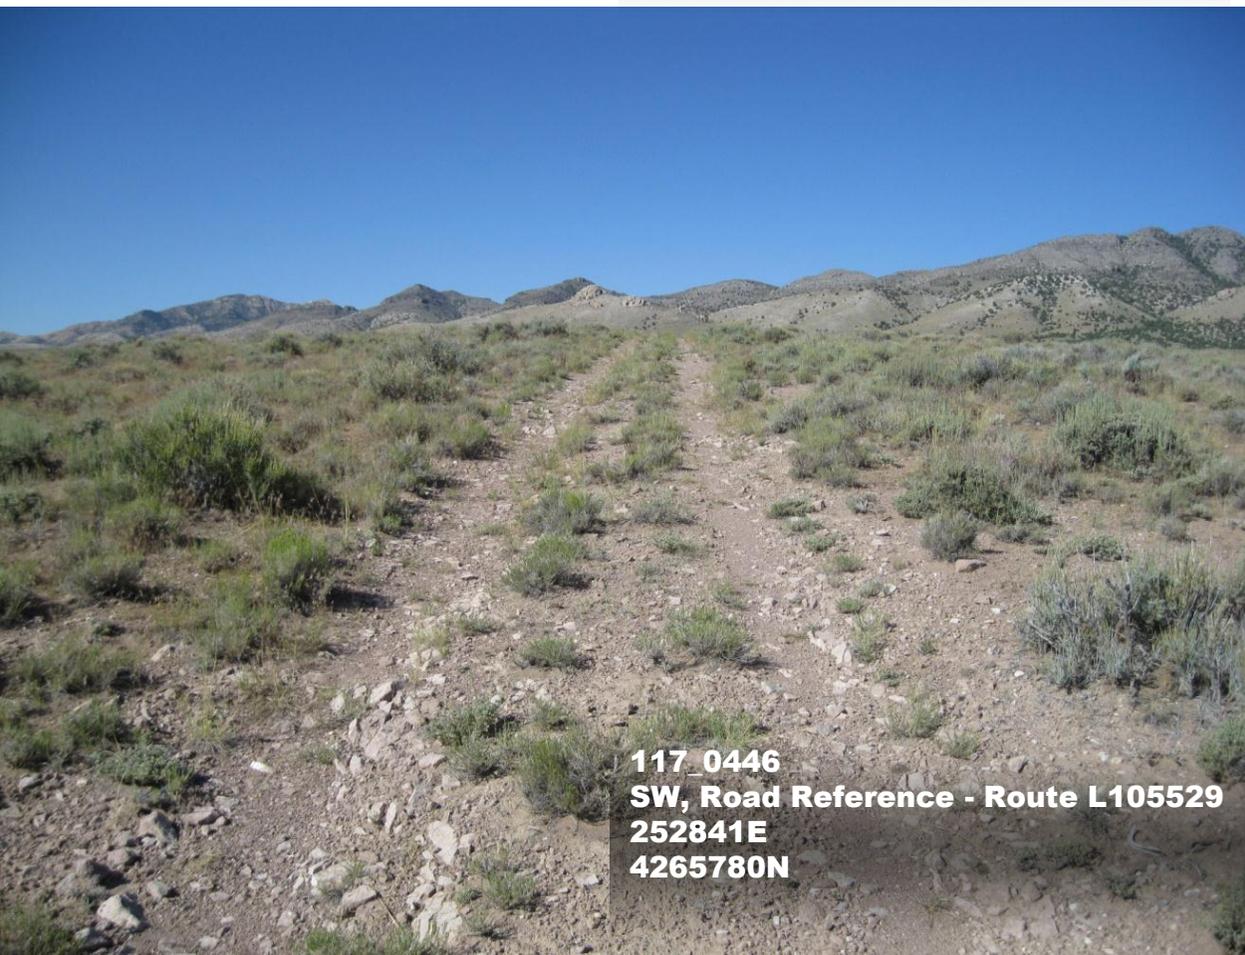
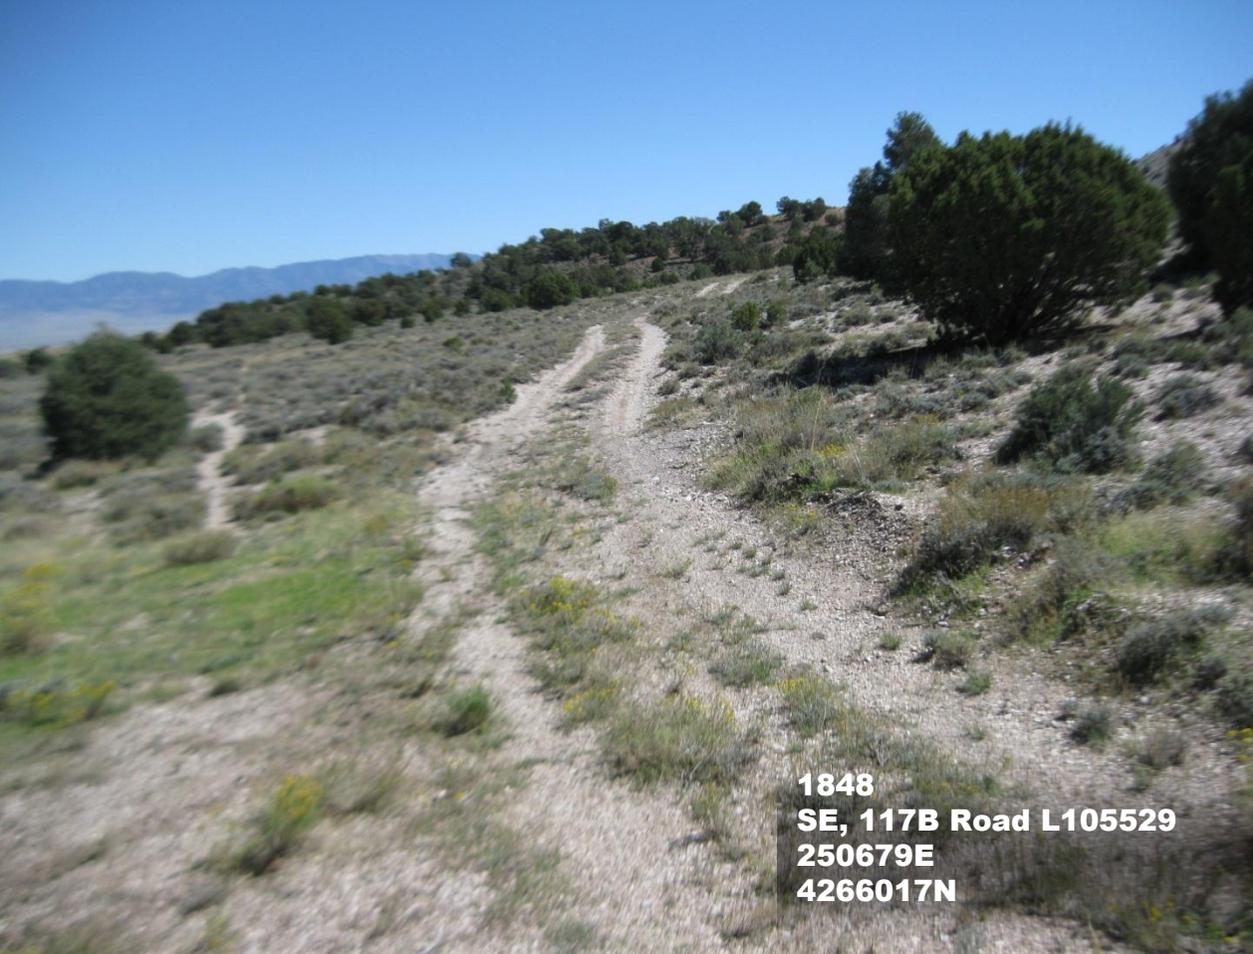
117_0443
SE, Road Reference - Route L105529
250736E
4265983N

117_0444
E, Road Reference - Route L105529
251110E
4265456N

117_0445
NE, Road Reference - Route L105529
252841E
4265780N

117_0446
SW, Road Reference - Route L105529
252841E
4265780N

1848
SE, 117B Road L105529
250679E
4266017N

Describe: portions of this road have vegetation in them but it was constructed at one time.

Describe: There are faint berms and evidence of blading on this route with this evidence being less prominent on the eastern end of the route but still evident.

Explain: The road has does not evidence of maintenance but it is still in good repair and may not have required maintenance. .

Describe: Vehicle tracks on the route and the vegetation in the middle of the route is smaller than vegetation adjacent to the route.

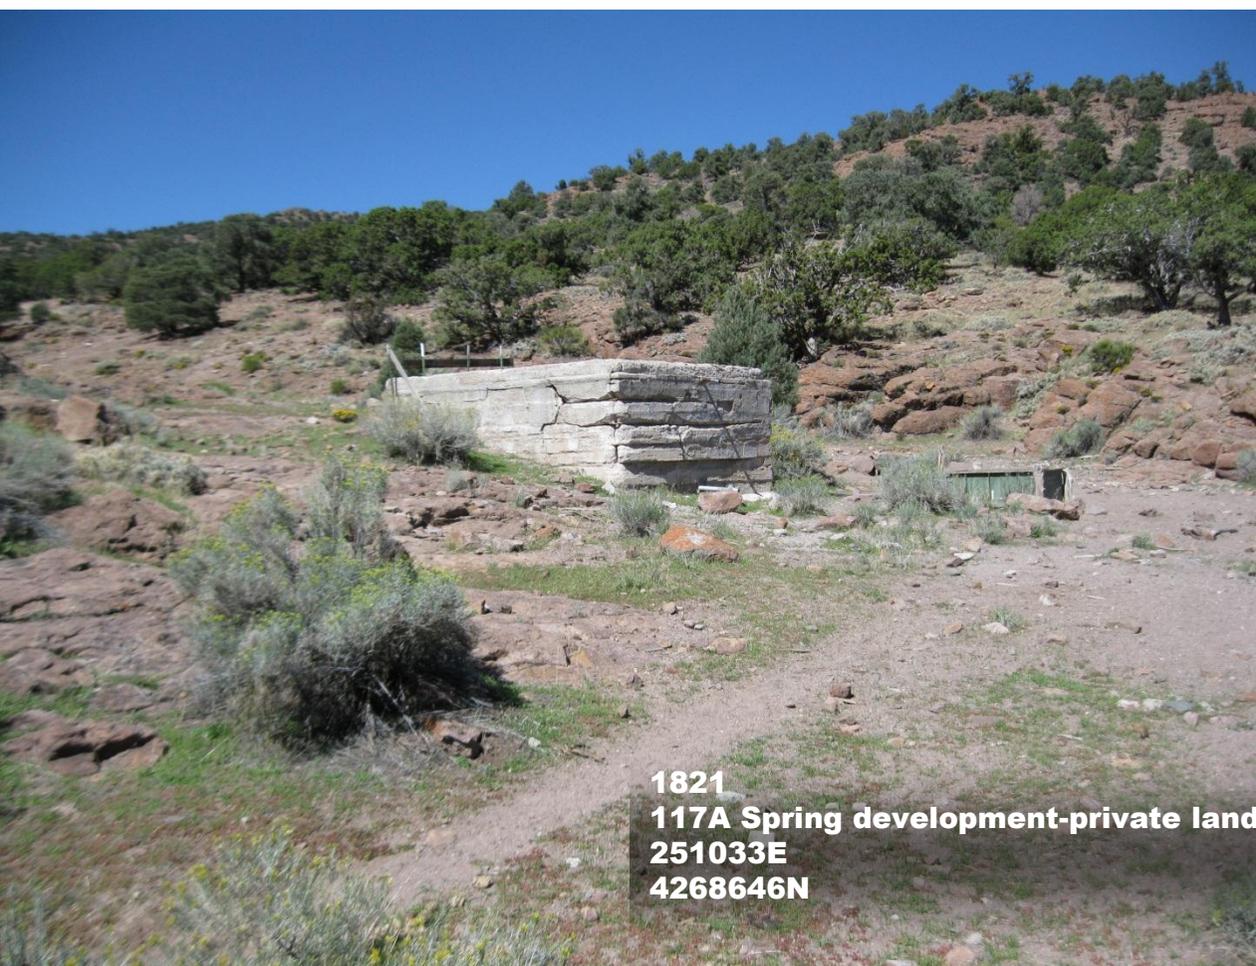
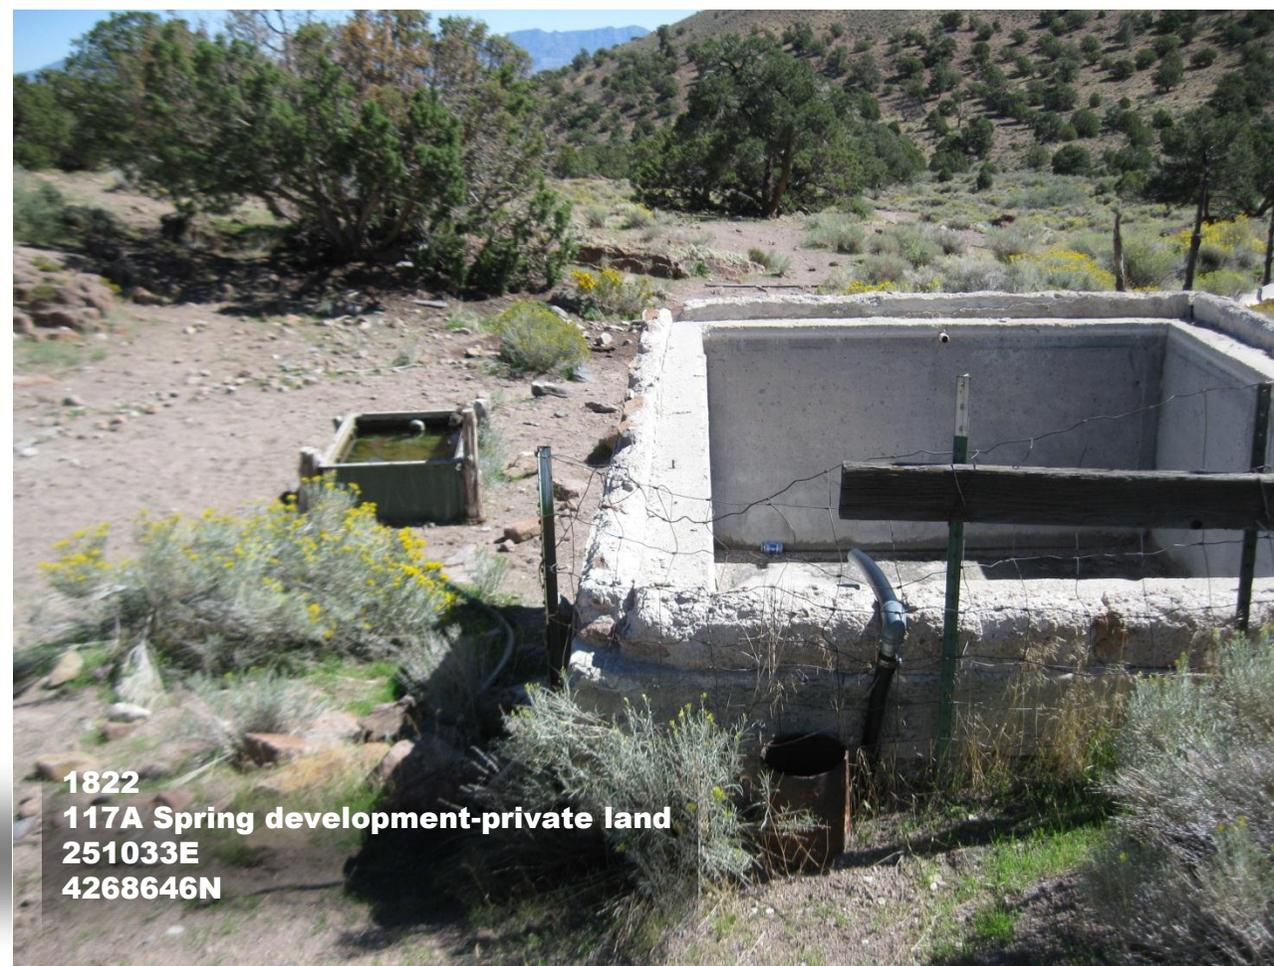
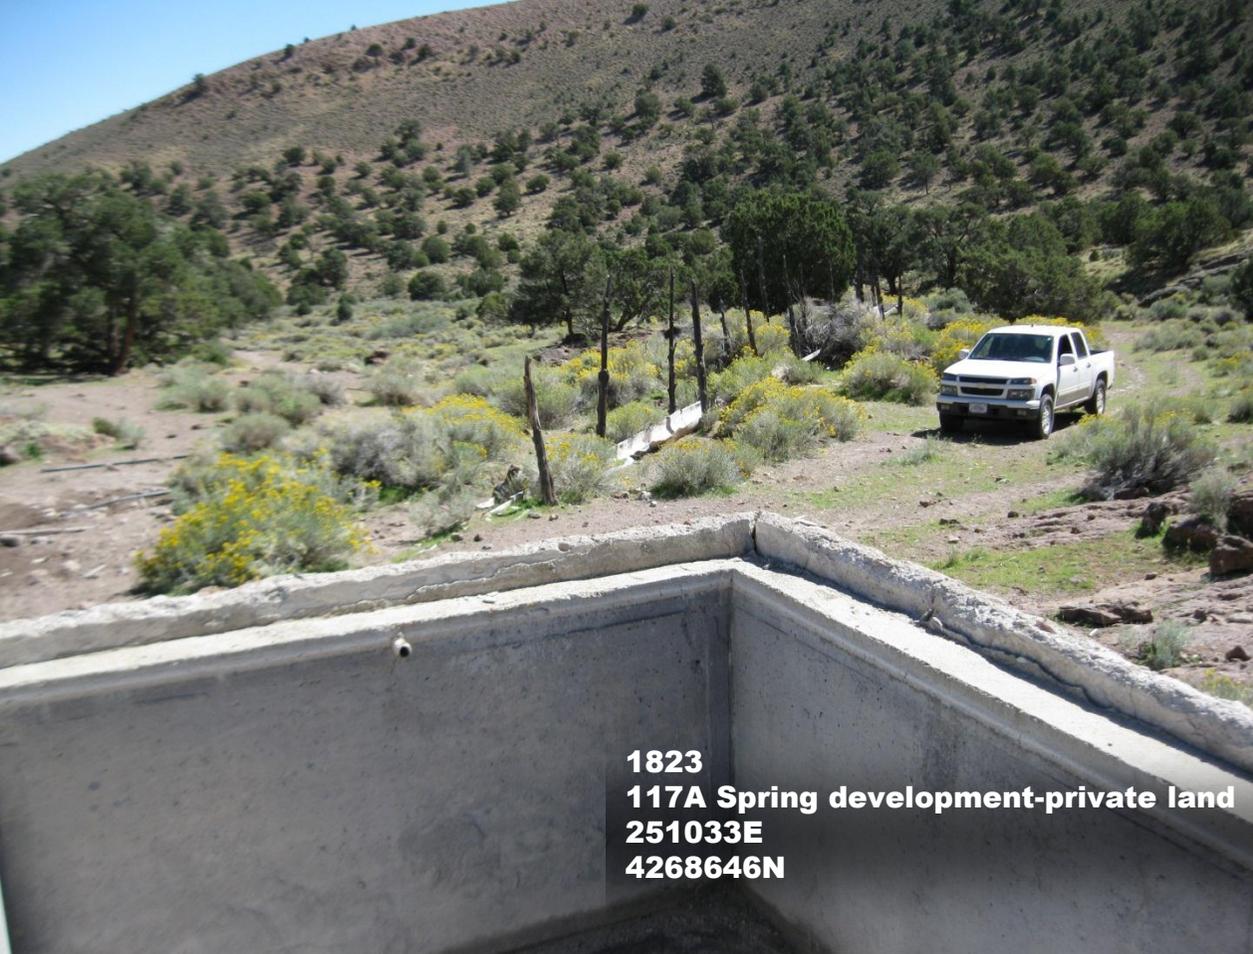
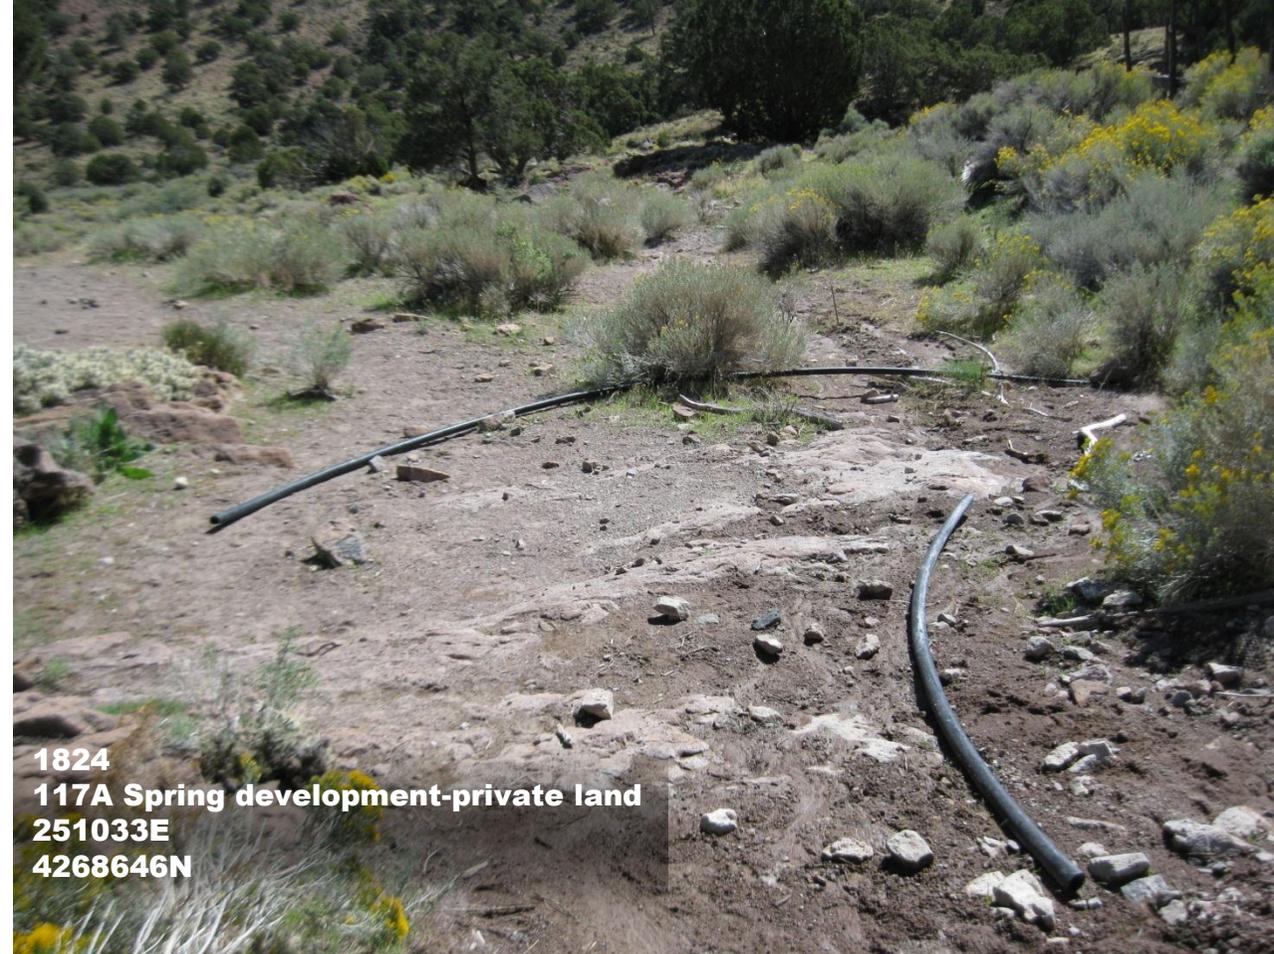
**1821
117A Spring development-private land
251033E
4268646N**

**1822
117A Spring development-private land
251033E
4268646N**

1823
117A Spring development-private land
251033E
4268646N

1824
117A Spring development-private land
251033E
4268646N
