Summary of Analysis*

Area Unique Identifier: UT-C010-117A, B, C & D-The Toad

Current Conditions: Presence or Absence of Wilderness Characteristics (Form 2)

WILDERNESS CHARACTERISTICS INVENTORY
APPENDIX C – ROUTE ANALYSIS¹

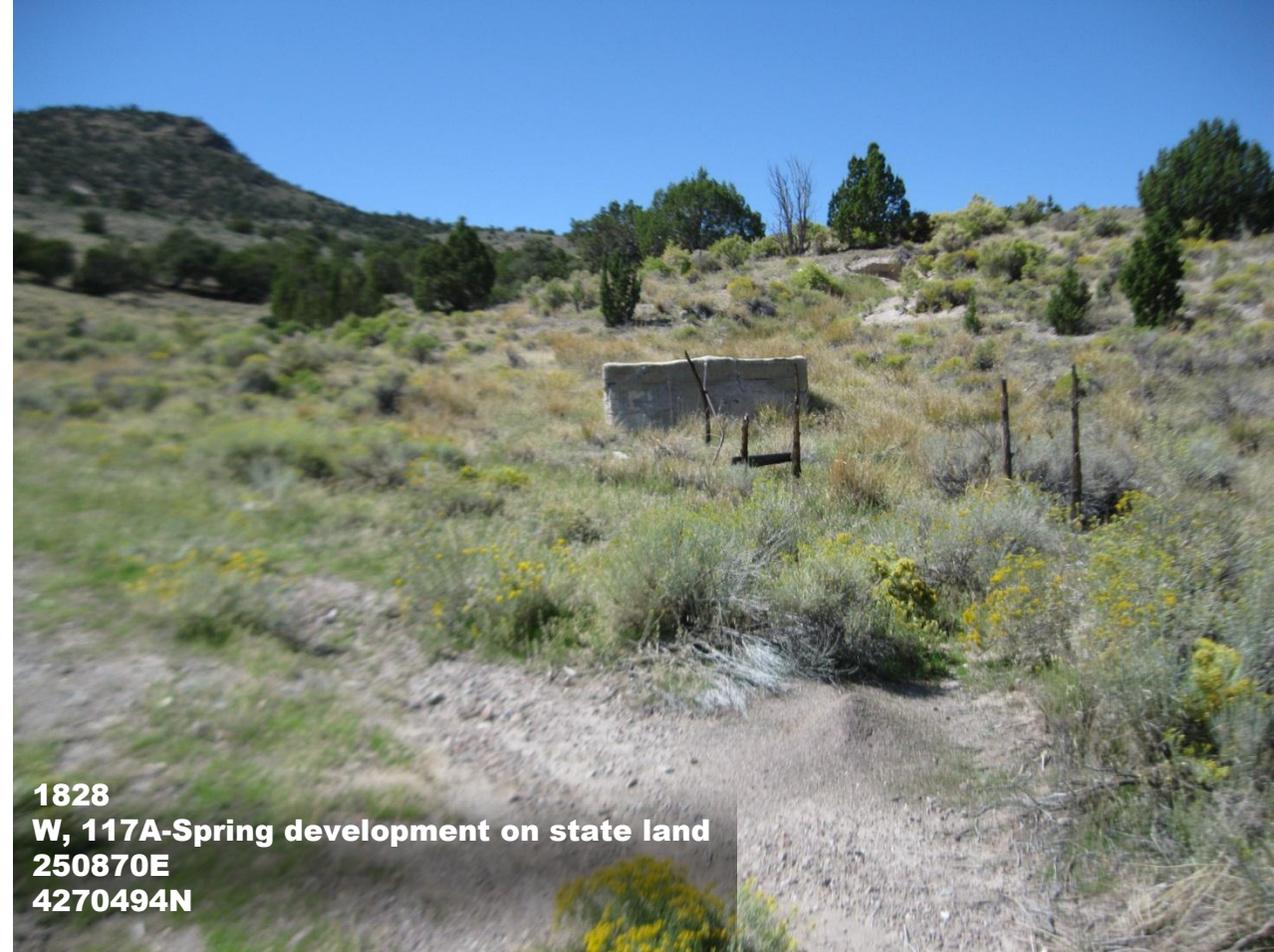
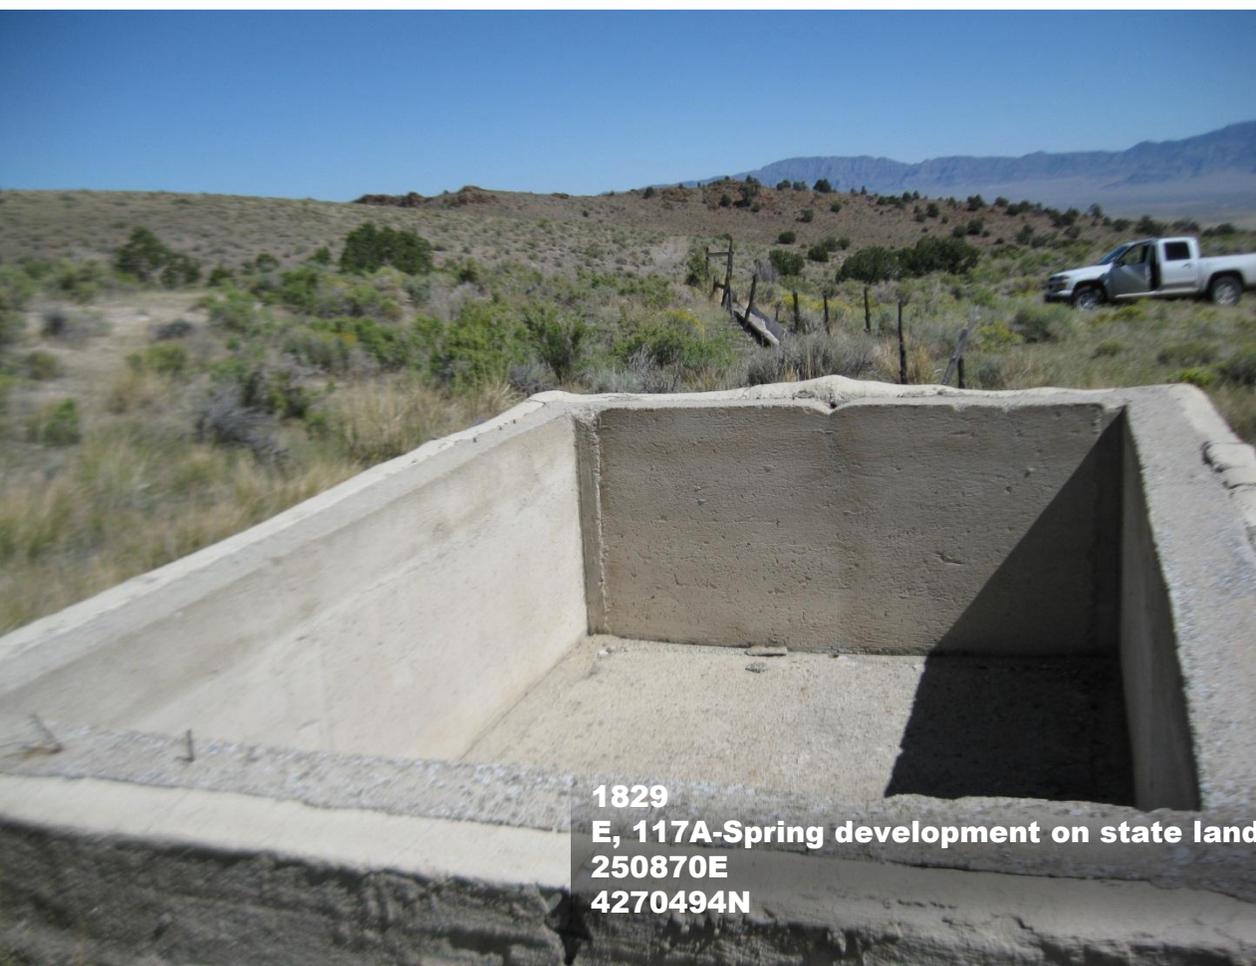
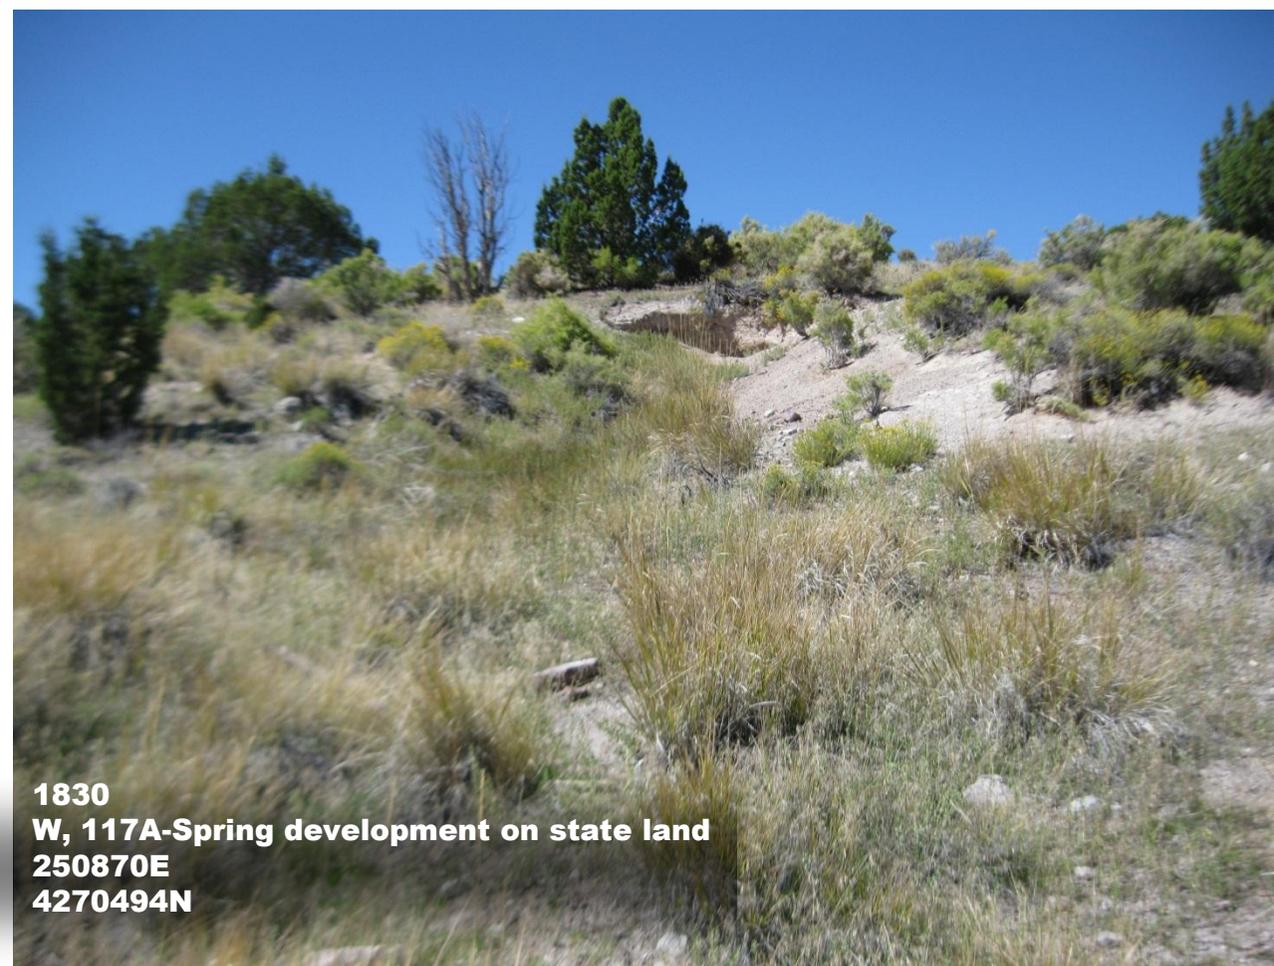
1828
W, 117A-Spring development on state land
250870E
4270494N

1829
E, 117A-Spring development on state land
250870E
4270494N

1830
W, 117A-Spring development on state land
250870E
4270494N

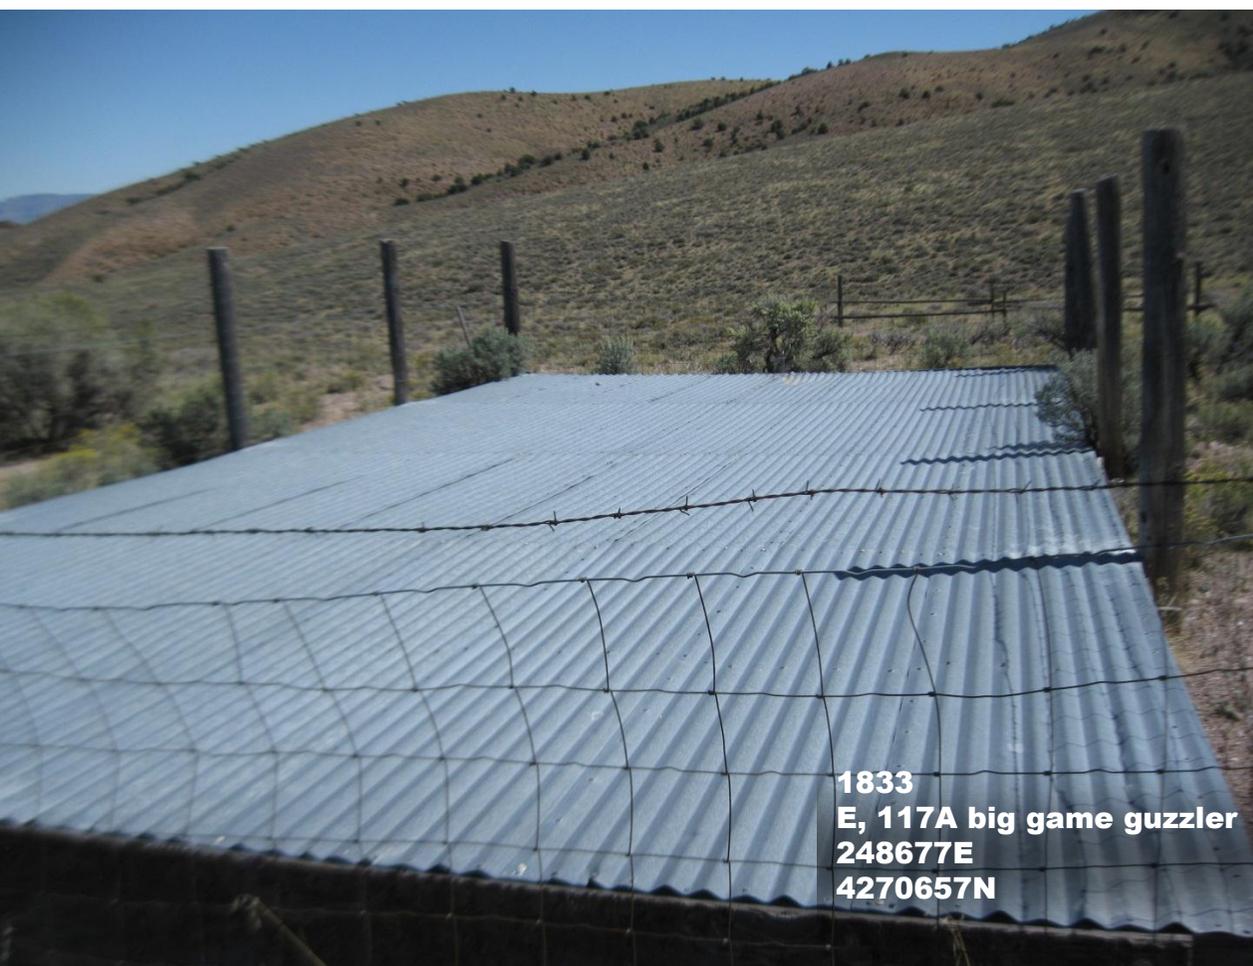
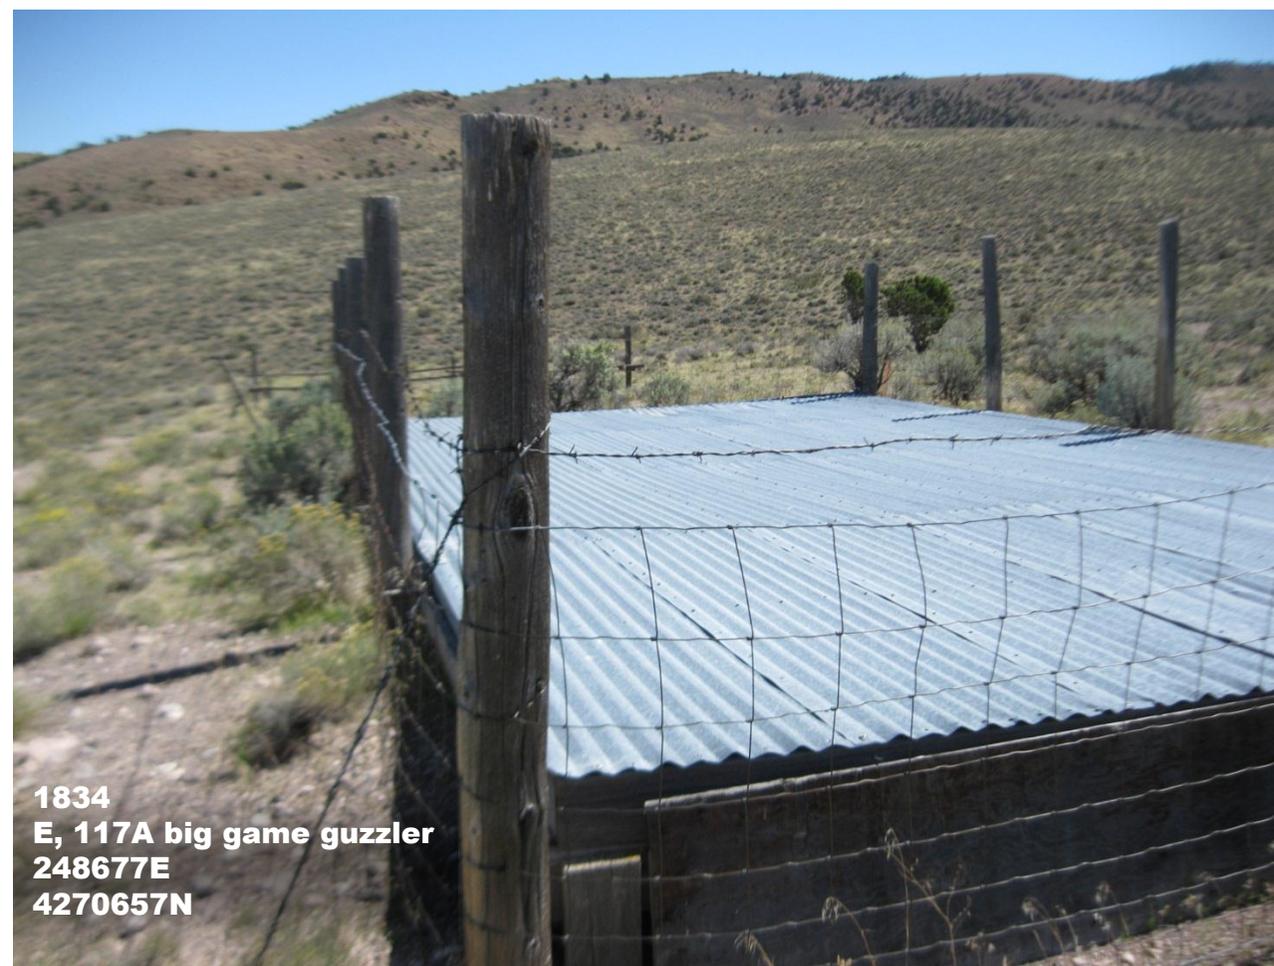
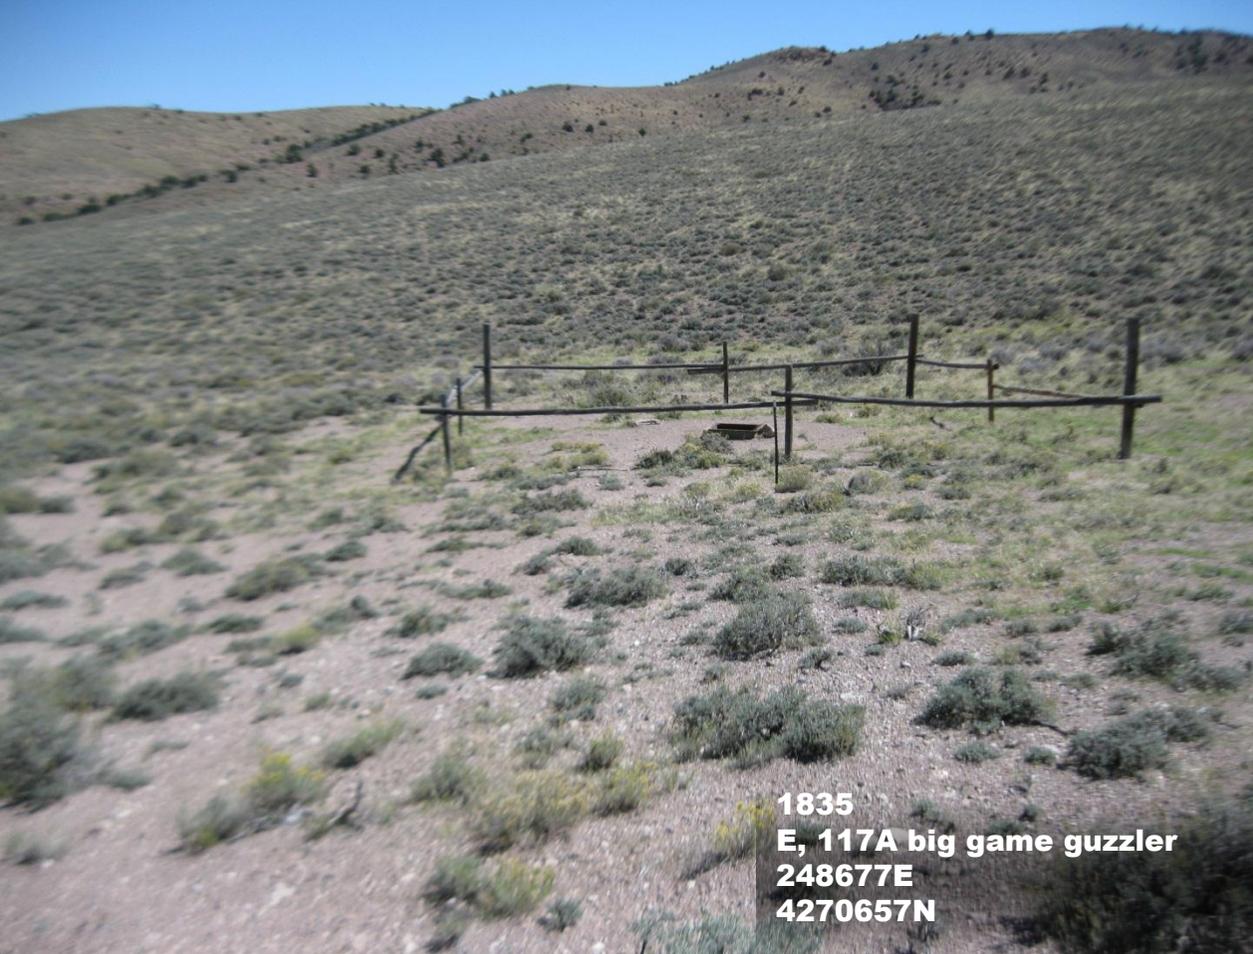
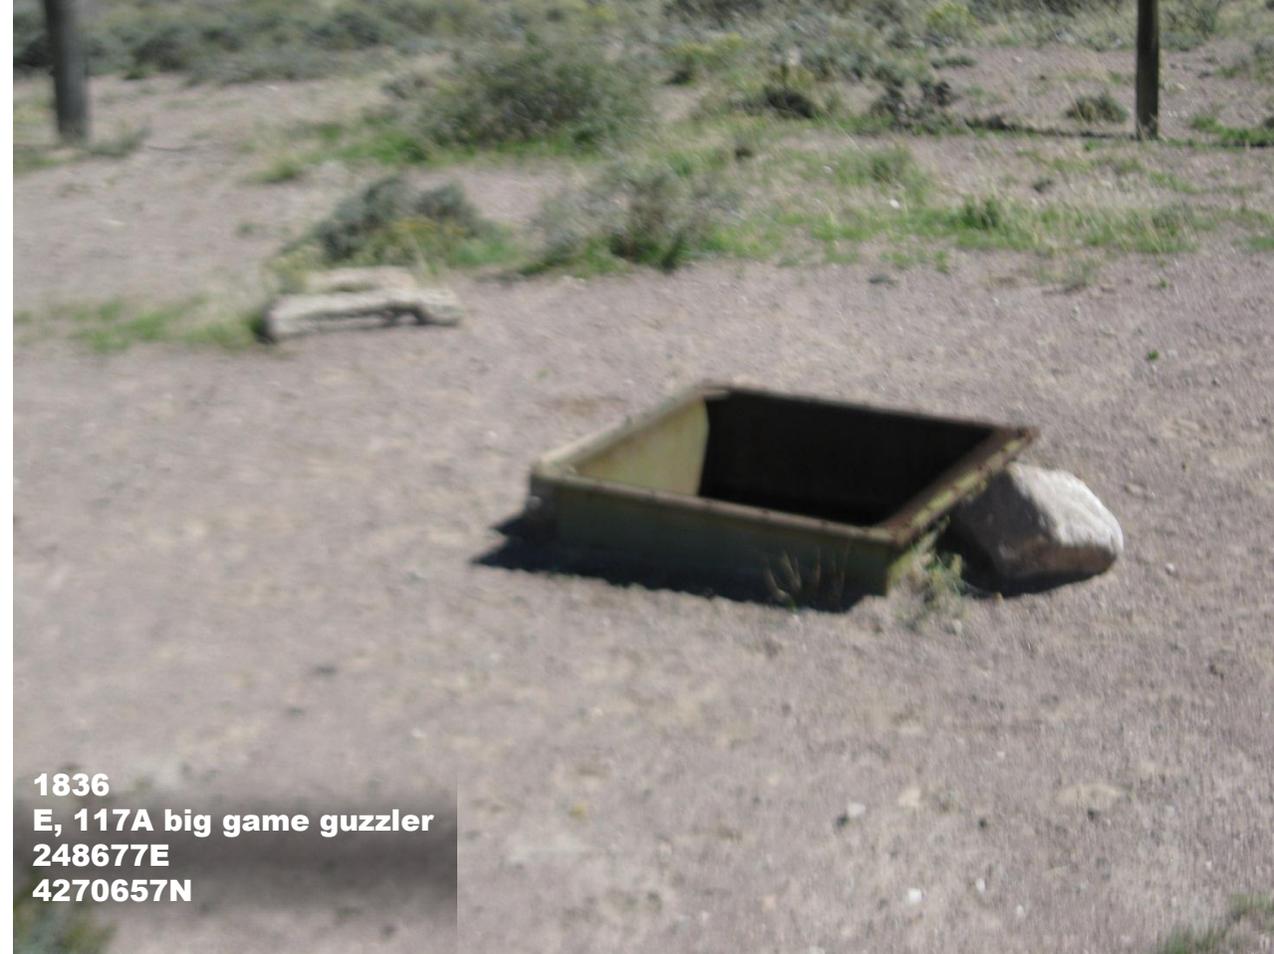
1833
E, 117A big game guzzler
248677E
4270657N

1834
E, 117A big game guzzler
248677E
4270657N

1835
E, 117A big game guzzler
248677E
4270657N

1836
E, 117A big game guzzler
248677E
4270657N

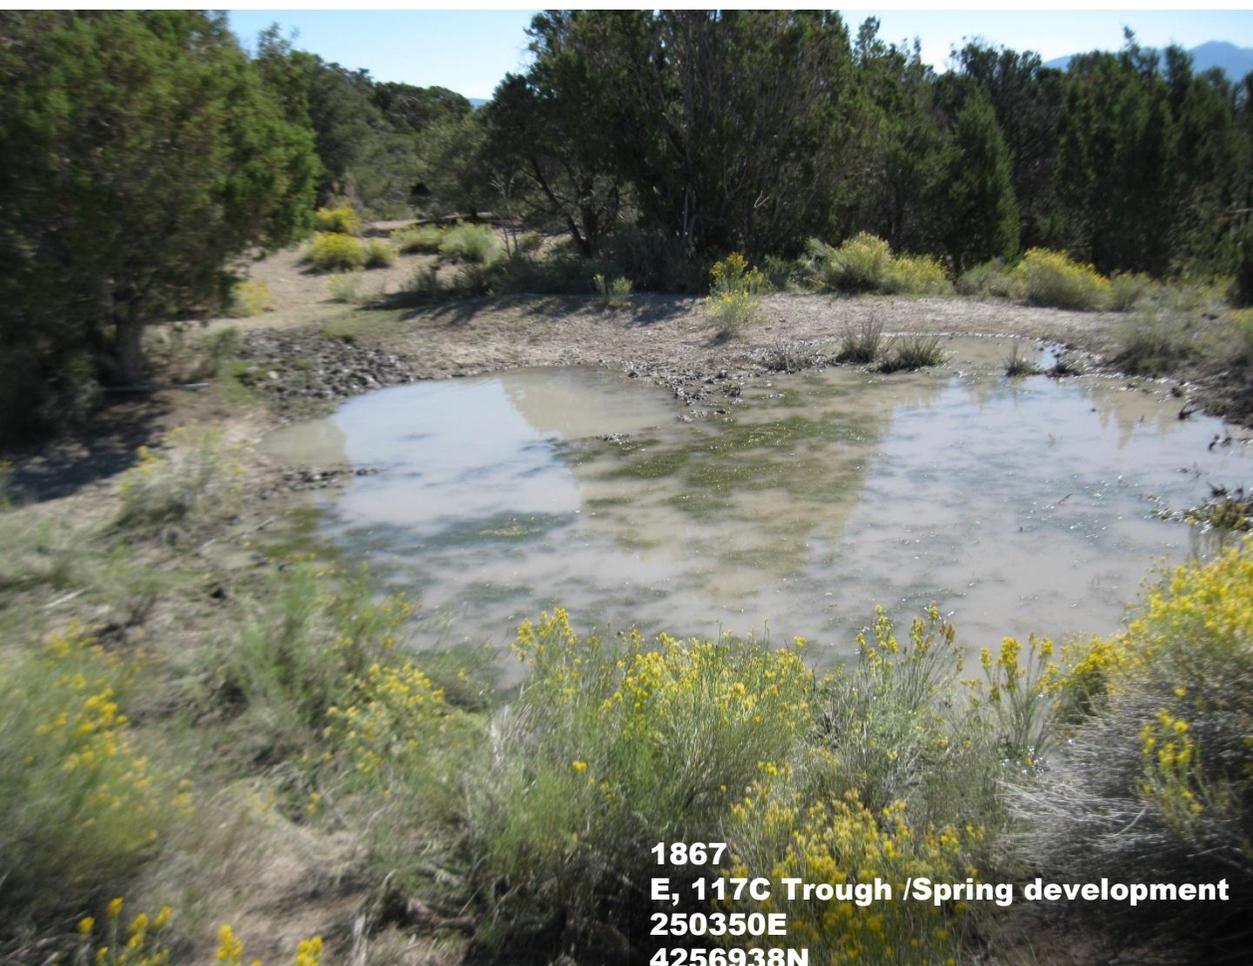
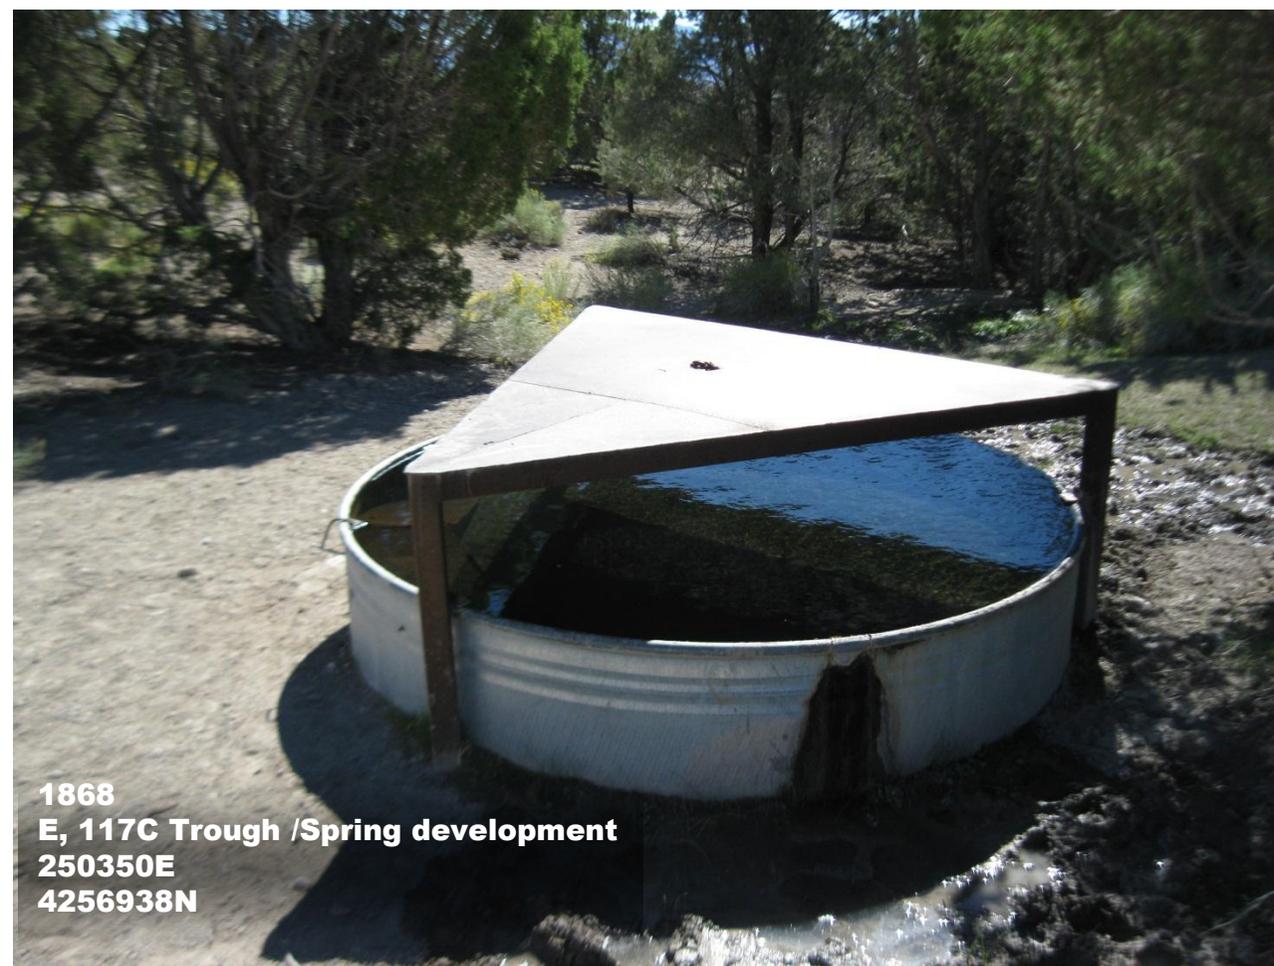
1867
E, 117C Trough /Spring development
250350E
4256938N

1868
E, 117C Trough /Spring development
250350E
4256938N
