Summary of Analysis*

Area Unique Identifier: UT-C010-117A, B, C & D-The Toad

Current Conditions: Presence or Absence of Wilderness Characteristics (Form 2)

**Wilderness Characteristics Inventory
Photo Log (Appendix D) *Modified***

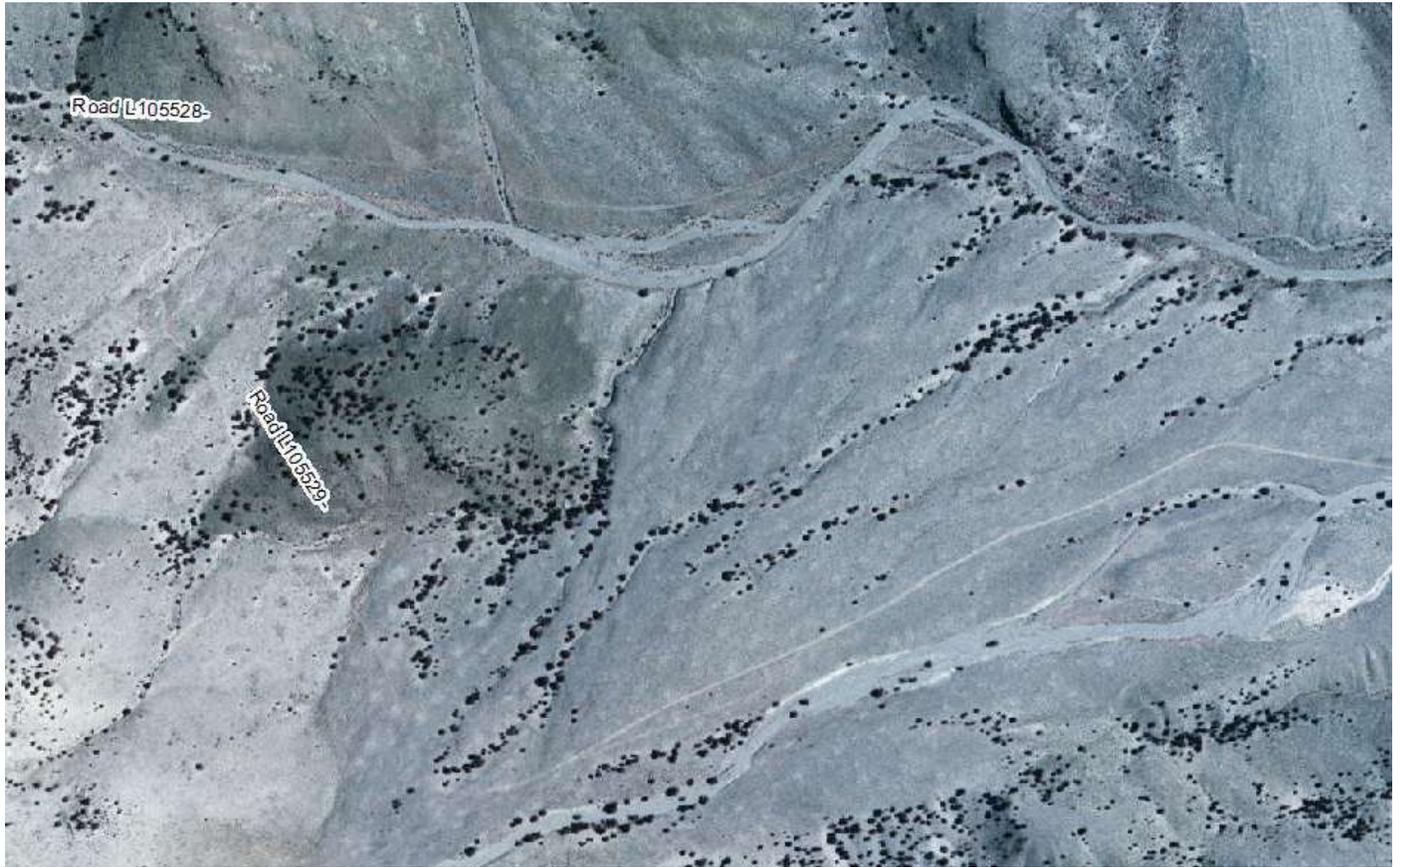
West end of Road L105529- taken in 1999, Scale 1:5,000

Describe: The road file indicates that this is a BLM maintained road (4316-6) and was in the Half Mile road maintenance area. The road appears to have been a main road in the area since at least 1976 as noted in the photographs attached at the end of this form.

Describe: There are faint berms and evidence of blading on this road with this evidence being less prominent on the eastern end of the road but still evident.
