BUREAU OF LAND MANAGEMENT

Specialist Report – Water and Riparian Resources

Field Office: Owyhee Field Office

Allotment Name/Number: Group 2 – Jump Creek: Alkali-Wildcat (514), Elephant Butte (513), Poison Creek (603), Rats Nest (522), Sands Basin (521)

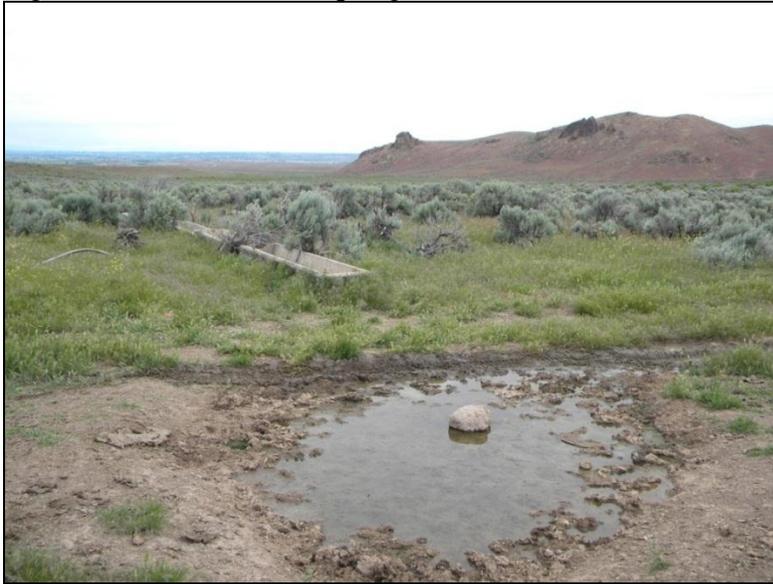
Figure RIPN-1: Wildcat Spring; Alkali-Wildcat Allotment; UTM: 4811522N 509814E

The two reaches of Jump Creek that occur on BLM lands within the allotment and outside of the exclosed canyon area have been assessed using the PFC protocol: 0.8 miles are functional-at-risk and 1.0 miles are functioning properly (Table RIPN 2). Consistent with the previous assessment, it is assumed that the approximate three miles of Jump Creek that traverse the western boundary of the allotment/ pasture and are excluded from livestock are in PFC. Wildcat Spring was assessed non-functional (NF)³ in 2011; however, the observers noted the spring water source is intermittent, the area contained no hydric vegetation, and the assessment may not be applicable. The spring is developed with a non-functioning trough present (Figure RIPN-1).

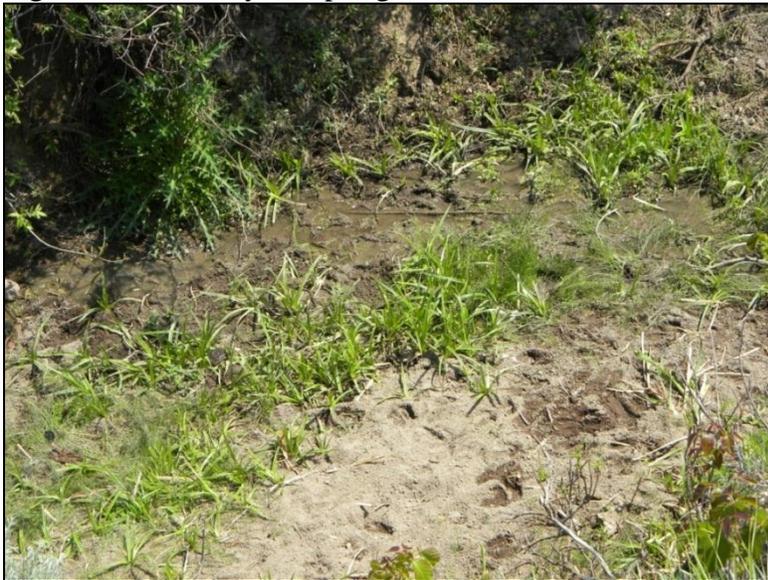
Figure RIPN 2: Coyote Spring; Rats Nest Allotment; UTM: 4806759N 516180E

Three of the springs have been assessed. Coyote Spring (Figure RIPN 2) was in PFC in 2007, but FAR with a downward trend in 2011 because the riparian-wetland area is shrinking from excessive soil erosion, subsurface flow patterns have been altered by hoof action, and there is inadequate hydric vegetation present to protect soil surface. Bathtub spring was evaluated; however, the PFC protocol was not applicable because the spring consists of a livestock trough that fills from a pipeline at the spring source. The spring source is not excluded from livestock. Upper Rats Nest Spring was assessed NF because the riparian-wetland area has been reduced to a dry pond development without any hydric species or soil types to support them present.

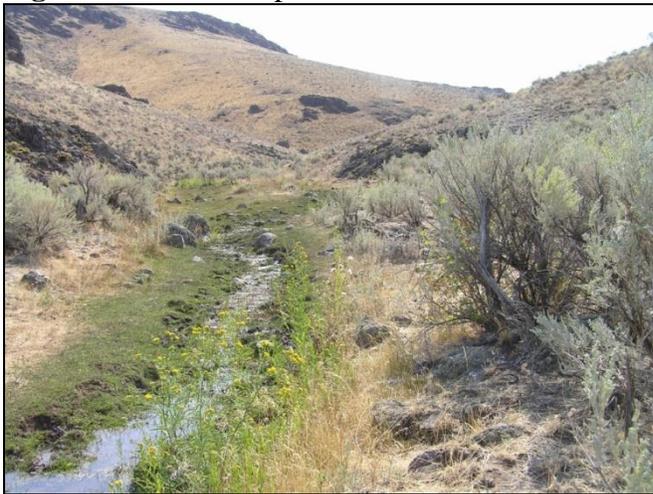
Figure RIPN 3: Jump Creek; Sands Basin Allotment; UTM: 501849E 4804542N

The Sands Basin Spring Complex was assessed in 2007 as FAR primarily based on the presence of two headcuts creating vertical instability in the system. Additionally, there was a lack of a woody component when the site likely has the potential to support woody species and the spring source nor the riparian-wetland area were exclosed from livestock.

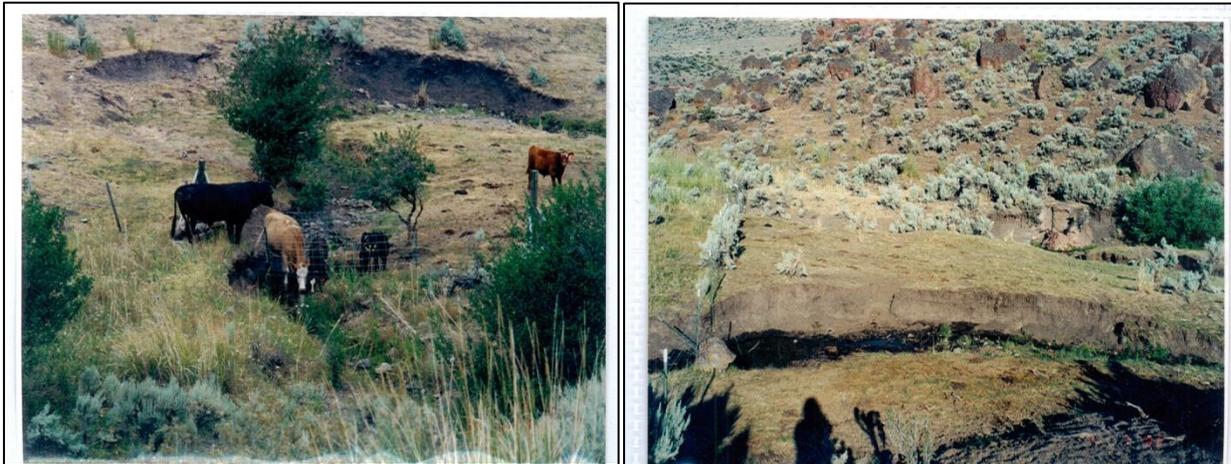
Figure RIPN 2: McBride Creek- livestock in exclosure and water gap condition; Blackstock Springs Allotment; UTM: 4789448N 504354E

Approximately 1.2 miles of McBride Creek were assessed FAR in 2002 (Figure RIPN 2) primarily because the exclosure fence was down and livestock had accessed the area that was recovering relatively well. Also, the inventory report noted the presence of lateral and vertical (2 headcuts

) instability, noxious weed presence, and the NF condition of the water gaps that were included in the reach. The same reach was re-visited in 2011, but was not assessed with the PFC protocol because the area is exclosed from livestock and appears to be recovering well (Figure RIPN 3).

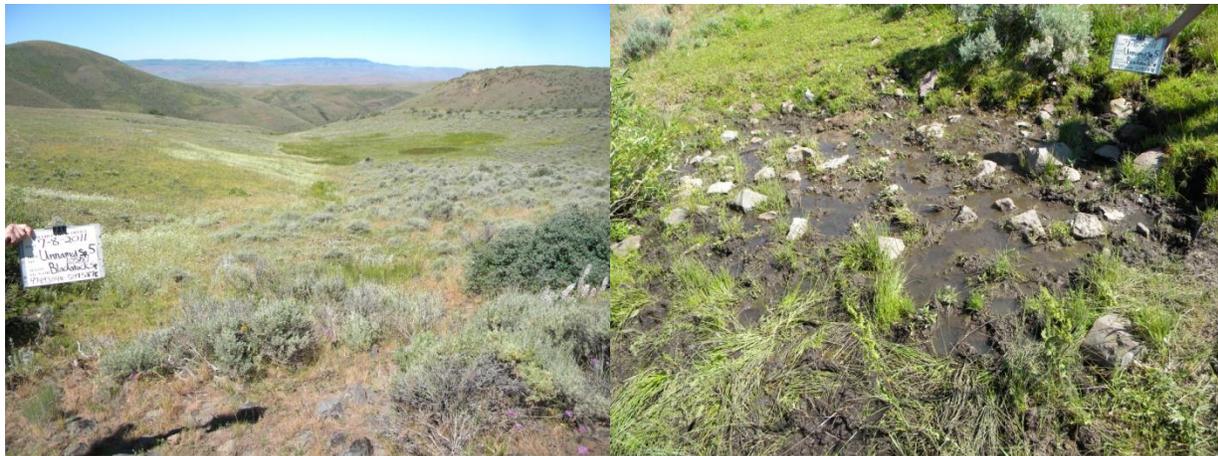
Figure RIPN 4: Unnamed Spring; Blackstock Springs Allotment- Native Pasture; UTM: 4789304N 507587E

A large (about 4 acres) unnamed spring (Figure RIPN 4) at the headwaters of the tributary to Little McBride Creek in the southern portion of the Native pasture was also rated FAR. The wet meadow complex is comprised of six seeps and has light to moderate grazing and pugging that appears to be altering the flow pattern and is also limiting wetland obligates in some places.

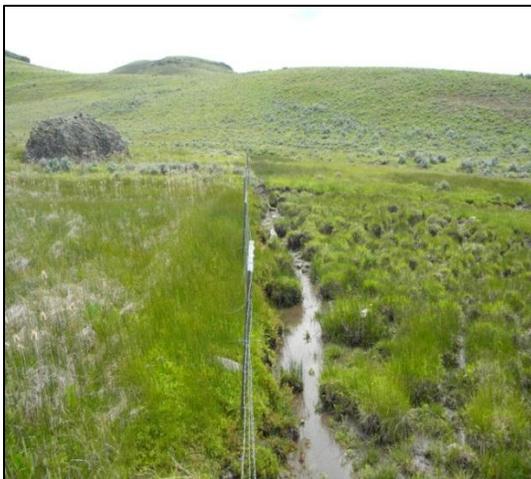
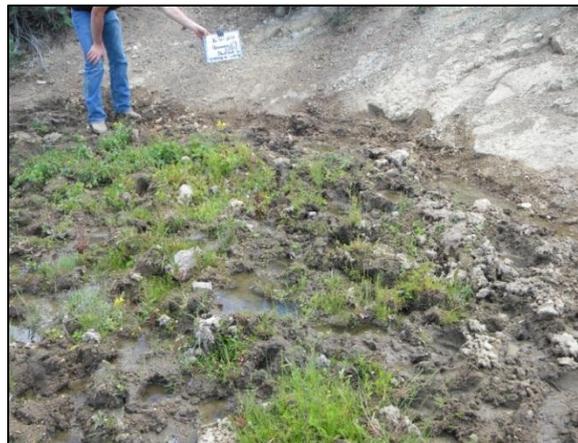
Pasture; UTM: 4794880N 507479E

Six additional and different unnamed springs in the Seeding pasture were assessed in 2003; one was in PFC, two were FAR, and three were NF. The Unnamed spring that was in PFC is a large two acre riparian-wetland area to the east of Little Squaw Creek, and was re-assessed in 2011 and rated FAR. The downward trend was based on the livestock trampling and pugging along the outer edges of the wet meadow. The hoof action is altering the surface flows and leading to high and dry hummocks that do not support hydric species. The first of the two FAR springs is primarily exclosed from livestock; however, the riparian-wetland area outside of the enclosure was affected by hoof action that altered the surface flow pattern and vigor of the hydric

vegetation. The second FAR spring is developed with a trough, but is not enclosed. The riparian-wetland area has been impacted by hoof action in the form of pugging, soil shearing, reduced vigor of hydric plants, and drying of hydric soils.

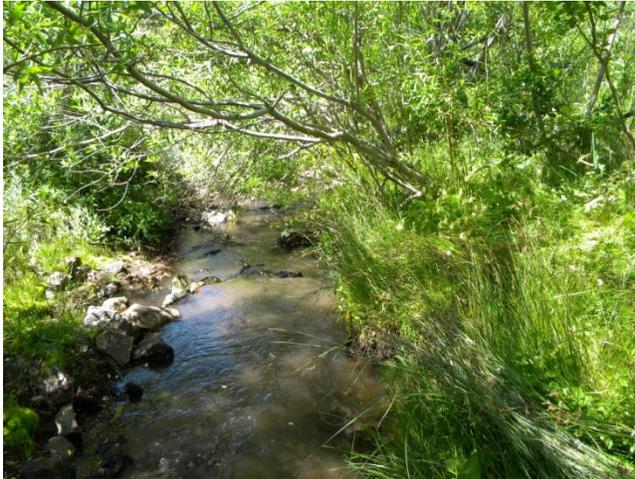
Figure RIPN- 7: McBride Creek MIM site- Blackstock Springs Allotment/ South Native Pasture

Based on the sites metrics, an evaluation was made for the stream reach in relation to the following three capability groups: 1) ecological status, 2) vegetation-erosion resistance (i.e., streambank stability), and 3) site wetland status (Tables RIPN 5 and 6). The summary rating for the McBride Creek reach showed that the greenline ecological status was at a late seral stage, the vegetation-erosion resistance was moderate, and the site wetland status was good. The outcome of the MIM data in regard to the three capability groups provides a good indication of a streambank's ability to buffer the hydrologic forces of moving water.

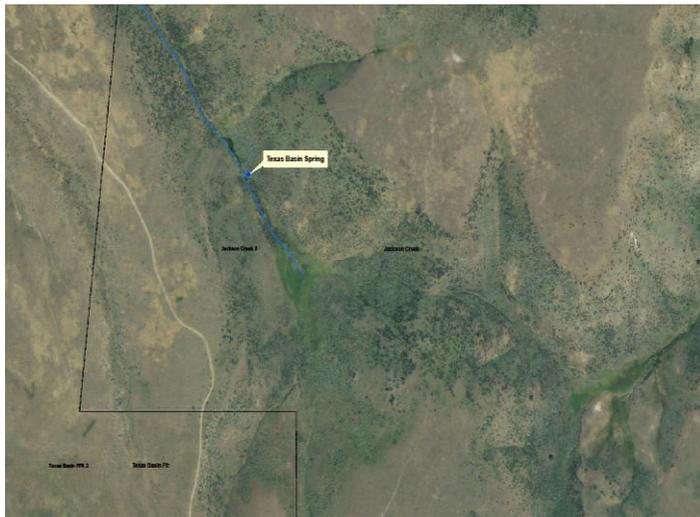
Figure RIPN 8: Texas Basin Spring- example of wet meadow are observed using the 2011 NAIP

The NHD identifies one spring (Texas Basin Spring) that was rated FAR because >40% of the available forage had been grazed and 35-45% of the site was covered in undesirable herbaceous (ie. Kentucky Blue Grass) species. The spring is developed; however, at the time of the assessment, the trough was non-functional. The spring appears to flow for about 0.10 mile and supports approximately 0.5 acres of wet meadow area (NAIP 2011; Figure RIPN 8). A second spring was discovered just north of Succor Creek and assessed FAR. The spring is a small wet meadow area on a relatively steep slope; it appears to be shrinking in size as upland plant species encroach on the edges. In addition, the surface flow patterns are disrupted by hoof action and livestock trailing.

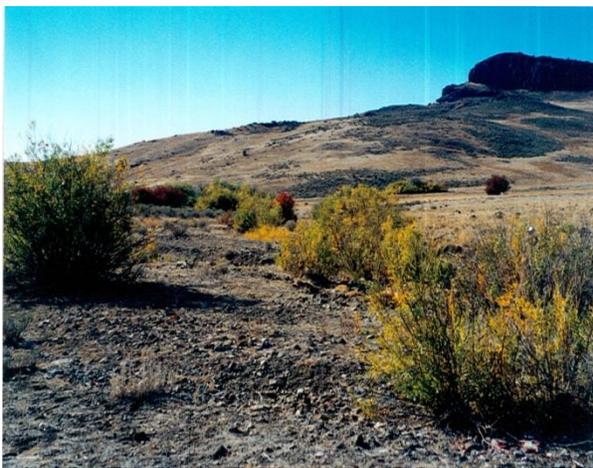
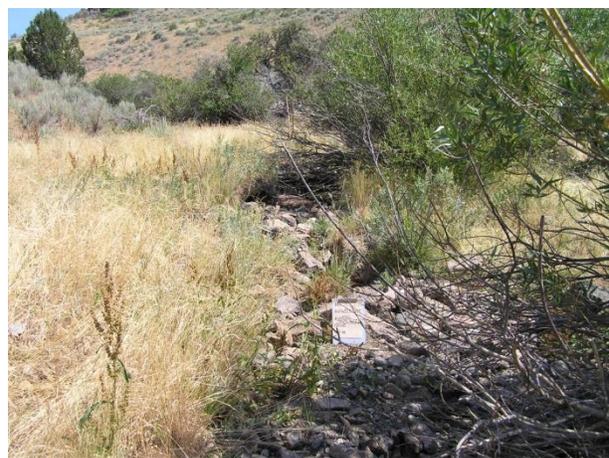
Figure RIPN 9: Wildcat Canyon in 2002 (left) and again in 2008 (right); Jackson Creek Allotment/ Pasture 4

According to the NHD, portions of Coyote Creek (0.4 mile), Jackson Creek (1.5 mile), and Wildcat Canyon (1.5 miles) occur within pasture 4. Approximately 1.0 mile of Wildcat Canyon that traverses pasture 4 was rated FAR (Figure RIPN 9) in 2002. Issues identified at the time included a lack of binding herbaceous and woody species because >35% of the vegetation had been foraged, the stubble height was 3.0 inches, and >25% of the area was bare ground. About 20% of the area was affected by hoof action in the form of pugging and livestock browse was inhibiting regeneration of the woody species. The same reach was revisited in 2008 (Figure RIPN 9) and rated in PFC. The reach appeared to have improved and is armored with rock and large, mature willows.

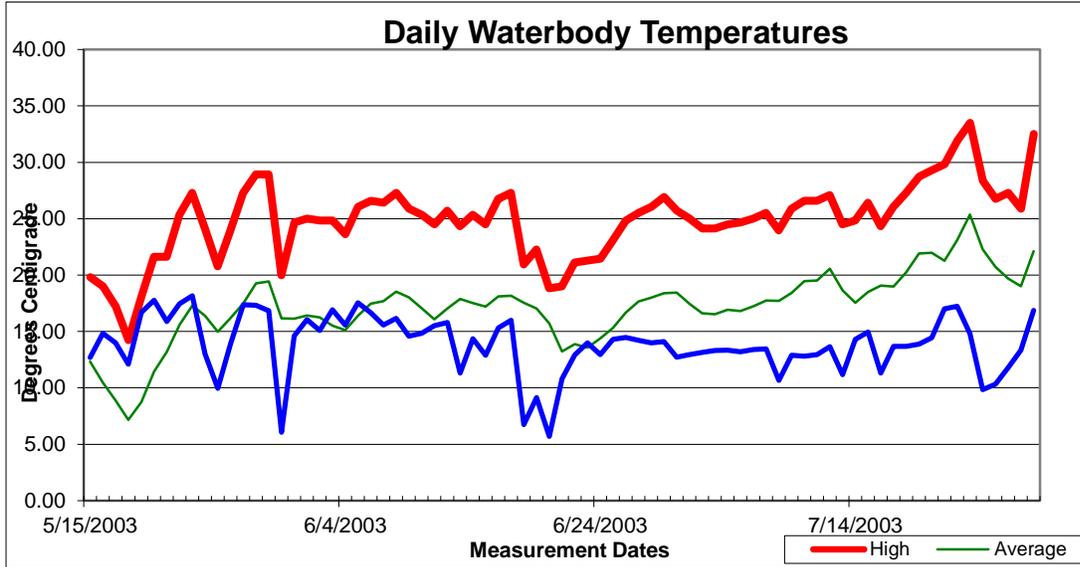
Figure RIPN-10: McBride Creek Temperature Information, 2003 (MDMT = 33.5°C and MDAT = 25.4°C)

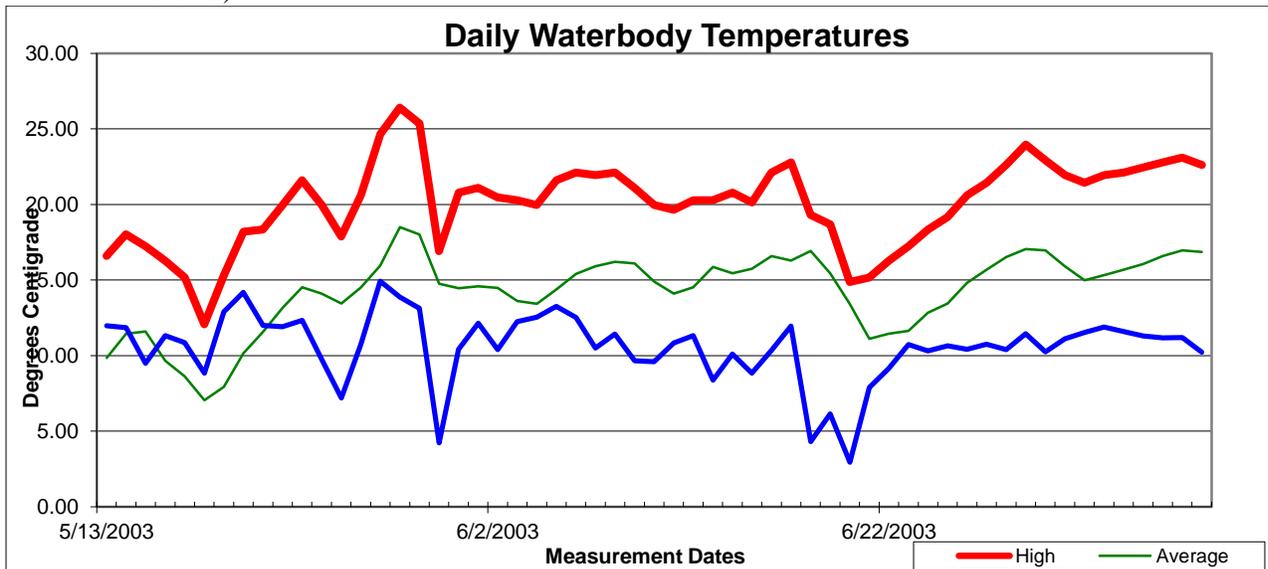
Figure RIPN-11: Little McBride Creek Temperature Information, 2003 (MDMT = 26.4°C and MDAT = 18.5°C)

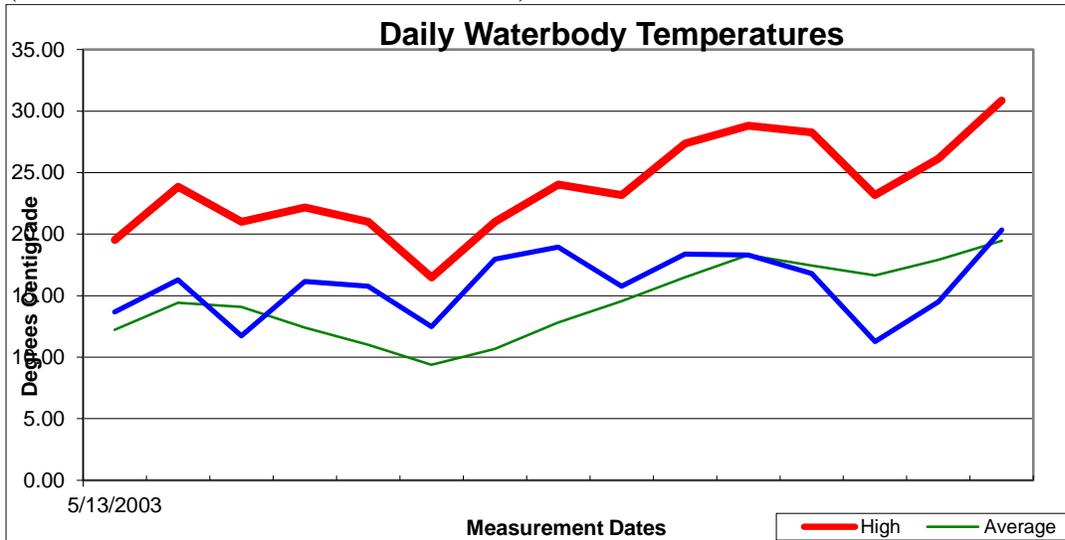
Deadhorse Creek, and two tributaries of McBride Creek that occur within pasture 2 are not supporting the watershed’s beneficial uses. All of the streams are on the IDEQ 303(d) list of impaired waters. Little Squaw and a tributary of Squaw Creek are fully supporting the watershed’s beneficial uses. The BLM has monitored water temperature on Little Squaw Creek (Figure RIPN-12) and the stream exceeded the State’s criteria for support of the cold water aquatic life beneficial use. The criteria, as defined by the State, sets a Maximum Daily Maximum Temperature (MDMT) of 22° C and a Maximum Daily Average Temperature (MDAT) of 19° C.

Figure RIPN-12: Little Squaw Creek Temperature Information, 2003
(MDMT = 30.9°C and MDAT = 19.5°C)

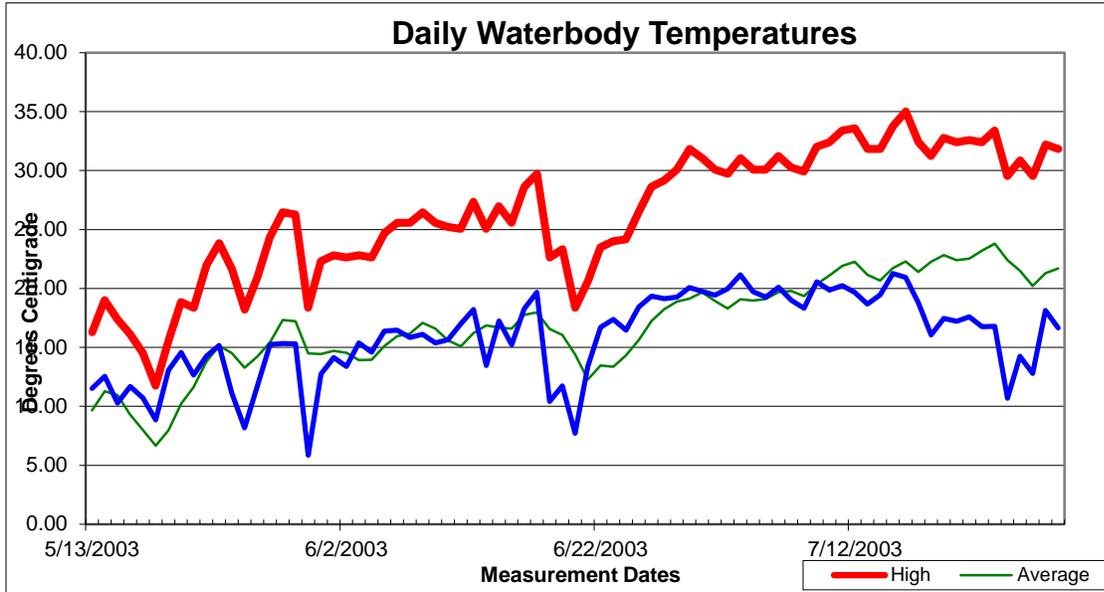
McBride, and two tributaries of Succor Creek that occur within pasture 3 are not supporting the watershed's beneficial uses. The reaches of McBride Creek that traverse the pasture are also on the IDEQ 303(d) list of impaired waters. The BLM has monitored water temperature on McBride Creek (Figures WATR 4) and the stream exceeded the State's criteria for support of the cold water aquatic life beneficial use. The criteria, as defined by the State, sets a Maximum Daily Maximum Temperature (MDMT) of 22° C and a Maximum Daily Average Temperature (MDAT) of 19° C.

**Figure RIPN-13: McBride Creek Temperature Information, 2003
(MDMT = 35.0°C and MDAT = 23.8°C)**

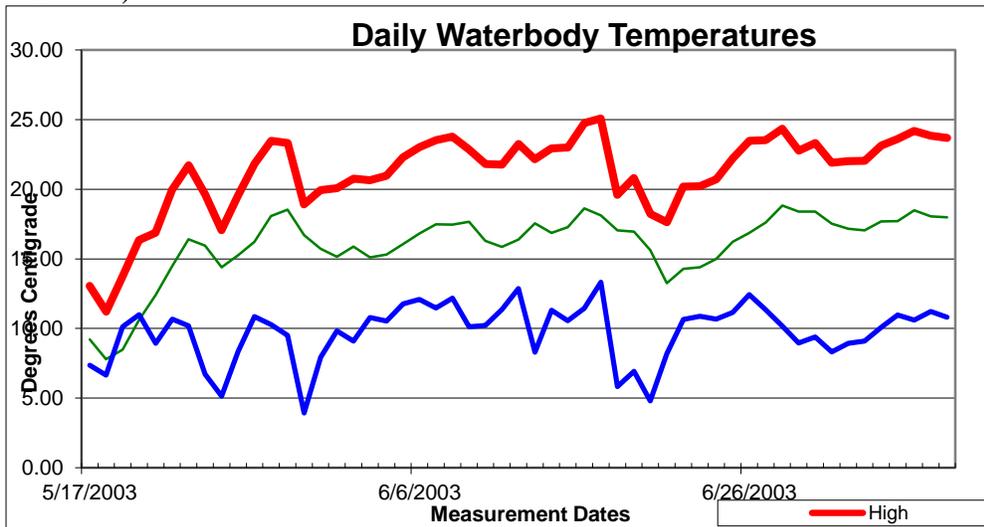
Figure RIPN-14: Succor Creek Temperature Information, 2003 (MDMT = 25.1°C and MDAT = 18.8°C)

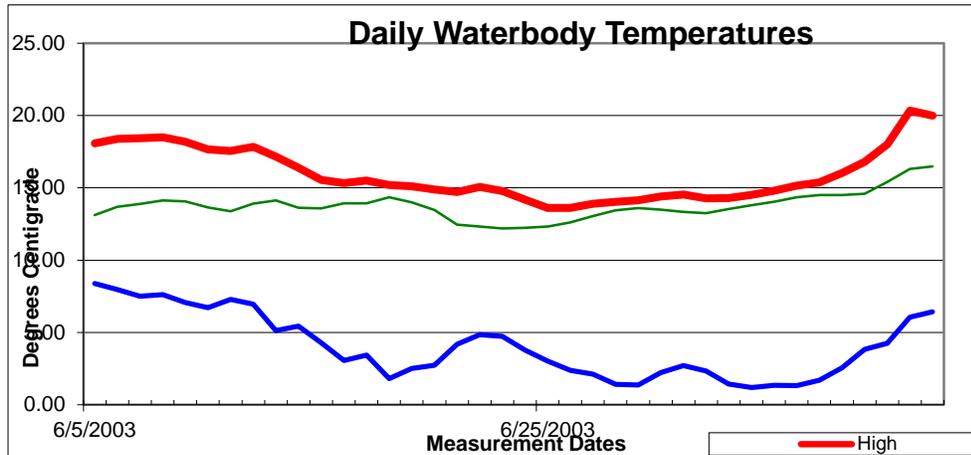
The reaches of Jackson Creek, Wildcat Canyon, and the unnamed tributaries of Cow Creek that traverse BLM lands in pasture 4 are on IDEQ's 303(d) list of impaired waters. The streams are not supporting the beneficial uses that were assigned to the Middle Snake-succor watershed. The BLM has monitored water temperature on Wildcat Canyon (Figure RIPN-15) and the stream was within the State's criteria for support of the cold water aquatic life beneficial use. The criteria, as defined by the State, sets a Maximum Daily Maximum Temperature (MDMT) of 22° C and a Maximum Daily Average Temperature (MDAT) of 19° C. However, the stream went dry after 38 days, and thus, temperature was measured from June 5 to July 12.

Figure RIPN-15: Unnamed Tributary to Cow Creek Temperature Information, 2003
(MDMT = 20.3°C and MDAT = 16.5°C)

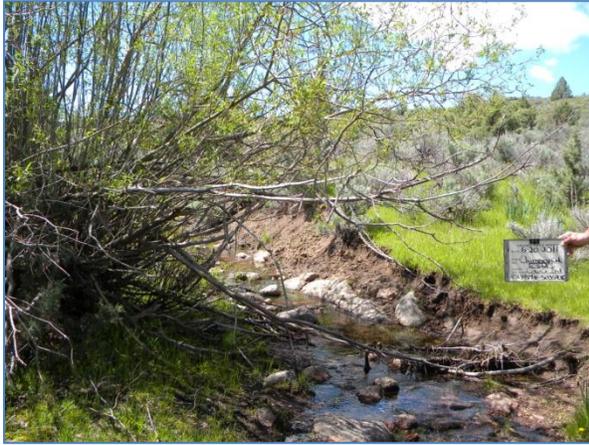
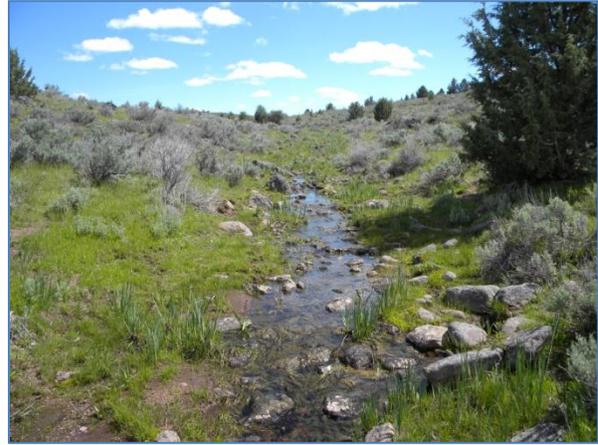
Figure RIPN-1: Chimney Creek MMIM site; Cow Creek Allotment/ Pasture 4;
UTM 503547N 4763929E

However, a MMIM site was established on Chimney Creek in 2011. Ten metrics were collected at the MIM site (Table RIPN 7). Median stubble height is the middle of the measured values of use on herbaceous vegetation along the greenline. Stubble height indicates whether the current grazing system is allowing adequate vegetation growth to maintain or enhance vigor and reproduction of the plants. Bank alteration is the percentage of streambank that has been altered by large herbivores walking along or crossing the stream resulting in bank shearing from hooves. Bank stability is the percentage of streambank in stable, intact condition (i.e. streambank that is not fractured, slumping, sloughing, or uncovered, eroding, and steep).

Table RIPN-7: Chimney Creek Multiple Indicator Monitoring (MIM) Metrics
Cow Creek Allotment/ Pasture 4

Median SH (inches)	Mean SH (inches)	Bank Alteration (%)	Woody Use (%)	Bank Stability (%)
Chimney Creek	4.5	5.6	0	NA	40

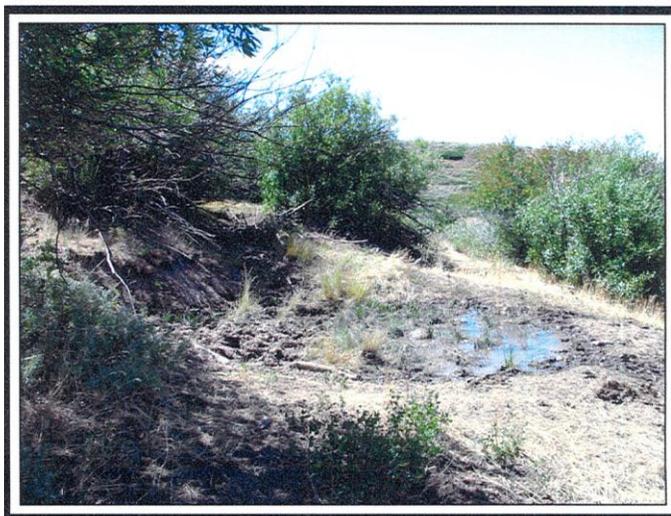
Figure RIPN-3: Spring 6523X; Soda Creek Allotment/ Pasture 3; UTM: 4768897 508936

The two springs that were rated NF in 2003 were developed with earth burms and had lost their form and function. The burming had made the area unstable and there was little or no hydric vegetation present. The shrubs were degrading and upland species were encroaching on the riparian-wetland areas.

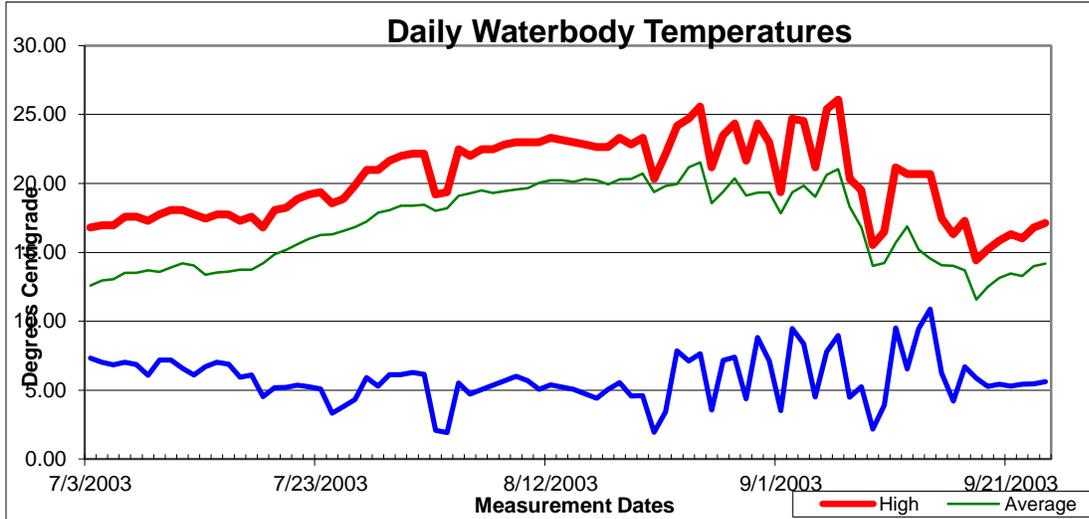
Figure RIPN-4: Succor Creek Temperature Information, 2003 (MDMT = 26.1°C and MDAT =21.5°C)

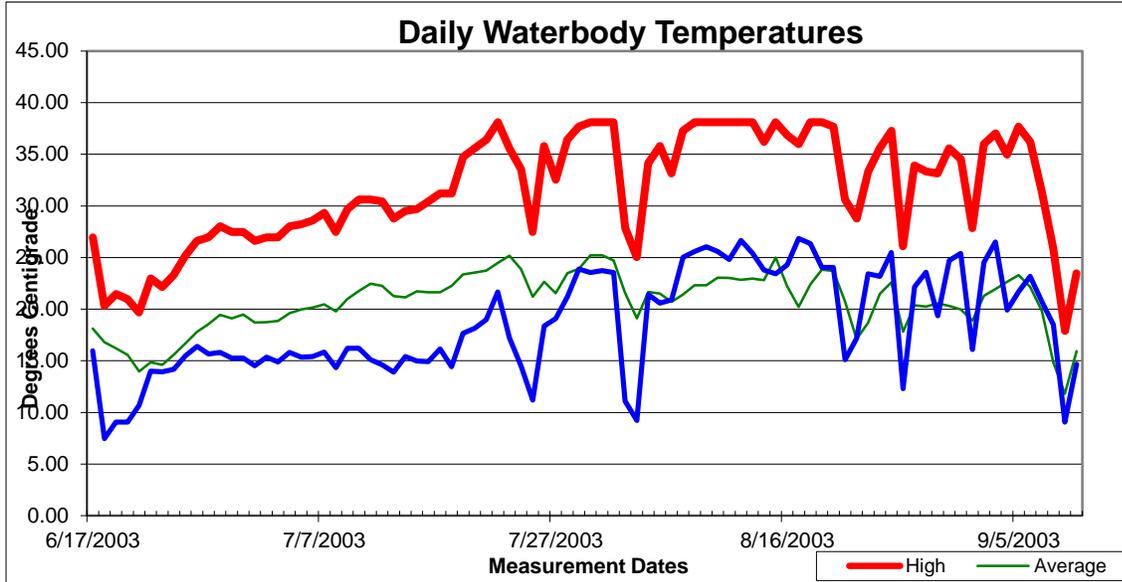
Figure RIPN-5: Cow Creek Temperature Information, 2003 (MDMT = 38.1°C and MDAT =25.2°C)

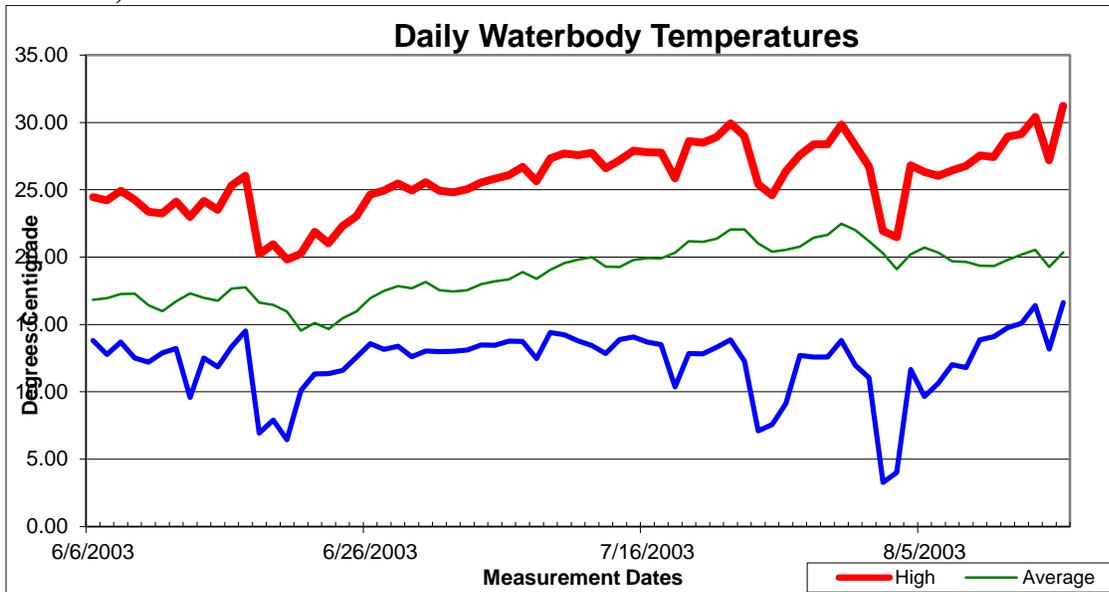
Figure RIPN-6: Soda Creek Temperature Information, 2003 (MDMT = 31.2°C and MDAT =22.5°C)

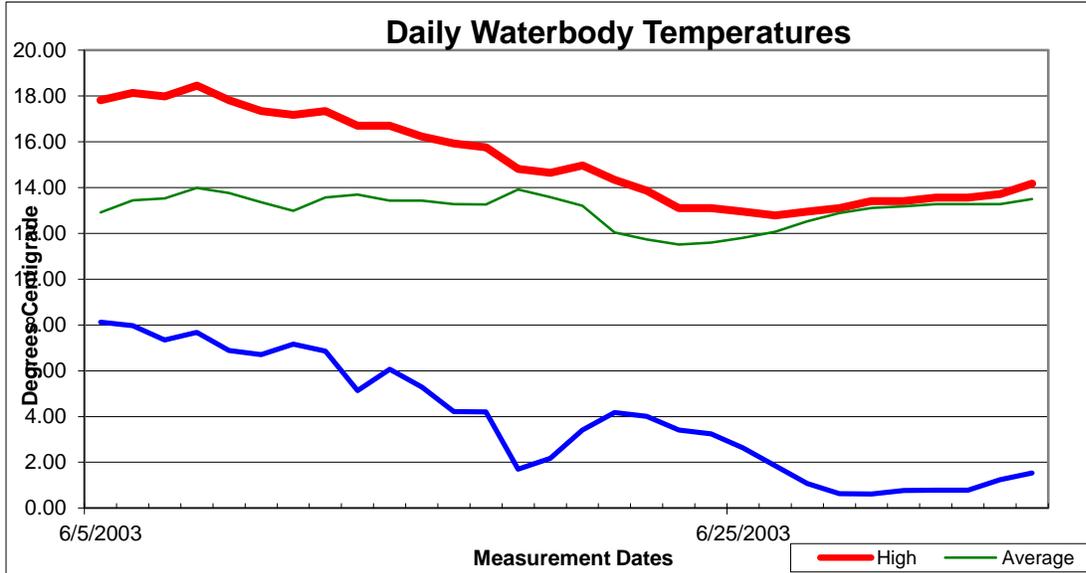
Figure RIPN-7: Sommercamp Basin Temperature Information, 2003 (MDMT = 18.5°C and MDAT =14.0°C)

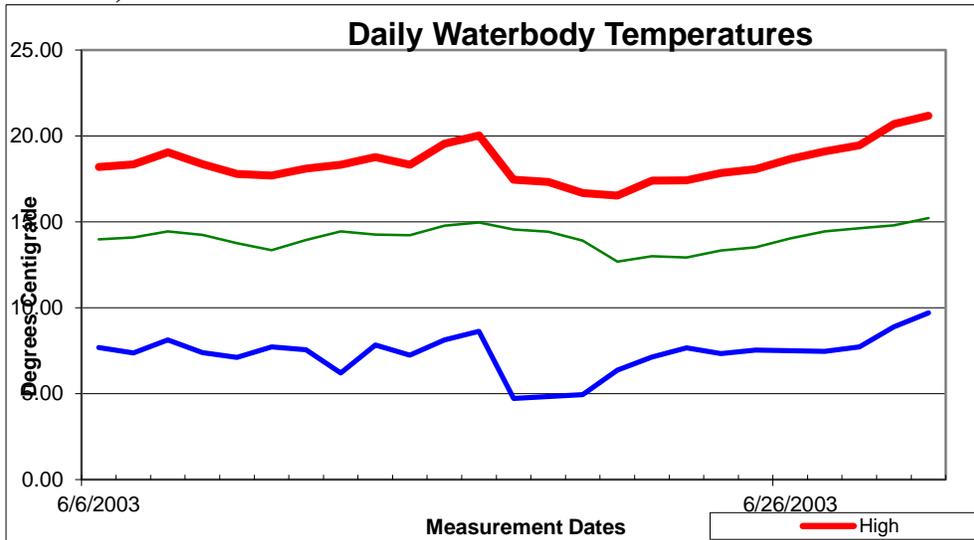
Figure RIPN-8: Soda Creek Temperature Information, 2003 (MDMT = 19.3°C and MDAT =15.2°C)

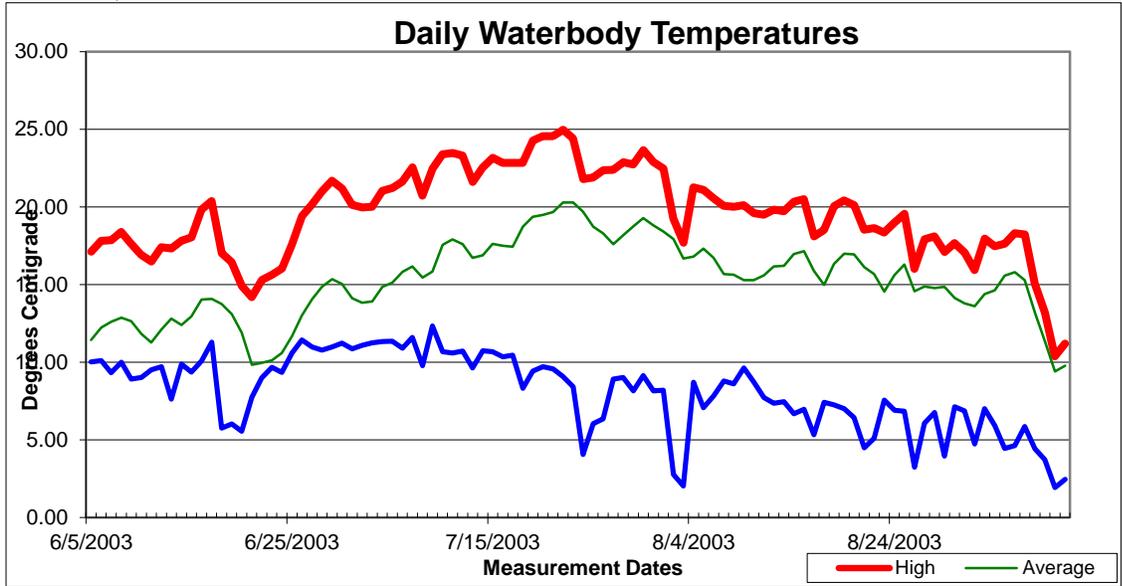
Approximately 2.0 miles of Cow, Little Cow and Jacks Creeks that traverse BLM lands within pasture 2 are on IDEQ's 303(d) list of impaired waters. Additionally, BLM has monitored temperature on both Cow and Little Cow Creeks within pasture 2. Both reaches of stream exceeded the temperature criteria set by the State. The criteria, as defined by the State, sets a Maximum Daily Maximum Temperature (MDMT) of 22° C and a Maximum Daily Average Temperature (MDAT) of 19° C.

Figure RIPN-9: Cow Creek Temperature Information, 2003 (MDMT = 25.0°C and MDAT =20.3°C)

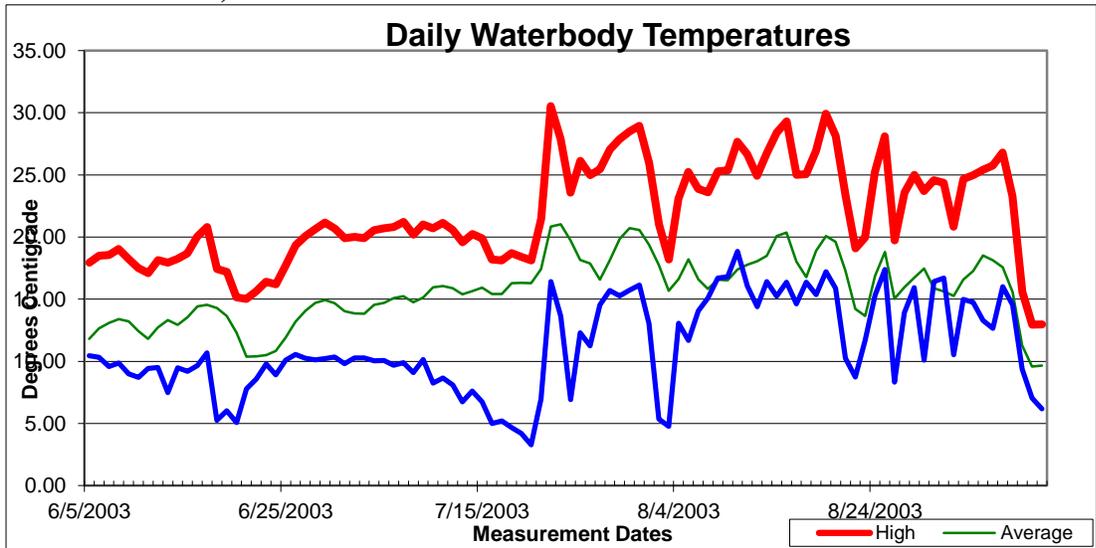
Figure RIPN-10: Little Cow Creek Temperature Information, 2003 (MDMT = 30.5°C and MDAT =21.0°C)

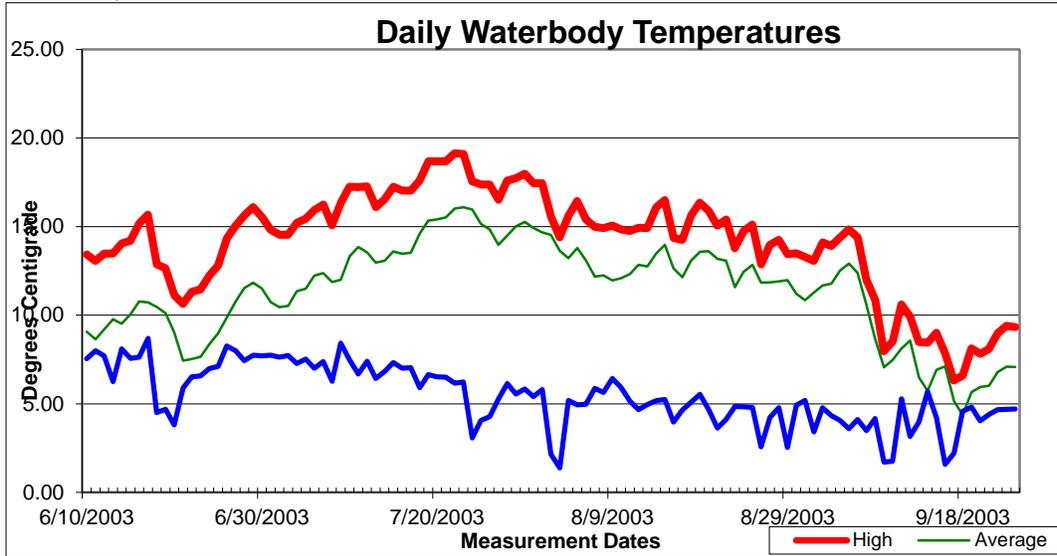
Approximately 0.4 miles of Cow Creek and 4.8 miles of Unnamed Creeks that traverse BLM lands within pasture 3 are on IDEQ’s 303(d) list of impaired waters. Additionally, BLM has monitored temperature in Cow Creek within pasture 3. The stream was within the temperature criteria set by the State. The criteria, as defined by the State, sets a Maximum Daily Maximum Temperature (MDMT) of 22° C and a Maximum Daily Average Temperature (MDAT) of 19° C.

Figure RIPN-11: Cow Creek Temperature Information, 2003 (MDMT = 19.1°C and MDAT =16.1°C)
