Appendix R – Proper Functioning Condition and Water Resources Narrative and Photos

Devils Gate Lentic Stations

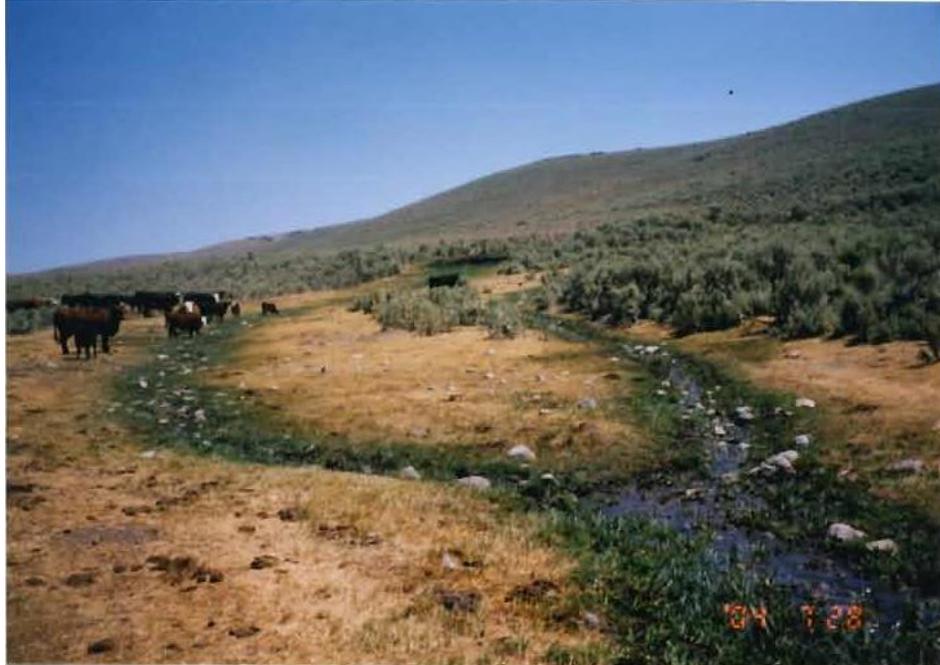
The riparian area is about 0.6 acres in size and is supported by several spring sources which have a combined flow of about 30 gallons per minute (GPM). The springs are within a 2.5 acre liberty pipe enclosure which has been in place since around 2006. The lentic assessment in 2004 rated the riparian area as functional at risk with downward trend (FARD) citing livestock use as a causal factor. Assessment teams observed that in the past this spring complex had supported a much larger riparian area as evidenced by adjacent soils and vegetation along with the dependable high rate of flow from the spring. Long term grazing at this site has resulted in narrowing of the riparian area due to erosion of riparian soils and channelization of the spring outflow. The presence of riparian soils and vegetation is well below potential due to these hydrologic impacts along with long term effects of persistent grazing and hoof action. Since the livestock enclosure was installed the condition of the wetted area has improved but it will take some time for the riparian vegetation to expand laterally. The lentic area was rated as functional at risk with upward trend (FARU) in 2013.

Photo 1 – Riparian area assessed for the 2004 Devils Gate 4 assessment. Stressed riparian vegetation and hoof action have destabilized and eroded riparian soils resulting in exposed rock at the surface. Instead of flowing laterally and watering a wide riparian area, water flows down the channel and may infiltrate into the ground more rapidly. Soils adjacent to the channel are dry and less stable than riparian soils.

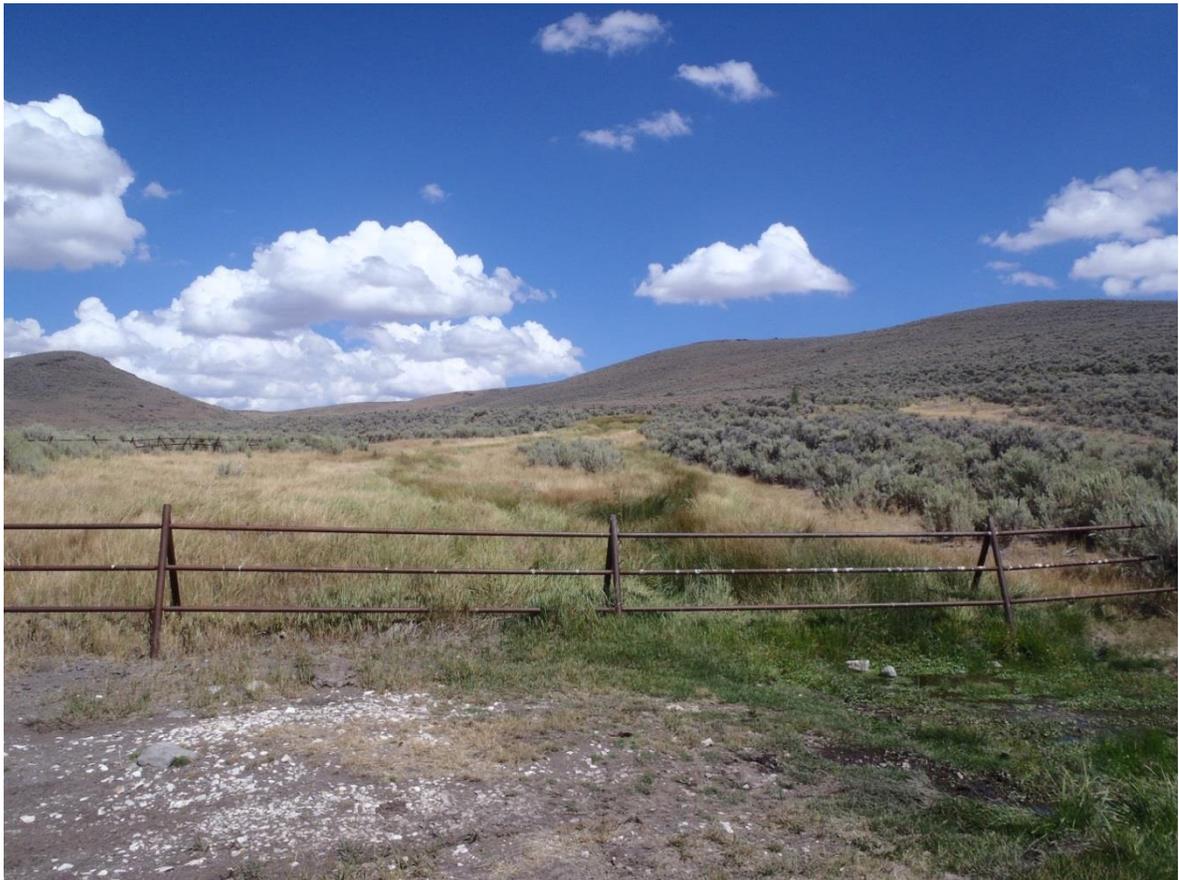
Photo 2 – Repeat of photo 1 taken as part of the 2013 Stag Mountain 4 assessment. Riparian vegetation is dense within the stream channel and with time the channel will aggrade and the riparian area will expand laterally.

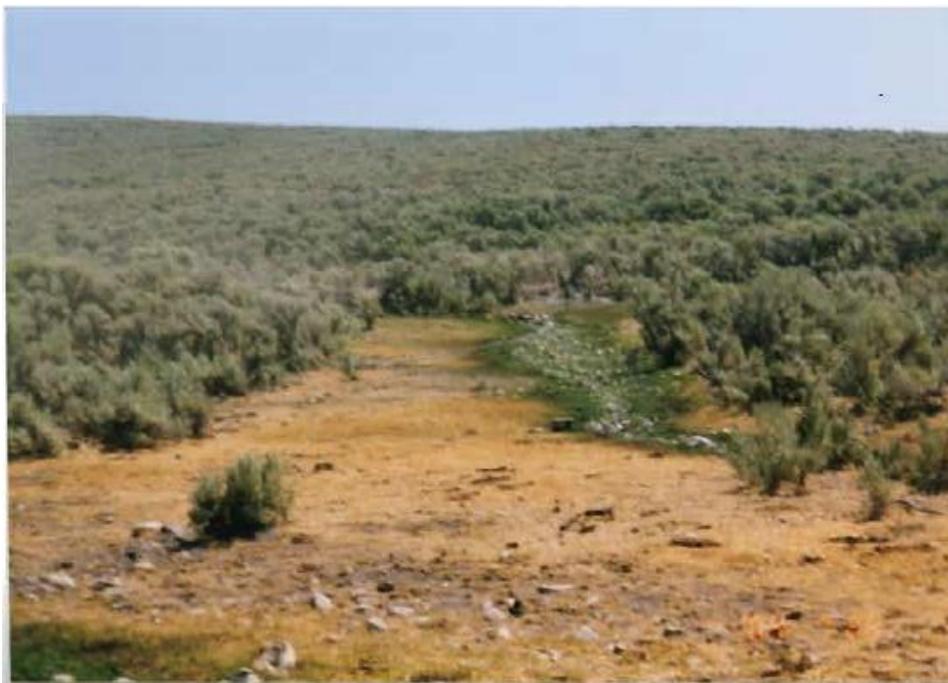
Photo 3 – Riparian area assessed for the 2004 Devils Gate 4 assessment. Similar description to photo 1.

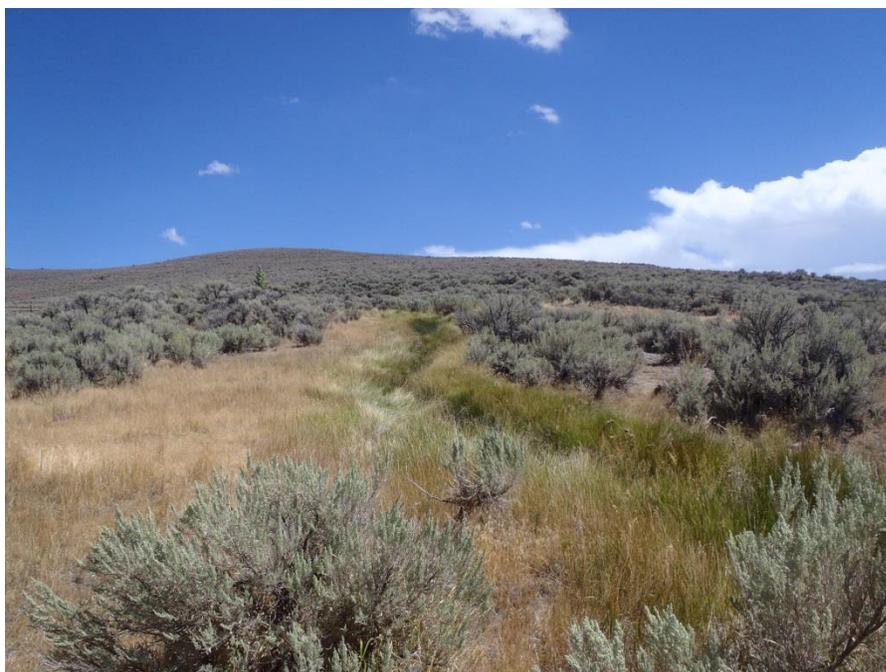
Photo 4 – Repeat of photo 3 taken as part of the 2013 Stag Mountain 4 assessment. Similar description to photo 1.

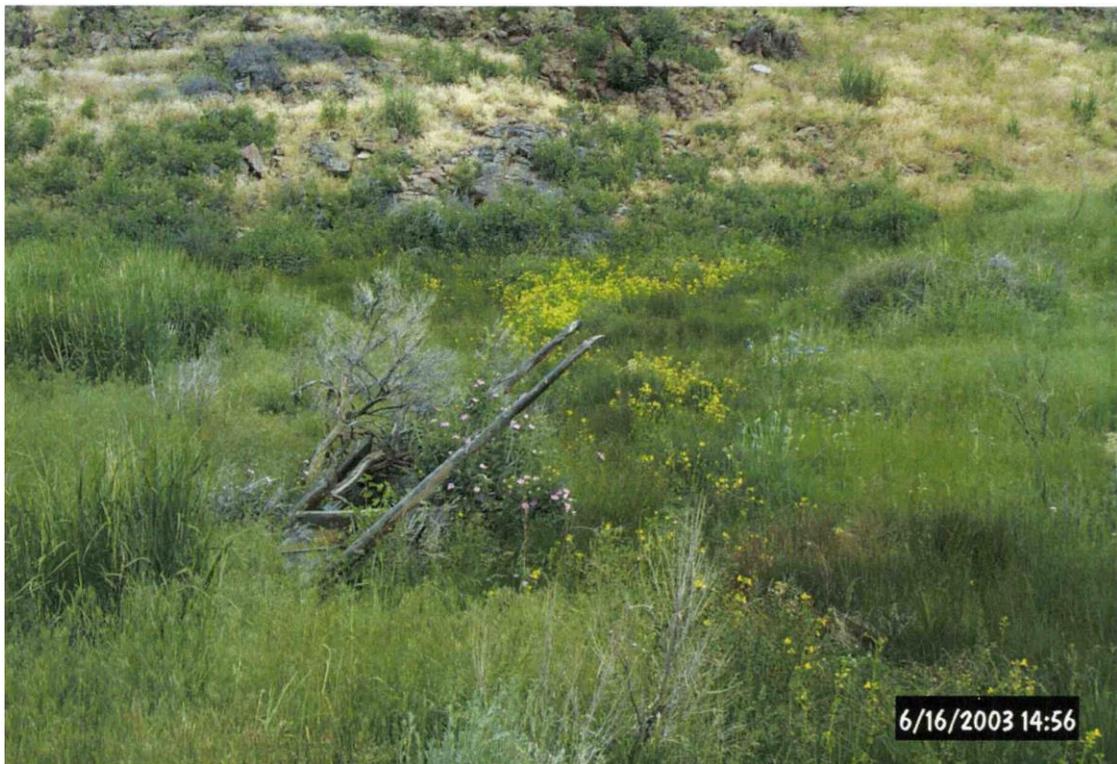
Riparian area is about 0.23 acres in size and is supported by several spring sources. Flow is too low to measure in many of the springs but the total measurable flow from these sources is about one gpm. The lentic assessments in 2003 divided the site into three separate areas and rated them all PFC. This assessment occurred during a period of two to three years when cattle were not present in the pasture due to a grazing closure following the 2001 stag fire. A reassessment in 2012 was done following grazing and indicated the area is FARD with livestock grazing as a causal factor.

Photo 5 – One of the areas assessed during the 2003 Stag Mountain UNSP 3,4,5 assessment. Vigorous vegetation production is observed, however, it does appear that many of these grasses are upland varieties suggesting that recovery of the riparian area has just started.

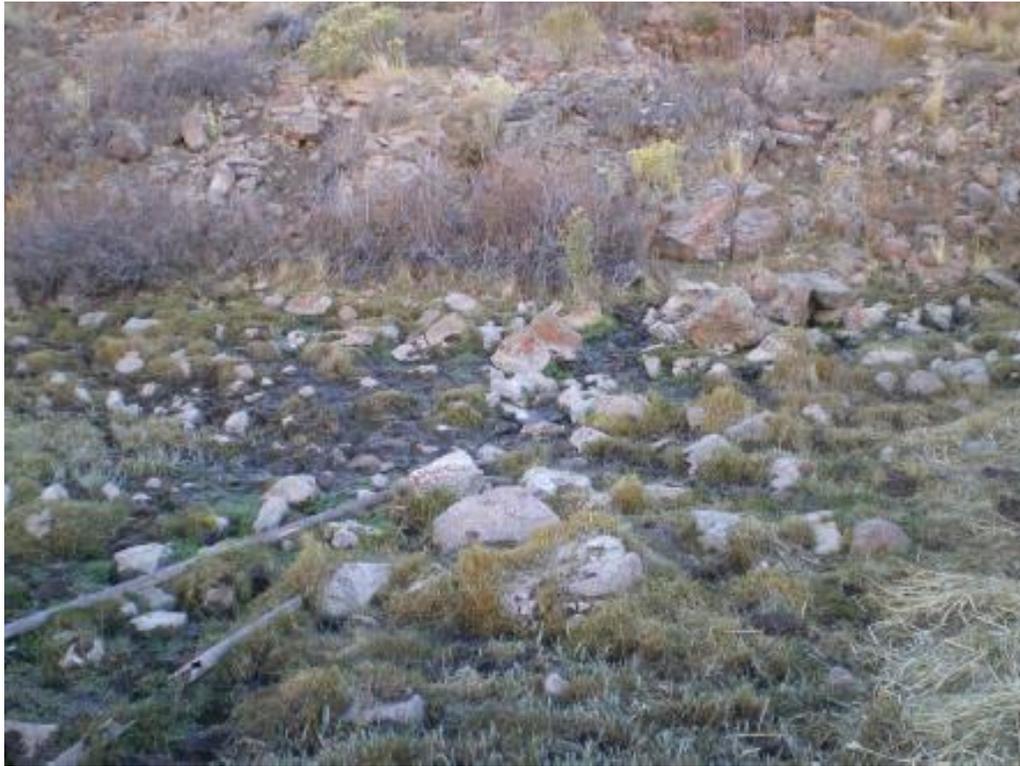
Photo 6 - Repeat of same site showing areas of bare ground and lack of vigorous riparian vegetation in 2012.

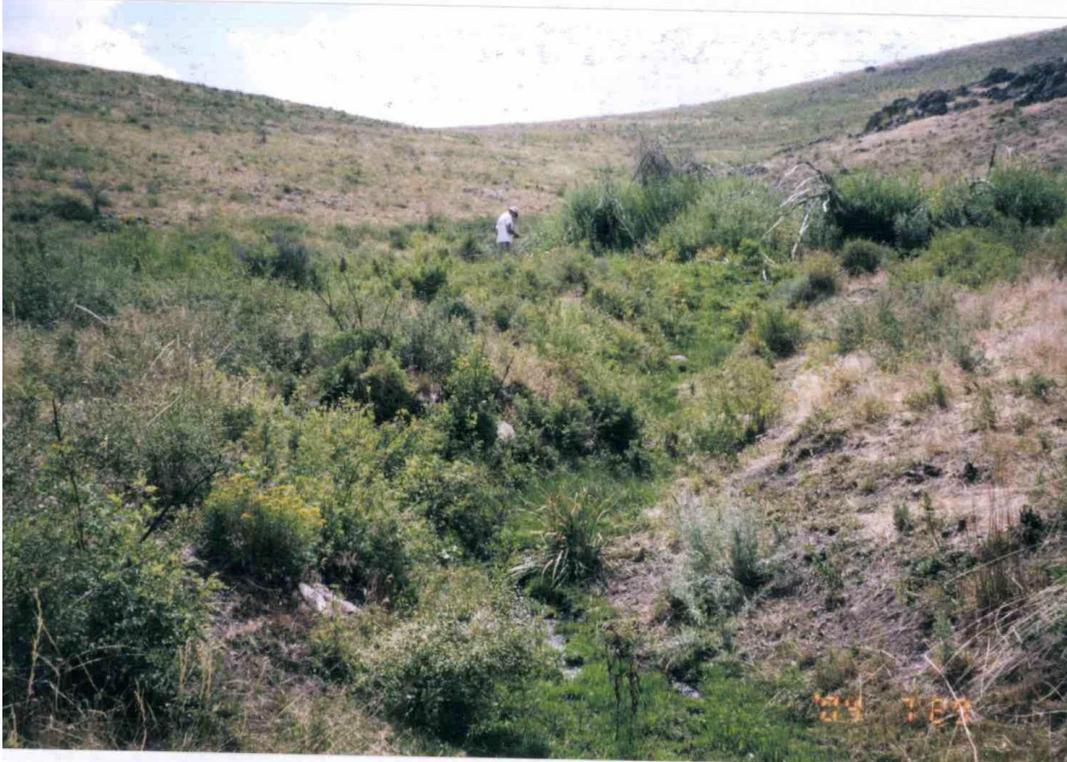
The Riparian area consists of a small herbaceous and woody riparian area about 0.18 acres in size which is supported by a spring. Flow has never been measured at this spring source. The area was rated as PFC. The assessment team noted that woody vegetation had burned in a recent fire and as a result their older age classes were missing, however this did not reduce functionality enough to warrant an at risk rating.

Photo 7 – Area assessed as part of the 2004 Devils Gate 15 assessment.

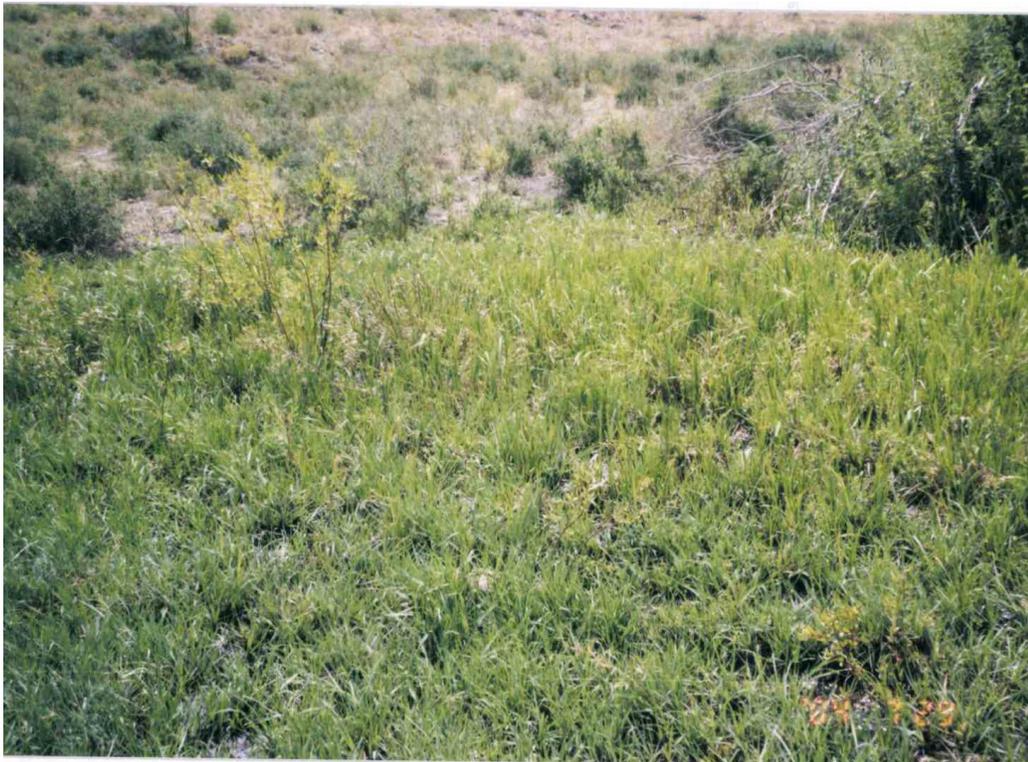
Photo 8 – Area assessed as part of the 2004 Devils Gate 15 assessment.

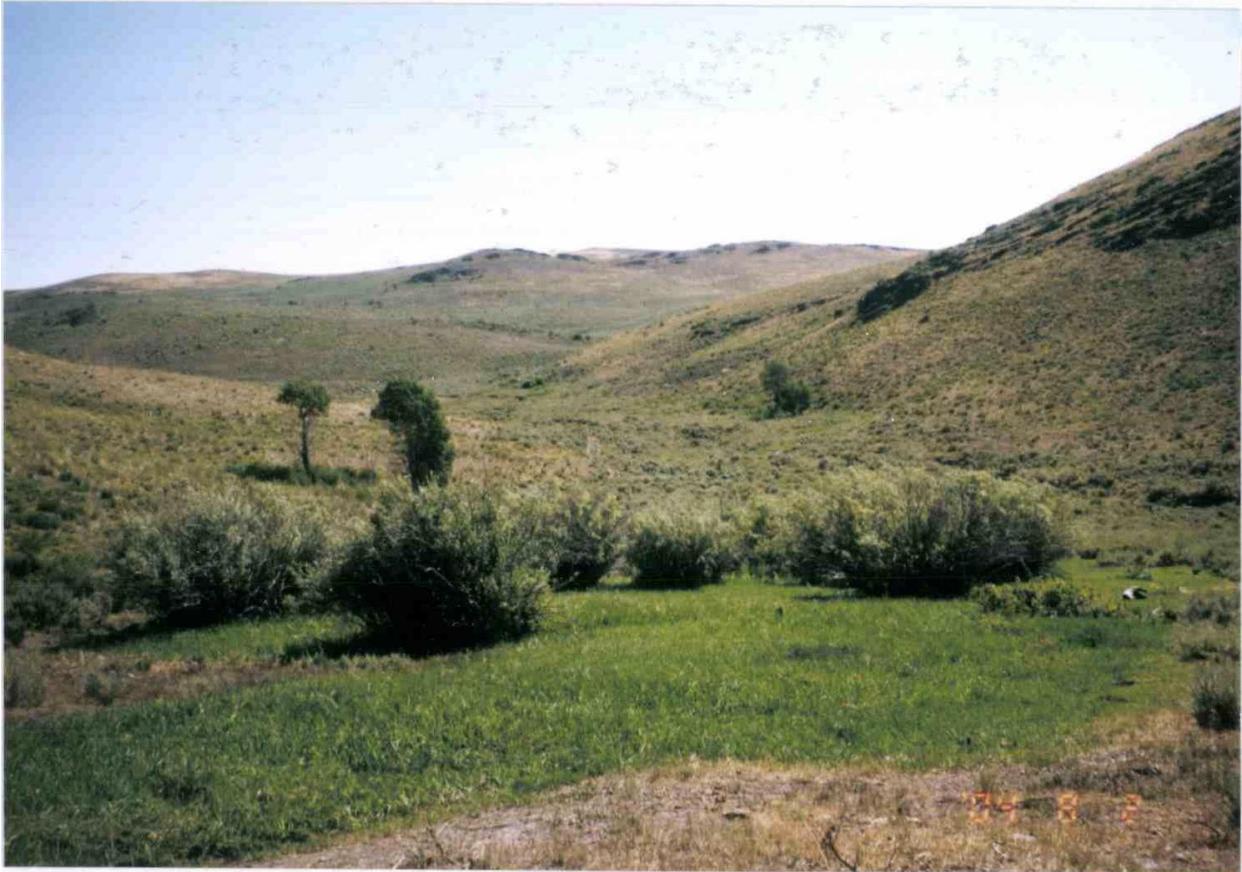
Riparian area is about 0.6 acres in size and is supported by a spring source that flows an average of 0.6 gpm. The lentic area was rated FARU in 2004. In 2013 the assessment team rated it FARD recording that the site is a fraction of its potential size, appears to be shrinking, and is impacted by hoof action.

Photo 9 - Area assessed as part of the 2004 Devils Gate 19 assessment.

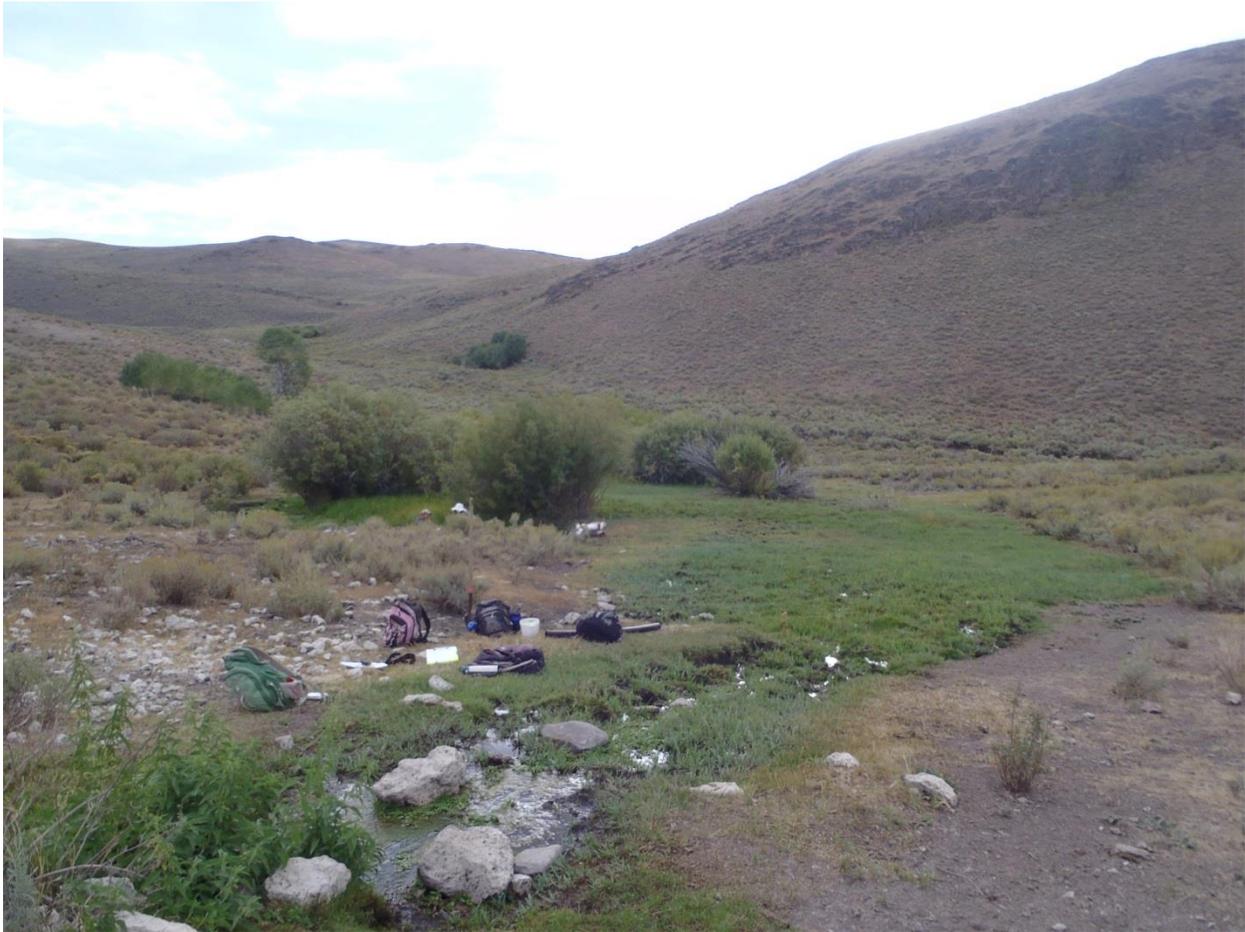
Photo 10 – Repeat of photo 9 taken as part of the 2013 Stag Mountain 19 assessment.

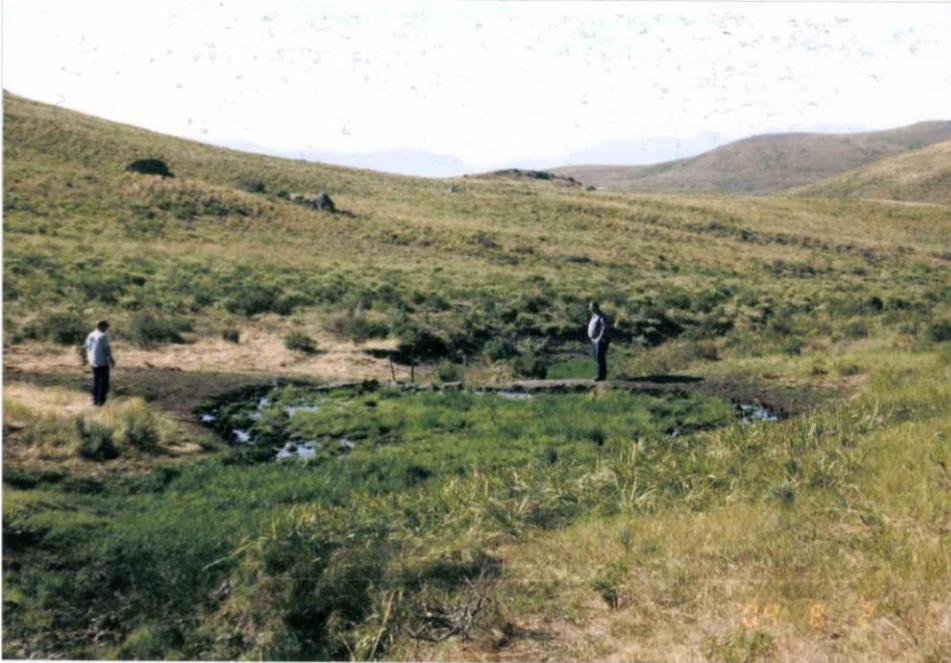
Riparian area is about one acre and is supported by a spring which flows about one gpm. Flow from the spring was originally impounded in a small pond but this pond has filled with sediment and has become part of a riparian meadow. The 2004 lentic assessment rated this area as FARD citing a shrinking riparian area caused by livestock. The 2013 assessment team also rated the site FARD, but BLM personnel changed the rating to FARNA because it was not clear whether the functionality was actually in decline, or just appeared to be in decline due to the ongoing drought.

Photo 11 - Area assessed as part of the 2004 Devil's Gate 16 assessment.

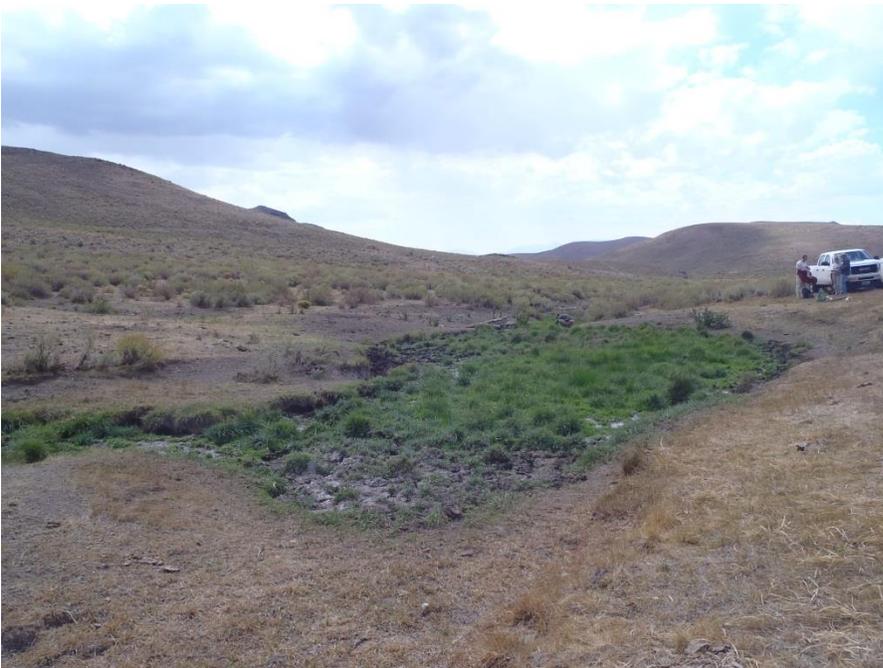
Photo 12 - Repeat of photo 11 taken as part of the 2013 Stag Mountain 16 assessment.

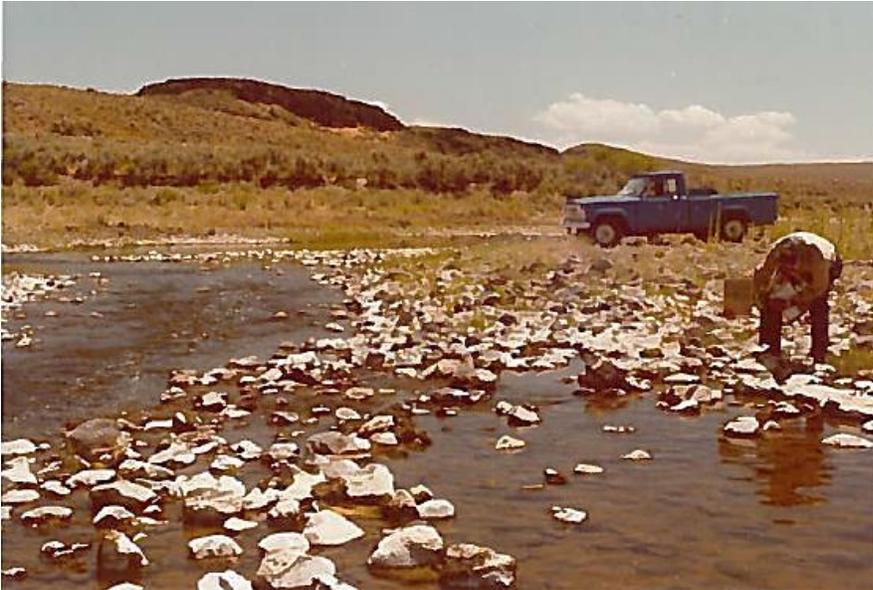
North Fork of Humboldt River is a perennial system. The Riparian Condition Indices for station 4 was 42 % (fair) for 1978 and 65% (good) in 2010. The 2010 lotic assessment rated this area as FARU citing past livestock practices. Since 2006, this station has been in Devil's Gate riparian pasture.

Photo 13 – Downstream view from Station 4. Area assessed in 1978.

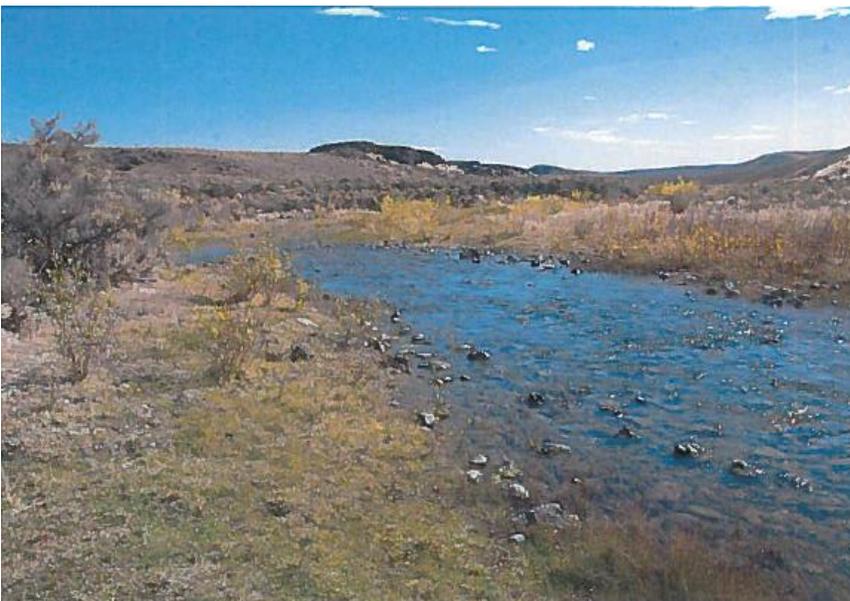
Photo 14 – Repeat of photo 13 taken in 2014.

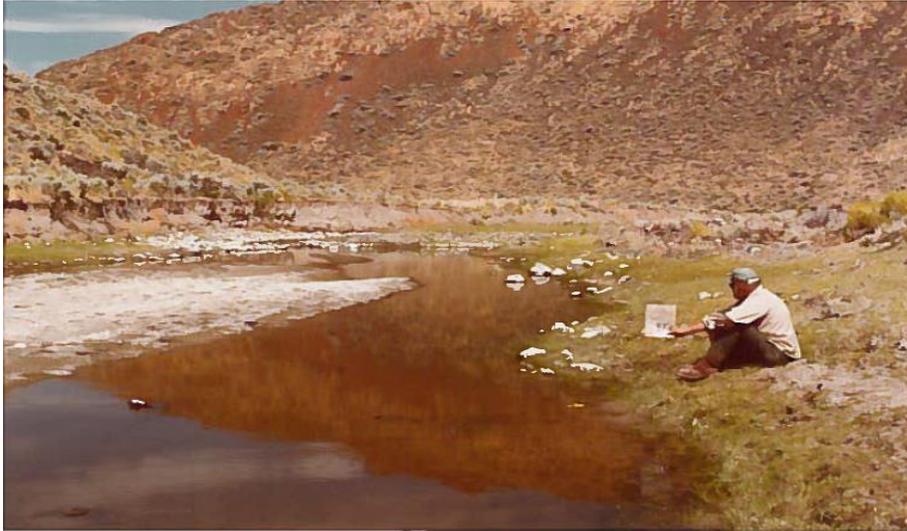
The North Fork of the Humboldt River is a perennial system. The Riparian Condition Indices for station 8 was 42 % (fair) for 1978 and 75% (good) in 2010. The 2010 lotic assessment rated this area as PFC. Since 2006, this station has been in Devil's Gate riparian pasture.

Photo 15 – North Fork of the Humboldt River, downstream view of Station 8. Area assessed in 1978.

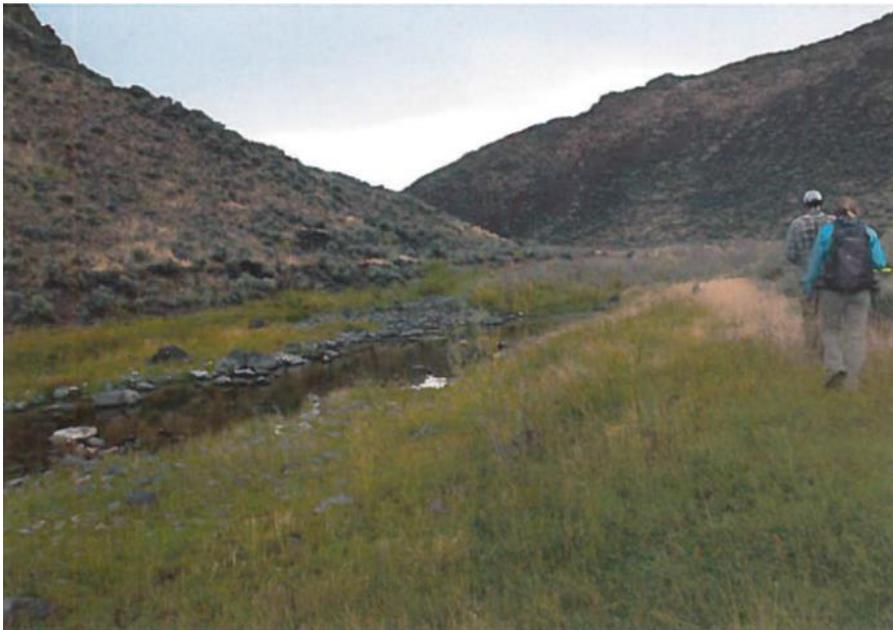
Photo 16 – Repeat of photo 15 taken in 2014.
