Energy Gateway South Transmission Project

Draft Visual Resource Technical Report

Prepared by
Environmental Planning Group
208 East 800 South
Salt Lake City, Utah 84111

February 2014

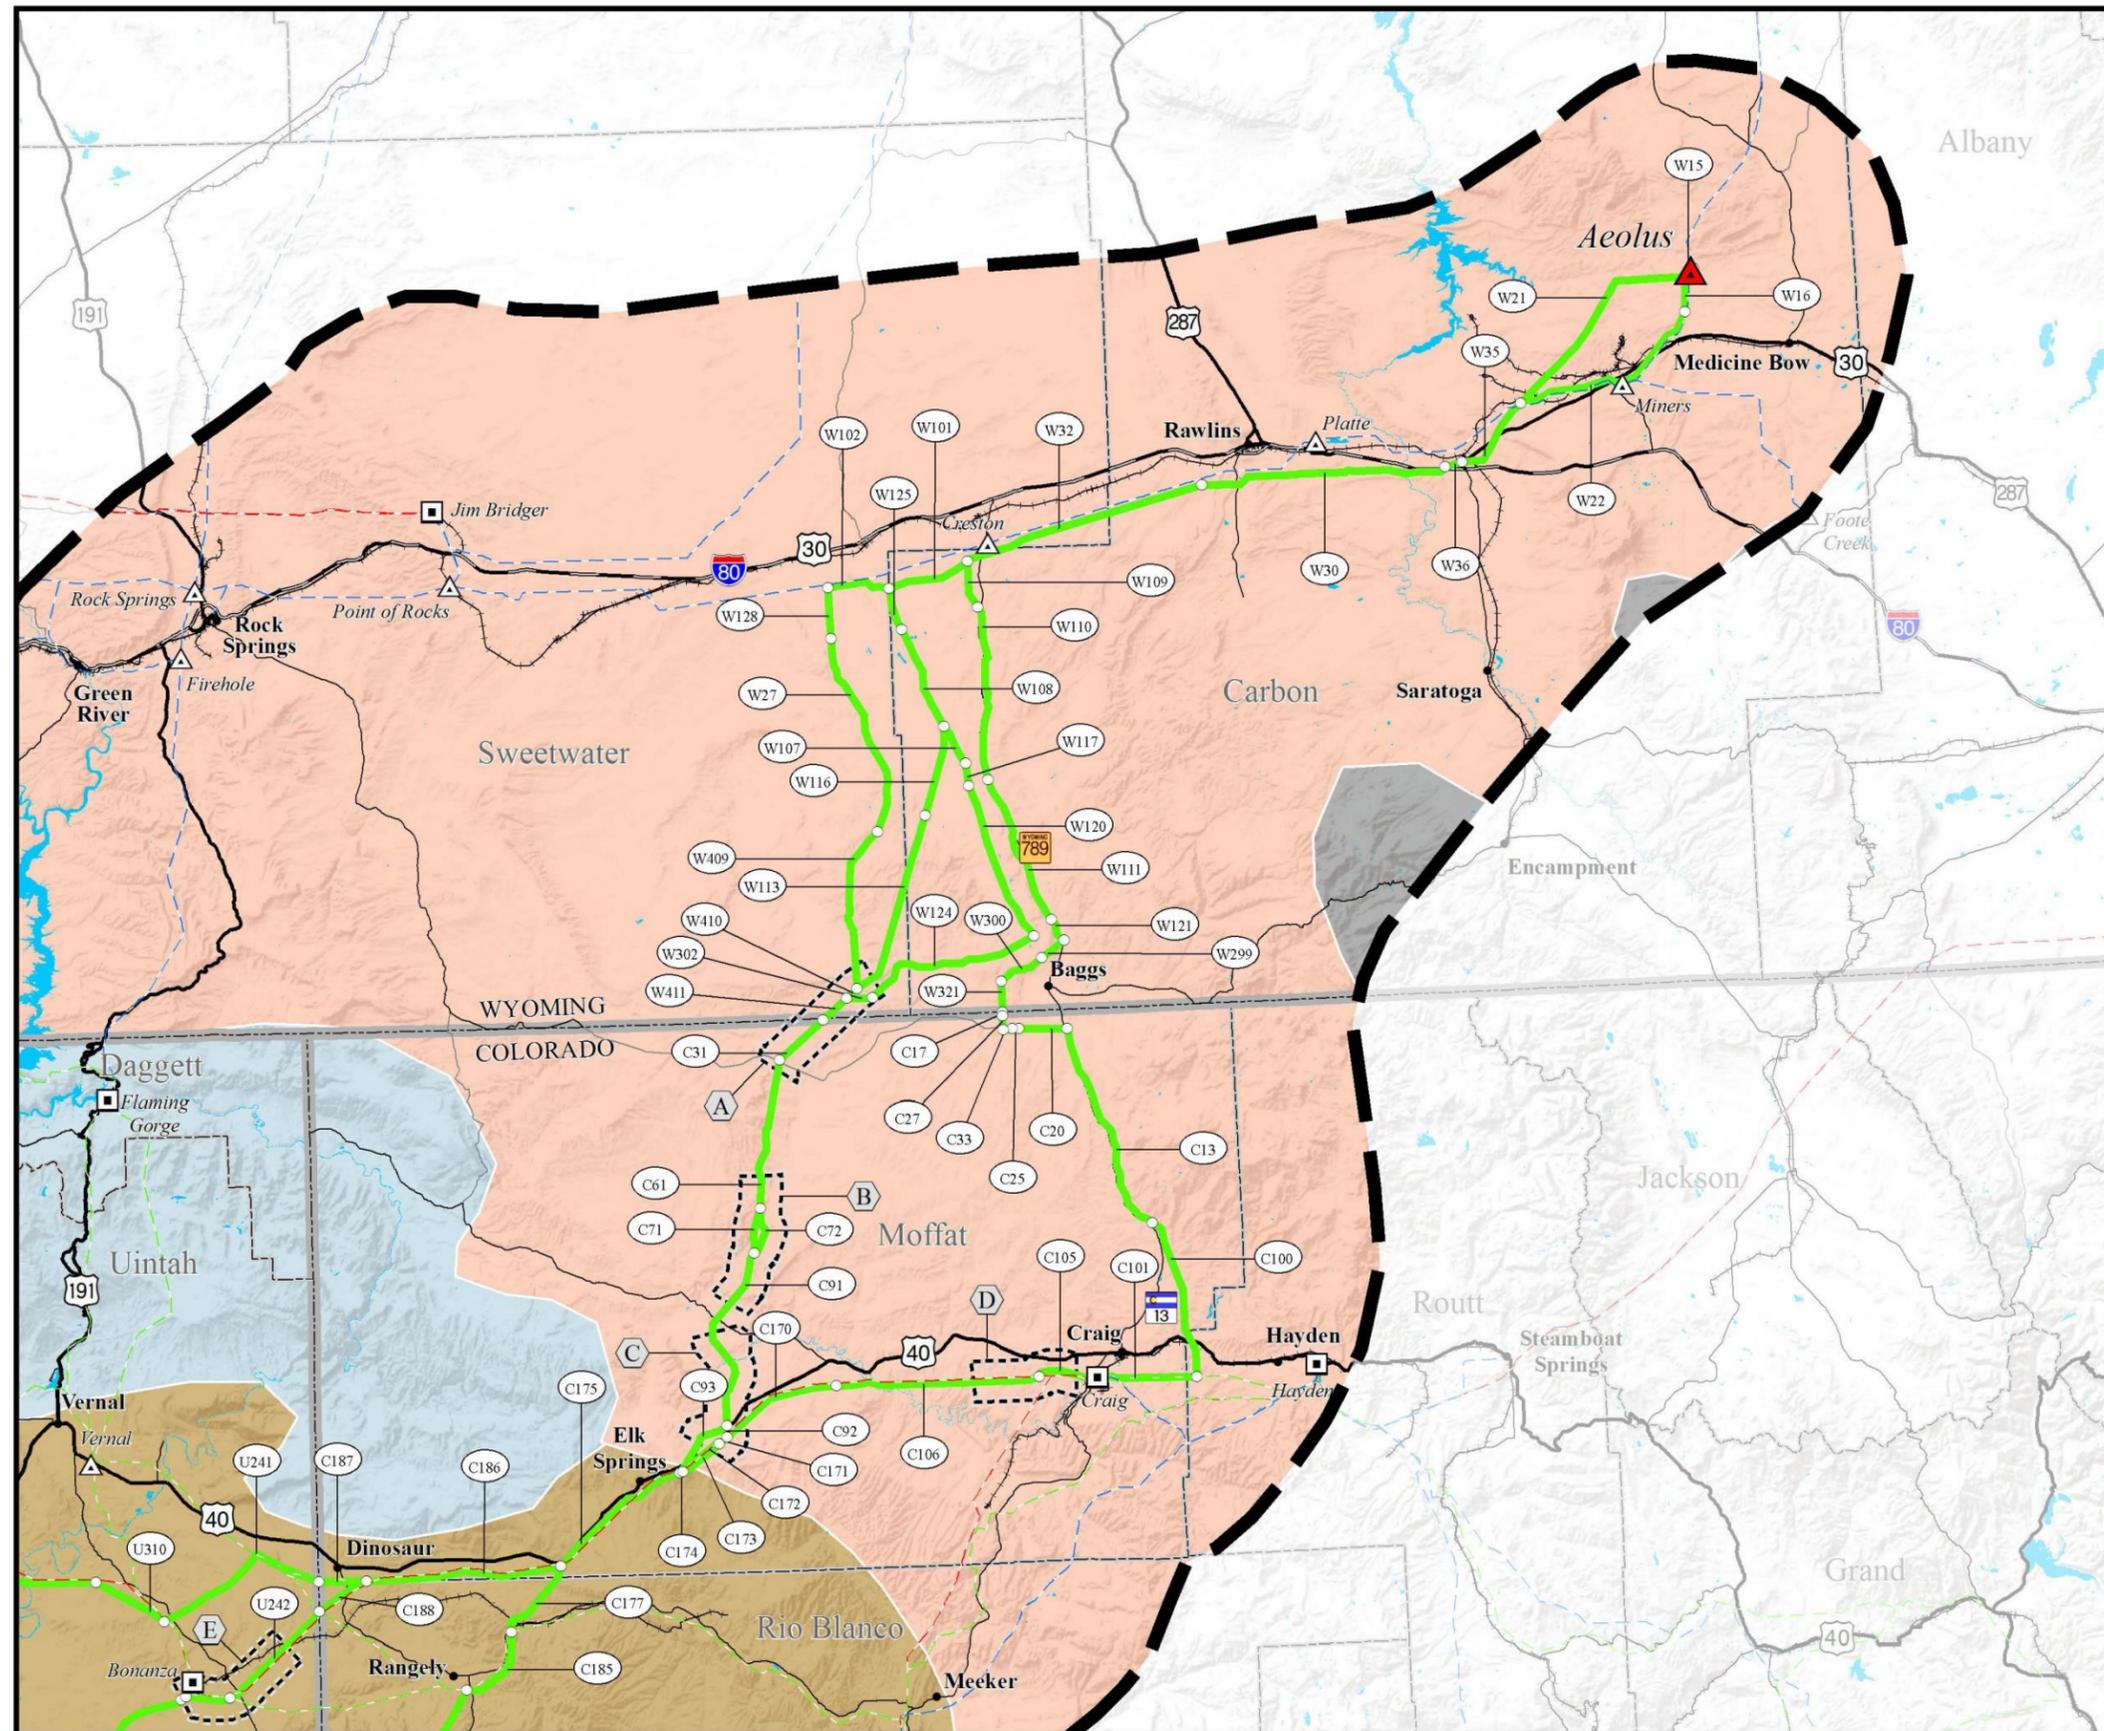
Map 1-1a
**Physiographic Provinces
 Northern Area**

The Project is located in the Basin and Range, Wyoming Basin, Middle Rocky Mountains, and Colorado Plateau physiographic provinces (Fenneman 1931). The Colorado Plateau physiographic province is further divided into three sections: Uinta Basin, Canyon Lands, and High Plateaus of Utah. To provide geographic context for the Project, below are summaries of each physiographic province (or section as applicable) traversed by the Project and maps showing these areas (Maps 1-1a and 1-1b).

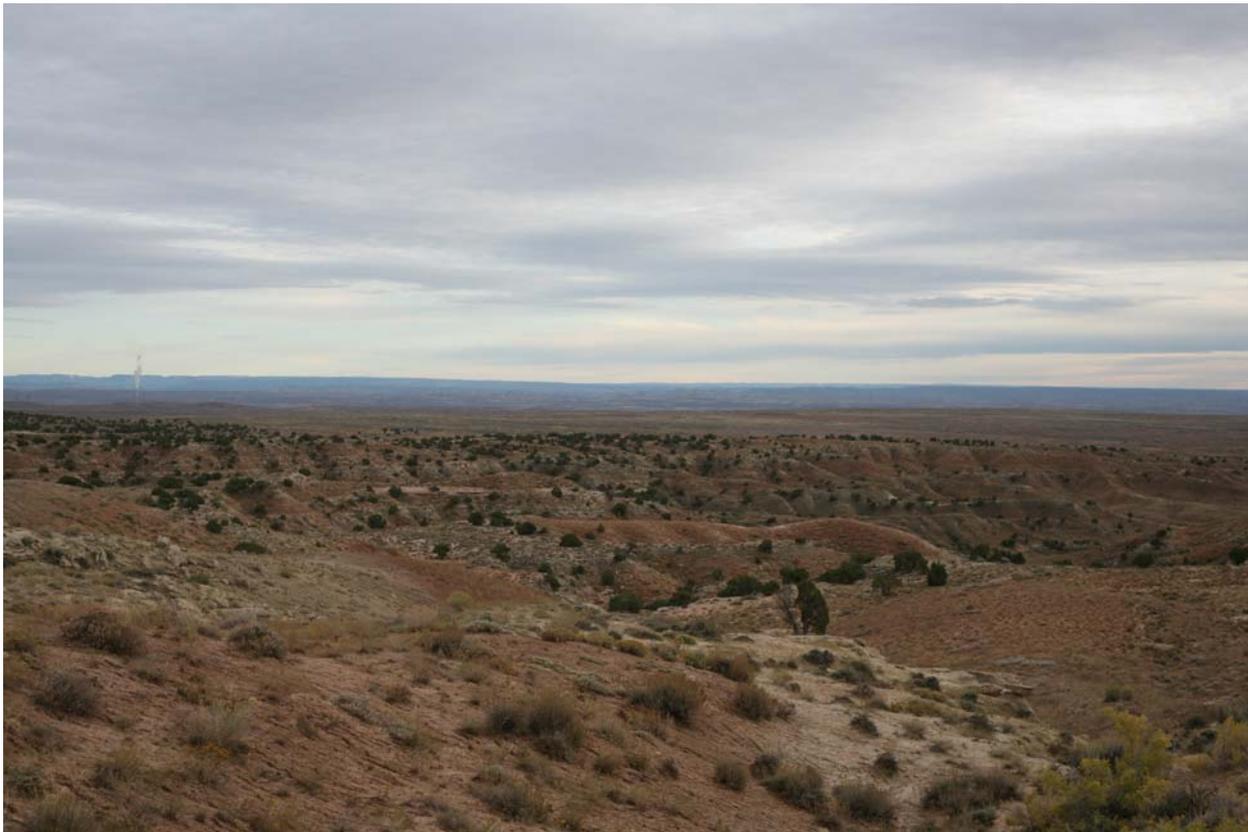
Badlands

Located in the Uinta Basin of the Colorado Plateau physiographic province, the landscape unit is characterized by steep, eroded hills that blend into each other creating a complex pattern of horizontal and vertical lines. This landscape unit is primarily found along the northeastern edge of the Uinta Basin. Color diversity is moderate with a range of tans, browns, and reds in the rocks and soil that contrast with widely scattered vegetation. Texture is created by the variously sized eroded channels that form on the surface of the badlands. Adjacent scenery is comprised of sagebrush and shrub dominated valleys that contrast with the highly dissected badlands in this landscape. Cultural modifications to this landscape include roads and oil/gas operations with transmission lines traversing portions of this landscape that have locally modified the character of the landscape through the introduction of repetitive vertical (structures) and horizontal (conductors) lines. These transmission lines and other cultural modifications have minimal influence on the overall character of this landscape.

Location Date	Location Time	Location		Viewing Direction
10/10/2011	5:00 PM	40.181435	-109.351397	S

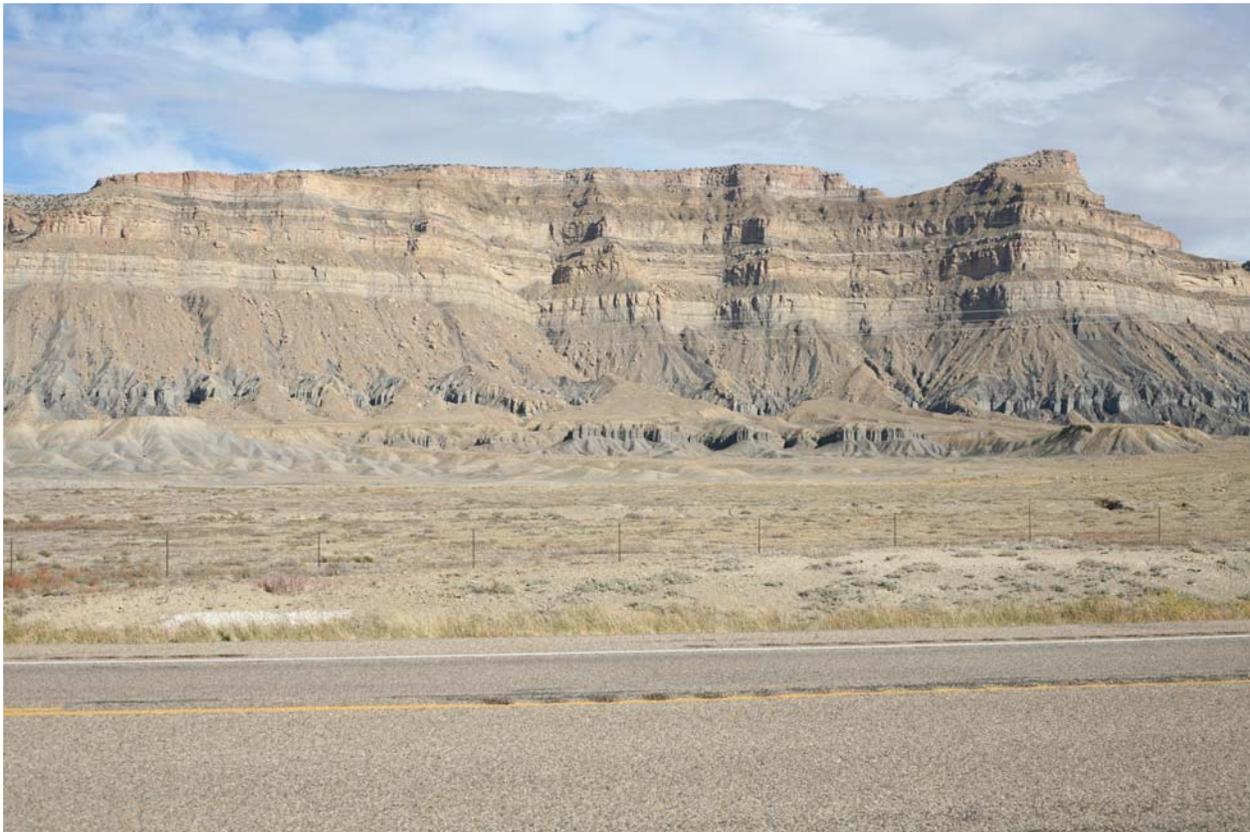
Book Cliffs

This landscape, located in the Colorado Plateau physiographic province, is characterized by a bold, rocky, continuous cliff face surrounded by eroded alluvial debris formations that are set in generally flat, sagebrush dominated valleys. Strong horizontal lines of rust, light brown, and gray are exposed in rock layers, ledges, and outcrops with broken vertical and diagonal lines within the landform adding to the complexity of the landscape. Vegetation, limited to pinyon-juniper, shrubs, and grasses, is widely scattered on ledges and debris slopes and contrasts the reds, grays, and tans within the cliffs. Texture is comprised of horizontal striations, ledges, debris slopes, and vegetation, with the coarsest textures expressed within exposed rock formations, as well as the eroded boulders that collect at the base of the cliffs. Cultural modifications include two track roads but other modifications are limited due to the steep unstable landscape.

Location Date	Location Time	Location		Viewing Direction
10/4/2011	3:02 PM	39.195373	-110.338578	E
