**DOI-BLM-MT-C020-2016-0039-DNA
January 21, 2016**

MTM-108536 Road Trespass Reclamation

Worksheet
Documentation of NEPA Adequacy (DNA)

Proposed Action Title/Type: MTM-108536 Road Trespass Reclamation

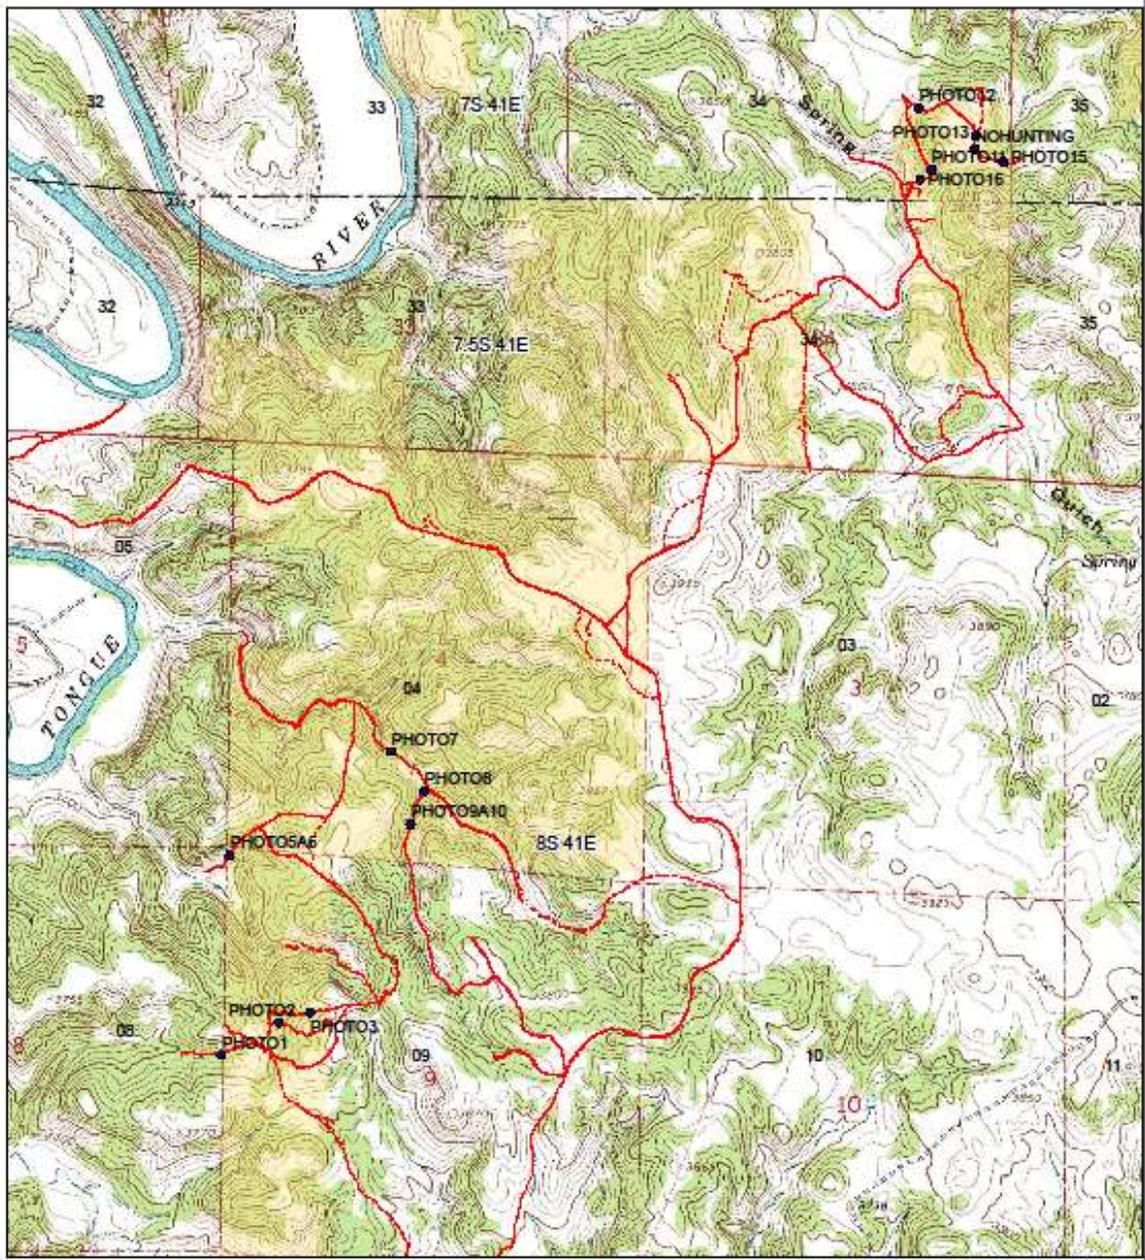
MTM-108536 Trespass

Disturbance (ft) at Photo Points:

Photo 2 – 150 ft
Photo 3 – 435 ft
Photo 5a 6 – 350 ft
Photo 8 – 100 ft
Photo 9A10 – 250 ft
Photo 11 – 830 ft
Photo 12 – 220 ft
Photo 13 – 240 ft
Photo 15 – 175 ft
Photo 16 – 110 ft

Total of 2,860 ft bladed and 7 ft wide = .46 acres

Some of the roads/trails that were upgraded or improved were already present; however, the responsible party did not have a right-of-way or authorization to improve the road. The unauthorized roads are approximately 2,860 feet long and 7 feet wide, consisting of 0.46 acres. As part of the trespass settlement, the trespasser would be responsible for the reclamation of the unauthorized roads/trails deemed new or unnecessary. The reclamation would involve pulling the berm back in place and smoothing out the area to blend into the surrounding landscape. Refer to the attached reclamation plan for more detail.
