U.S. DEPARTMENT OF THE INTERIOR
Bureau of Land Management
Coos Bay District

Worksheet
Documentation of NEPA Adequacy (DNA)

DNA Title: District Emergency Relief for Federally Owned Road Repairs

Federal Highways Administration Reference Number: ERFO OR-2015-1 BLM

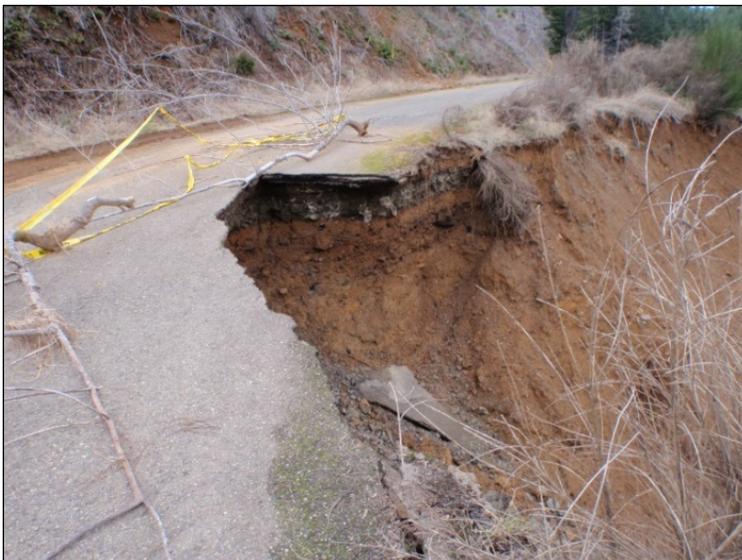
Figure 1. Site 1, Old Blue Road, Milepost 4.5 on January 22, 2015.

Saturation of the fill slope along the Old Blue Road caused the road-fill to fail during the December 2014 storm event. Once the fill slope failed, encroachment under the pavement caused portions of the roadway to collapse (**Figure 1** and **Map 1**).

The BLM proposes to stabilize the failed area with approximately 117 self-drilling soil nails, 51 self-drilling micropiles, 700 square feet of geosynthetically-confined soil wall, and 1,500 square feet of reinforced shotcrete. Contouring the failure surface prior to soil nailing would require minor excavation and the removal of vegetation and debris. The BLM would repave approximately 150 feet of roadway.

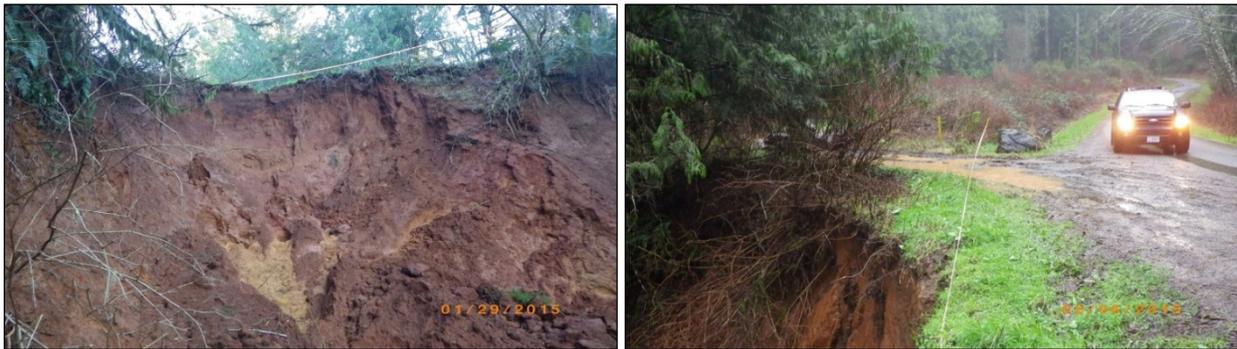
Figure 2. Site 2, Blue Ridge Road, Milepost 1.0 on January 29, 2015. *Left:* View from below the roadway. *Right:* View of roadside edge.

Heavy rain from the December 2014 storm event directed additional water from an adjacent loop road onto the Blue Ridge Road at milepost 1.0. The fill slope at the slide initiation point became saturated and failed (**Figure 2** and **Map 2**).

The BLM proposes to stabilize the compromised fill slope by installing approximately 72 soil nails along 115 linear feet of fill slope and reinforcing the soil nails with 910 square feet of 4-inch shotcrete. Contouring the failure surface would require minor excavation and the removal of vegetation and debris. The BLM would stop traffic during soil nail installation, but would allow intermittent traffic movement between nailing. The BLM would allow continuous traffic movement after working hours. The BLM may modify the adjacent loop road (e.g., water bars, blocking, or contouring) to prevent future runoff issues.

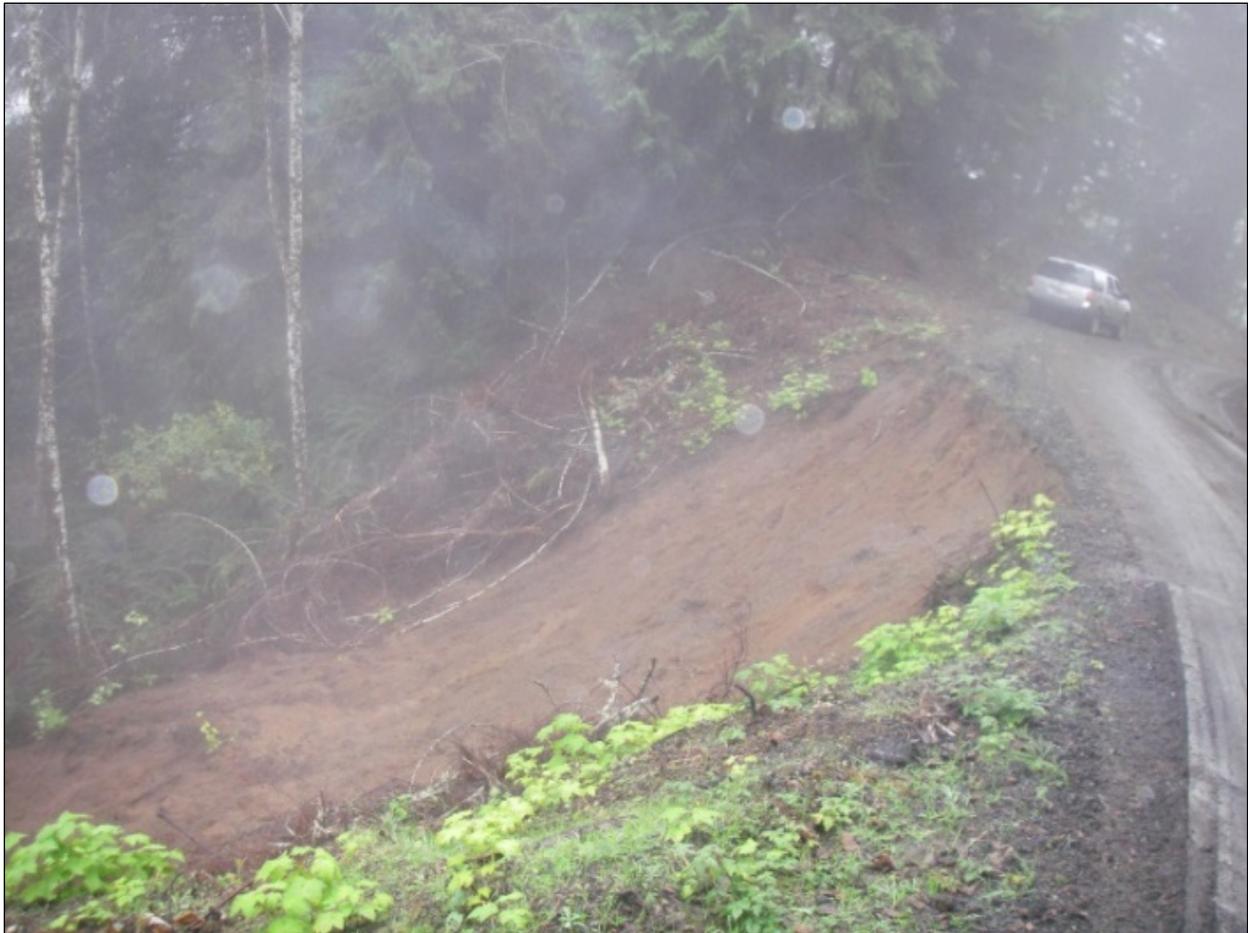
Figure 3. Site 3, South Blue Ridge Road, Milepost 0.3 on December 23, 2014.

Saturation of the fill slope during the December 2014 storm event caused the fill slope to fail (**Figure 3** and **Map 2**).

The BLM proposes minor excavation to contour the failure surface and remove vegetation and debris. The operation would then stabilize the roadside embankment with approximately 69 self-drilling soil nails and 910 square feet of 4" reinforced shotcrete.

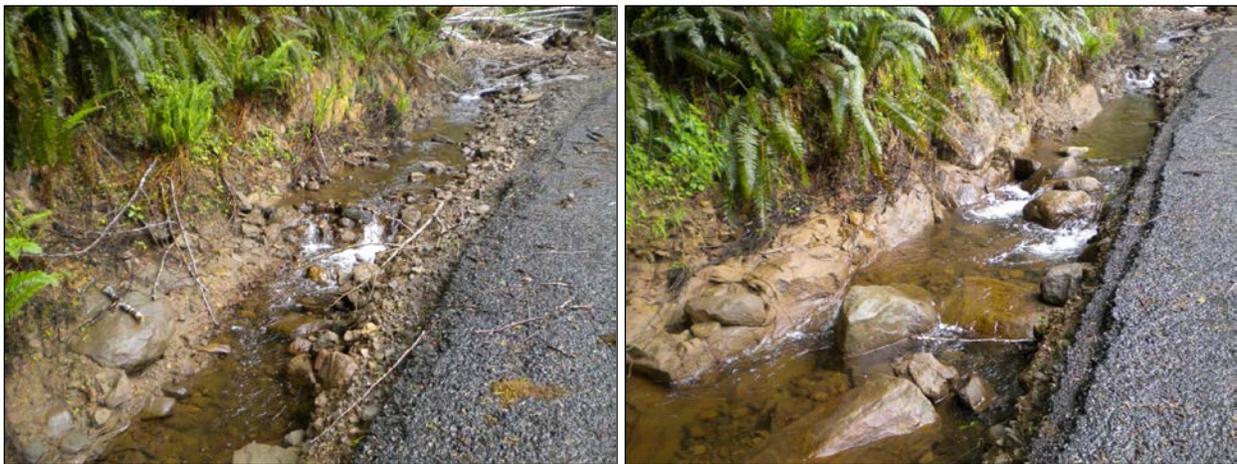
Figure 6. Typical ditch line damage between West Fork Brummit Creek Road Sites 6A and 6H.

A debris flow caused large woody debris to plug the culvert and divert a Brummit Creek tributary into the ditch line of the road for approximately 800 feet. The diverted water eroded the ditch line down approximately 3–5 feet, undermined the road surface, and caused two cross-drain culverts to fail. The diverted water washed away 9 points of the roadway, including approximately half of the road surface and subgrade (**Map 4**).

The BLM proposes to remove landslide debris, excavate borrow fill material, repair ditch lines (from Sites 6A to 6H), remove approximately 175 cubic yards of damaged asphalt, replace culverts, replace crushed aggregate subgrades, install approximately 170 tons of rip rap, and repave road surfaces with approximately 275 tons of asphalt (**Figure 6** and **Map 4**). The BLM would place weed-free native grass seed in disturbed areas.

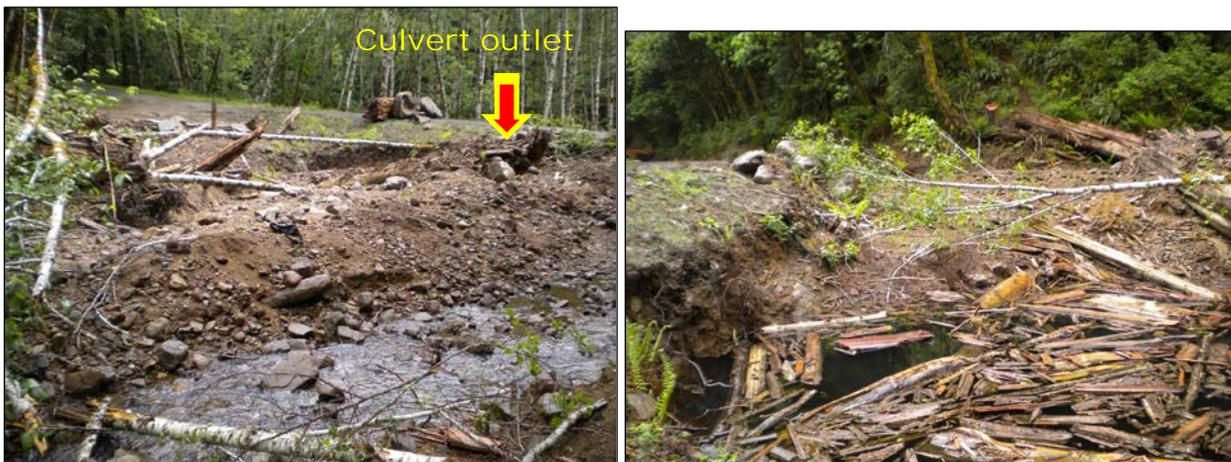
Figure 13. Site 6G/H, West Fork Brummit Creek Road. *Left:* East side of the road facing west. *Right:* West side of the road facing east.

This site is the bottom of the debris flow channel where material plugged the culvert (**Figure 13** and **Map 4**). The debris flow deposited material across the entire roadway. This event caused erosion across the entire roadway. The BLM proposes to excavate a new channel (for Reeves Creek) approximately 200 feet upstream and west of the road. The BLM would place the woody debris within 200 feet of the road from Site 6G at Site 6H to prevent the culvert from plugging again. If needed, the BLM would excavate approximately 2,400 cubic yards of material for a new channel to the north of Reeves Creek in order to route the flow of Reeves Creek away from the ditch on the west side of the road and under the roadway. The BLM would excavate the existing 5’ diameter culvert and replace it with an 8.5’ diameter culvert. The BLM’s culvert installation operations would include approximately 30 cubic yards of crushed aggregate and 130 cubic yards of slurry mix (concrete).

In addition to the culvert replacement between Sites 6G and 6H, the BLM proposes to excavate approximately 4,600 cubic yards of material at Site 6H. The BLM would excavate approximately 900 cubic yards of fill at borrow sites and transport those additional materials to the 6H repair site. The BLM would protect the repaired roadside slope at Site 6H with approximately 170 tons of riprap.

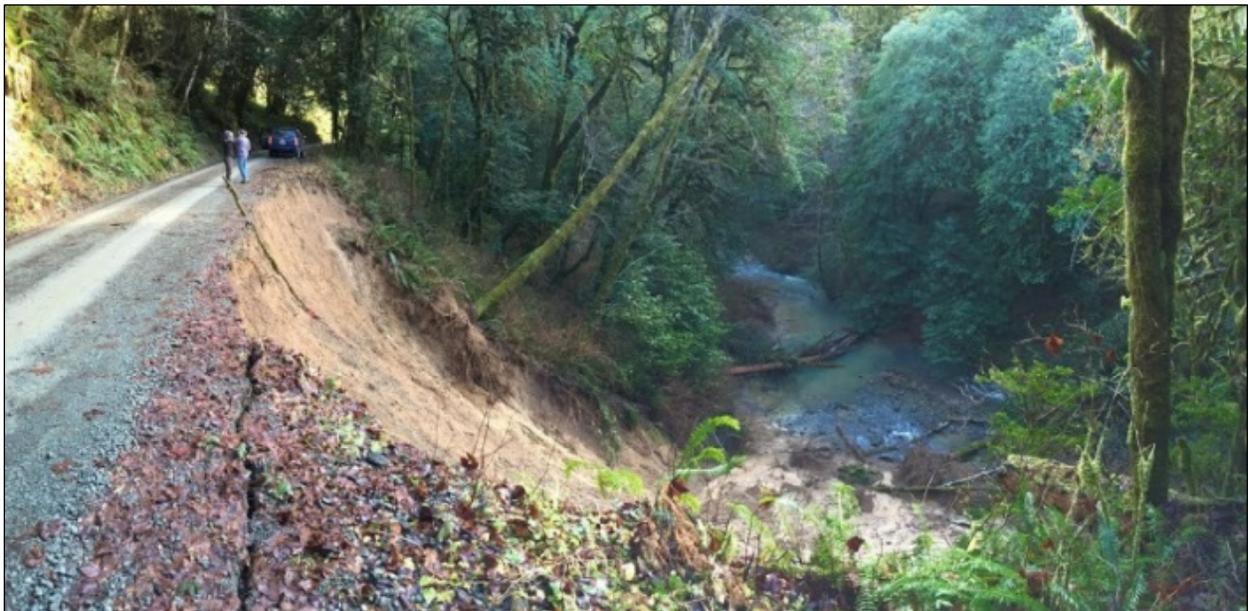
Figure 17. Site 8, Big Creek Road, Milepost 0.5 on January 21, 2015.

The storm event of December 2014 saturated the outer fill slope of Big Creek Road with water causing the slope to fail and slide into the stream below (**Figure 17** and **Map 7**). An additional storm in December 2015 caused further damage to the roadbed, which made it unsafe for haul traffic.

The BLM conducted emergency repair work (i.e., installed an erosion control mat, planted willows, and seeded and mulched) to try to prevent further migration of sediment into the adjacent Coho habitat. A 15' wide strip of the erosion control mat was damaged by a storm in 2015.

The BLM proposes to contour the failure surface and remove vegetation and debris with excavation equipment. The BLM would move approximately 100 cubic yards of waste to an approved waste area. The BLM would then stabilize the failed embankment with approximately 86 self-drilling soil nails (up to 20 feet long) along a 110' linear span. Operations to cover the soil nails would include the application of approximately 1,320 square feet of 4" reinforced shotcrete.

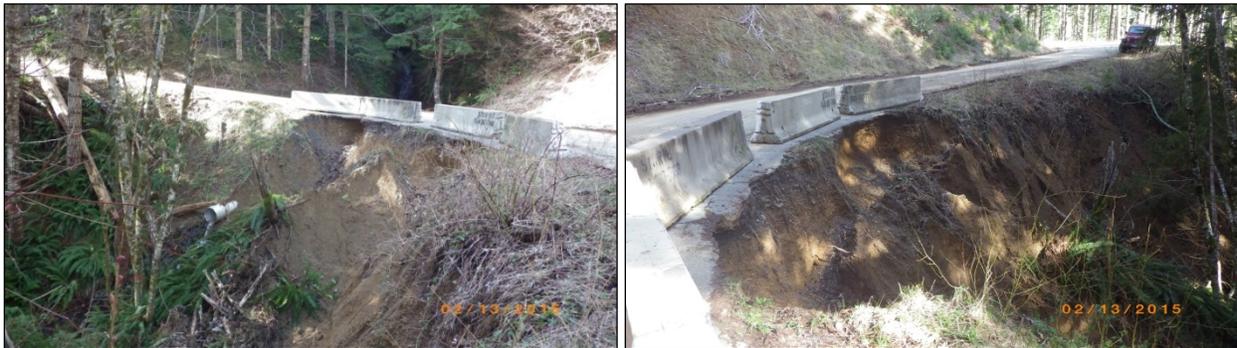
Figure 18. Site 9, Lower Signal Tree Road, Milepost 5.7 on February 13, 2015.

The storm event of December 2014 overwhelmed the capacity of an existing 36” diameter culvert under Lower Signal Tree Road at Milepost 5.7 (**Figure 18** and **Map 8**). The deluge caused excess storm water to accumulate and run across the road surface saturating the fill slope and resulting in fill failure and undercutting of the pavement.

The BLM proposes to excavate and replace the 36” culvert and stabilize unconsolidated material on the slope at the inlet end of the culvert with approximately 800 tons of riprap buttressing materials. The BLM would build up the subgrade with base rock, and add surface rock before repaving approximately 115 linear feet of roadway with asphalt. The BLM would rebuild the slope toe with approximately 300 square yards of geotextiles, and seed and mulch the area to reestablish vegetation.
