1. Project Name TransWest Express	4. Location Wyoming SH 71(northbound)	5. Location Sketch Please see Figure 3.1-1
2. Key Observation Point R-5	Township 21N	
3. VRM Class Private	Range 87W Section 31

TRANSWEST EXPRESS TRANSMISSION PROJECT

VISUAL CONTRAST RATING WORKSHEET

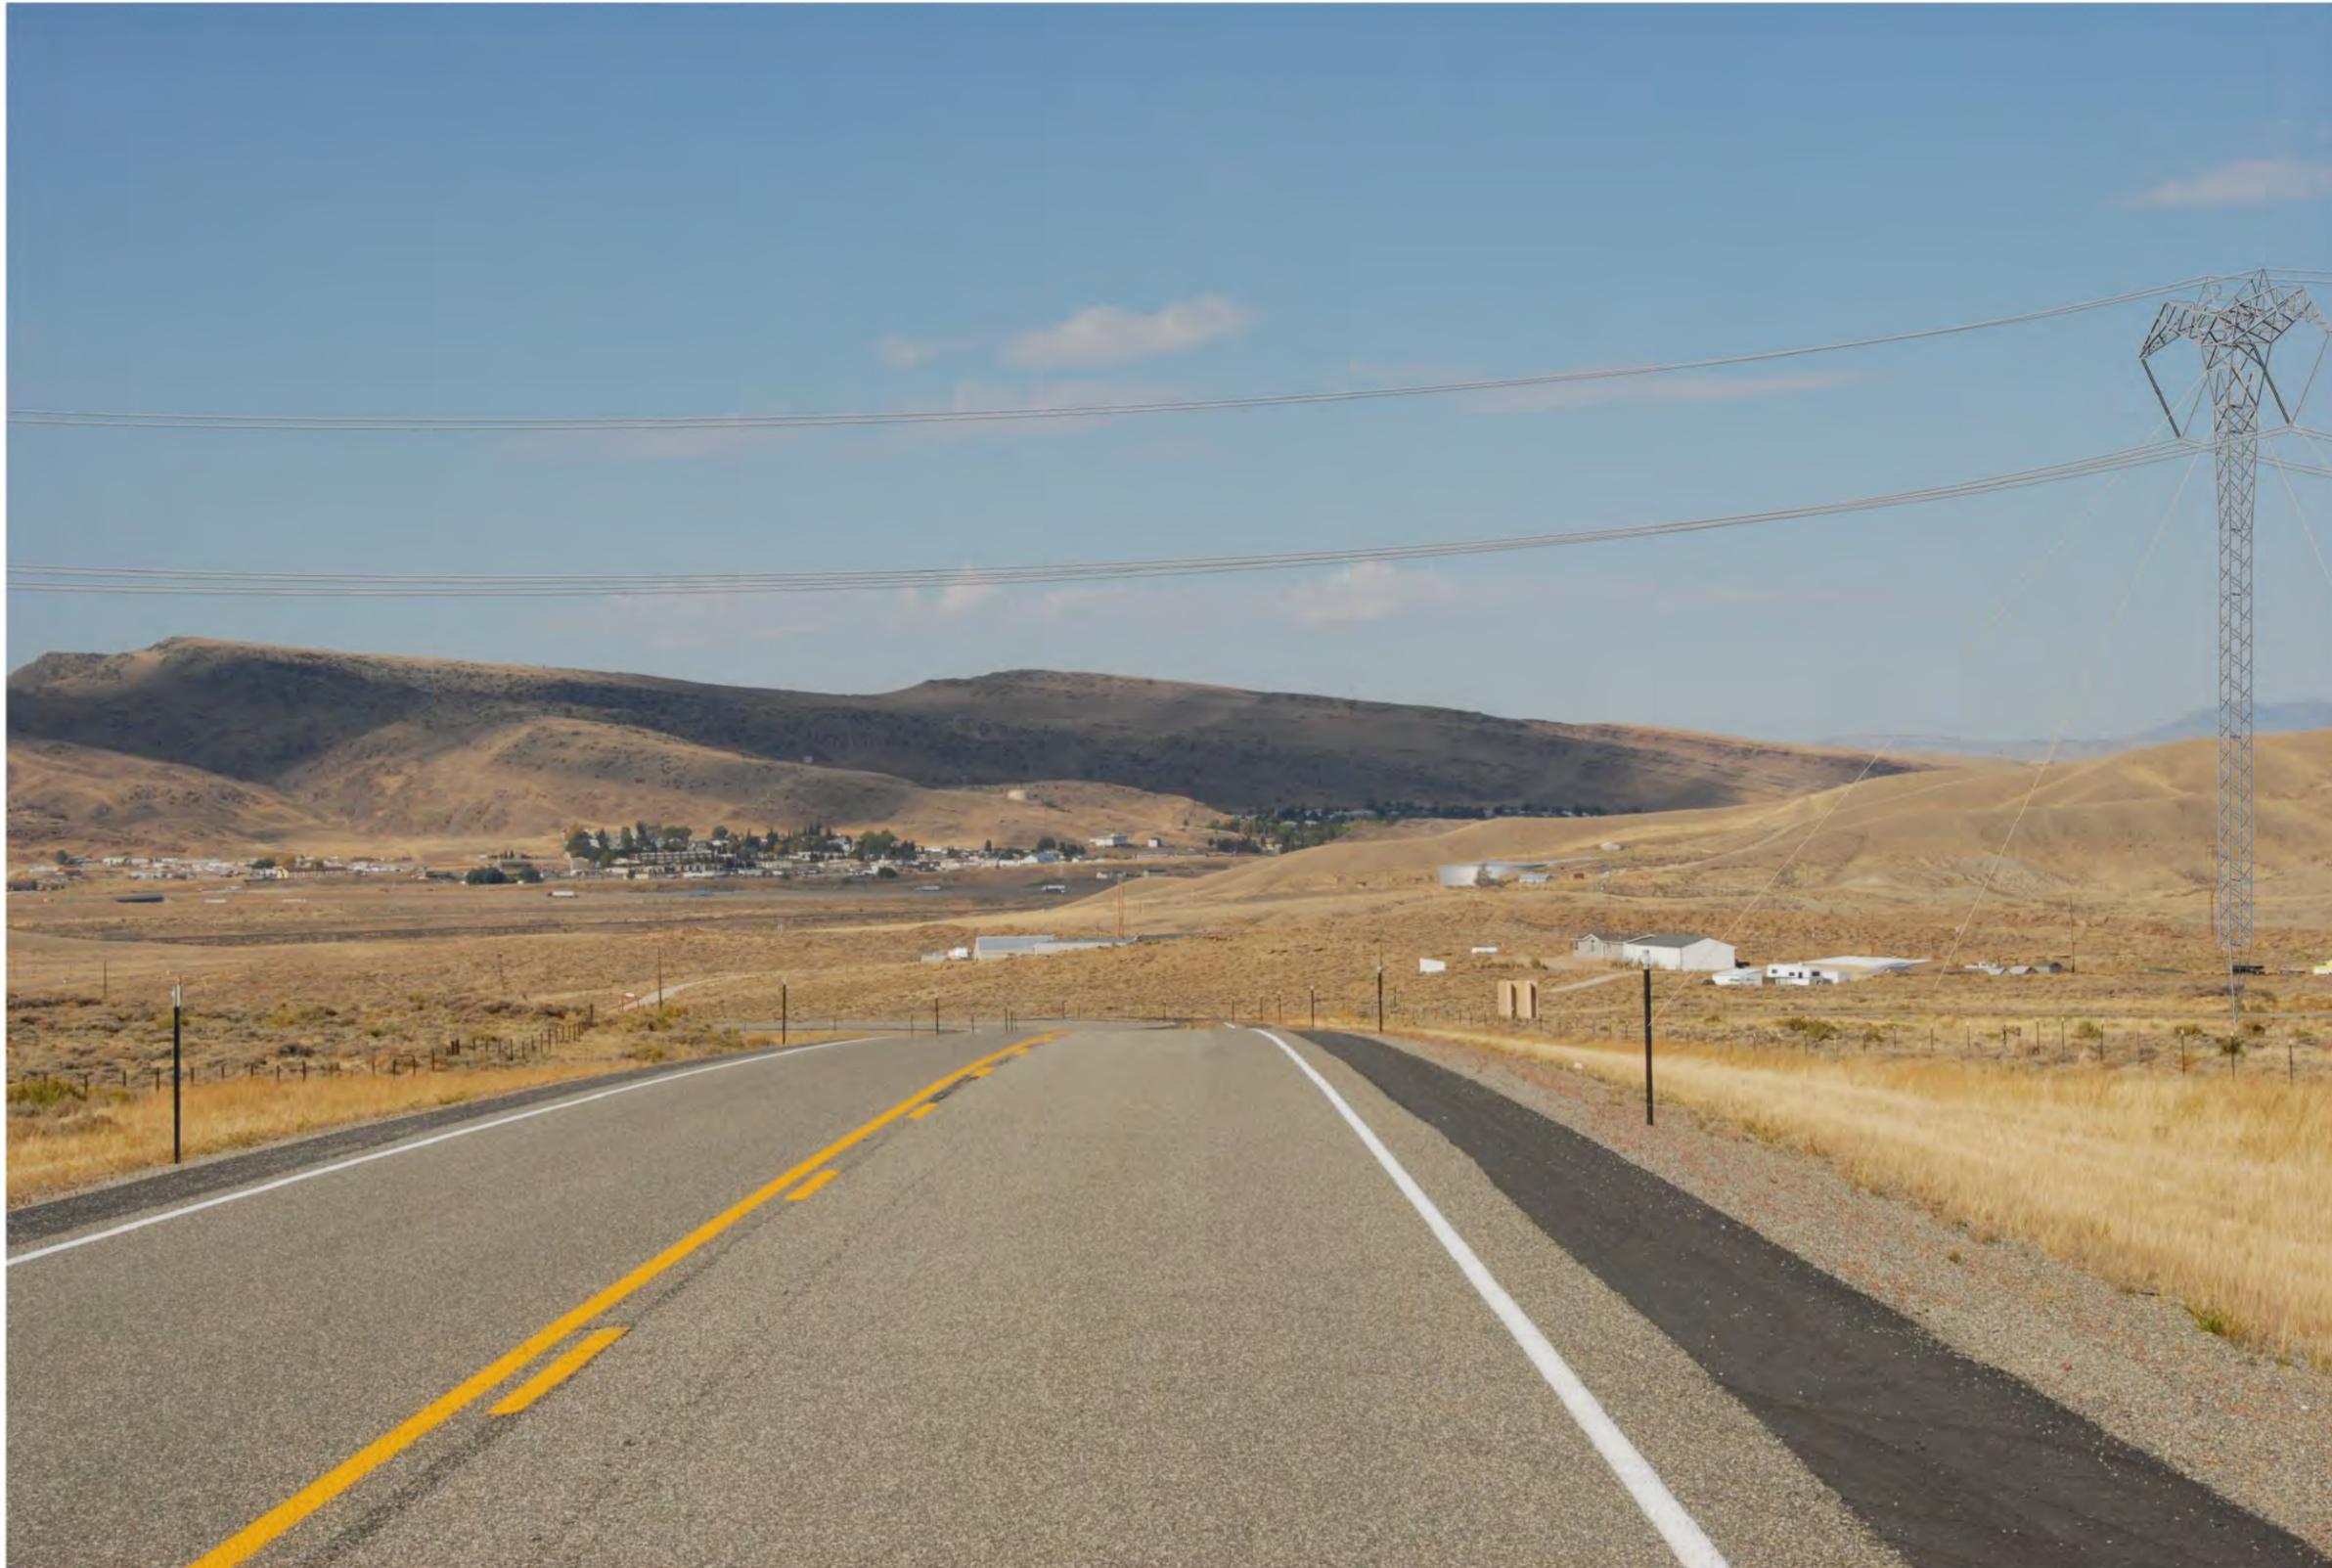
KOP R-5
Simulated Condition
(Segment 30)

1. LAND/WATER	2. VEGETATION	3. STRUCTURES
FORM			Strongly pyramidal steel lattice structures and guys, and tubular conductors.
LINE			Vertical steel lattice structures, angular guys, and curvilinear conductors.
COLOR			Light silver to dark grey steel lattice structures, guys, and conductors.
TEXTURE			Course steel lattice structures, and smooth guys and conductors.

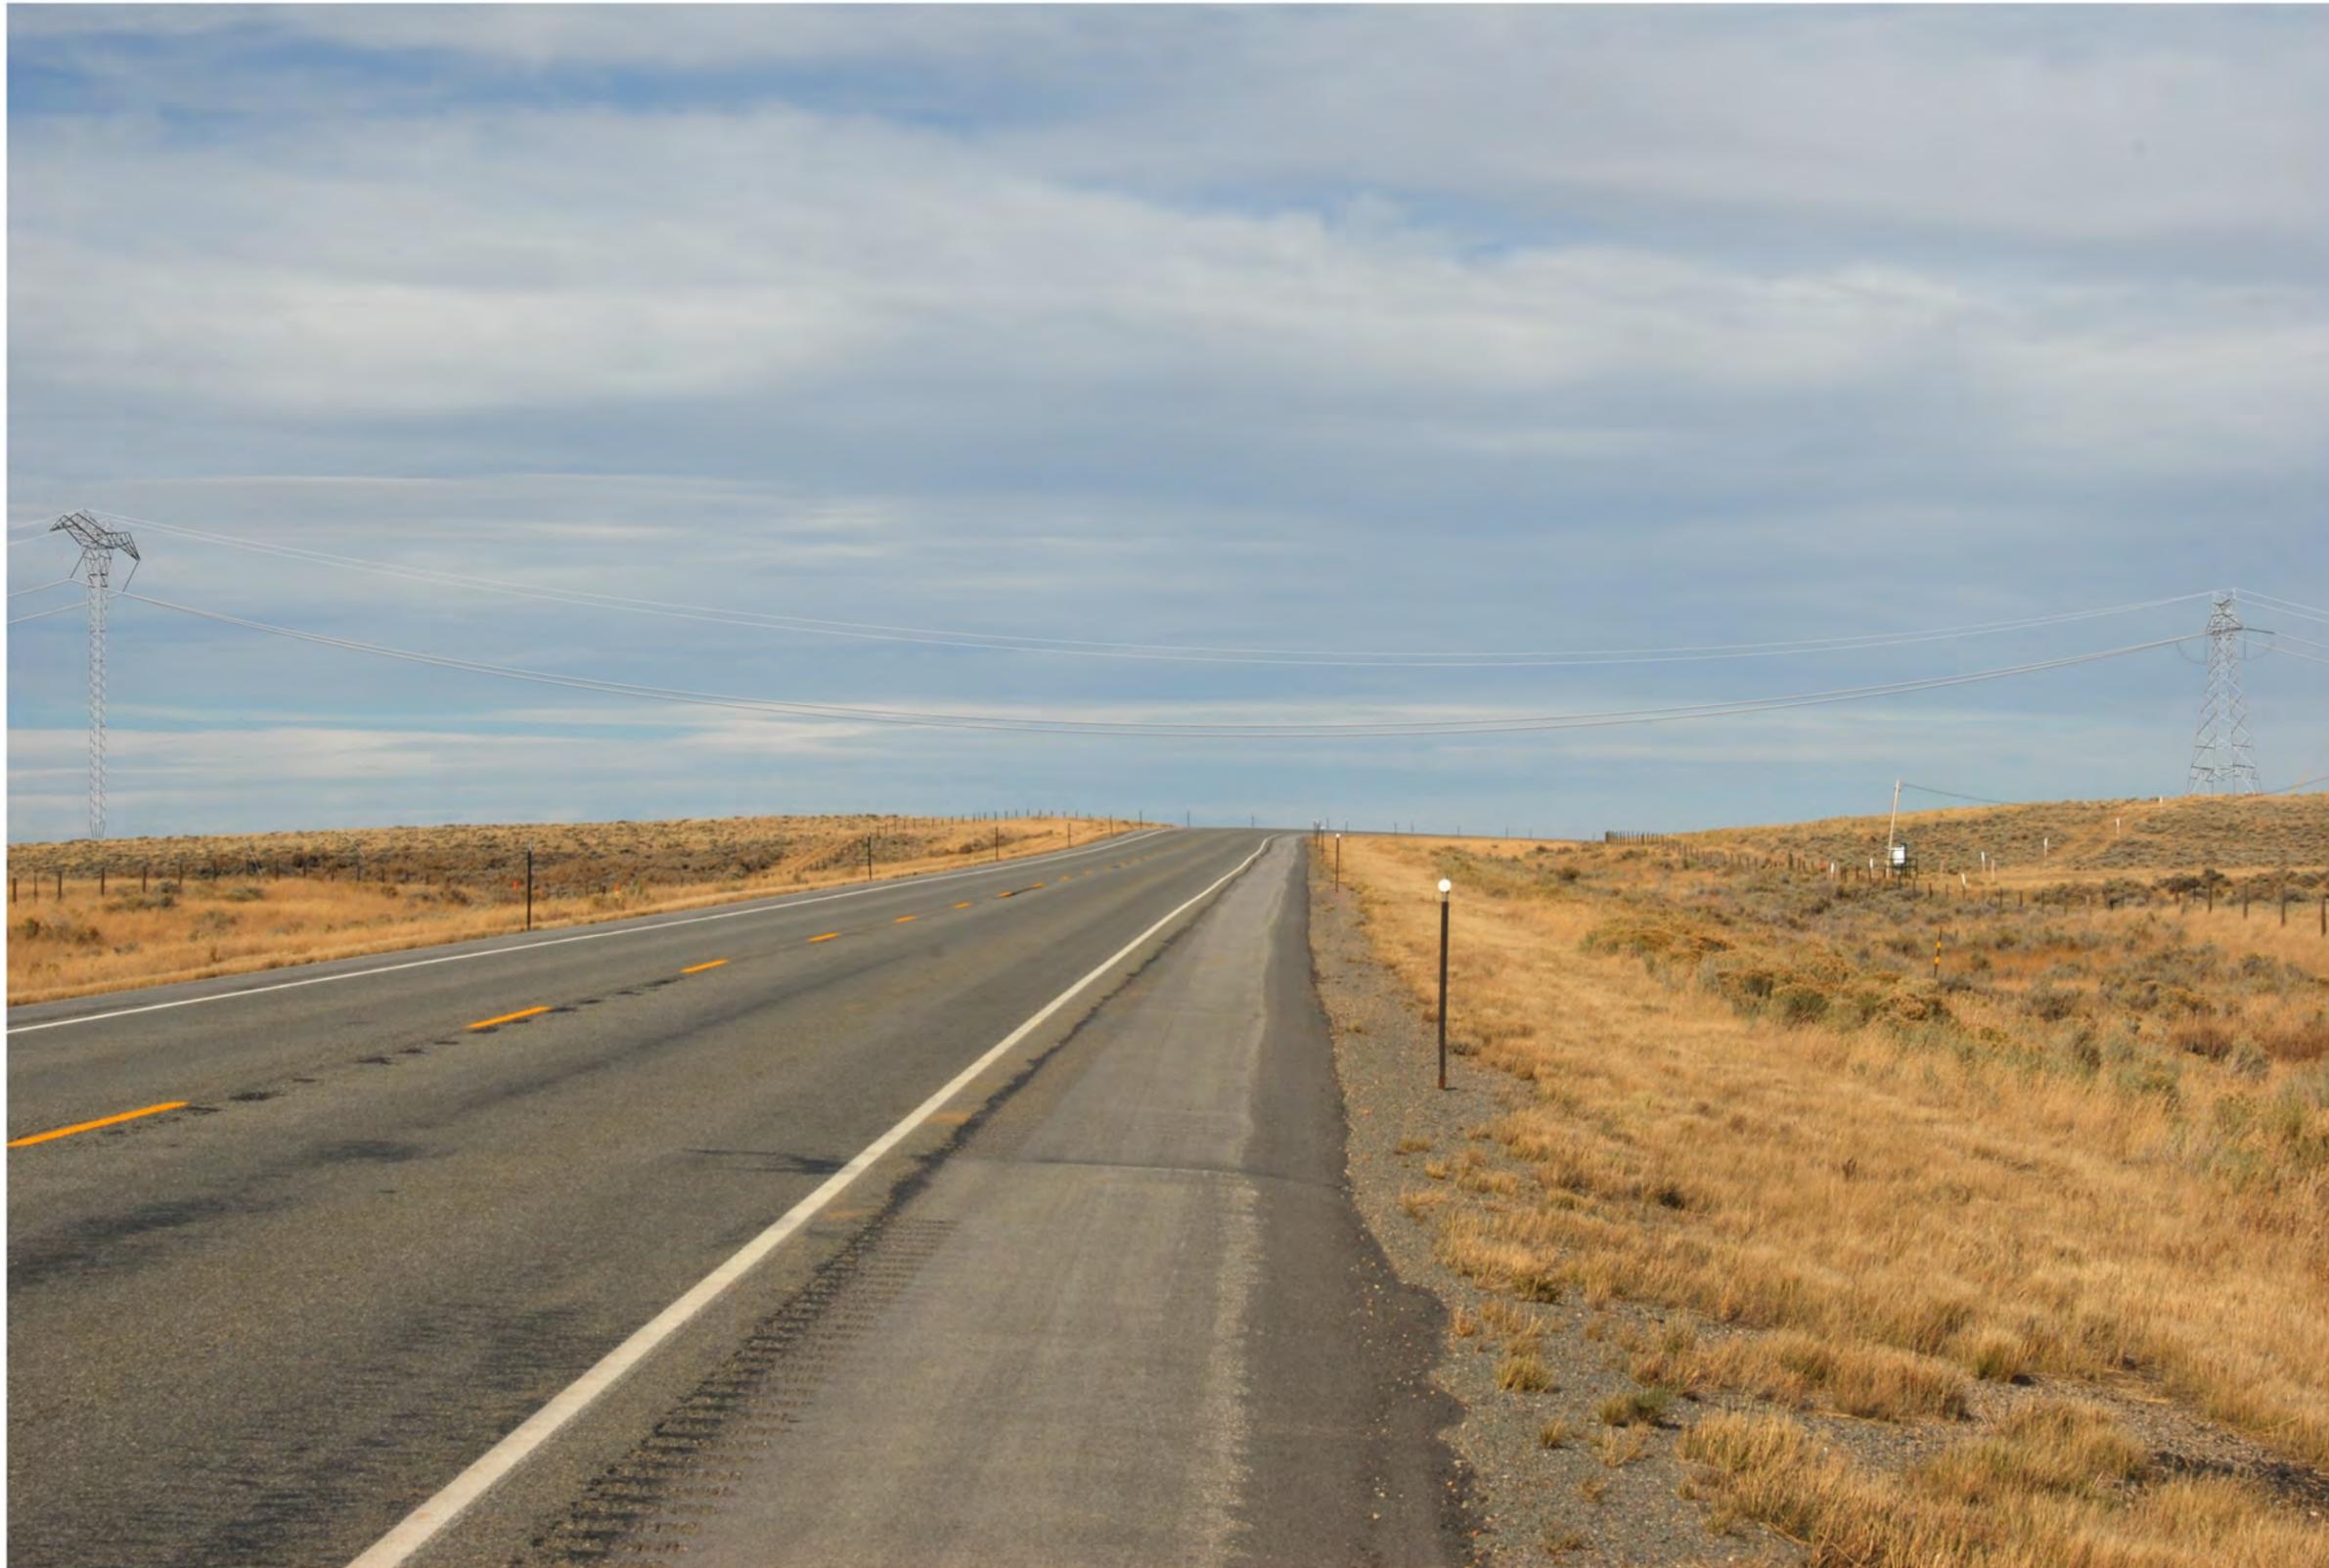
KOP R-6
Simulated Condition
(Segment 130)

1. LAND/WATER	2. VEGETATION	3. STRUCTURES
FORM			Strongly pyramidal steel lattice structures and guys, spherical jumpers, and tubular conductors.
LINE			Vertical steel lattice structures, angular guys, rounded jumpers, and curvilinear conductors.
COLOR			Light silver to dark grey steel lattice structures, guys, and conductors.
TEXTURE			Course steel lattice structures, and smooth guys and conductors.

Rationale:
The Project would be consistent with VRM Class IV management objectives. This management objective allows for strong (and all other) contrasts in the landscape.

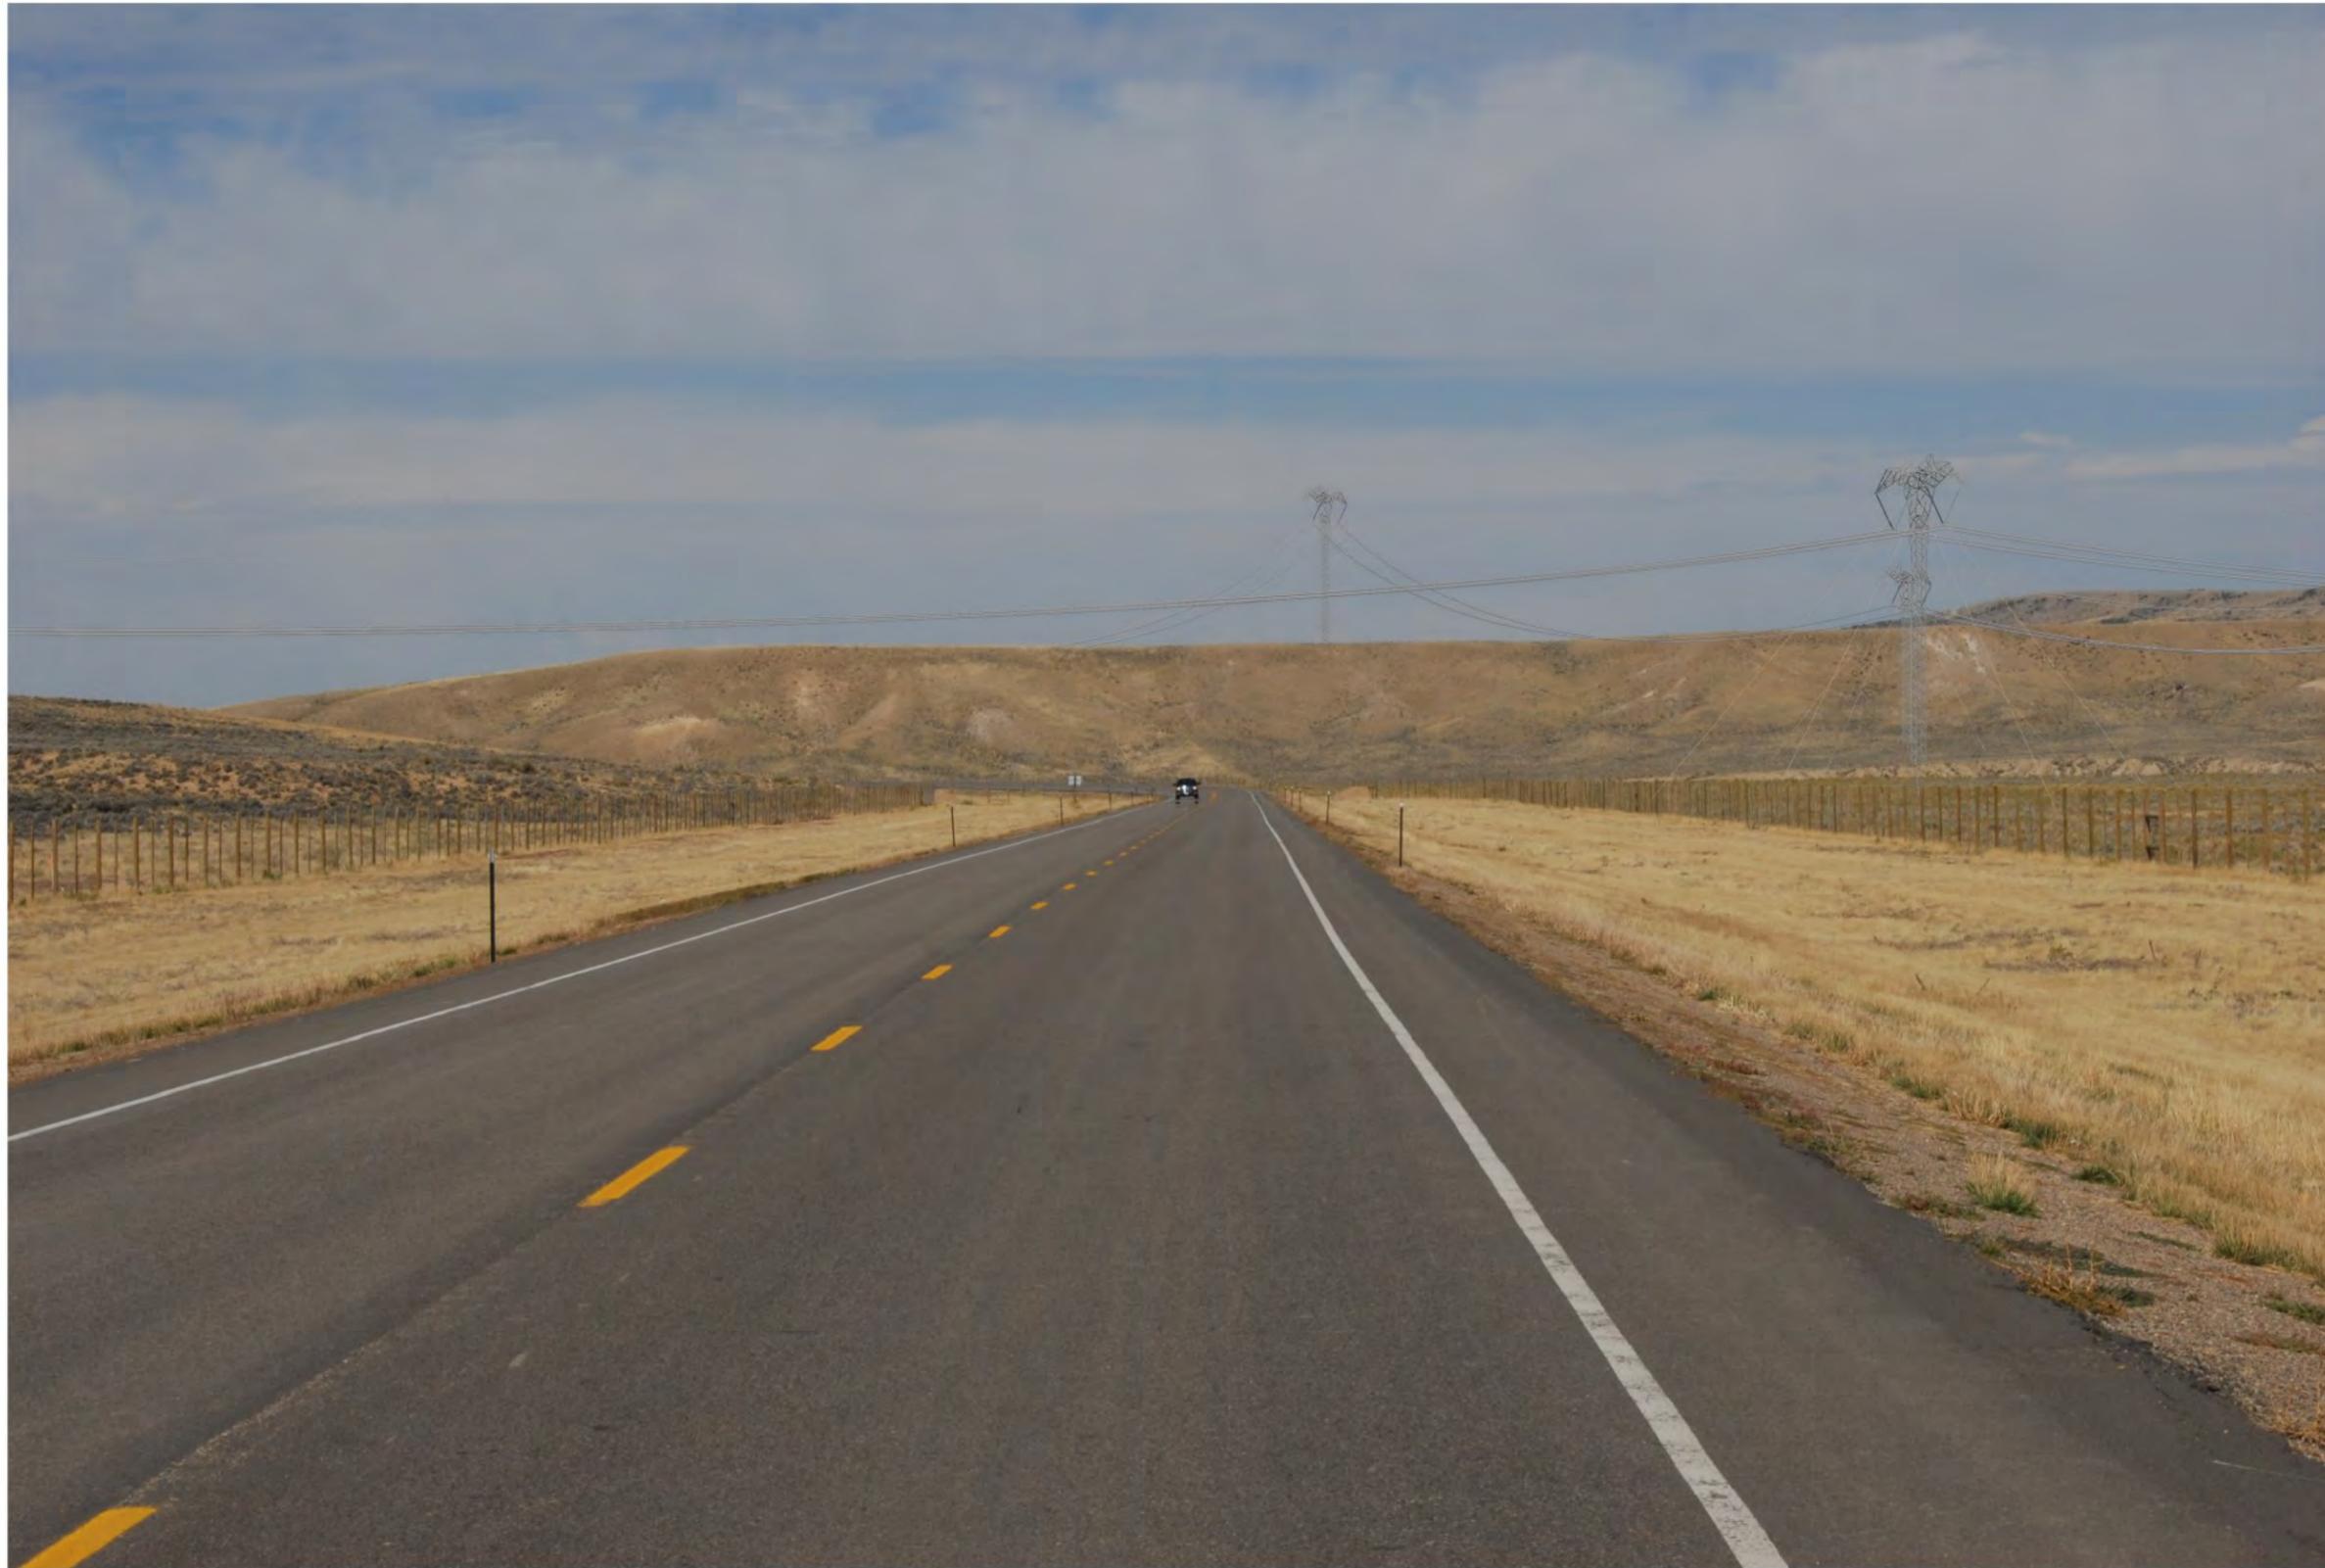
KOP R-8
Simulated Condition
(Segment 170)

1. LAND/WATER	2. VEGETATION	3. STRUCTURES
FORM			Strongly pyramidal steel lattice structures and guys, and tubular conductors.
LINE			Vertical steel lattice structures, angular guys, and curvilinear conductors.
COLOR			Light silver to dark grey steel lattice structures, guys, and conductors.
TEXTURE			Course steel lattice structures, and smooth guys and conductors.

Rationale:
 The Project would be consistent with VRM Class IV management objectives. This management objective allows for strong (and all other) contrasts in the landscape.

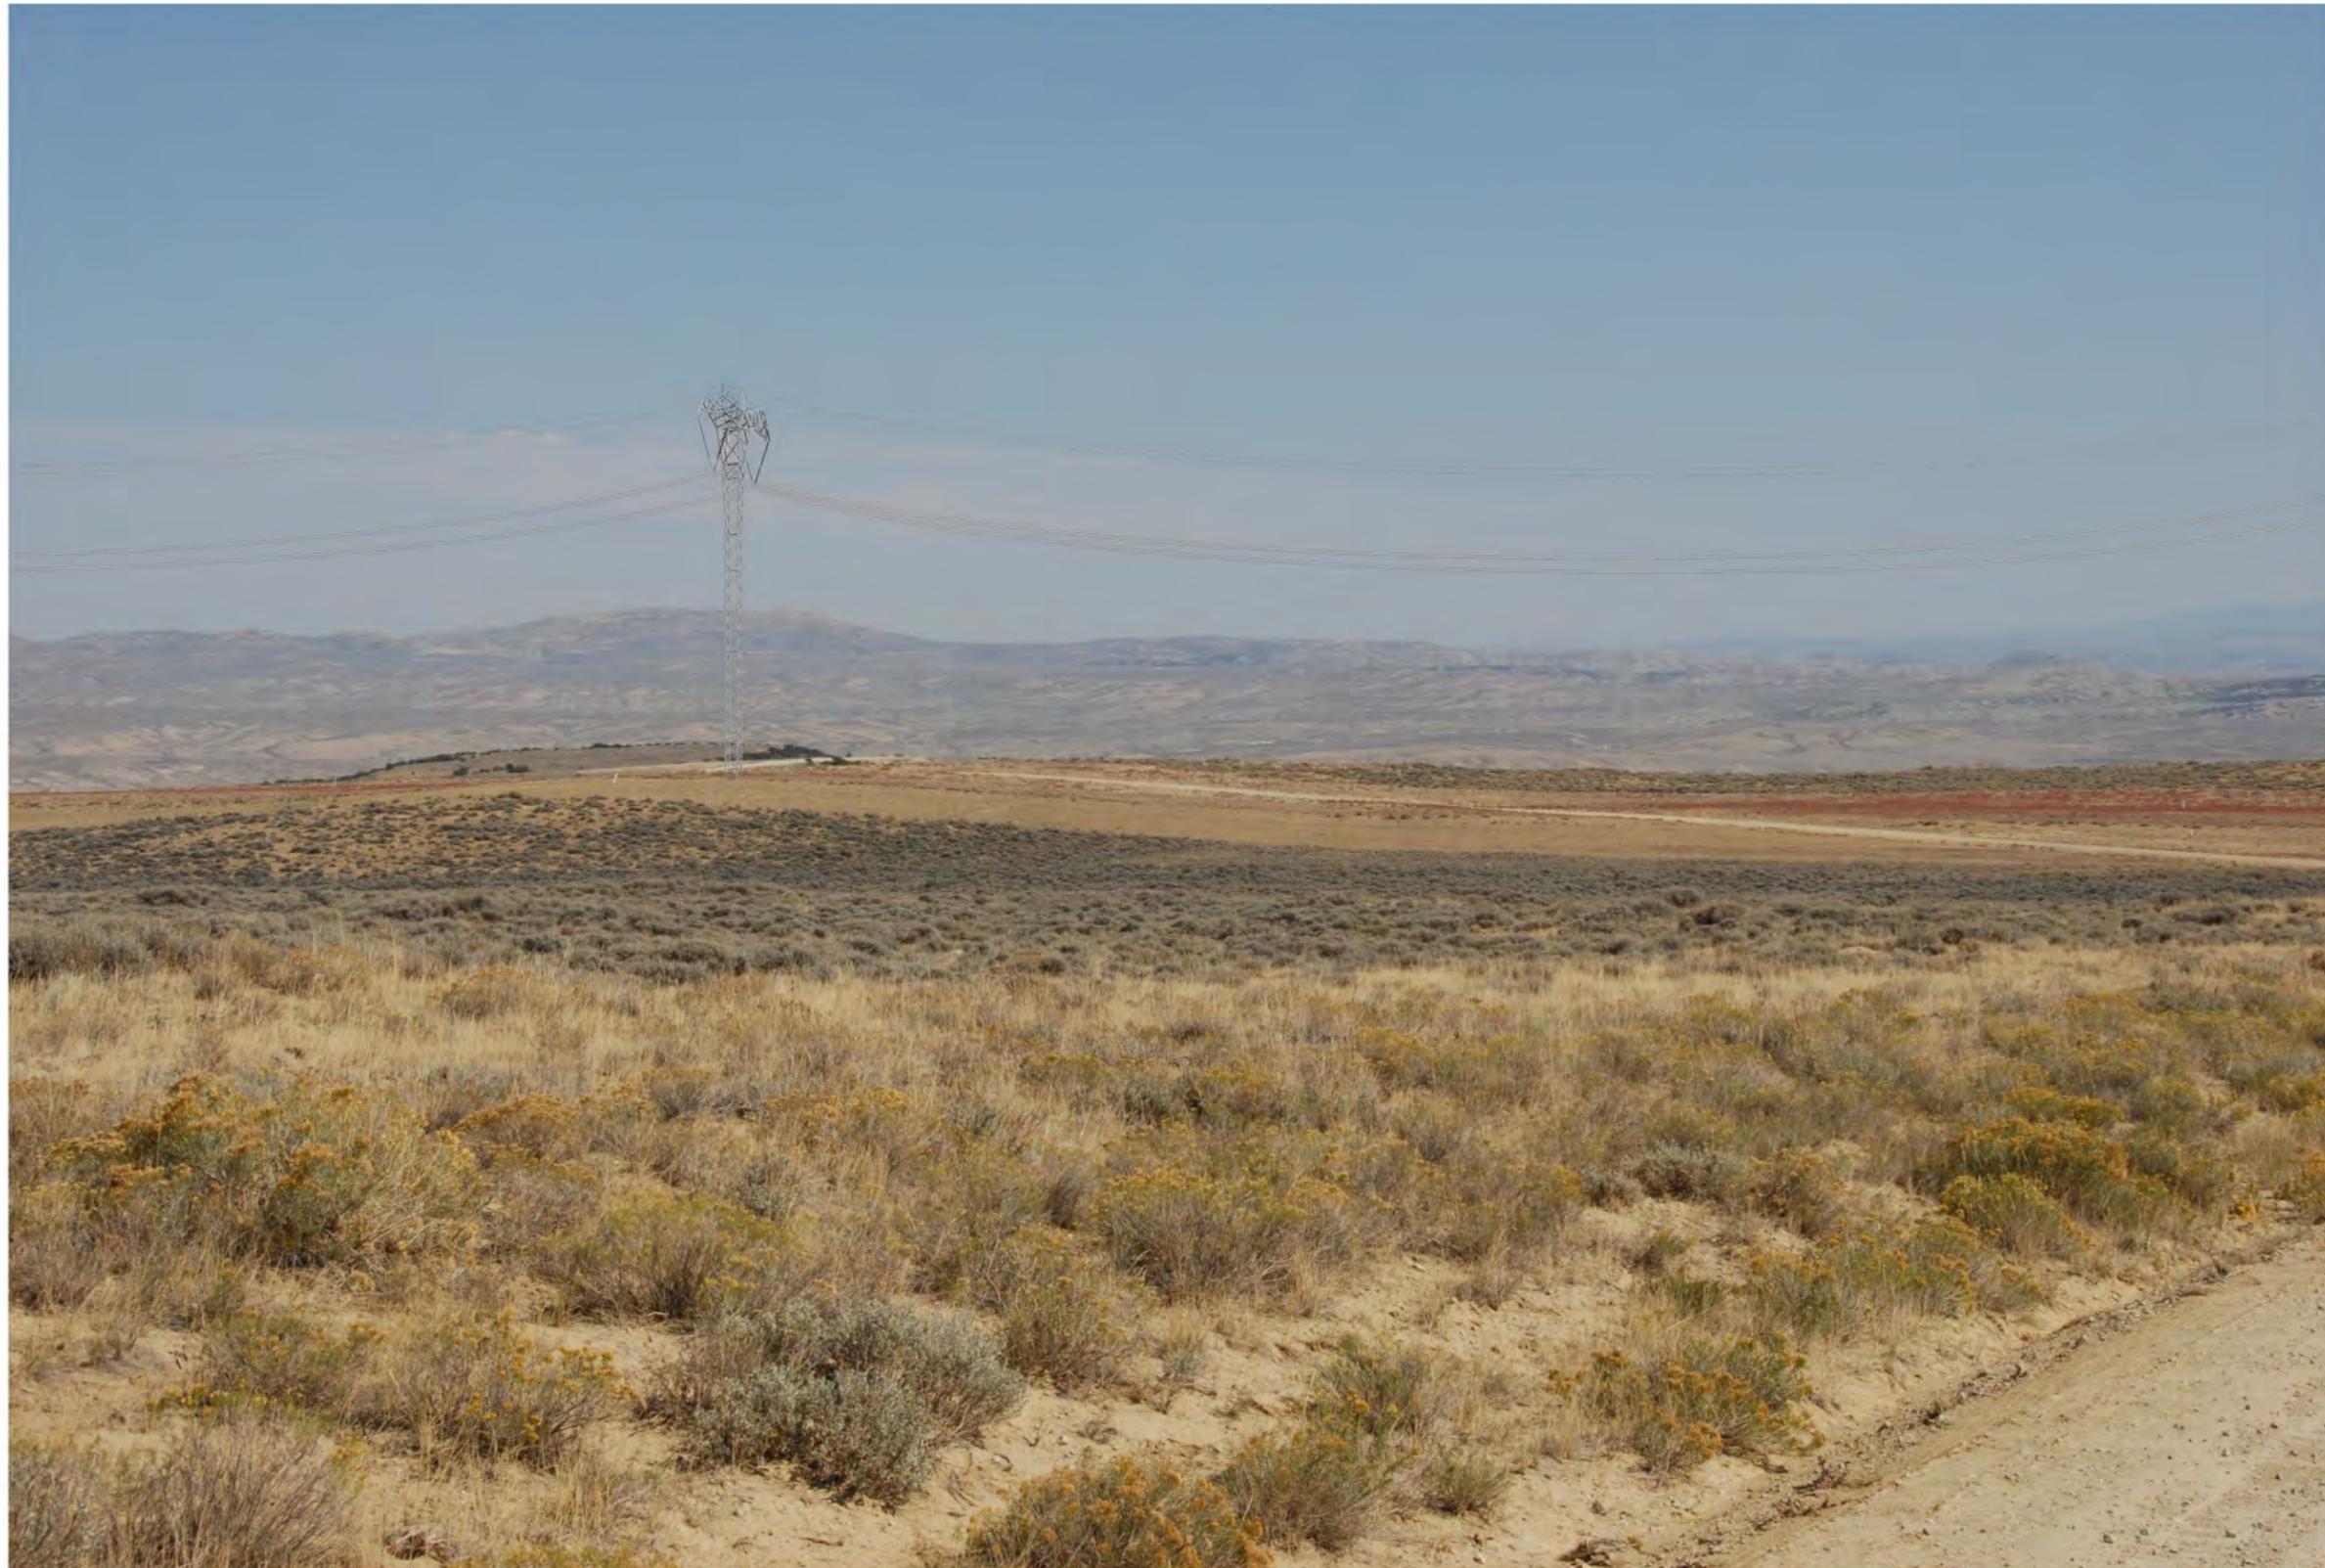
KOP R-10
Simulated Condition
(Segment 70)

1. LAND/WATER	2. VEGETATION	3. STRUCTURES
FORM			Strongly pyramidal steel lattice structures and guys, and tubular conductors.
LINE			Vertical steel lattice structures, angular guys, and curvilinear conductors.
COLOR			Light silver to dark grey steel lattice structures, guys, and conductors.
TEXTURE			Course steel lattice structures, and smooth guys and conductors.

Rationale:
Where the Project would be located within 0.5 miles of the viewer and does not parallel an existing transmission line and/or where access roads and vegetation clearing would occur in moderate to steep terrain, it would have a strong contrast and would not comply with VRM Class III management objectives. Mitigation measures (VR-1 and VR-7) would reduce strong contrasts to moderate resulting in moderate to low residual impacts where the Project is located more than 0.5 miles away from viewer locations.

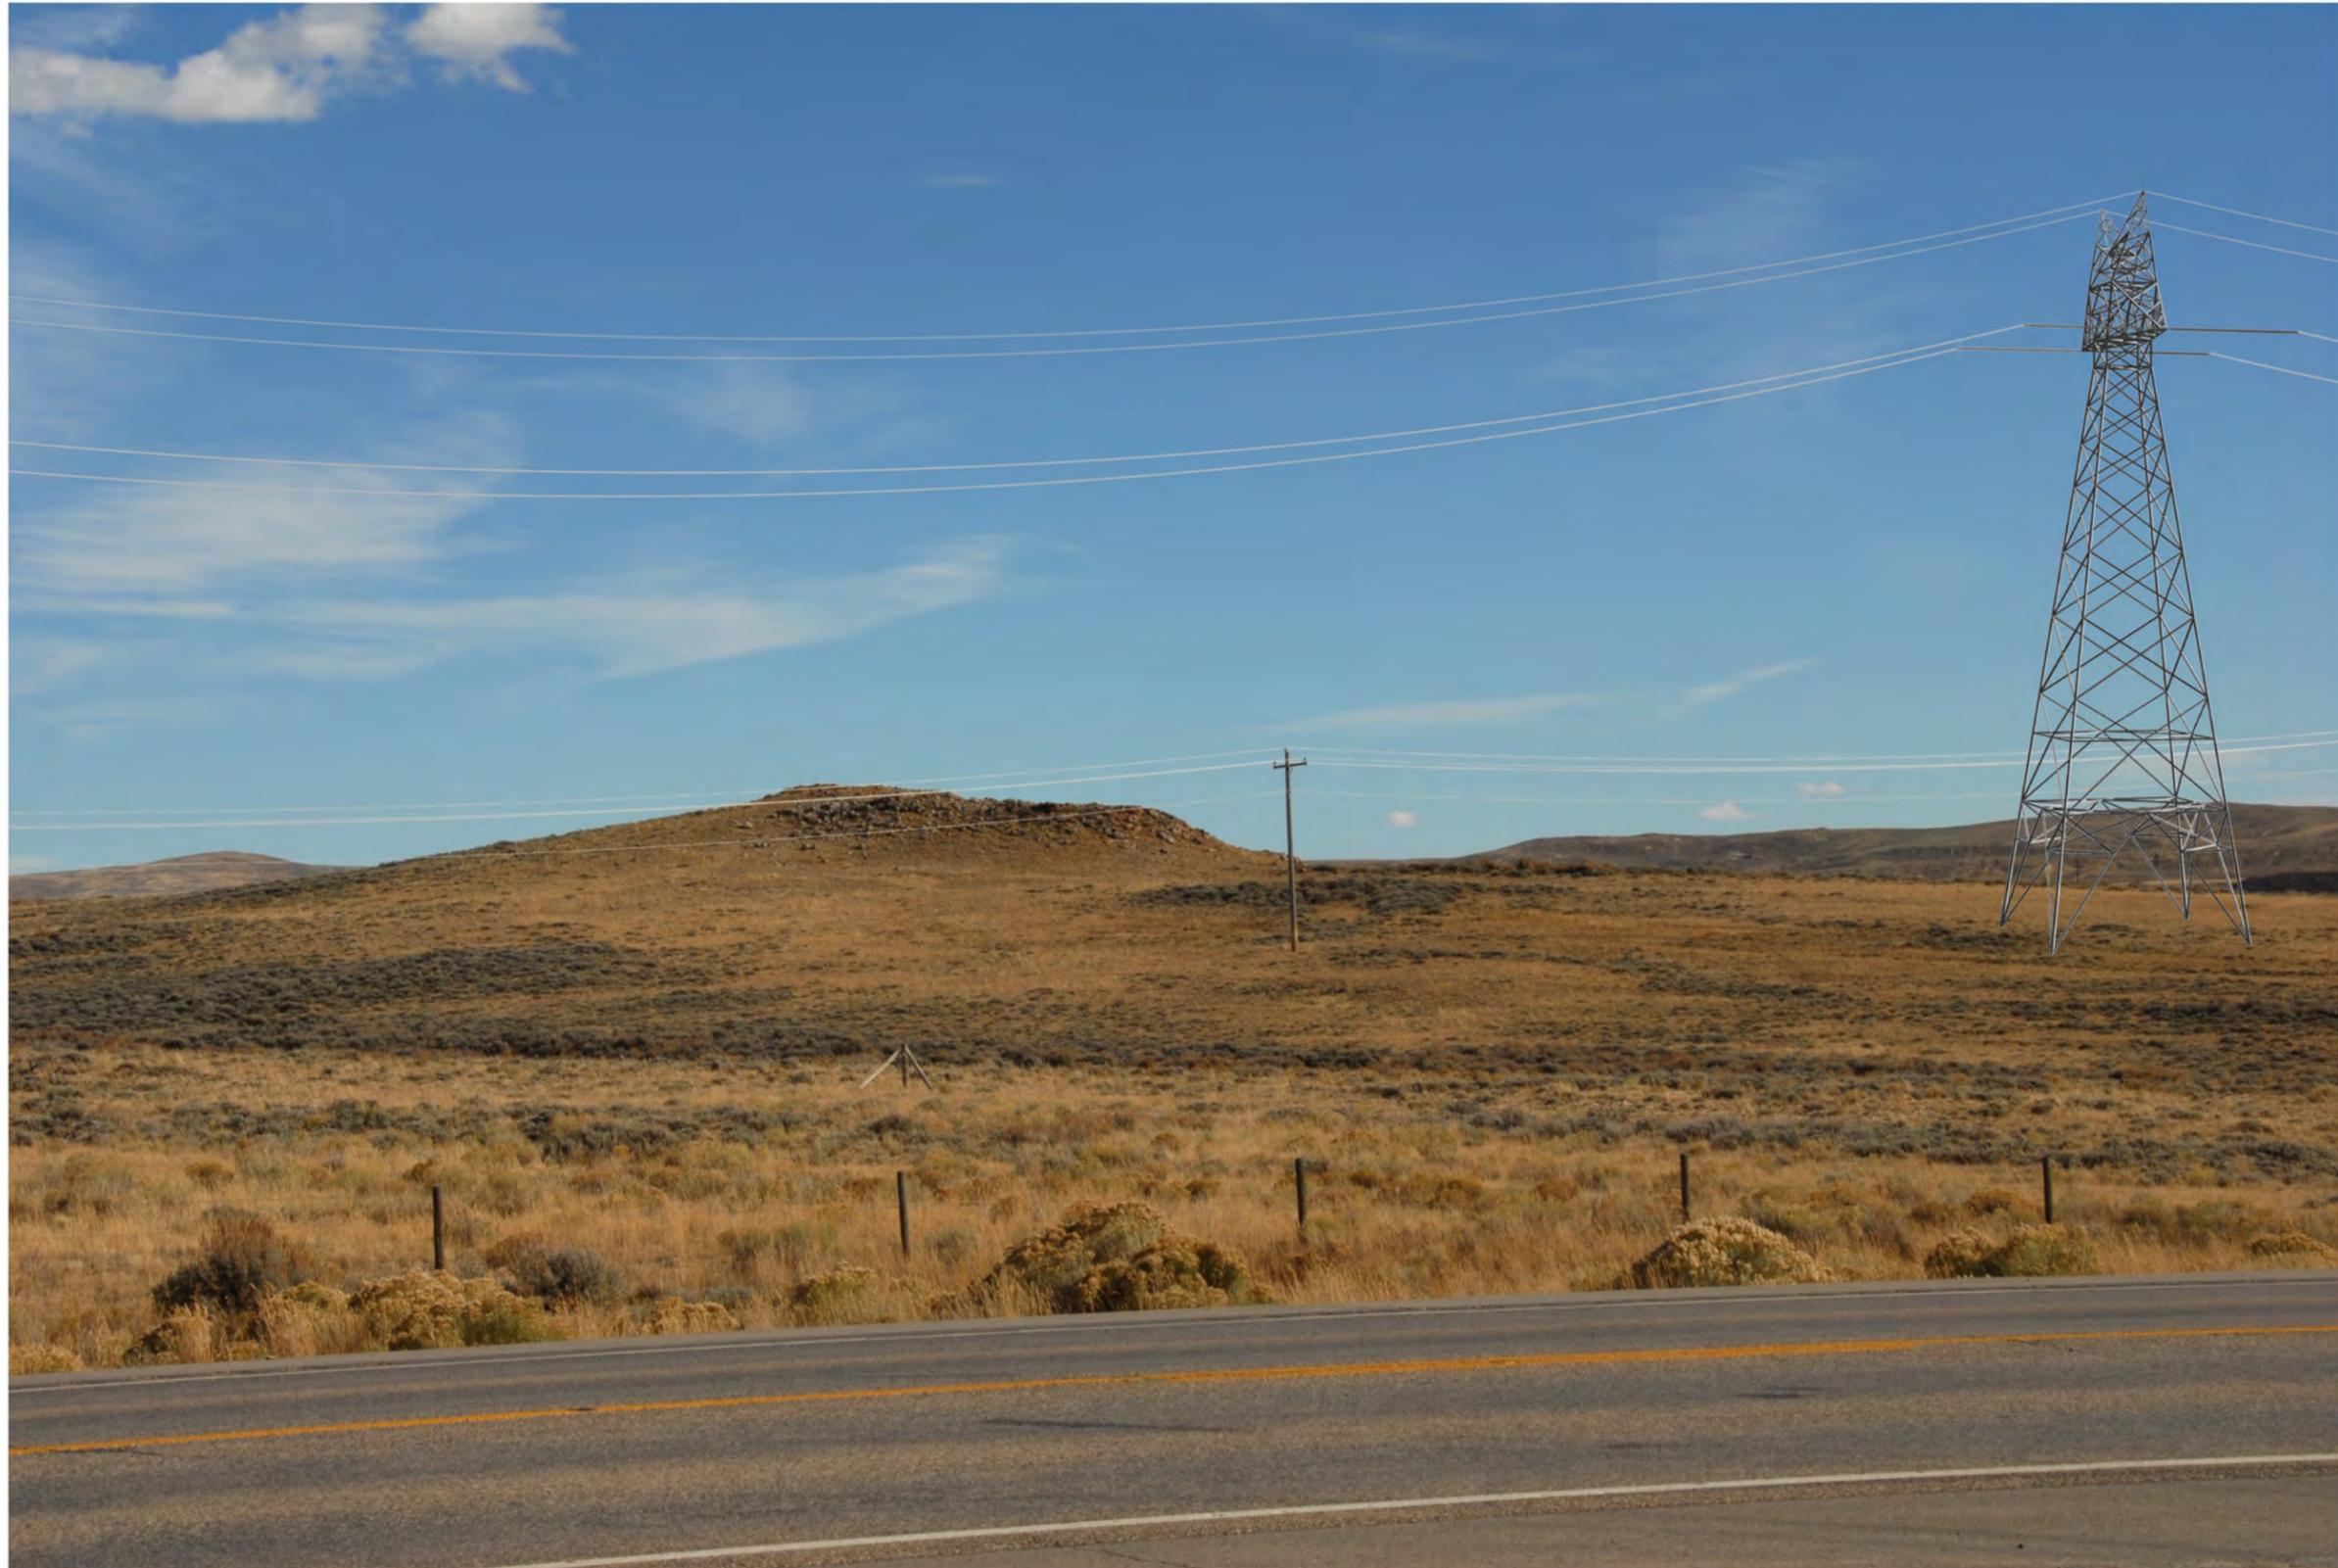
KOP R-13
Simulated Condition
(Segment 130)

1. LAND/WATER	2. VEGETATION	3. STRUCTURES
FORM			Strongly pyramidal steel lattice structures and spherical jumpers, and tubular conductors.
LINE			Vertical steel lattice structures, rounded jumpers, and curvilinear conductors.
COLOR			Light silver to dark grey steel lattice structures, jumpers, and conductors.
TEXTURE			Course steel lattice structures and smooth conductors.

The Project would be consistent with VRM Class IV management objectives. This management objective allows for strong (and all other) contrasts in the landscape.
