# TransWest Express Transmission Project *Draft Environmental Impact Statement*

## Visual Resources

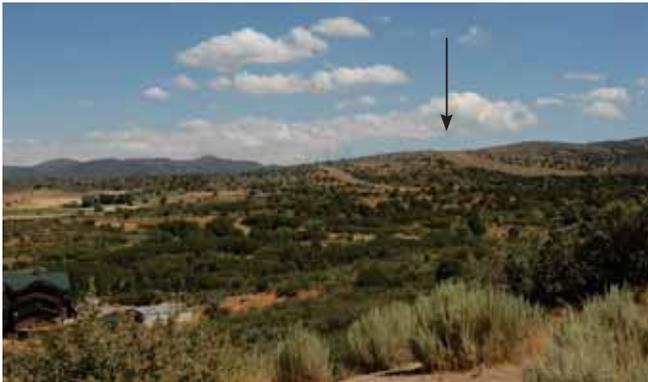
Simulated condition showing the TWE guyed transmission line structures and a cleared 250-foot ROW.

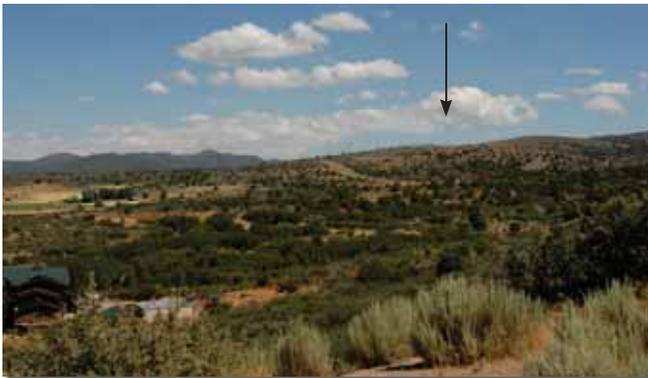
Simulated mitigation condition showing the TWE guyed transmission line structures and a selectively cleared 250-foot ROW.

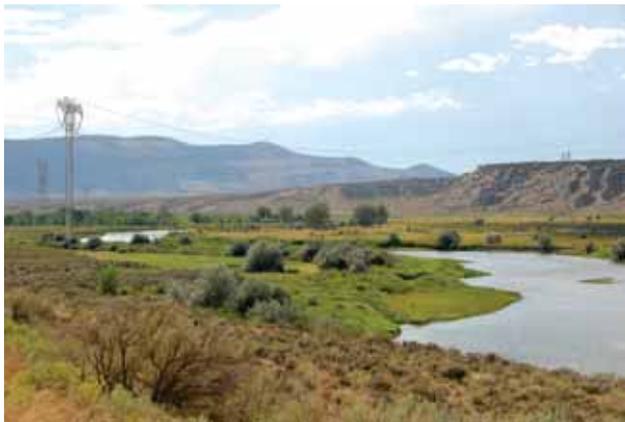
Simulated condition of cumulative projects.
