**U.S. Department of the Interior
Bureau of Land Management**

San Rafael Desert Travel Management Monitoring During Planning June 2020 Report

**Price Field Office
125 S. 600 W.
Price, Utah 84501
435-636-3600**

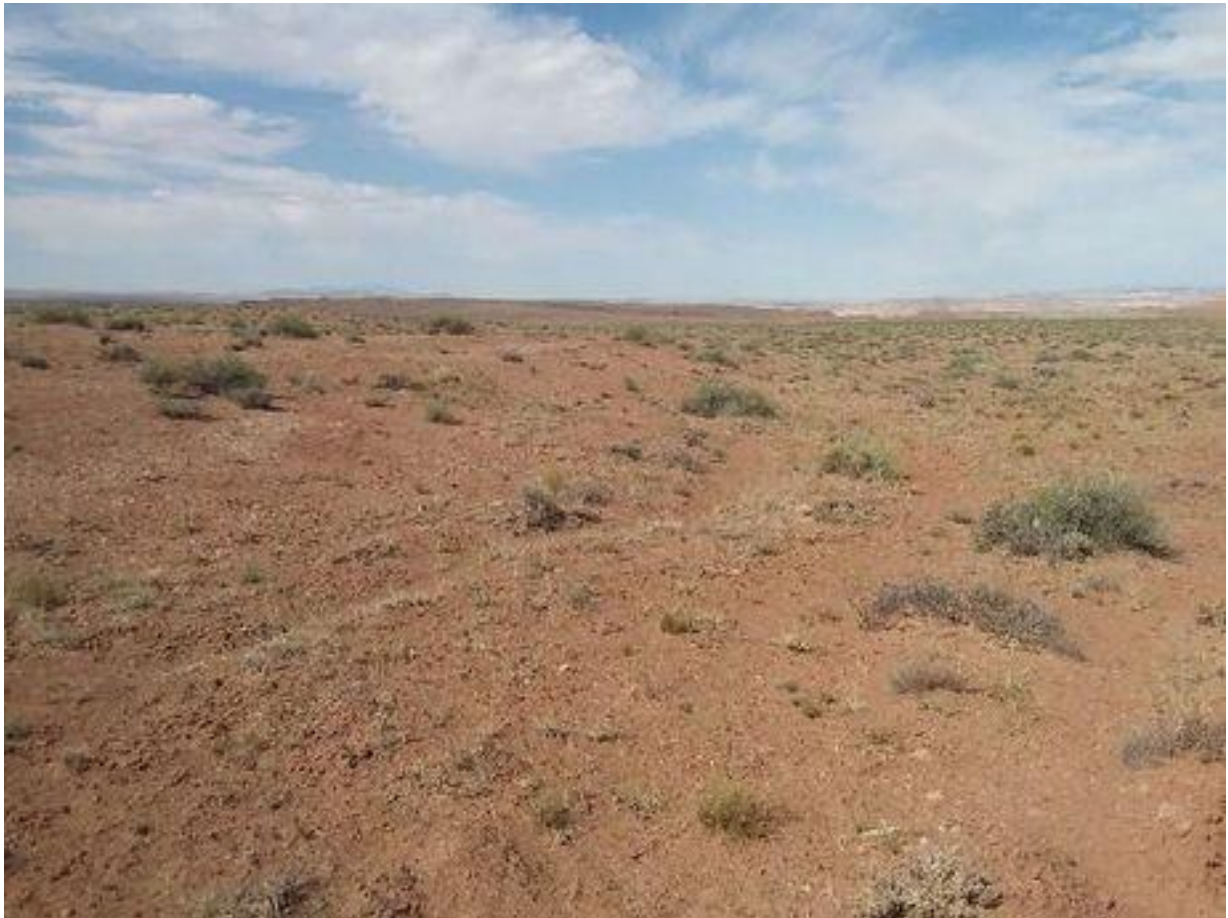
Type of Inspector:	Name of Inspector (Youth Corp)	Name of Inspector (BLM)	Has The Site Completely Rehabbed?
Youth Corps	Lucas Farmer	N/A	Yes
Site ID Number:	Date Of Physical Inspection	Price Field Office TMA:	Route ID:
15	06/03/2020 9:58 AM	San Rafael Desert	SD765

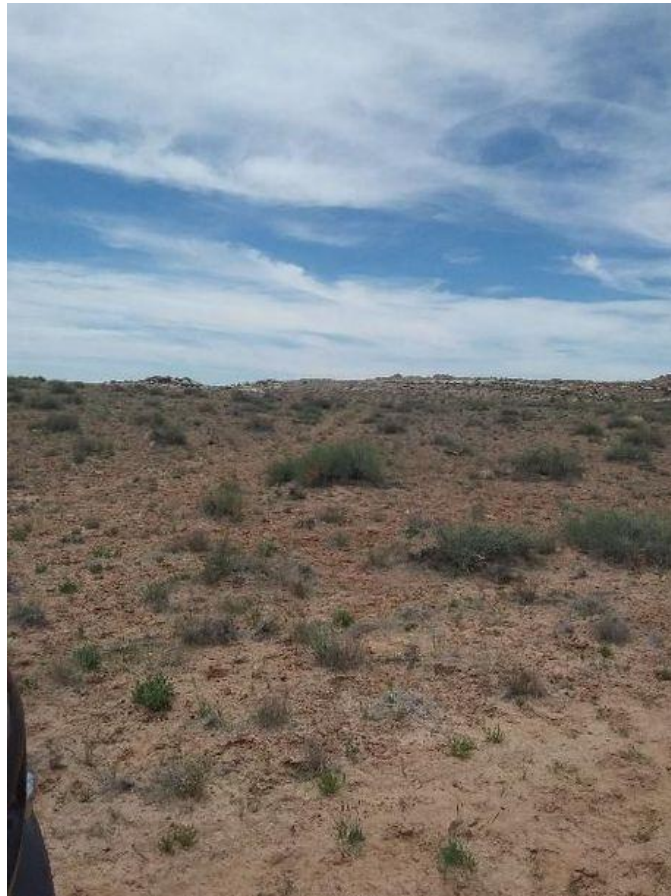
Type of Inspector:	Name of Inspector (Youth Corp)	Name of Inspector (BLM)	Has The Site Completely Rehabbed?
BLM Employee	N/A	Marc Johnson, Steve Petrich	No
Site ID Number:	Date Of Physical Inspection	Price Field Office TMA:	Route ID:
17	05/06/2020 12:22 PM	San Rafael Desert	SD838

Physical Inspection:	Observed Usage Intensity:	Linear Extent:	Area Extent:	Comments:
Disturbance Or Damage	Low	Continues beyond LOS	N/A	N/A
Apparent Type of Motor Vehicle:	Apparent Purpose of Damage:	Type Public Land Resource Damaged:		
ATV/UTV	Cross Country Travel	Soil, Vegetation		
Is This Site Improving/Recovering From Previously Documented Disturbance?	Rehabilitation Comments		Additional Comments	
Yes, This Site Is Improving Compared To Previous Documentation	N/A		N/A

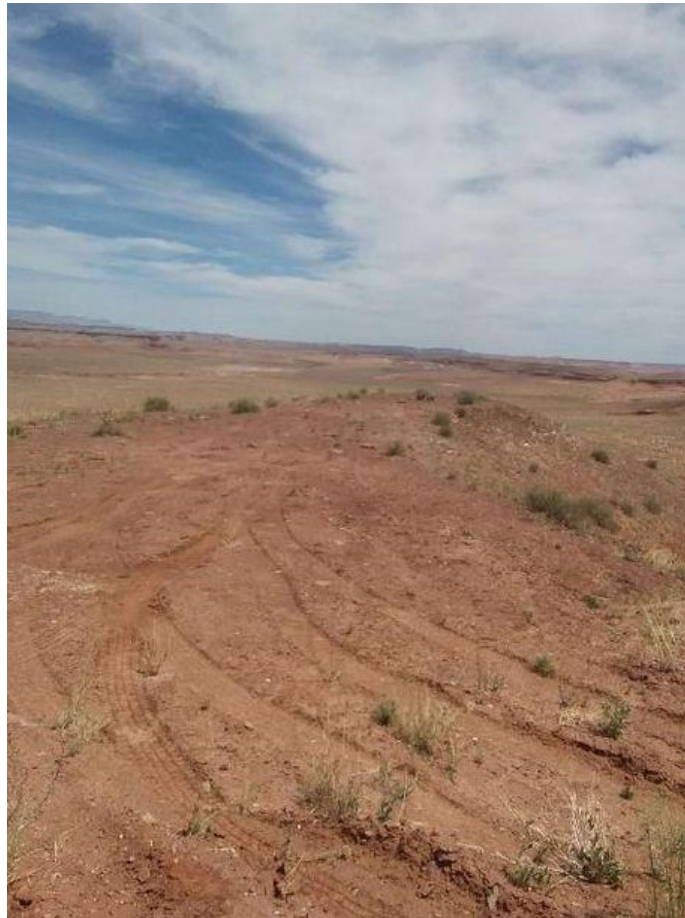
Type of Inspector:	Name of Inspector (Youth Corp)	Name of Inspector (BLM)	Has The Site Completely Rehabbed?
BLM Employee	N/A	Marc Johnson, Steve Petrich	No
Site ID Number:	Date Of Physical Inspection	Price Field Office TMA:	Route ID:
20	05/06/2020 1:09 PM	San Rafael Desert	SD 855

Disturbance Or Damage	Medium	50 - 100 ft	N/A	N/A
-----------------------	--------	-------------	-----	-----

Full Sized Vehicle	Dispersed Camping	Soil
--------------------	-------------------	------

This Site Has Neither Improved Nor Worsened Since Previous Documentation

Potential camping site within regulations

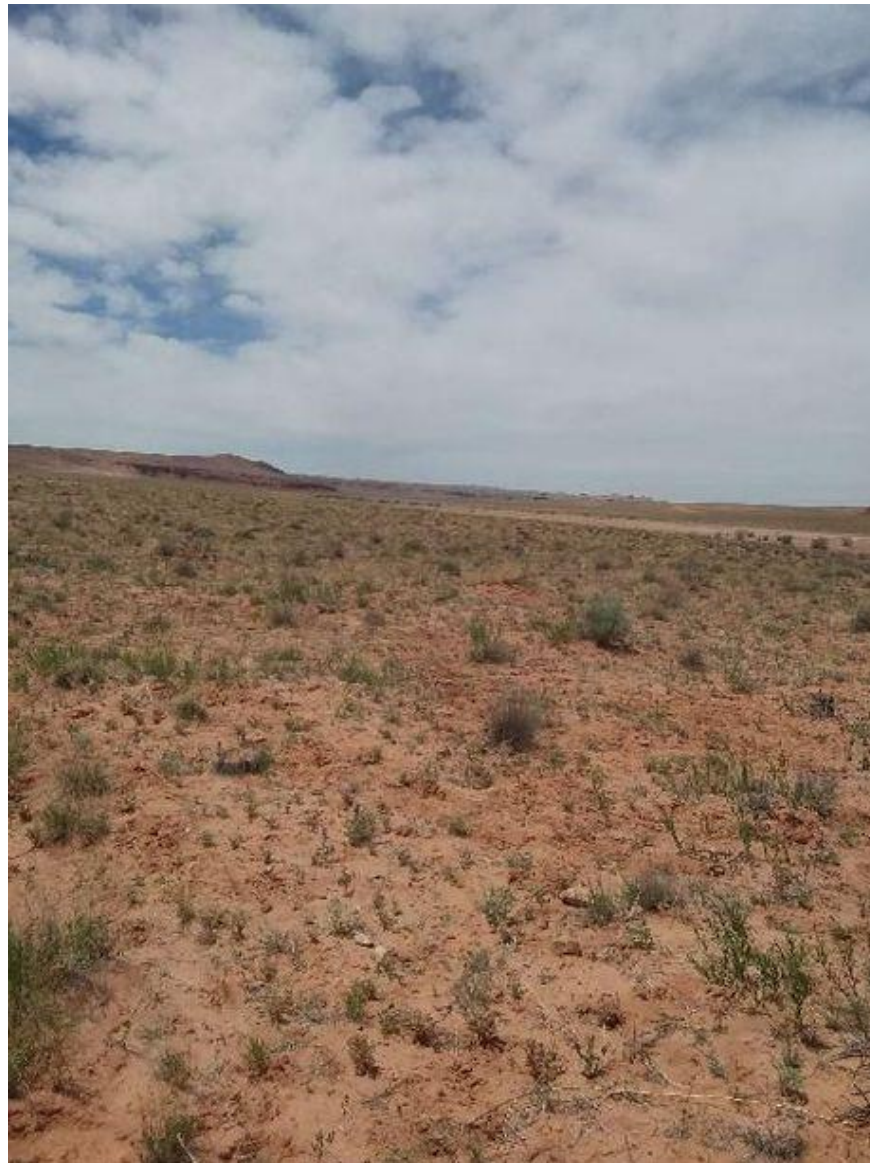
Type of Inspector:	Name of Inspector (Youth Corp)	Name of Inspector (BLM)	Has The Site Completely Rehabbed?
BLM Employee	N/A	Marc Johnson, Steve Petrich	Yes
Site ID Number:	Date Of Physical Inspection	Price Field Office TMA:	Route ID:
22	05/06/2020 1:22 PM	San Rafael Desert	SD796

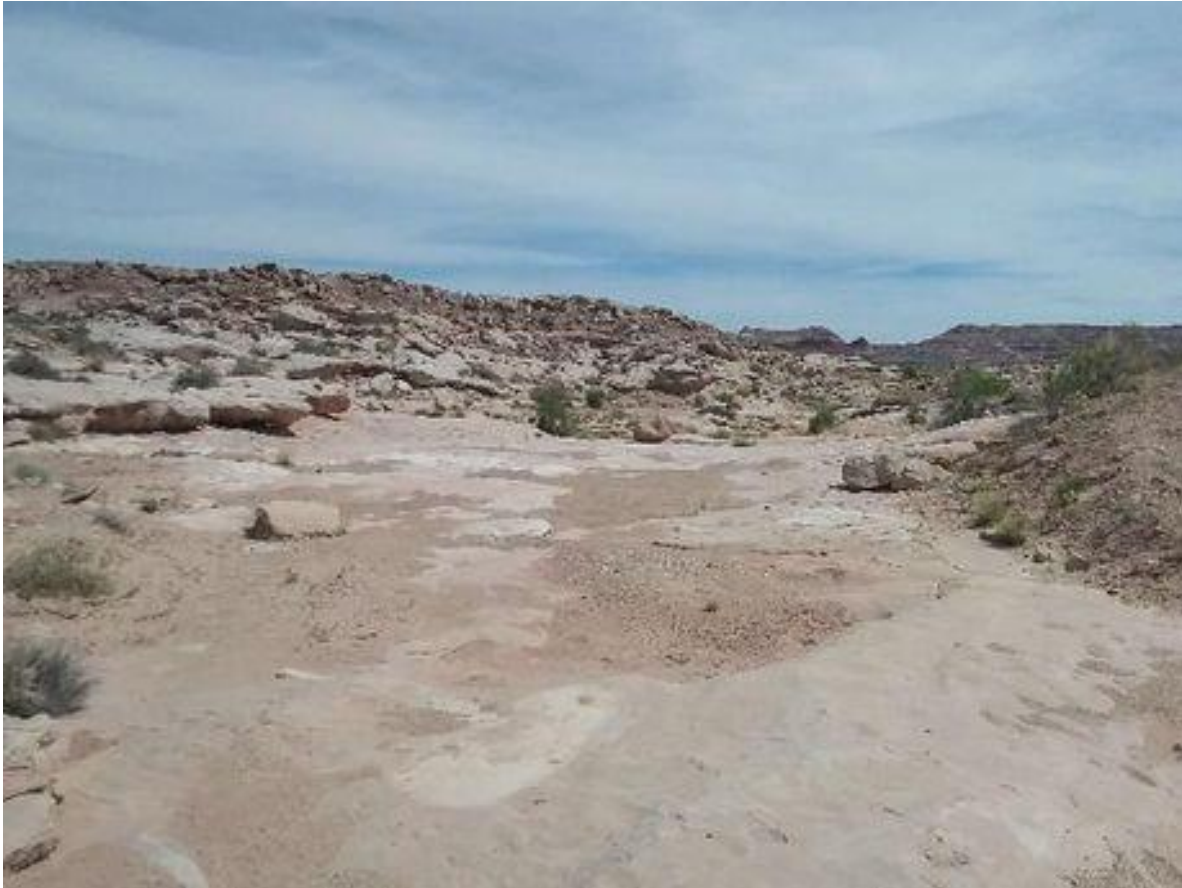
Type of Inspector:	Name of Inspector (Youth Corp)	Name of Inspector (BLM)	Has The Site Completely Rehabbed?
BLM Employee	N/A	Marc Johnson, Steve Petrich	Yes
Site ID Number:	Date Of Physical Inspection	Price Field Office TMA:	Route ID:
25	05/06/2020 11:38 AM	San Rafael Desert	SD421

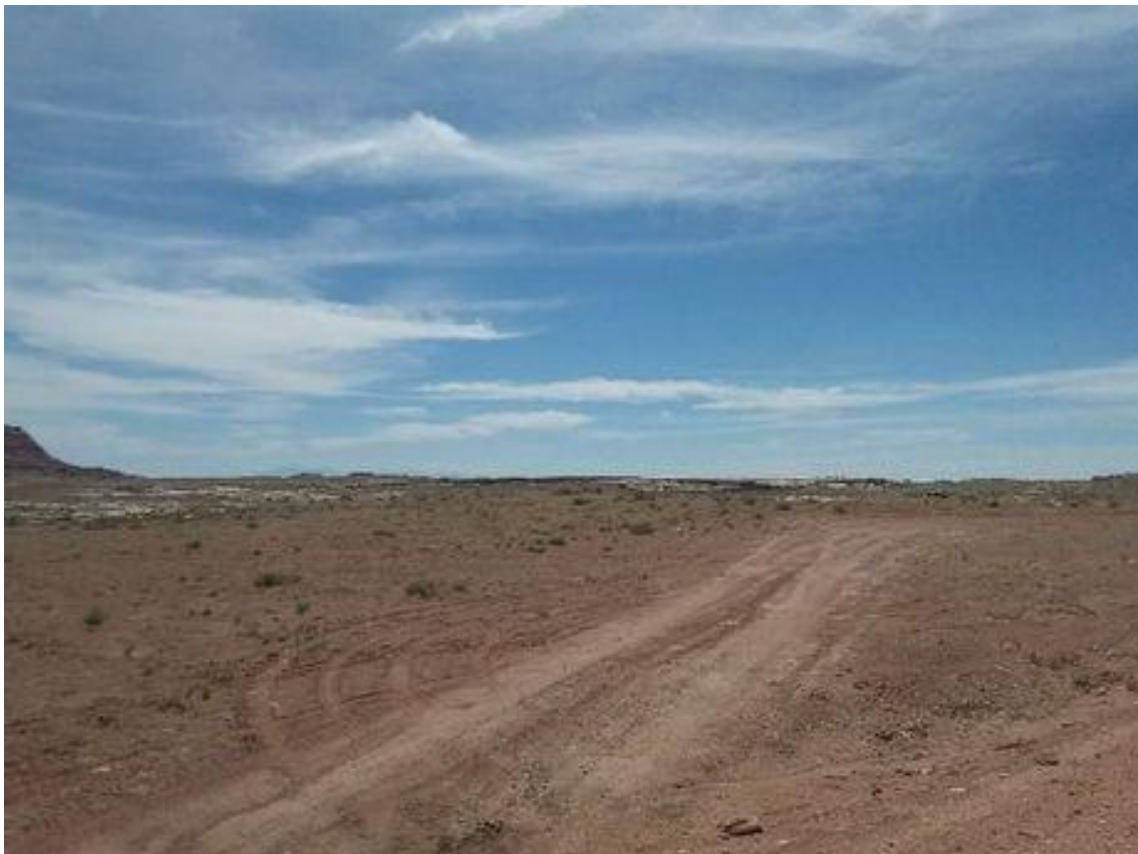
Type of Inspector:	Name of Inspector (Youth Corp)	Name of Inspector (BLM)	Has The Site Completely Rehabbed?
BLM Employee	N/A	Marc Johnson, Steve Petrich	No
Site ID Number:	Date Of Physical Inspection	Price Field Office TMA:	Route ID:
26	05/06/2020 11:31 AM	San Rafael Desert	SD421

Physical Inspection:	Observed Usage Intensity:	Linear Extent:	Area Extent:	Comments:
Disturbance Or Damage	High	N/A	<.25 acres	N/A
Apparent Type of Motor Vehicle:	Apparent Purpose of Damage:	Type Public Land Resource Damaged:		
Full Sized Vehicle, ATV/UTV	Play Area	Soil, Wilderness Characteristic		
Is This Site Improving/Recovering From Previously Documented Disturbance?	Rehabilitation Comments		Additional Comments	
This Site Has Neither Improved Nor Worsened Since Previous Documentation	N/A		Not really a disturbance, more of a pull off

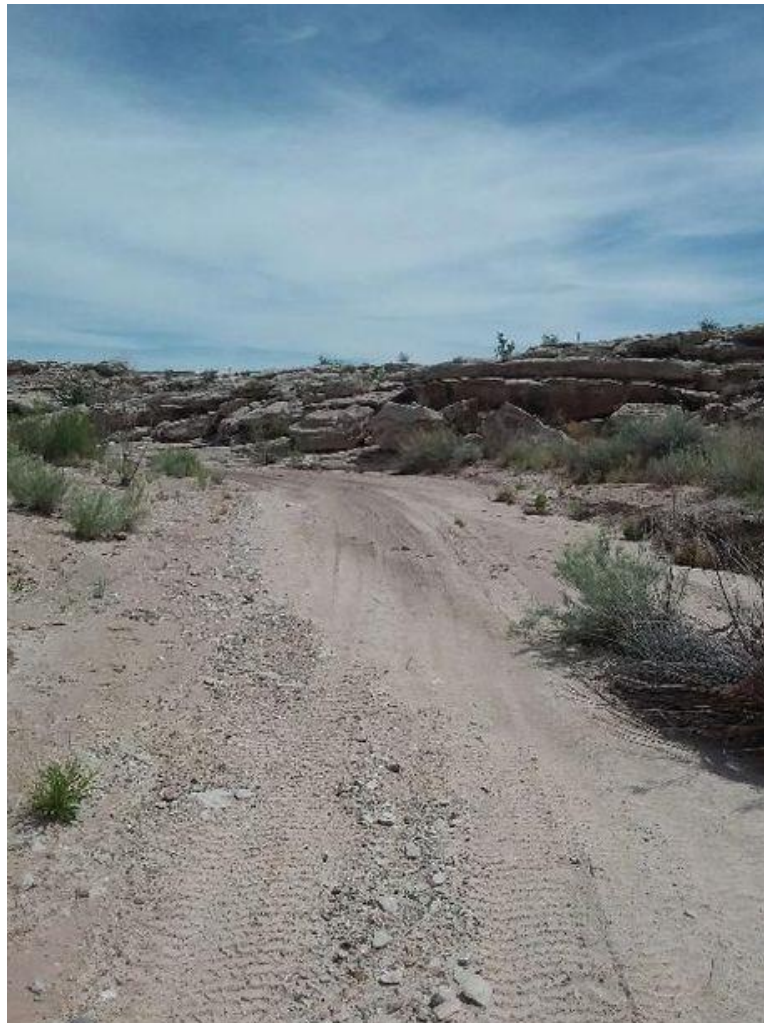
Type of Inspector:	Name of Inspector (Youth Corp)	Name of Inspector (BLM)	Has The Site Completely Rehabbed?
BLM Employee	N/A	Marc Johnson, Steve Petrich	No
Site ID Number:	Date Of Physical Inspection	Price Field Office TMA:	Route ID:
27	05/06/2020 11:51 AM	San Rafael Desert	SD819

Physical Inspection:	Observed Usage Intensity:	Linear Extent:	Area Extent:	Comments:
End of Route	N/A	N/A	N/A	N/A
Apparent Type of Motor Vehicle:	Apparent Purpose of Damage:	Type Public Land Resource Damaged:		
N/A	N/A	N/A		
Is This Site Improving/Recovering From Previously Documented Disturbance?	Rehabilitation Comments	Additional Comments		
Yes, This Site Is Improving Compared To Previous Documentation	N/A	N/A

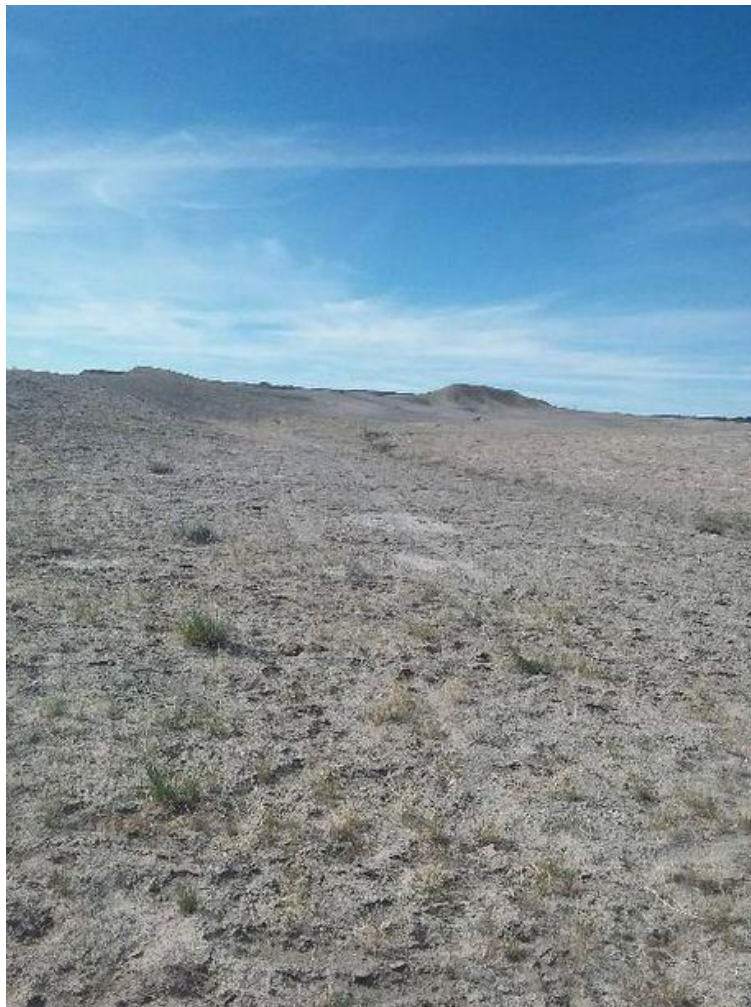
Type of Inspector:	Name of Inspector (Youth Corp)	Name of Inspector (BLM)	Has The Site Completely Rehabbed?	
BLM Employee	N/A	Steve Petrich	No	
Site ID Number:	Date Of Physical Inspection	Price Field Office TMA:	Route ID:	
29	05/06/2020 9:33 AM	San Rafael Desert	SD1305	
Disturbance Or Damage Observations:				
Physical Inspection:	Observed Usage Intensity:	Linear Extent:	Area Extent:	Comments:
Disturbance Or Damage	Low	100 - 200 ft	N/A	N/A
Apparent Type of Motor Vehicle:	Apparent Purpose of Damage:	Type Public Land Resource Damaged:		
Full Sized Vehicle	Other Damage	Soil		
Is This Site Improving/Recovering From Previously Documented Disturbance?		Rehabilitation Comments	Additional Comments	
Yes, This Site Is Improving Compared To Previous Documentation		N/A	N/A

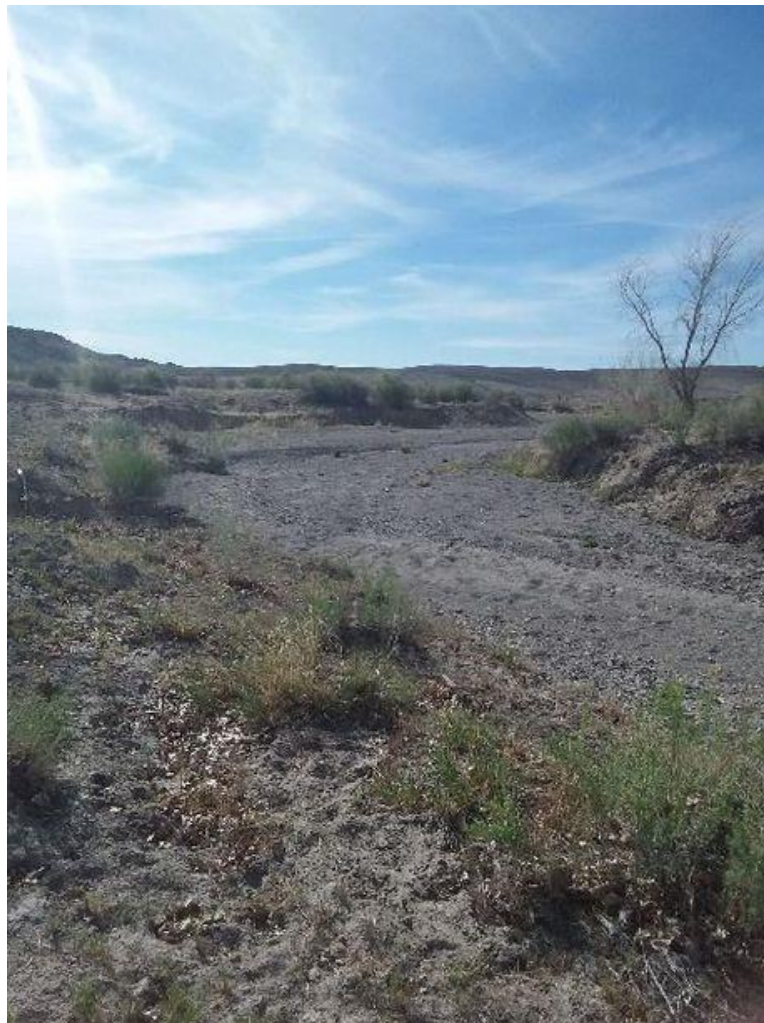
Type of Inspector:	Name of Inspector (Youth Corp)	Name of Inspector (BLM)	Has The Site Completely Rehabbed?
BLM Employee	N/A	Marc Johnson, Steve Petrich	No
Site ID Number:	Date Of Physical Inspection	Price Field Office TMA:	Route ID:
30	05/06/2020 9:23 AM	San Rafael Desert	SD1305

Physical Inspection:	Observed Usage Intensity:	Linear Extent:	Area Extent:	Comments:
Route not Apparent	N/A	N/A	N/A	N/A
Apparent Type of Motor Vehicle:	Apparent Purpose of Damage:	Type Public Land Resource Damaged:		
N/A	N/A	N/A		
Is This Site Improving/Recovering From Previously Documented Disturbance?		Rehabilitation Comments	Additional Comments	
Yes, This Site Is Improving Compared To Previous Documentation		N/A	N/A

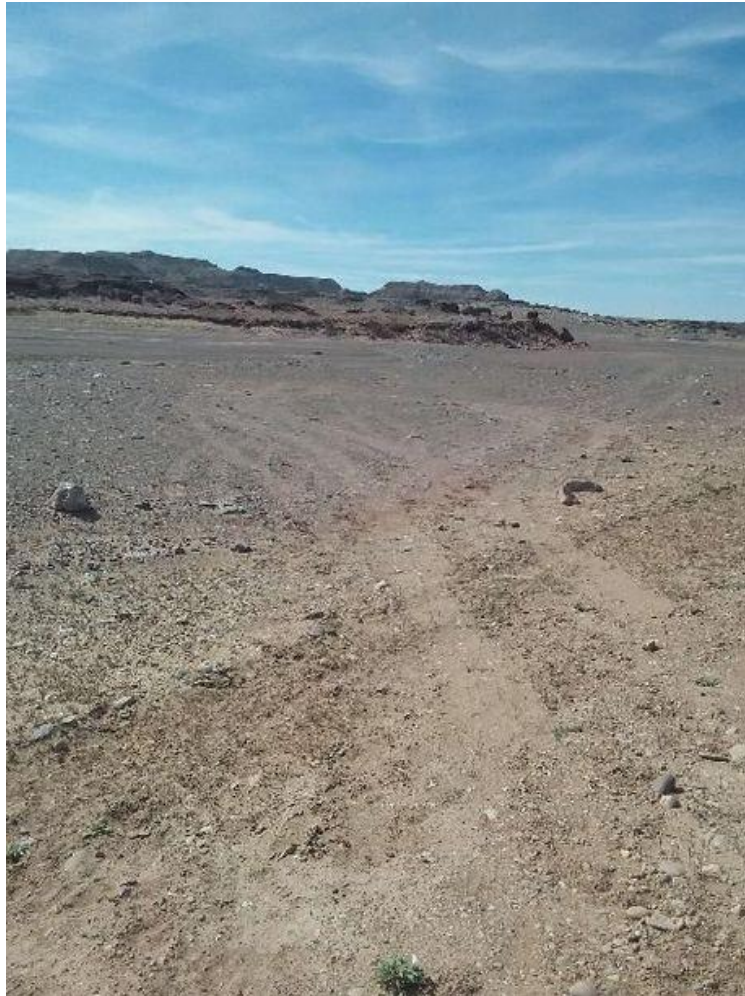
Type of Inspector:	Name of Inspector (Youth Corp)	Name of Inspector (BLM)	Has The Site Completely Rehabbed?
BLM Employee	N/A	Marc Johnson, Steve Petrich	No
Site ID Number:	Date Of Physical Inspection	Price Field Office TMA:	Route ID:
41	05/06/2020 9:56 AM	San Rafael Desert	SD421

Physical Inspection:	Observed Usage Intensity:	Linear Extent:	Area Extent:	Comments:
Disturbance Or Damage	Medium	N/A	<.25 acres	N/A
Apparent Type of Motor Vehicle:	Apparent Purpose of Damage:	Type Public Land Resource Damaged:		
Full Sized Vehicle	Play Area	Soil		
Is This Site Improving/Recovering From Previously Documented Disturbance?	Rehabilitation Comments		Additional Comments	
This Site Has Neither Improved Nor Worsened Since Previous Documentation	N/A		N/A

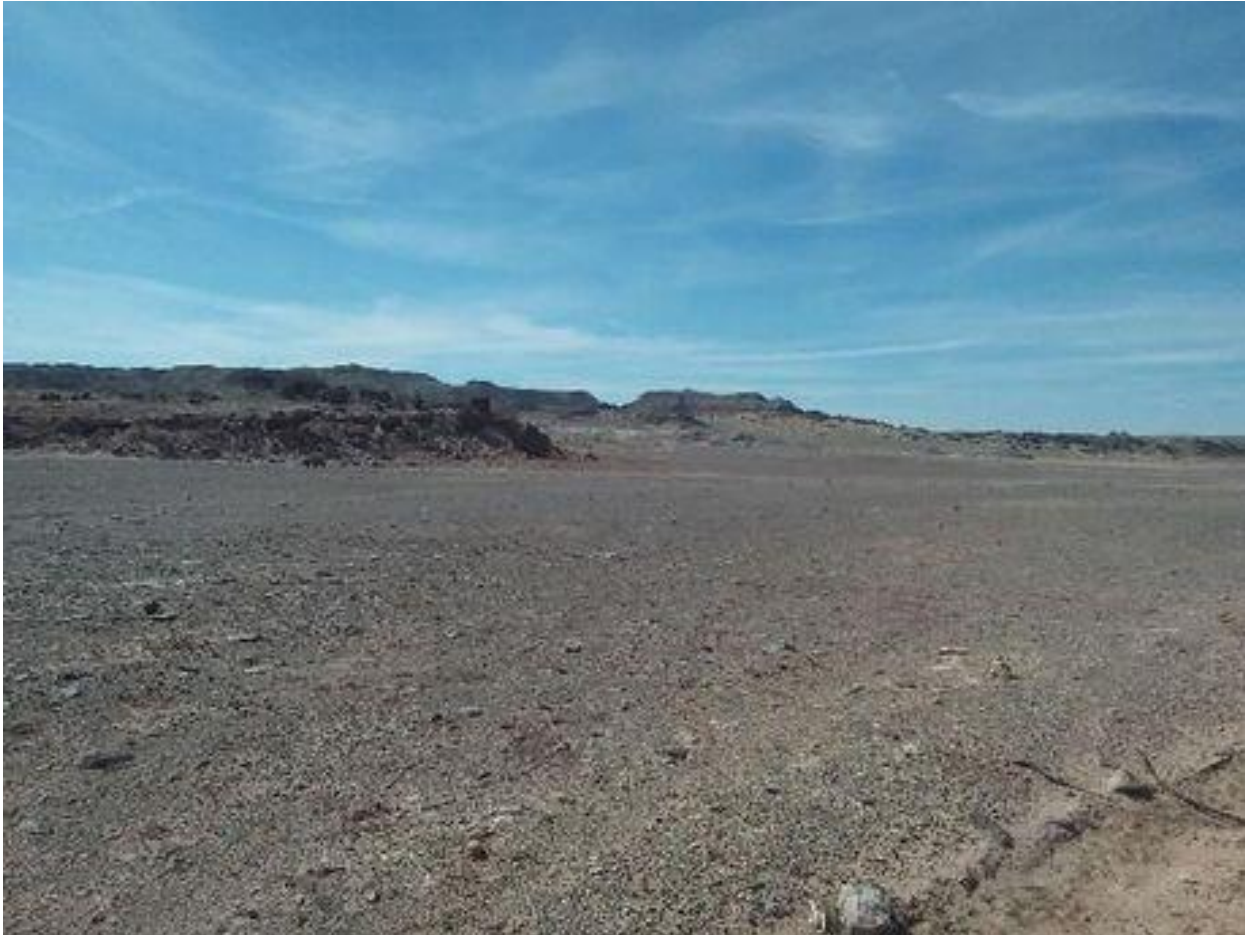
Type of Inspector:	Name of Inspector (Youth Corp)	Name of Inspector (BLM)	Has The Site Completely Rehabbed?
BLM Employee	N/A	Marc Johnson, Steve Petrich	No
Site ID Number:	Date Of Physical Inspection	Price Field Office TMA:	Route ID:
42	05/06/2020 9:53 AM	San Rafael Desert	SD421

Physical Inspection:	Observed Usage Intensity:	Linear Extent:	Area Extent:	Comments:
Disturbance Or Damage	Low	Continues beyond LOS	N/A	N/A
Apparent Type of Motor Vehicle:	Apparent Purpose of Damage:	Type Public Land Resource Damaged:		
Full Sized Vehicle	Cross Country Travel	Soil		
Is This Site Improving/Recovering From Previously Documented Disturbance?		Rehabilitation Comments	Additional Comments	
Yes, This Site Is Improving Compared To Previous Documentation		N/A	N/A

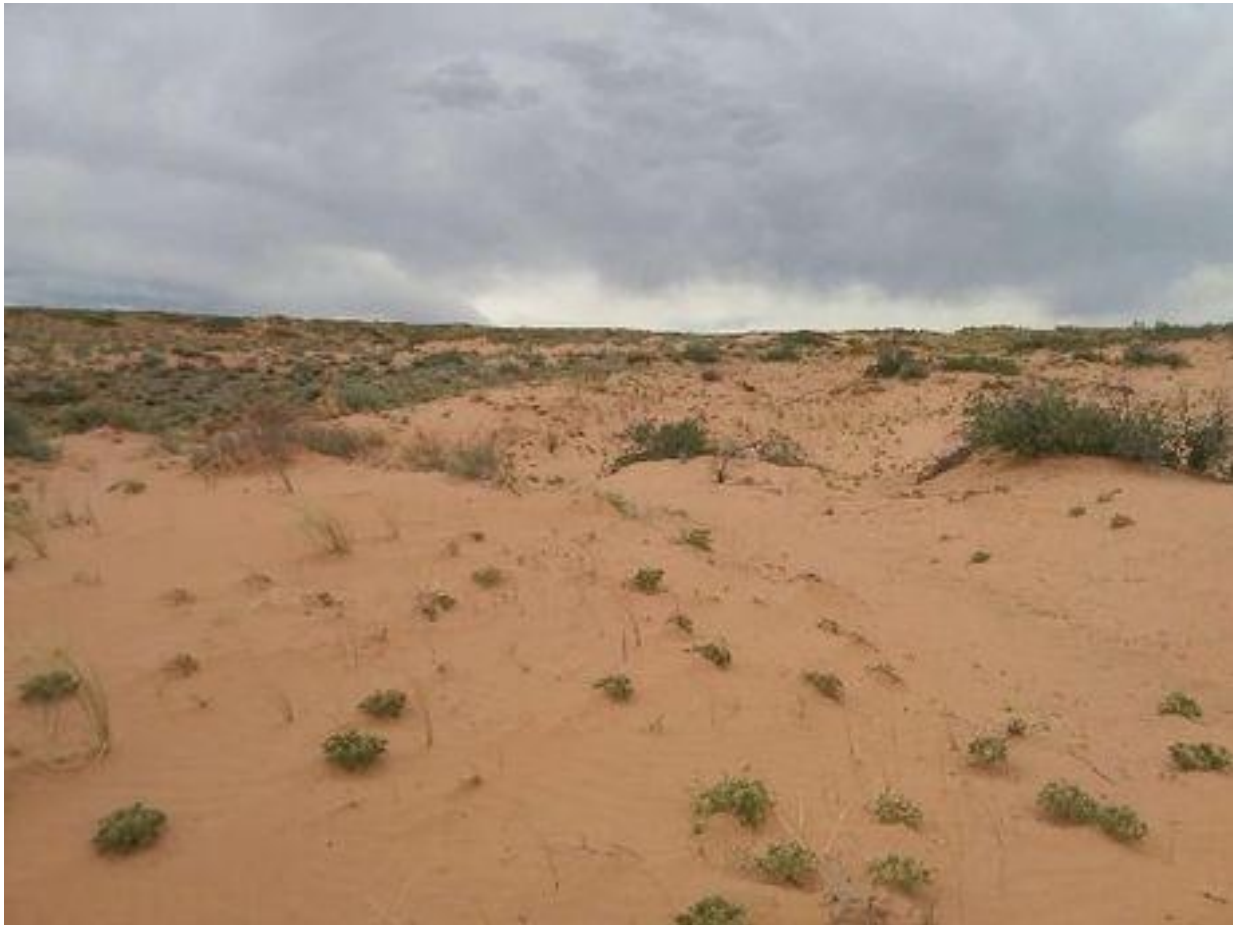
Type of Inspector:	Name of Inspector (Youth Corp)	Name of Inspector (BLM)	Has The Site Completely Rehabbed?
Youth Corps	Lucas Farmer	N/A	Yes
Site ID Number:	Date Of Physical Inspection	Price Field Office TMA:	Route ID:
54	06/03/2020 2:36 PM	San Rafael Desert	SD084

Sand dunes taken over site. Based off previous photo of disturbance, the sand dunes have shifted drastically.

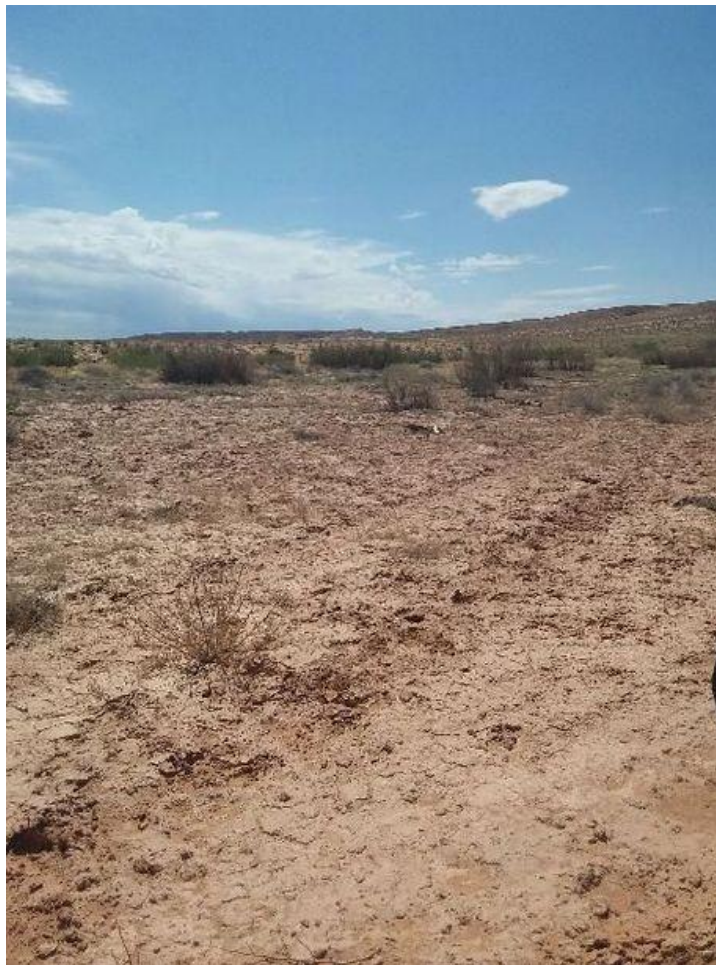
Type of Inspector:	Name of Inspector (Youth Corp)	Name of Inspector (BLM)	Has The Site Completely Rehabbed?
BLM Employee	N/A	Marc Johnson, Steve Petrich	No
Site ID Number:	Date Of Physical Inspection	Price Field Office TMA:	Route ID:
67	05/11/2020 11:43 AM	San Rafael Desert	SD876

Physical Inspection:	Observed Usage Intensity:	Linear Extent:	Area Extent:	Comments:
Disturbance Or Damage	Low	Continues beyond LOS	N/A	N/A
Apparent Type of Motor Vehicle:	Apparent Purpose of Damage:	Type Public Land Resource Damaged:		
Full Sized Vehicle, ATV/UTV	Short Spur	Soil		
Is This Site Improving/Recovering From Previously Documented Disturbance?			Rehabilitation Comments	Additional Comments
Yes, This Site Is Improving Compared To Previous Documentation			N/A	N/A

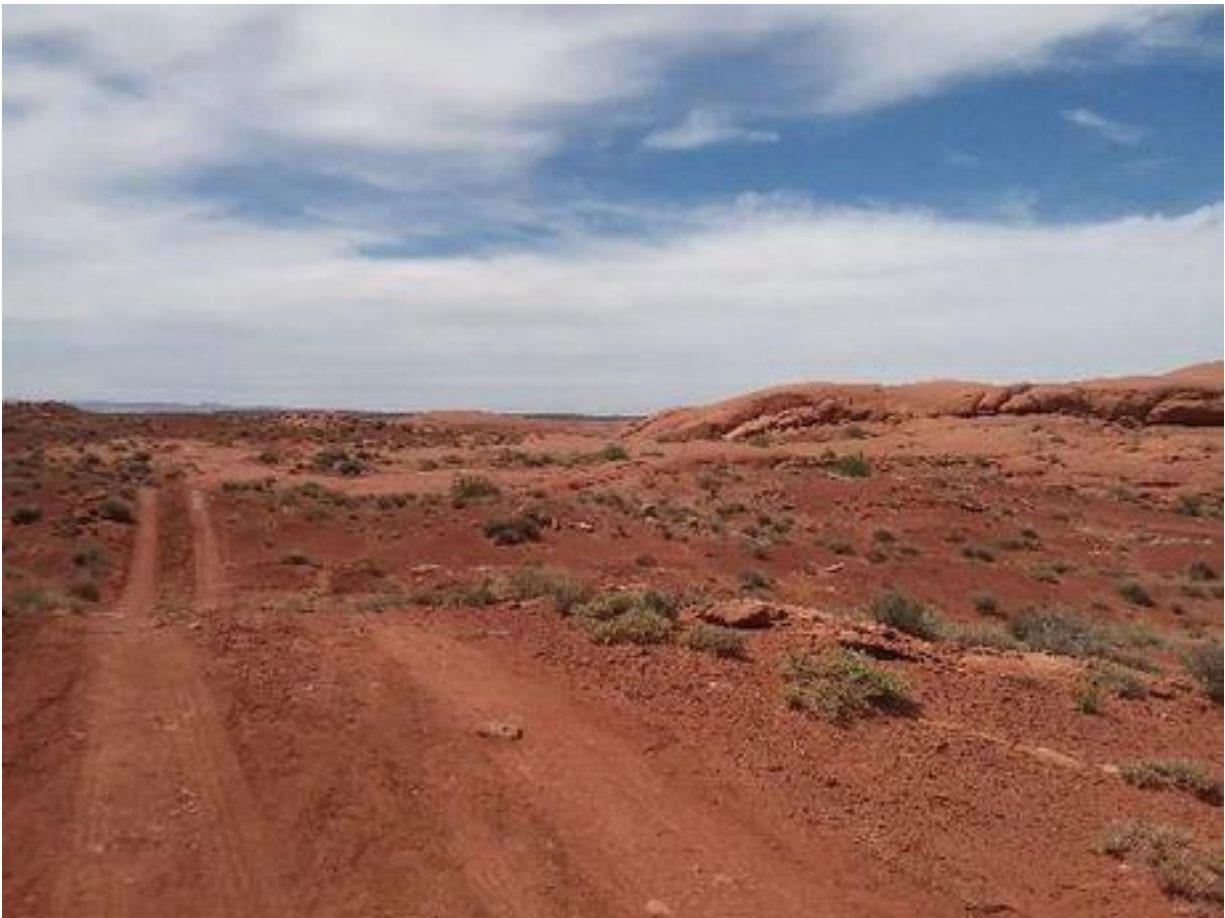
Type of Inspector:	Name of Inspector (Youth Corp)	Name of Inspector (BLM)	Has The Site Completely Rehabbed?
BLM Employee	N/A	Marc Johnson, Steve Petrich	No
Site ID Number:	Date Of Physical Inspection	Price Field Office TMA:	Route ID:
80	05/06/2020 3:02 PM	San Rafael Desert	SD668

Physical Inspection:	Observed Usage Intensity:	Linear Extent:	Area Extent:	Comments:
Disturbance Or Damage	High	Continues beyond LOS	N/A	N/A
Apparent Type of Motor Vehicle:	Apparent Purpose of Damage:	Type Public Land Resource Damaged:		
Full Sized Vehicle	Short Spur, Dispersed Camping	Soil		
Is This Site Improving/Recovering From Previously Documented Disturbance?		Rehabilitation Comments	Additional Comments	
This Site Has Neither Improved Nor Worsened Since Previous Documentation		N/A	N/A

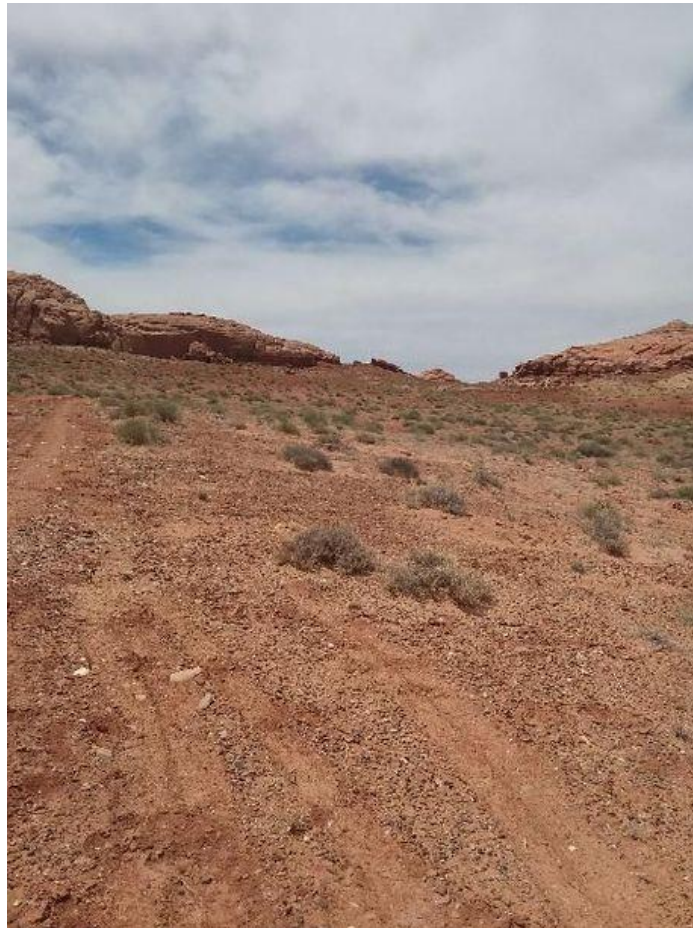
Type of Inspector:	Name of Inspector (Youth Corp)	Name of Inspector (BLM)	Has The Site Completely Rehabbed?
BLM Employee	N/A	Marc Johnson, Steve Petrich	No
Site ID Number:	Date Of Physical Inspection	Price Field Office TMA:	Route ID:
93	05/06/2020 2:23 PM	San Rafael Desert	SD682

Physical Inspection:	Observed Usage Intensity:	Linear Extent:	Area Extent:	Comments:
Disturbance Or Damage	Medium	Continues beyond LOS	N/A	N/A
Apparent Type of Motor Vehicle:	Apparent Purpose of Damage:	Type Public Land Resource Damaged:		
Full Sized Vehicle	Cross Country Travel	Soil, Wilderness Characteristic		
Is This Site Improving/Recovering From Previously Documented Disturbance?	Rehabilitation Comments		Additional Comments	
This Site Has Neither Improved Nor Worsened Since Previous Documentation	N/A		N/A

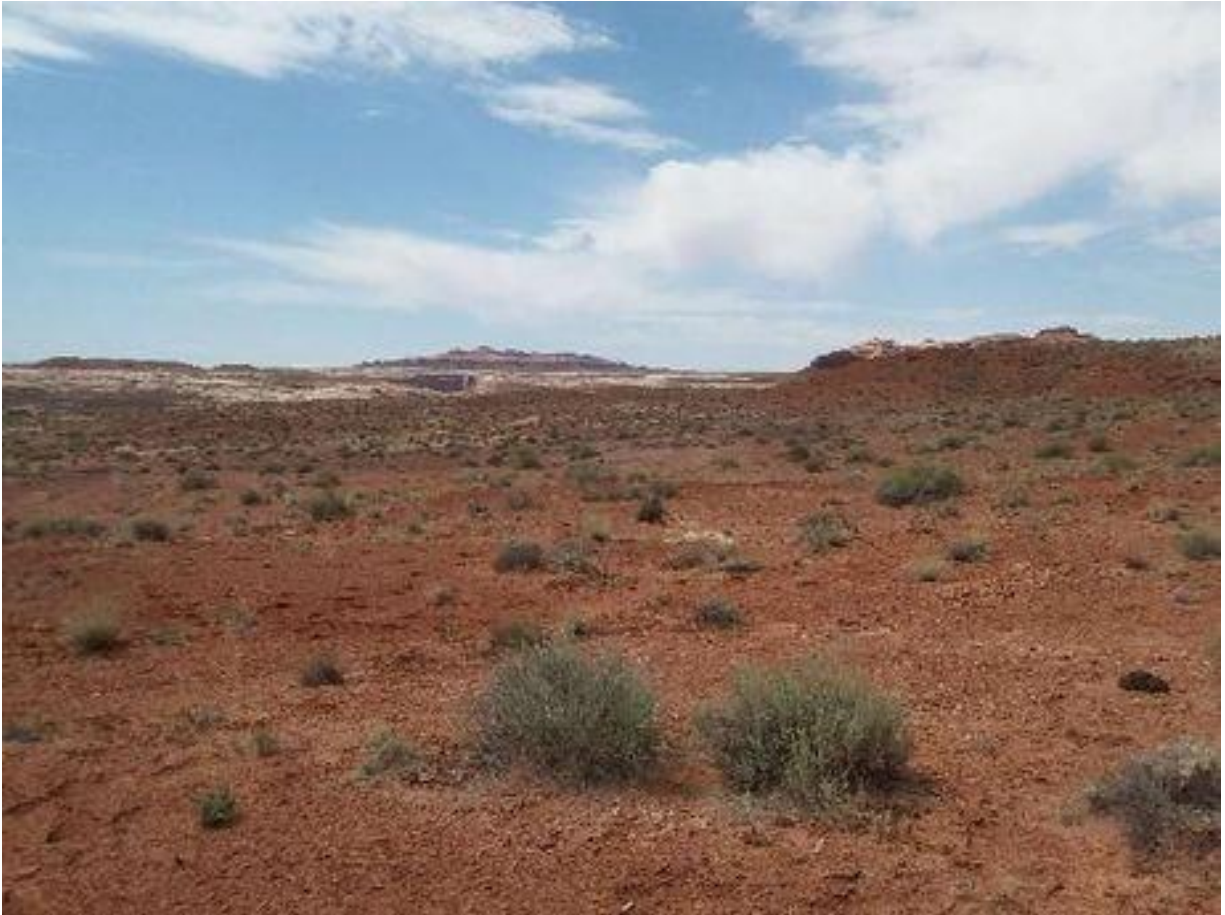
Type of Inspector:	Name of Inspector (Youth Corp)	Name of Inspector (BLM)	Has The Site Completely Rehabbed?
Youth Corps	Lucas Farmer	N/A	Yes
Site ID Number:	Date Of Physical Inspection	Price Field Office TMA:	Route ID:
94	06/03/2020 11:02 AM	San Rafael Desert	SD681

Site has been reclaimed. Signs of previous disturbance can't be found.

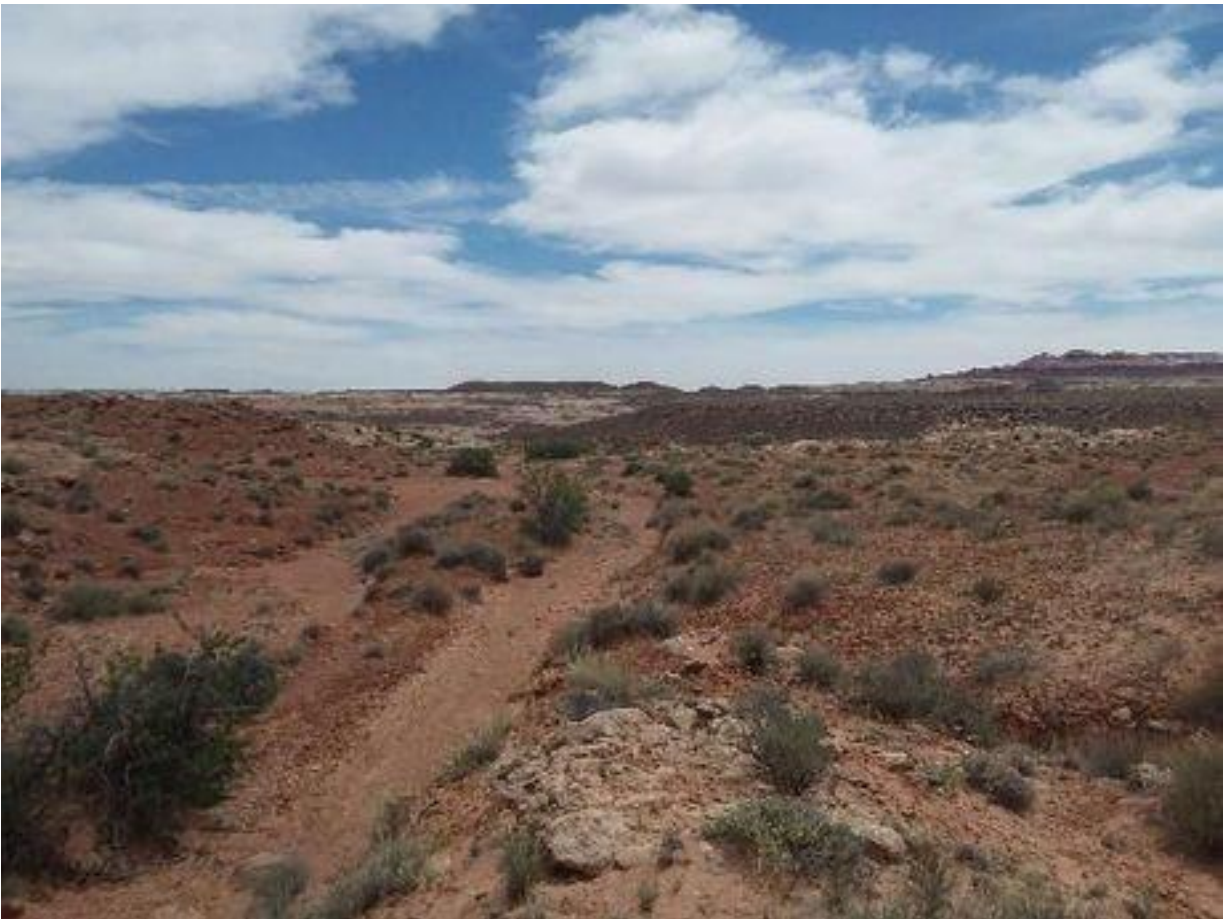
Type of Inspector:	Name of Inspector (Youth Corp)	Name of Inspector (BLM)	Has The Site Completely Rehabbed?
BLM Employee	N/A	Marc Johnson, Steve Petrich	Yes
Site ID Number:	Date Of Physical Inspection	Price Field Office TMA:	Route ID:
96	05/06/2020 2:09 PM	San Rafael Desert	SD681

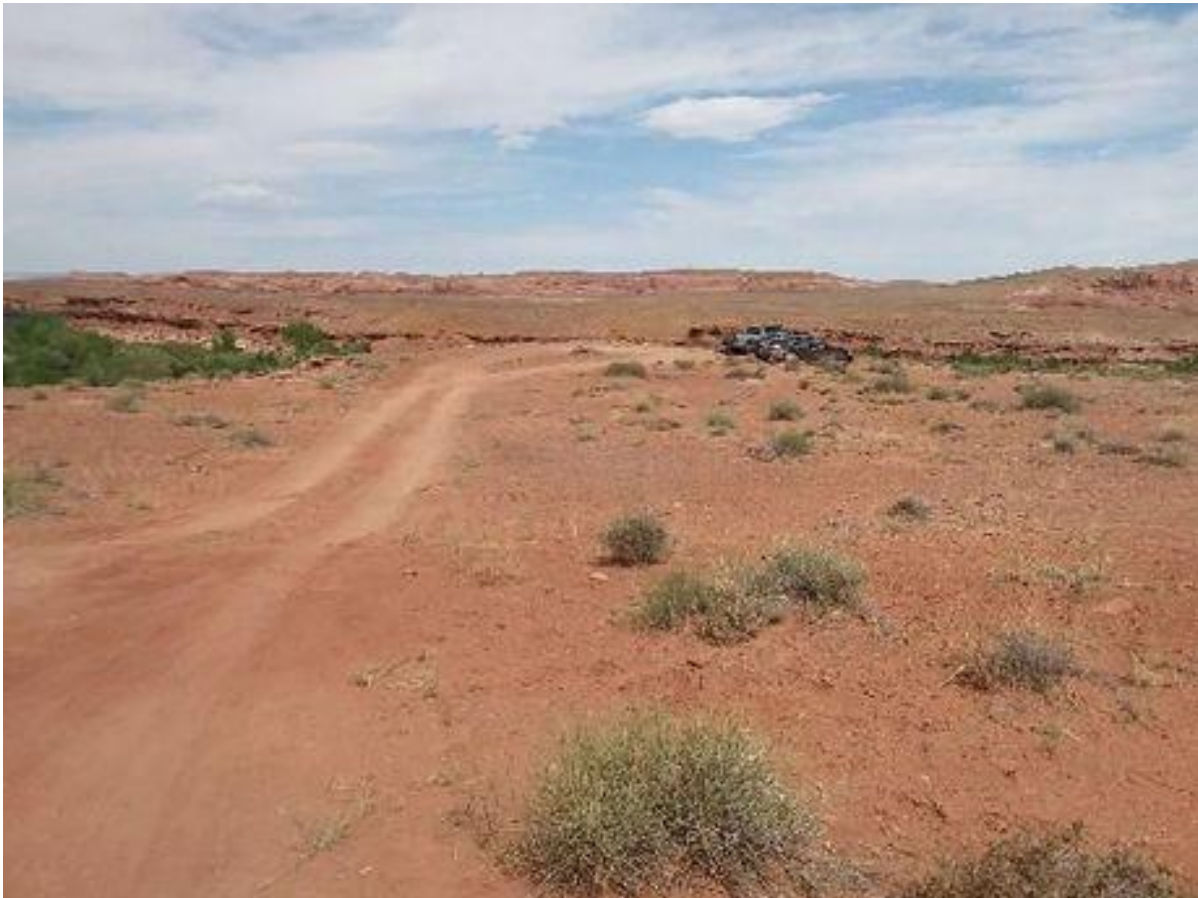
Type of Inspector:	Name of Inspector (Youth Corp)	Name of Inspector (BLM)	Has The Site Completely Rehabbed?	
Youth Corps	Lucas Farmer	N/A	No	
Site ID Number:	Date Of Physical Inspection	Price Field Office TMA:	Route ID:	
98	06/03/2020 10:27 AM	San Rafael Desert	SD706	
Disturbance Or Damage Observations:				
Physical Inspection:	Observed Usage Intensity:	Linear Extent:	Area Extent:	Comments:
Disturbance Or Damage	High	50 - 100 ft	N/A	Short spur to campsite
Apparent Type of Motor Vehicle:	Apparent Purpose of Damage:	Type Public Land Resource Damaged:		
Full Sized Vehicle	Short Spur, Dispersed Camping	Soil, Vegetation		
Is This Site Improving/Recovering From Previously Documented Disturbance?	Rehabilitation Comments		Additional Comments	
No, This Site Has Gotten Worse Since Previous Documentation	Heavy use does not allow site to reclaim.		N/A

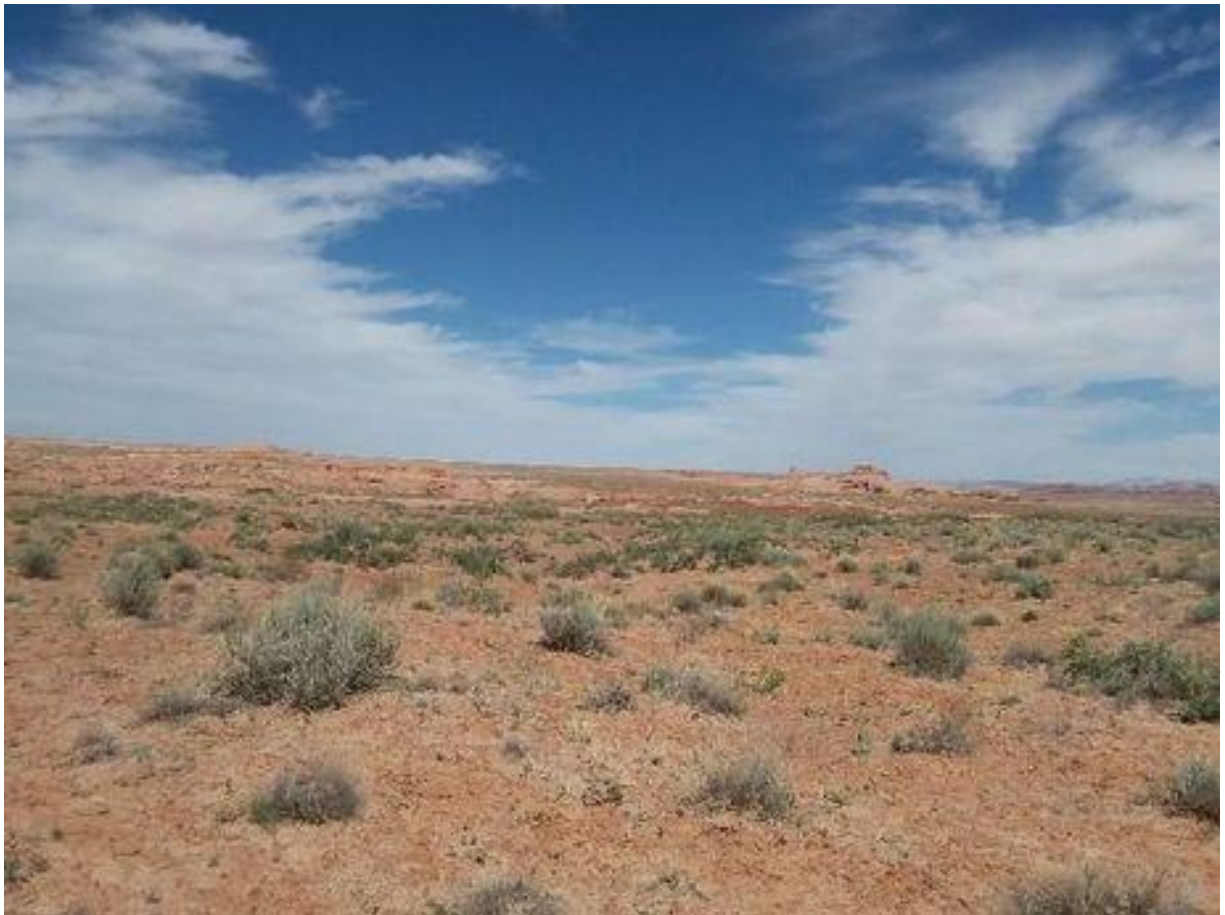
Type of Inspector:	Name of Inspector (Youth Corp)	Name of Inspector (BLM)	Has The Site Completely Rehabbed?
BLM Employee	N/A	Marc Johnson, Steve Petrich	Yes
Site ID Number:	Date Of Physical Inspection	Price Field Office TMA:	Route ID:
106	05/06/2020 3:44 PM	San Rafael Desert	SD771

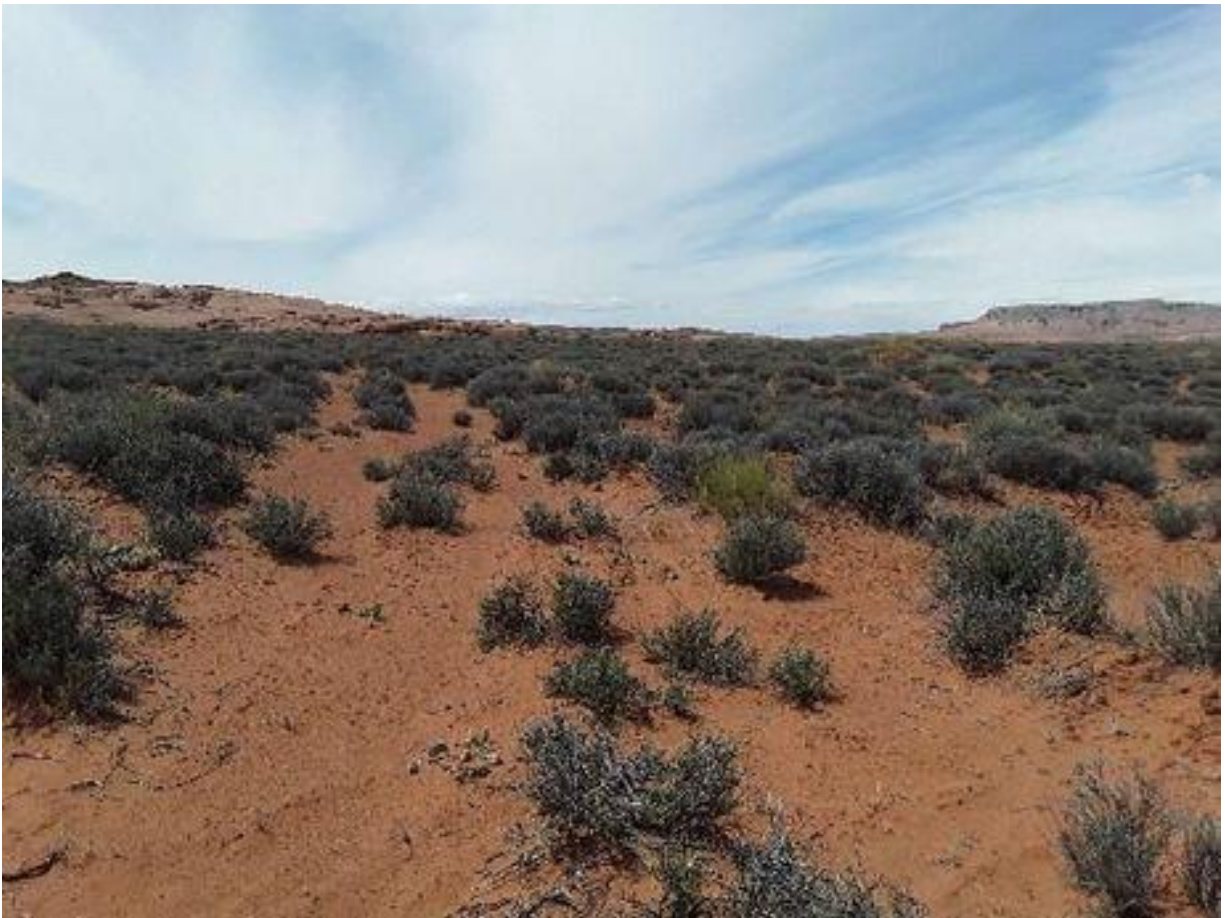
Type of Inspector:	Name of Inspector (Youth Corp)	Name of Inspector (BLM)	Has The Site Completely Rehabbed?	
BLM Employee	N/A	Steve Petrich	No	
Site ID Number:	Date Of Physical Inspection	Price Field Office TMA:	Route ID:	
139	05/15/2020 12:10 PM	San Rafael Desert	SD142	
Disturbance Or Damage Observations:				
Physical Inspection:	Observed Usage Intensity:	Linear Extent:	Area Extent:	Comments:
Disturbance Or Damage	Low	Continues beyond LOS	N/A	N/A
Apparent Type of Motor Vehicle:	Apparent Purpose of Damage:	Type Public Land Resource Damaged:		
Full Sized Vehicle, ATV/UTV	Short Spur, Unknown	Soil, Vegetation		
Is This Site Improving/Recovering From Previously Documented Disturbance?		Rehabilitation Comments	Additional Comments	
Yes, This Site Is Improving Compared To Previous Documentation		N/A	N/A
