**U.S. Department of the Interior
Bureau of Land Management**

San Rafael Desert Travel Management Monitoring During Planning June 2020 Report

**Price Field Office
125 S. 600 W.
Price, Utah 84501
435-636-3600**

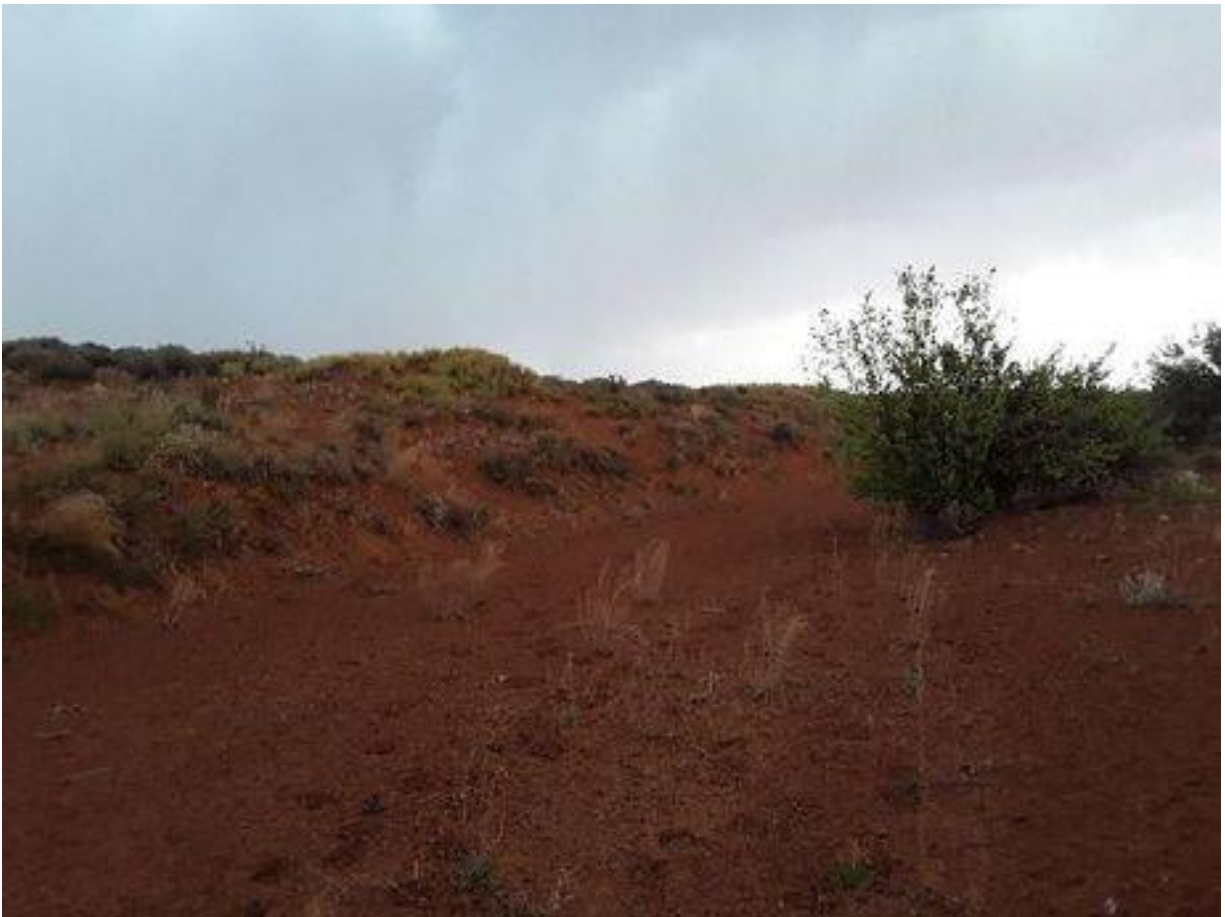
Type of Inspector:	Name of Inspector (Youth Corp)	Name of Inspector (BLM)	Has The Site Completely Rehabbed?
BLM Employee	N/A	Marc Johnson, Steve Petrich	Yes
Site ID Number:	Date Of Physical Inspection	Price Field Office TMA:	Route ID:
146	05/11/2020 2:26 PM	San Rafael Desert	SD050

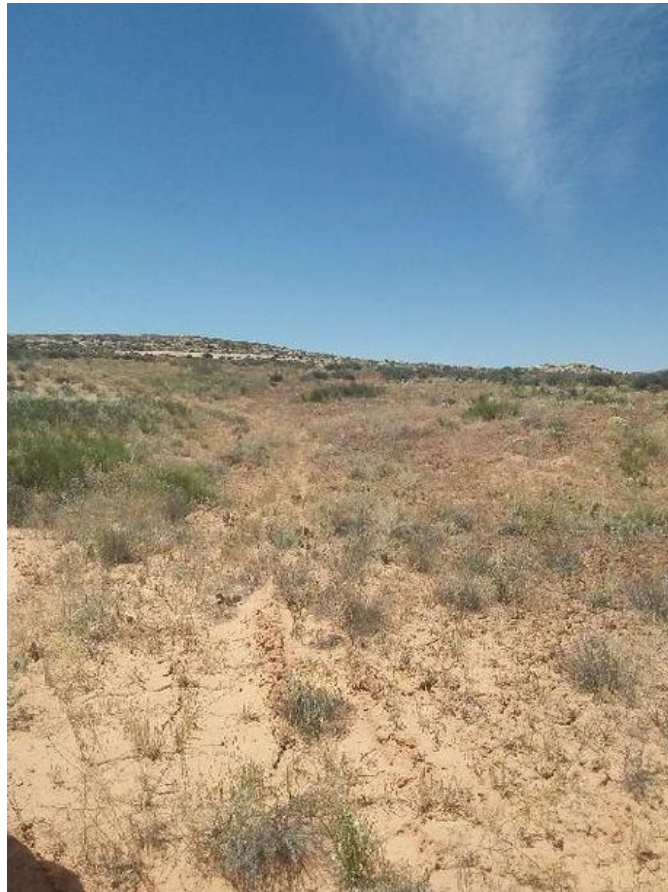
Type of Inspector:	Name of Inspector (Youth Corp)	Name of Inspector (BLM)	Has The Site Completely Rehabbed?	
Youth Corps	Lucas Farmer	N/A	No	
Site ID Number:	Date Of Physical Inspection	Price Field Office TMA:	Route ID:	
307	05/07/2020 12:55 PM	San Rafael Desert	SD431	
Disturbance Or Damage Observations:				
Physical Inspection:	Observed Usage Intensity:	Linear Extent:	Area Extent:	Comments:
Disturbance Or Damage	Low	50 - 100 ft	N/A	Tracks around a bad part of SD431 route
Apparent Type of Motor Vehicle:	Apparent Purpose of Damage:	Type Public Land Resource Damaged:		
Full Sized Vehicle	Short Spur	Soil, Vegetation		
Is This Site Improving/Recovering From Previously Documented Disturbance?	Rehabilitation Comments		Additional Comments	
Yes, This Site Is Improving Compared To Previous Documentation	Very close to being fully restored.		Be aware of condition of road between 308 and 307. Consider walking from 308

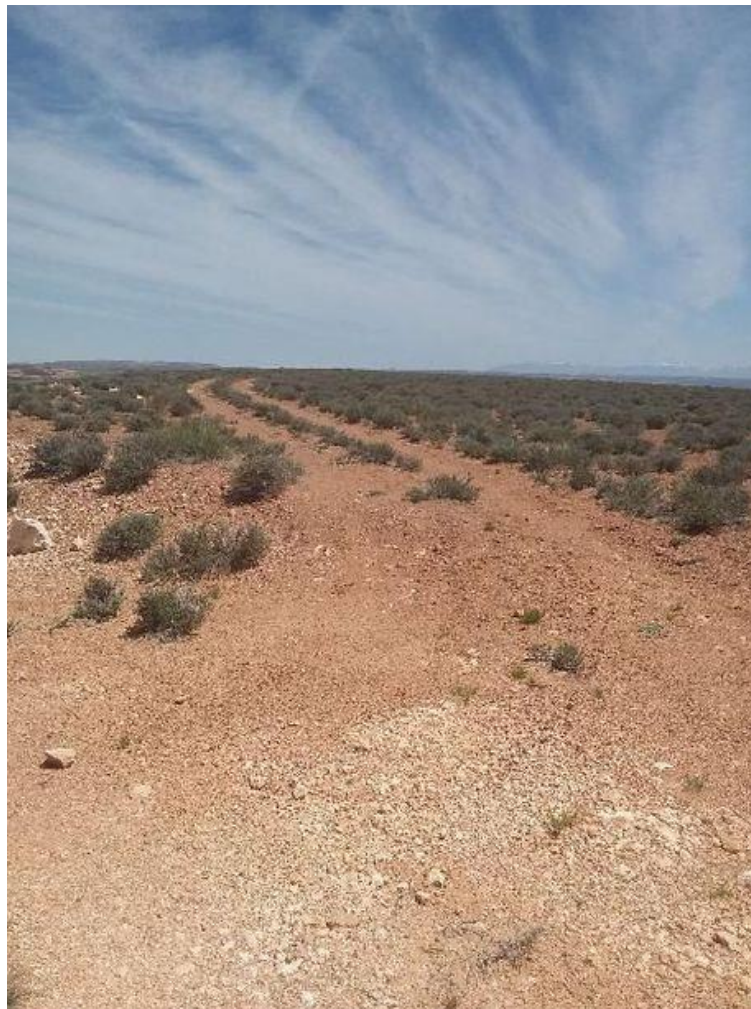
Site ID Number:	Date Of Physical Inspection	Price Field Office TMA:	Route ID:
308	05/07/2020 12:47 PM	San Rafael Desert	SD431

Physical Inspection:	Observed Usage Intensity:	Linear Extent:	Area Extent:	Comments:
Disturbance Or Damage	Medium	Continues beyond LOS	N/A	50 to 100 feet beyond LOS

Apparent Type of Motor Vehicle:	Apparent Purpose of Damage:	Type Public Land Resource Damaged:
Full Sized Vehicle	Short Spur	Soil, Vegetation, Wilderness Characteristic
Is This Site Improving/Recovering From Previously Documented Disturbance?	Rehabilitation Comments	Additional Comments
This Site Has Neither Improved Nor Worsened Since Previous Documentation	N/A	N/A

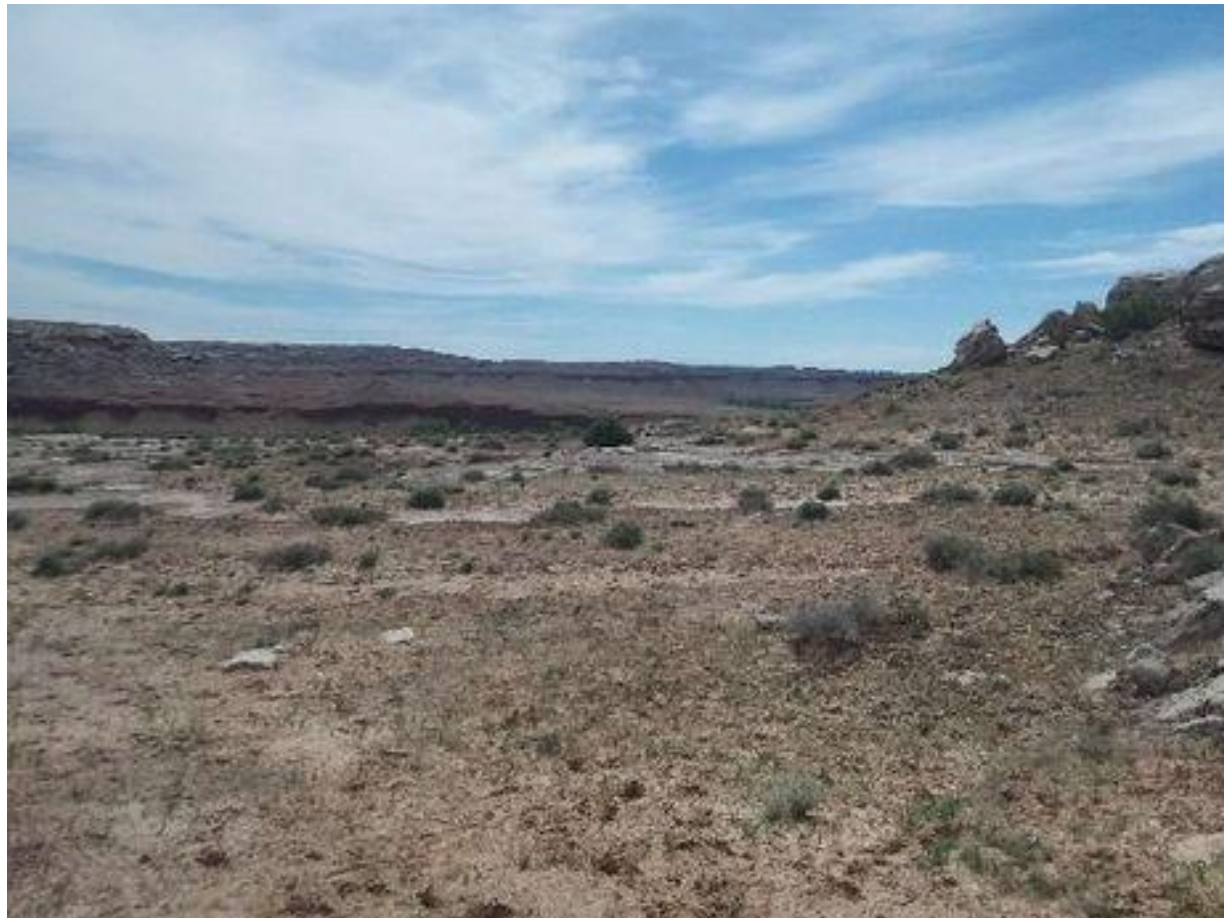
Type of Inspector:	Name of Inspector (Youth Corp)	Name of Inspector (BLM)	Has The Site Completely Rehabbed?
BLM Employee	N/A	Marc Johnson, Steve Petrich	Yes
Site ID Number:	Date Of Physical Inspection	Price Field Office TMA:	Route ID:
337	05/06/2020 10:49 AM	San Rafael Desert	SD817
