Here is my comment on the ANWR DEIS regarding feasibility of rehabilitating gravel pads on

Here's What Oil Drilling Looks Like in the Arctic Refuge, 30 Years Later

· · · These satellite images of a small part of the Arctic National Wildlife Refuge show the site of what, so far, is the only oil well ever drilled in the refuge, an exploratory well known as KIC-1 that was completed in the mid-1980s. The well was plugged and abandoned, and the drilling equipment and a special timber pad it sat on have long since been removed.

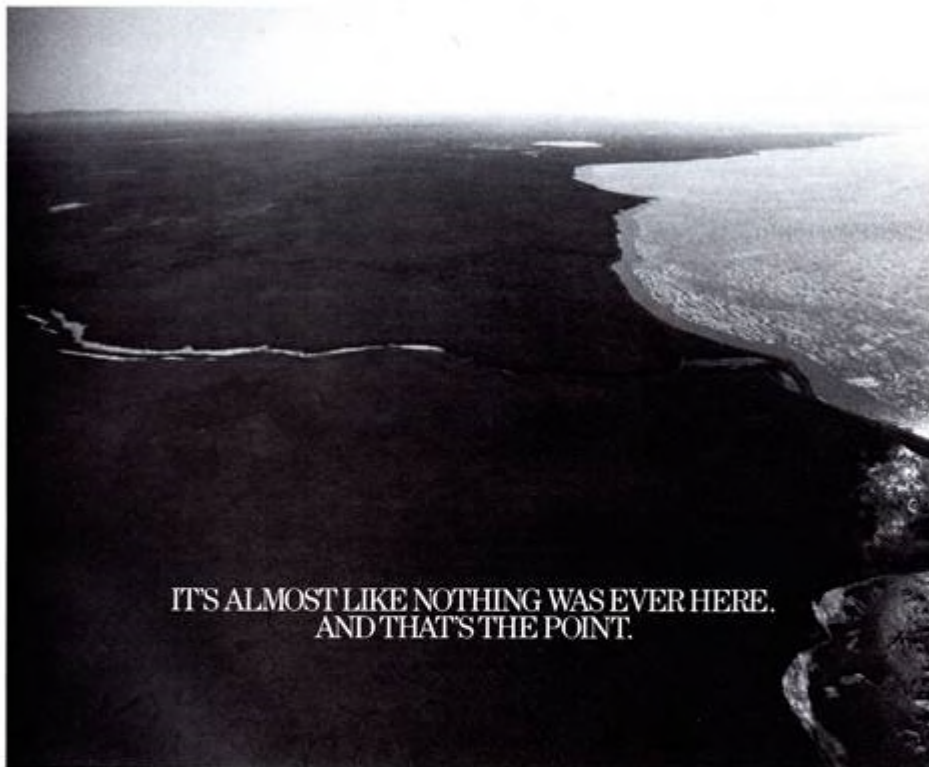
In 1985-86, an exploratory well was drilled 14 miles east of Kaktovik on private lands in the Arctic National Wildlife Refuge.

All equipment was transported during winter months on an ice road or flown in to an ice airstrip. All drilling was done in winter. The rig was operated on an insulated timber pad that was removed when work was completed.

Ad in Alaska Magazine, August 1991. With photo of the same well site, claiming 'it's almost like nothing was ever here'.

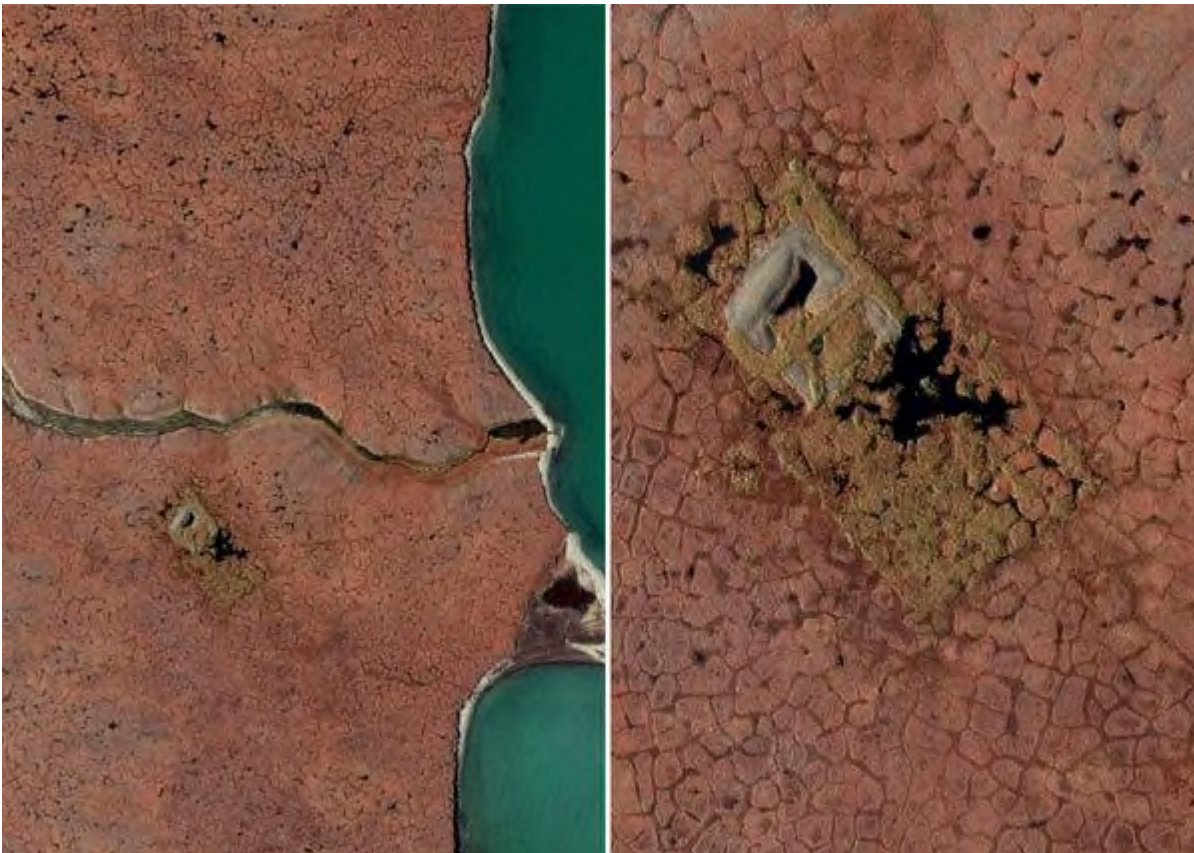
A false-color infrared satellite image from this year (in closer detail at right) shows natural tundra in pink. The yellow area shows the footprint of the old well. (Credit U.S. Fish and Wildlife Service)

But as these infrared images show, **even after three decades, the well's footprint — about 600 feet long on its longest side — is easily distinguishable from the undisturbed tundra around it.**

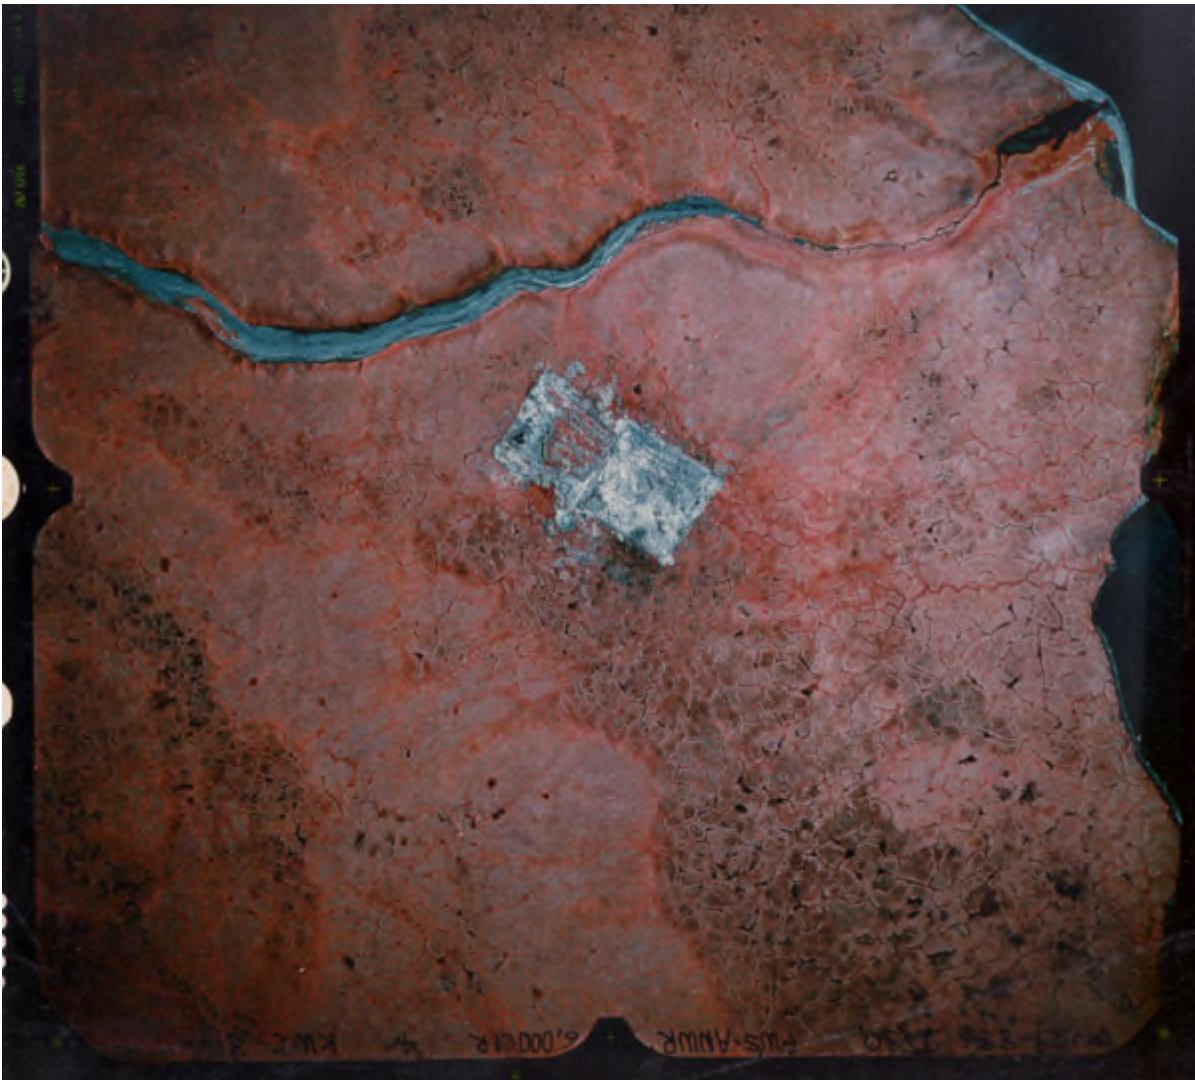
An infrared photo taken in 1988 shows the area of damaged tundra not long after the drilling site was cleared out. Credit U.S. Fish and Wildlife Service

Here's the site in 1988, a couple of years after operations at the well ceased, when most of the vegetation was dead:

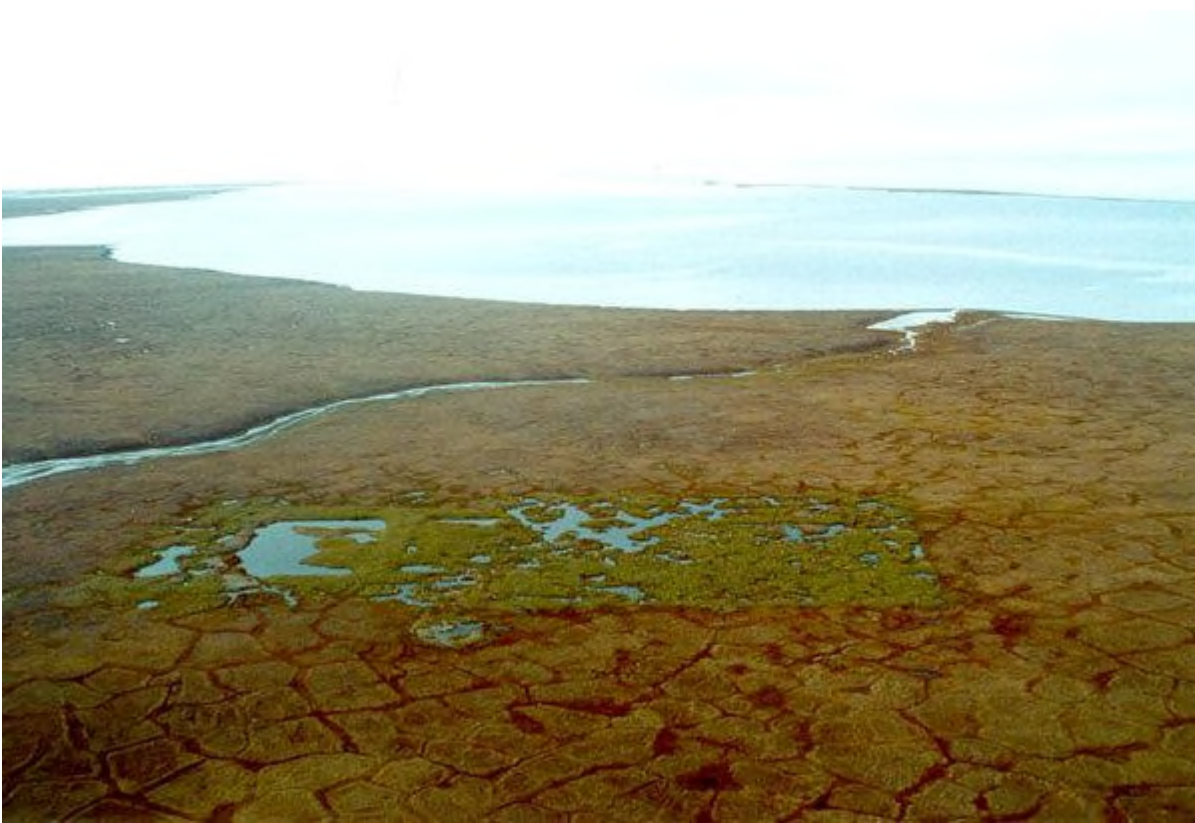
The former well site in 1988. The polygonal patterns in the undisturbed tundra are signs of ice wedges, which in the disturbed area have melted, leading to the pooled water. Credit U.S. Fish and Wildlife Service

Vertical wedges of solid ice melted, creating pools of water. The two pits, which were initially covered with soil, subsided over the years, leading to more pooling. They were topped with gravel a decade ago and now have very little vegetation. Given all the thawing and melting, Ms. Jorgenson said, **about 17 percent of the site is covered in water now, compared with about 2 percent of the surrounding tundra.**

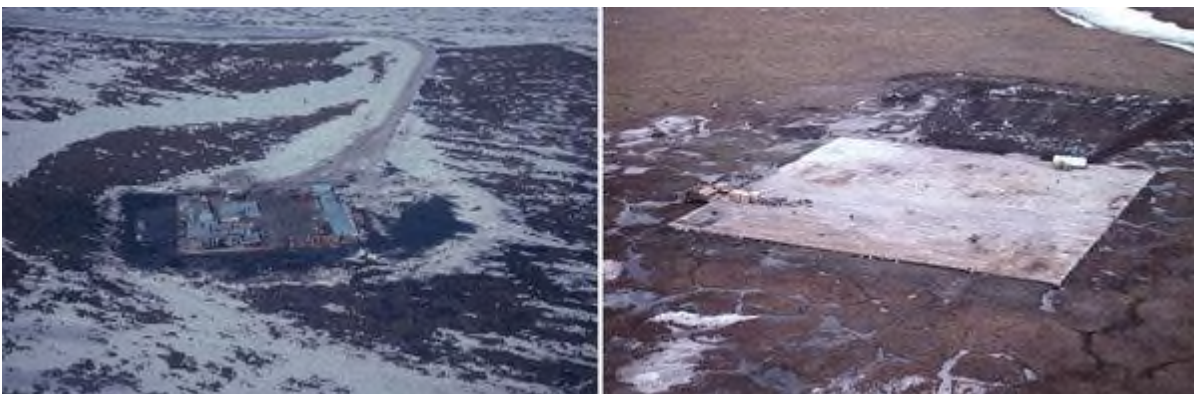
These photos of the well site show the pad with drilling equipment and without. It was in place for about a year and a half, from 1985 to 1986, including two winters.

Drilling equipment, left, and the platform it was built on. Credit U.S. Fish and Wildlife Service

Drilling equipment, left, and the platform it was built on.CreditU.S. Fish and Wildlife Service
