## **Draft Standards Determination Document**

### **Marys River Complex**

#### **Appendix L – Lentic Proper Functioning Condition and Water Resources Inventory Data**

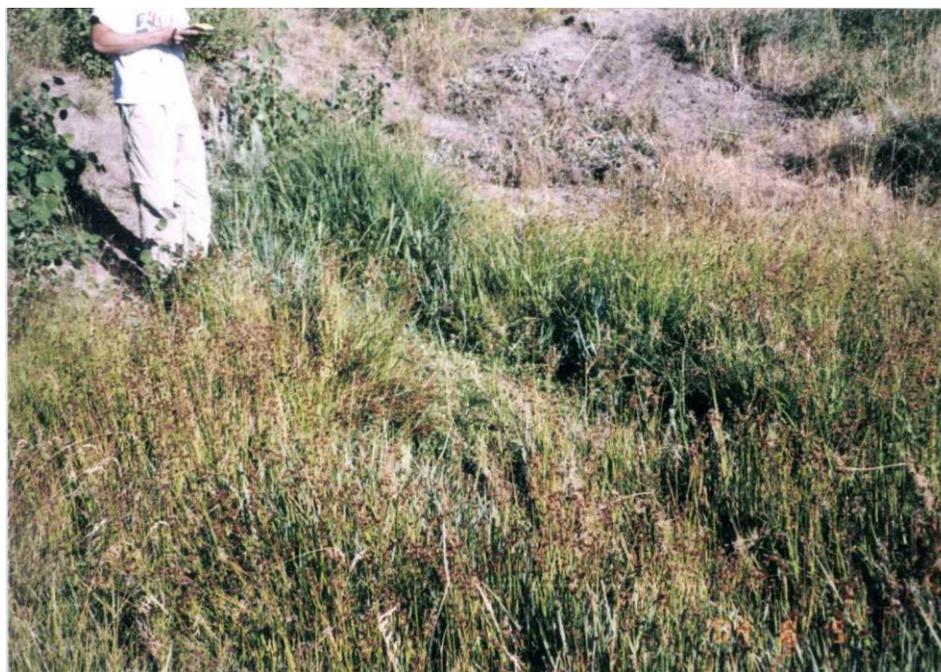
Riparian area is about 0.6 acres in size and is supported by a spring source that flows about 0.5 gpm. Vegetation consists of aspen and herbaceous riparian vegetation. Observers did not record any livestock related impacts and rated the area as being in properly functioning condition in 2004.

Photo 17 – Spring source for the area described in Photo 16.
