Tri-State Montrose-Nucla-Cahone Transmission Line Improvement Project
Final Environmental Assessment
(*DOI-BLM-CO-S000-2013-0001*)

Appendix C. Draft Visual Resources Report

**VISUAL ASSESSMENT REPORT
FOR THE TRI-STATE MONTROSE-NUCLA-CAHONE
TRANSMISSION LINE IMPROVEMENT PROJECT
SOUTHWEST COLORADO**

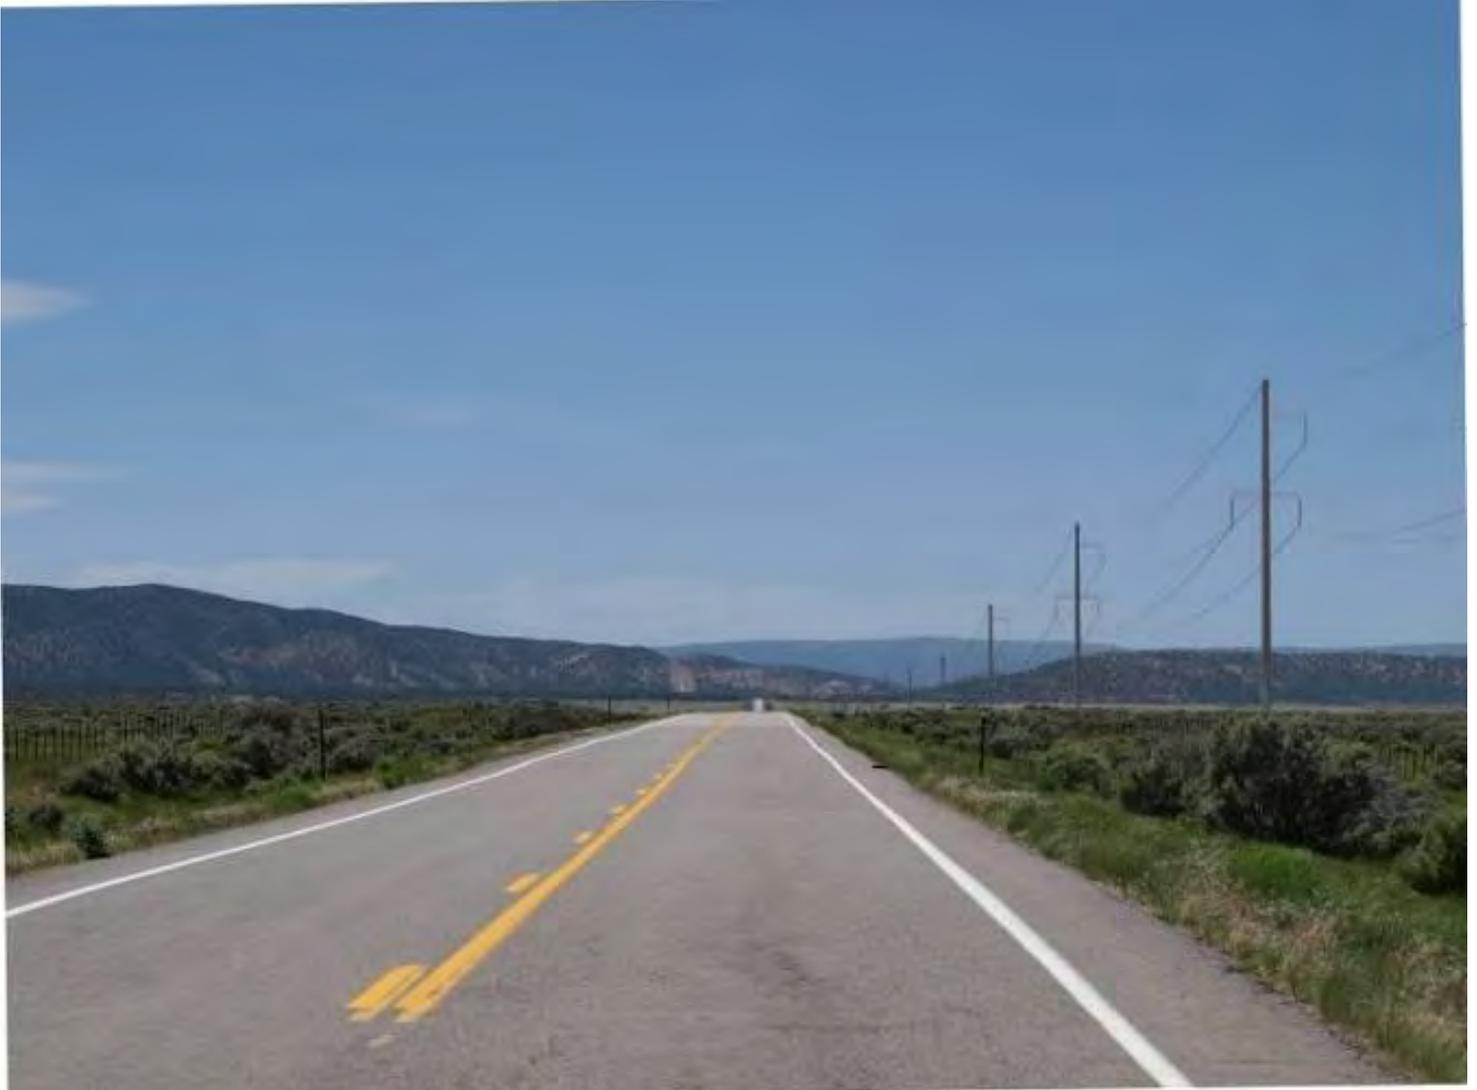
Photo 6b. KOP6, Alternative C: Combinations that include Dry Creek Basin Routing Option (Realignment) with the Transmission Line on the West Side of SH141 (View South)

Alternative C: Combinations that include Dry Creek Basin Routing Option (Realignment along SH 141) (Photo 6b and 6c) – Because the proposed transmission line would be located adjacent, and parallel to either side of SH 141, the conductors and structures would be highly visible to travelers on SH 141 in both directions, and therefore impact views in both directions of travel. Views from the private roads and structures near the Town of Basin, including the BLM Kiosk, would also include the proposed conductors and structures in close proximity to all observation points in the vicinity of KOP 6. Therefore, effects to visual resources from SH141 would be high because the conductors and structures would be highly visible, in high contrast with the existing landscape, partially-obstruct some views, and be visible for the entire duration of the drive through the basin. Effects to visual resources from the Town of Basin and the BLM kiosk would also be high for the same reasons.

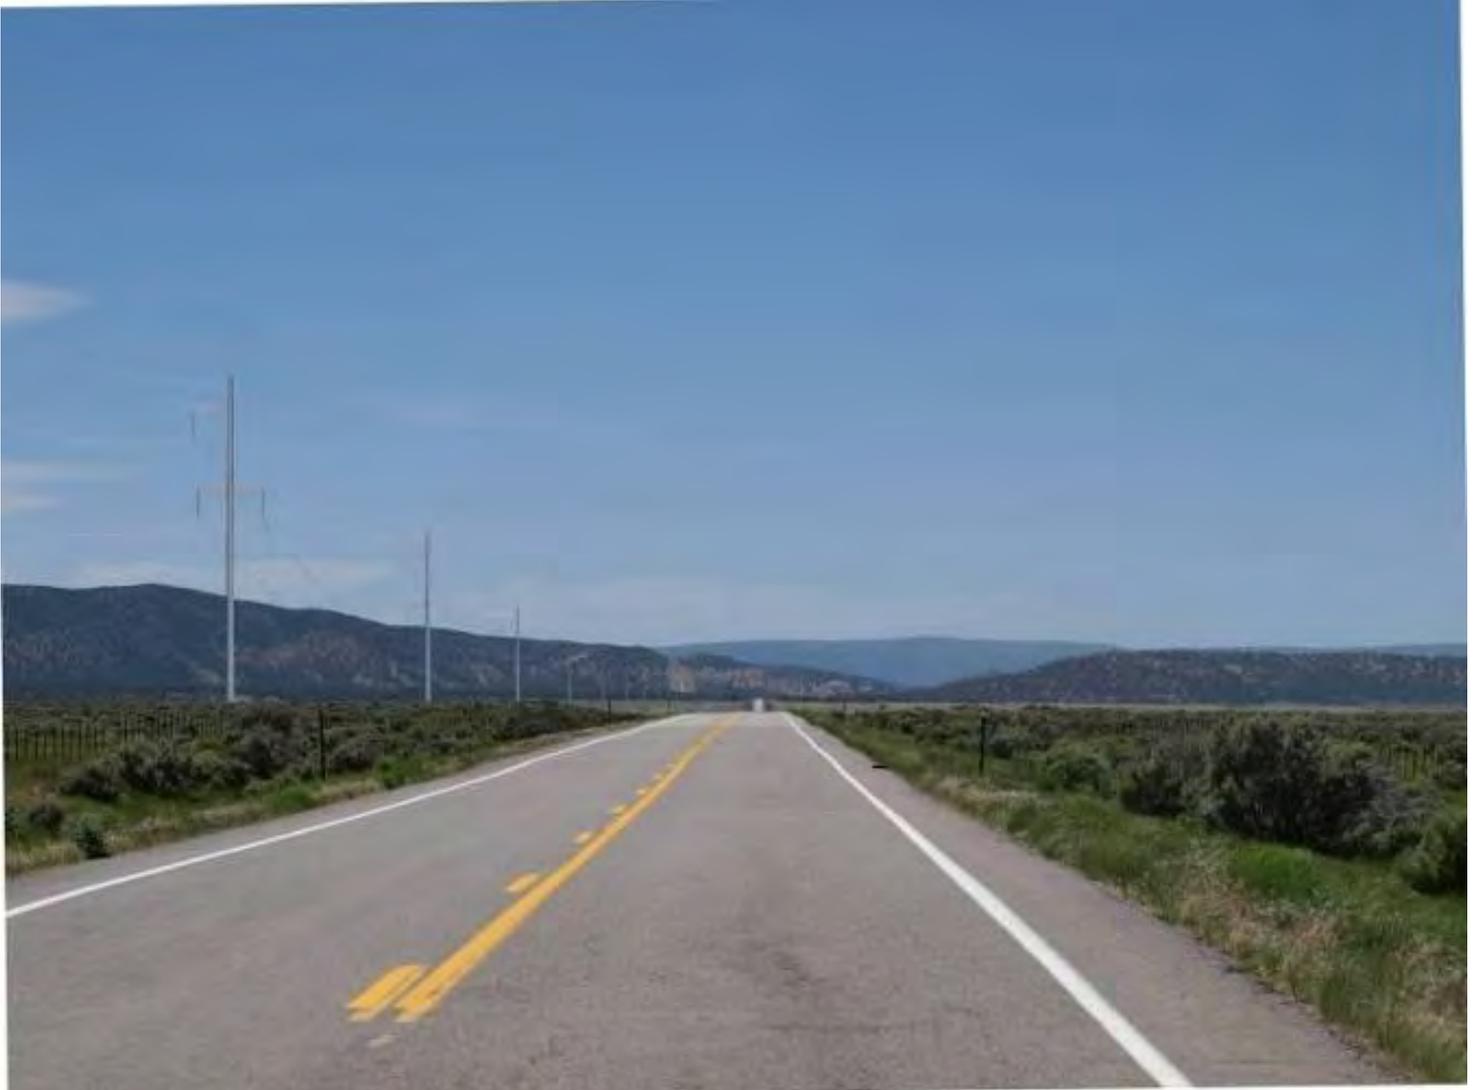
Photo 6c. KOP6, Alternative C: Combinations that include Dry Creek Basin Routing Option (Realignment) with the Transmission Line on the East Side of SH141 (View South)

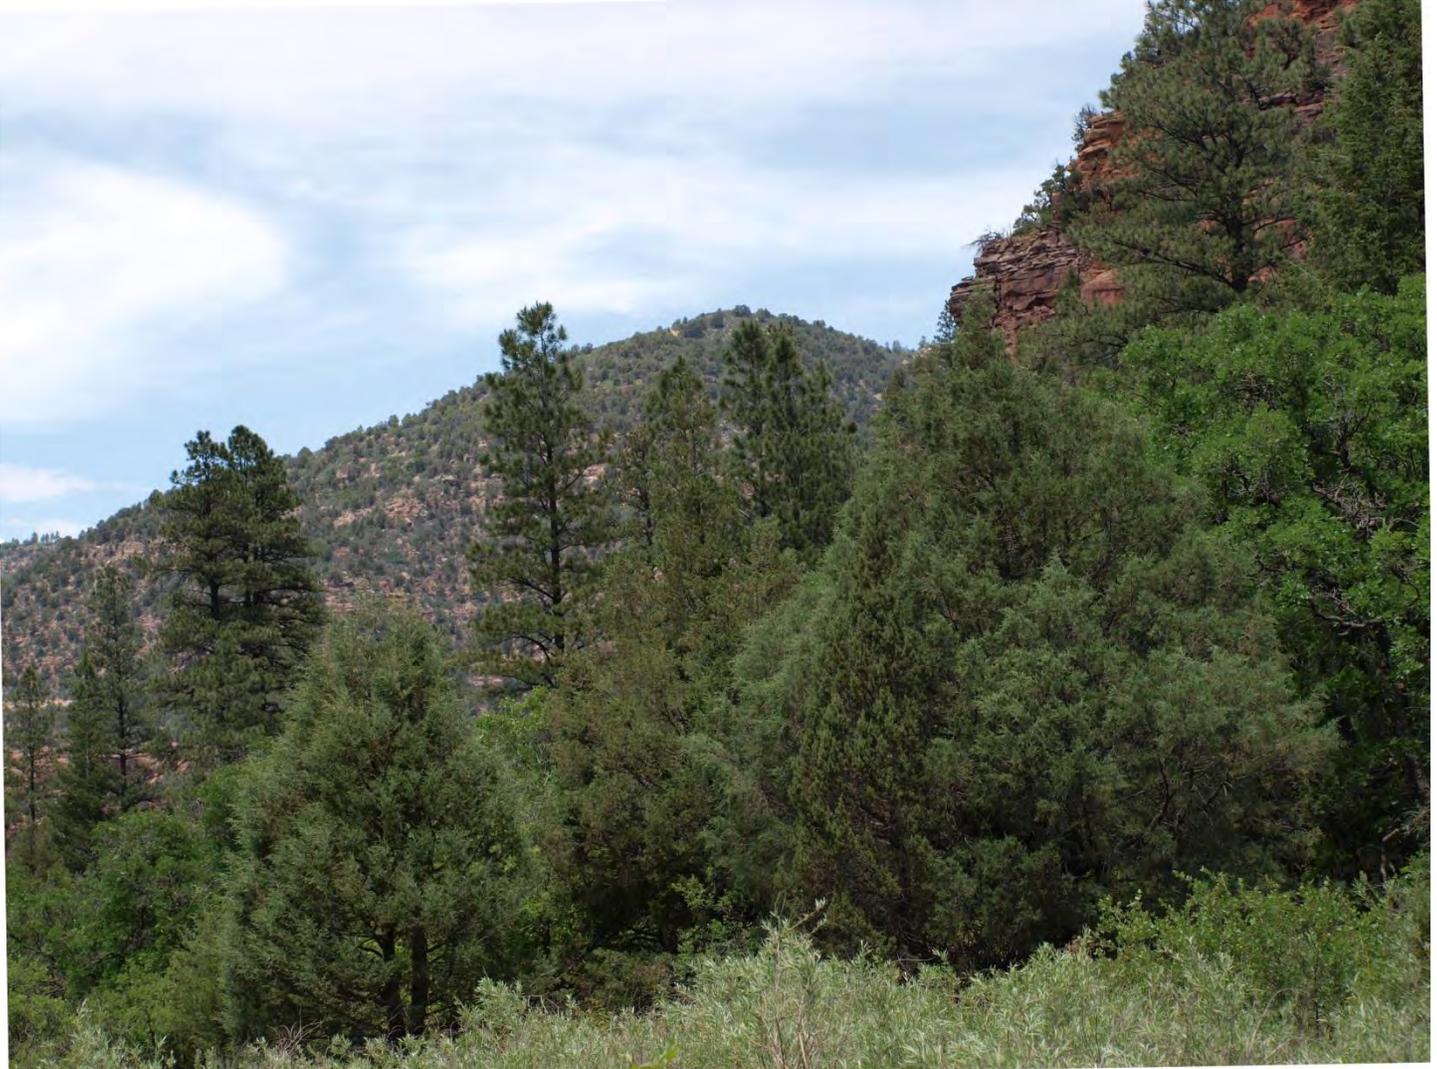
Photo 10a. KOP10, Alternatives A and C-Dolores River Crossing Realignment Option

Alternative A: Proposed Action and Alternative C-Dolores River Crossing Realignment Option (Photo 10a) – The proposed transmission line would be approximately 1.0 mile farther north from the KOP, and the proposed structure would no longer be visible in the photo view. The view of the proposed structure and conductors would be in one direction, downstream and upward from the KOP, and be relatively small in the view. If the viewer were camping in, or hiking through the trees adjacent to the KOP, the proposed structure would be completely obscured by the trees. Effects would be offset by removal of the existing structure upstream. Tri-State would provide revised mapping and brochures for river users due to the change in transmission line location, because the existing structures and crossing are used as a frame of reference for river users. The transmission line is an expected component of the landscape. Overall, effects to visual resources would be low.

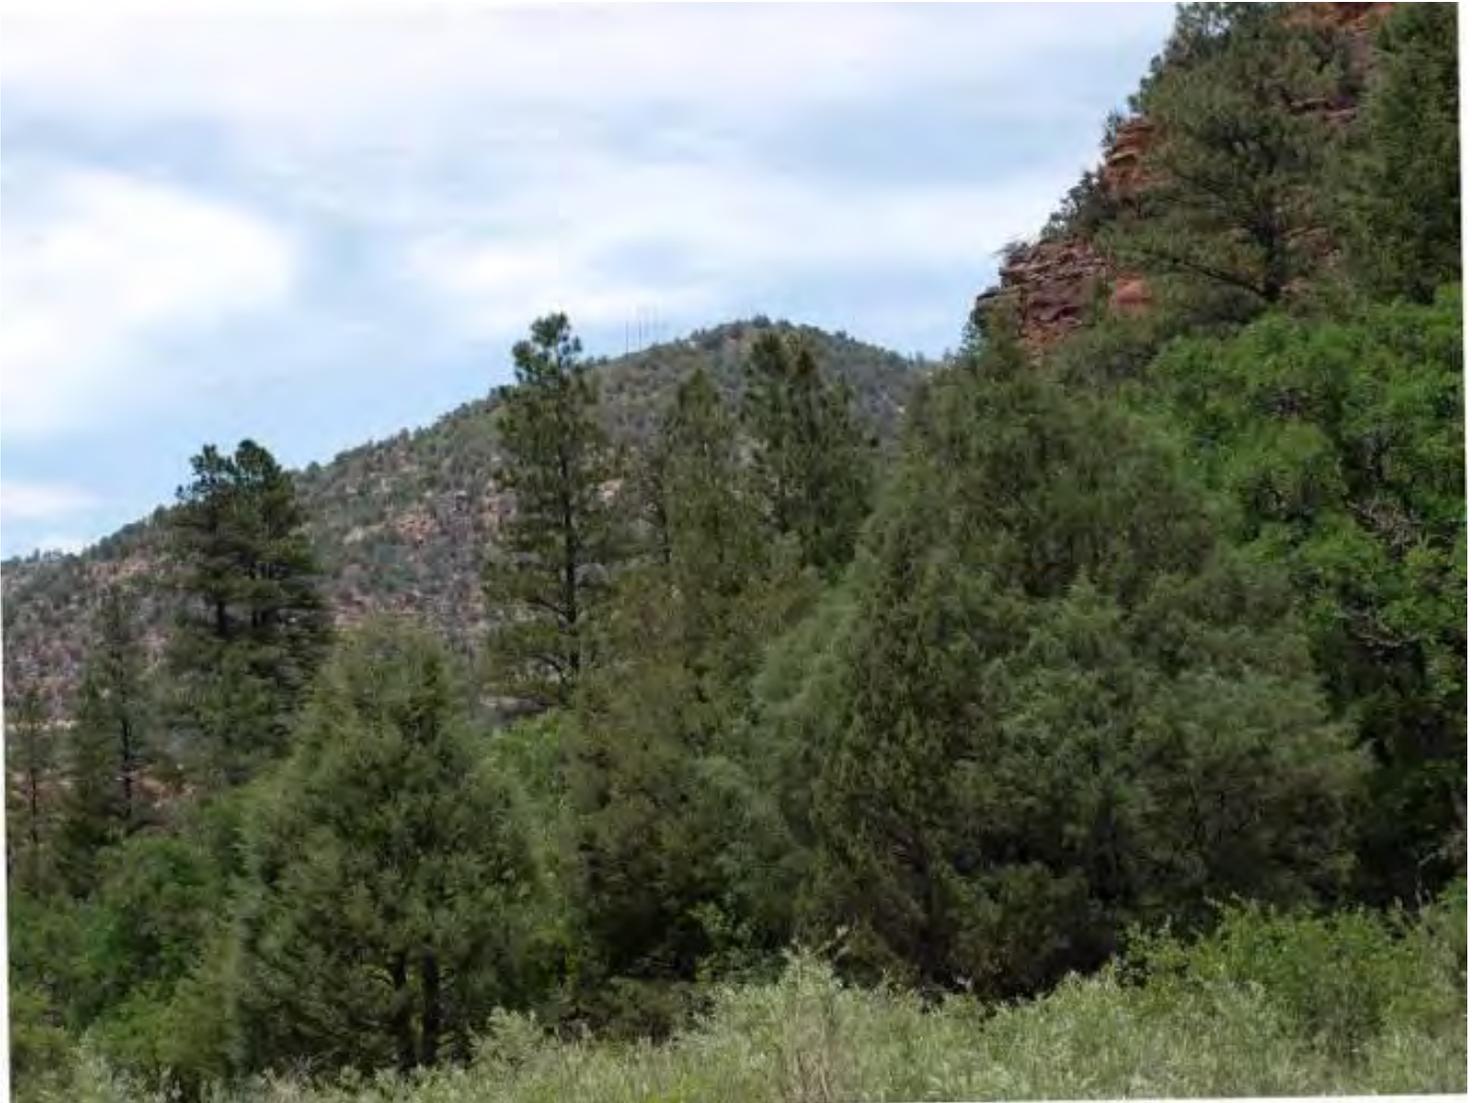
Photo 10b. KOP10, Alternative B (No Action)

Alternative B: No Action (Photo 10b) – Because the existing transmission line would remain unchanged, there would be no effect to visual resources.

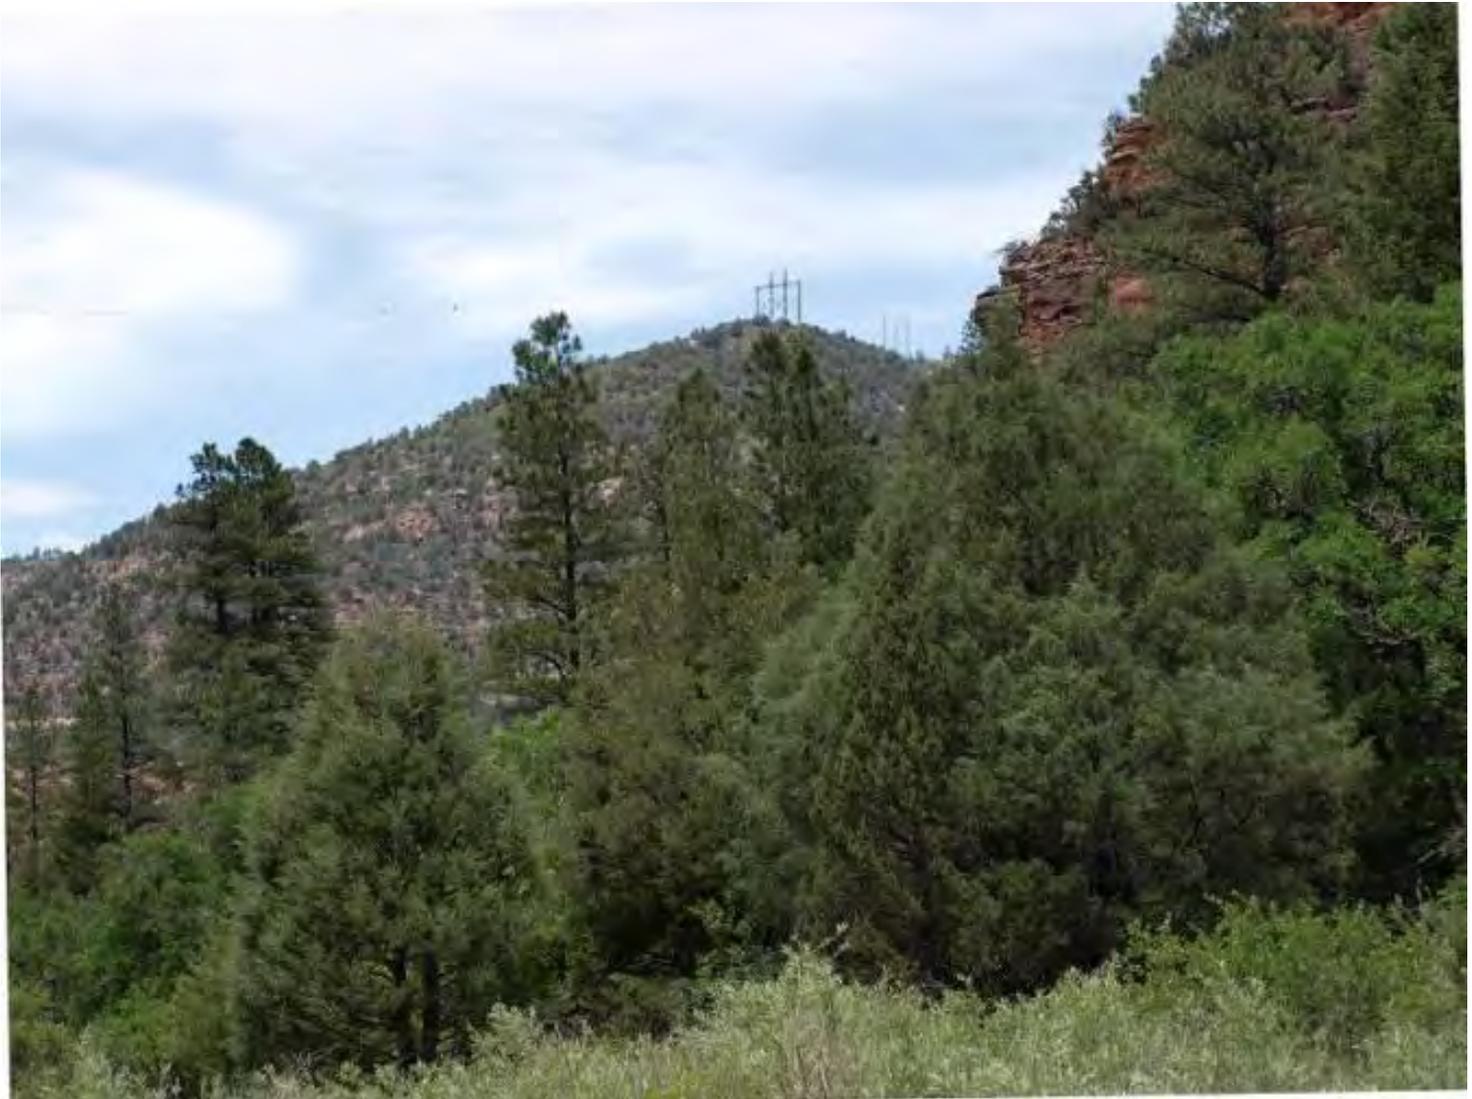
Photo 10c. KOP10, Alternative C: Combinations that include the Dolores River Crossing Routing Option (upgrade-in-place)

Note: Structure type would resemble the type shown in Photo 2a simulation

Alternative C: Combinations that include Dolores River Crossing Routing Option (upgrade-in-place) (Photo 10c) – The existing structure would move farther away from the canyon rim, and therefore be less visible. However, the taller structures near, but not on, the canyon rim with more structural members would create more contrast with the background of sky. Therefore, effects to visual resources would be low.

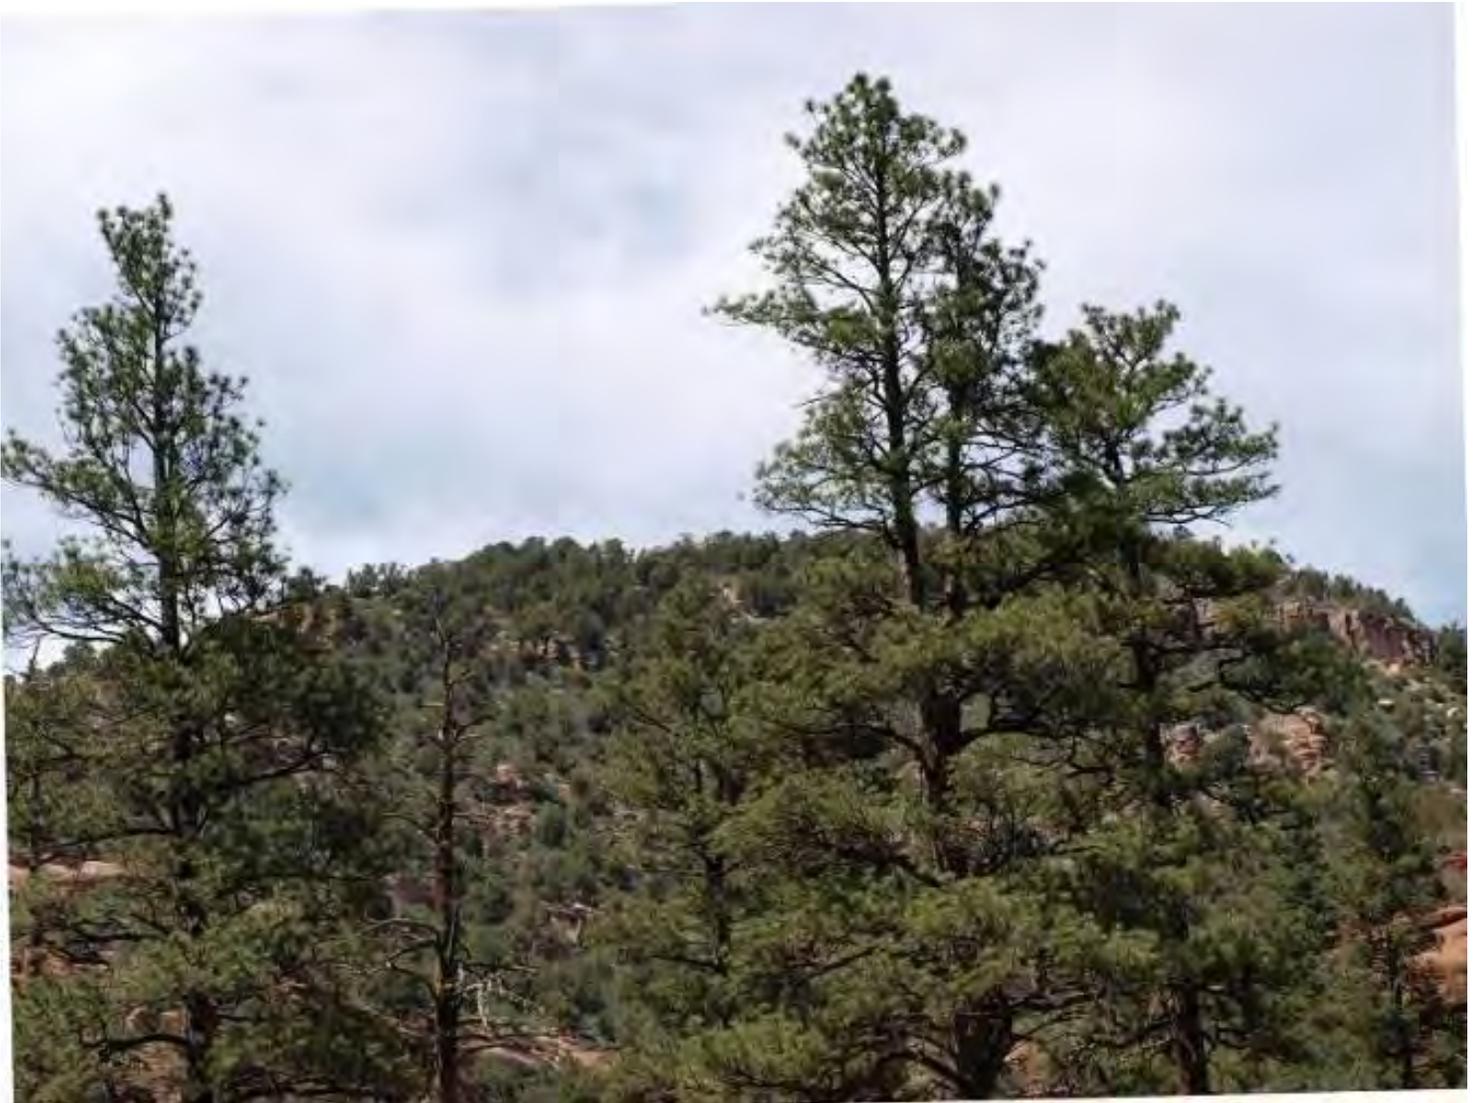
Photo 11a. KOP11, Alternatives A and C- Dolores River Crossing Realignment Option

Alternative A: Proposed Action and Alternative C- Dolores River Crossing Realignment Option (Photo 11a) – The proposed transmission line would be approximately 1.0 mile farther north of the existing transmission line location, but would remain visible from KOP 11. Therefore, contrasts of the existing

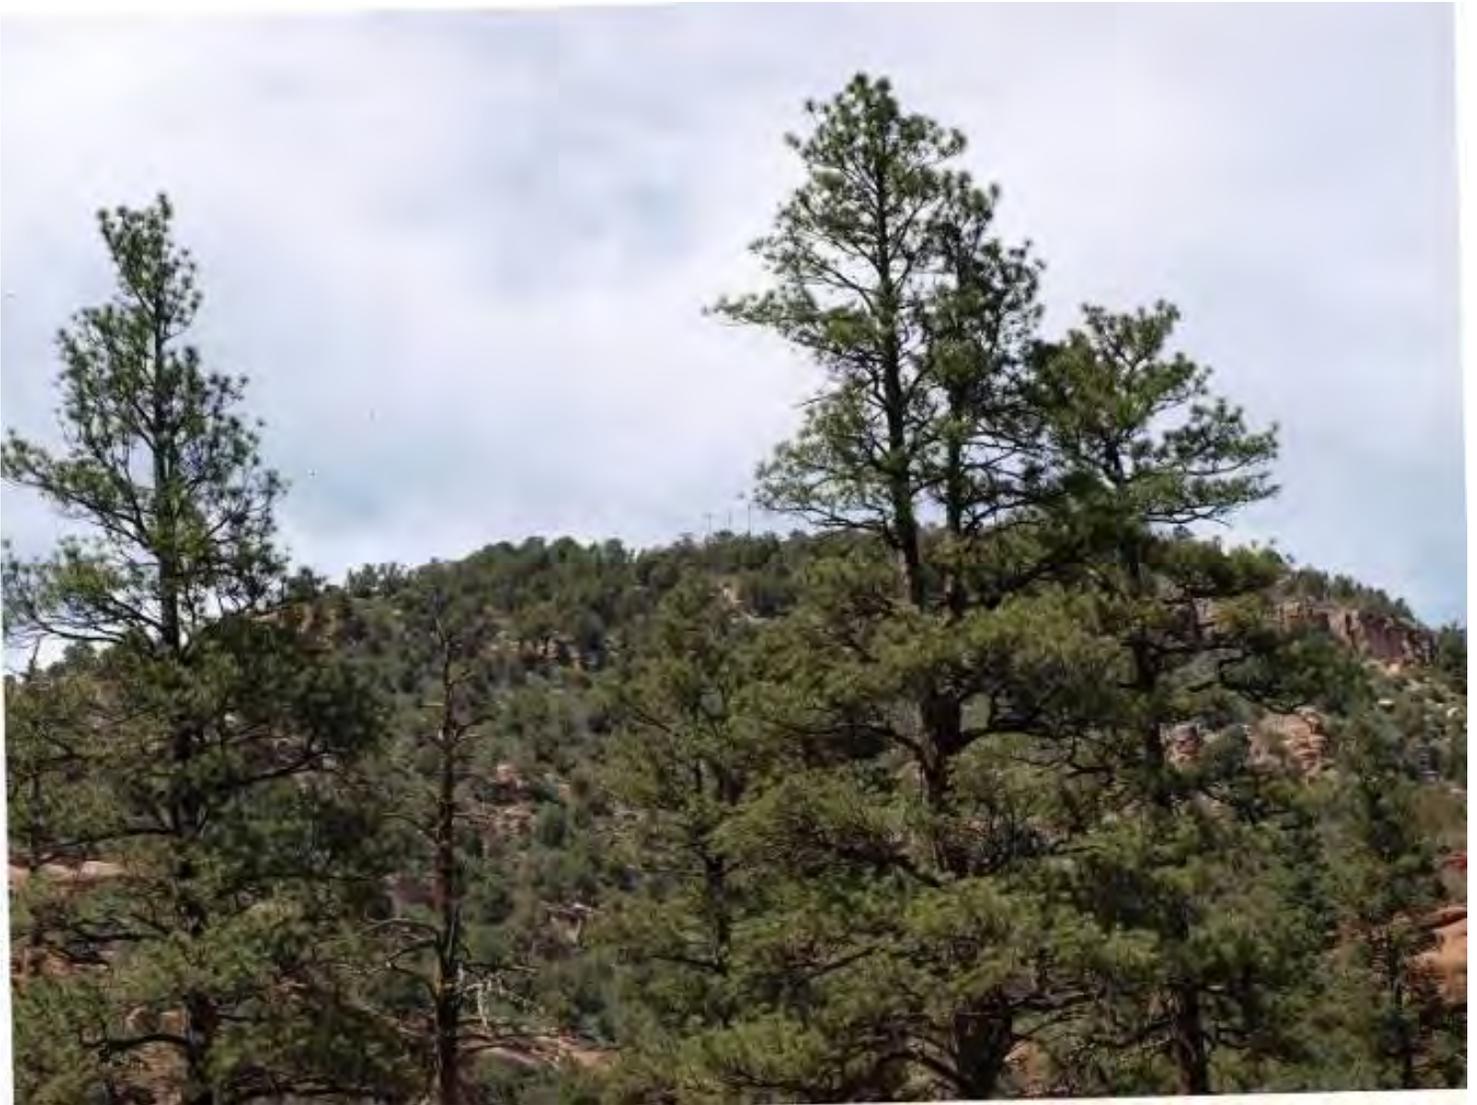
Photo 11b. KOP11, Alternative B

Alternative B: No Action (Photo 11b) – Because the existing transmission line would remain unchanged, there would be no effect to visual resources.

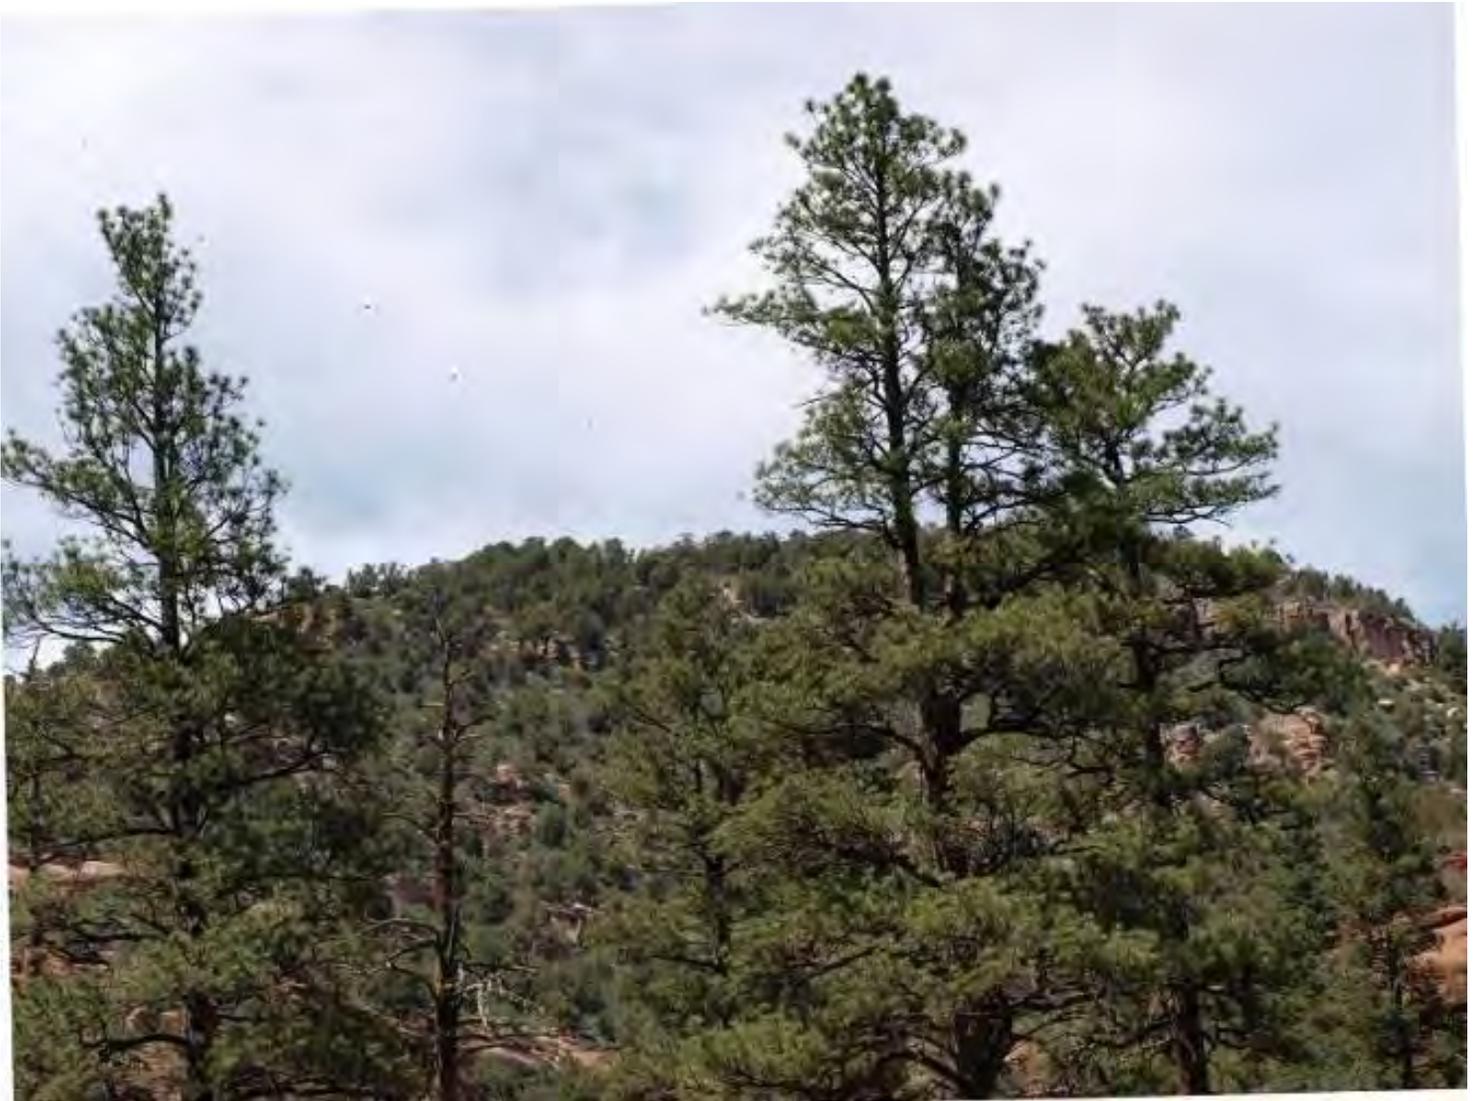
Photo 11c. KOP11, Alternative C: Combinations that include Dolores River Crossing Routing Option (Upgrade-in-Place)

Alternative C: Combinations that include Dolores River Crossing Routing Option (Upgrade in Place) (Photo 11c) – Because the proposed structure would be located farther from the canyon rim, it would not be visible in the photo simulation frame due to the screening effects of topography. The conductors would remain visible. Therefore, contrasts of the existing structure with the surrounding landscape and sky would be removed from the existing view within the photo simulation frame. There would be fewer structural elements remaining in the viewshed from this KOP with the setback of the pole structures. However, in general from the canyon bottom at this location, the structure would be more visible. Effects are offset by the fact that the existing structures and crossing are used as a frame of reference for river users, and the transmission line is an expected component of the landscape.

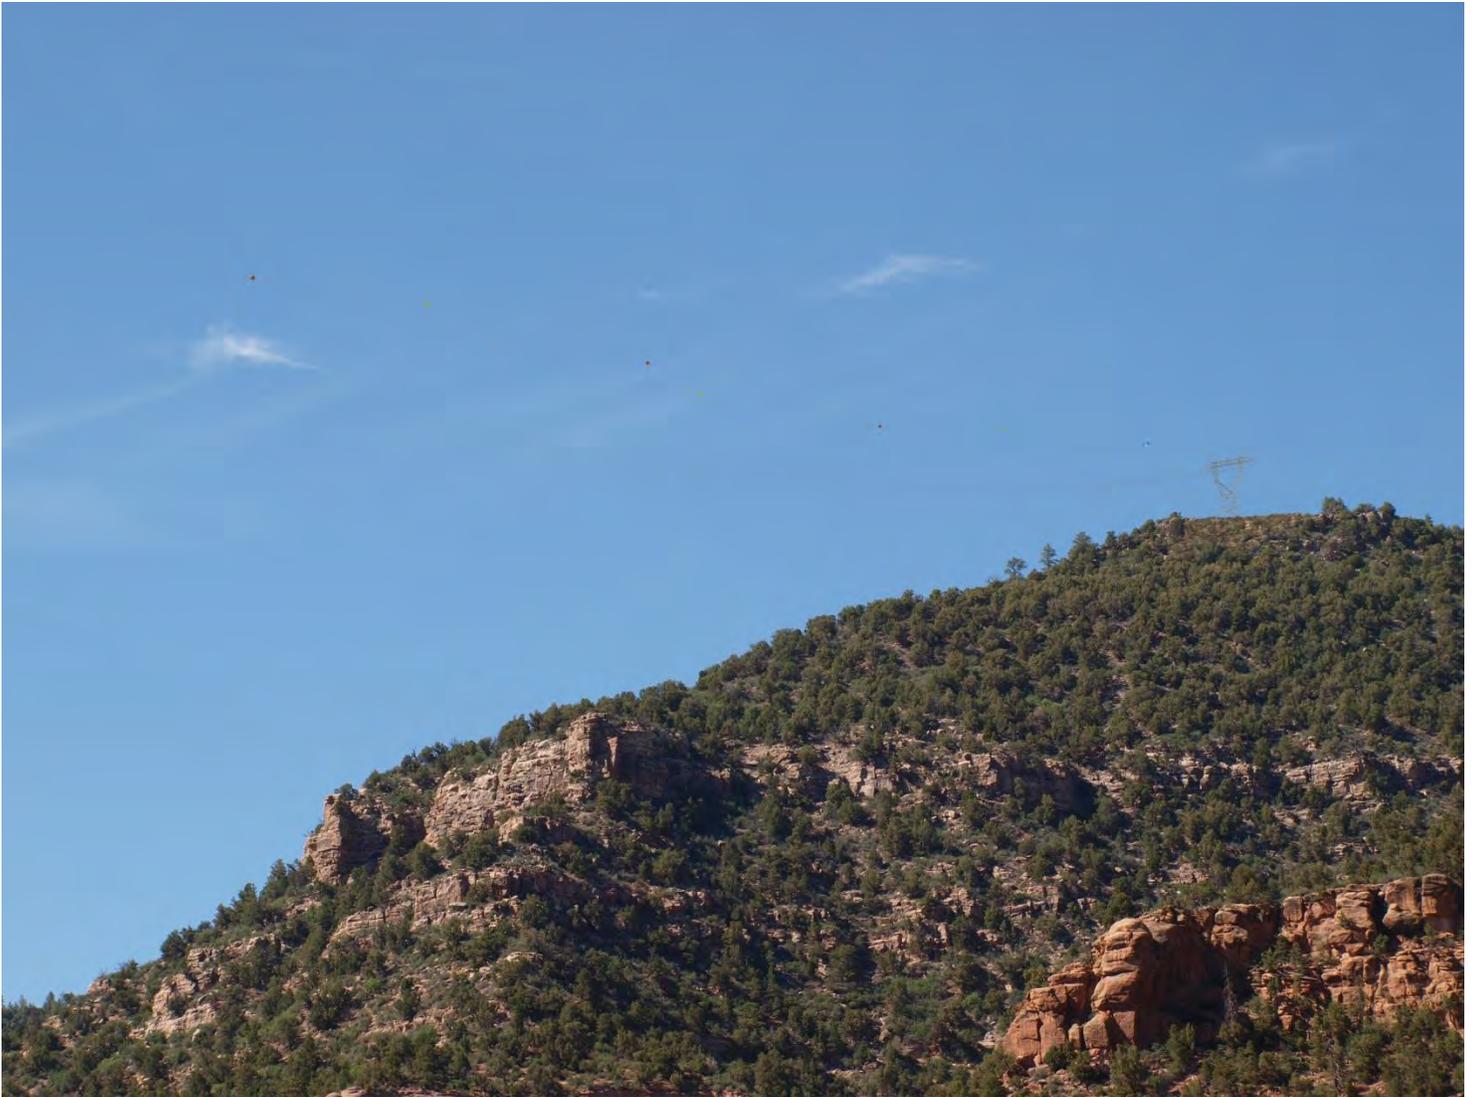
**Photo 12a. KOP12, Alternatives A and C- Dolores River Crossing Realignment Option
(View of the North Rim)**

Alternative A: Proposed Action and Alternative C- Dolores River Crossing Realignment Option (Photos 12a and 12c) – Impacts to visual resources, would vary dependent upon the direction of the view. In views to the east and west, effects to

visual resources would be low, because the crossing would be north of the KOP, and therefore not visible in any other direction. There would be a high level of visual contrast in views to the north compared to existing conditions because the north rim structure and most of the conductors would be highly visible without obstruction (Photo 12a). Also, views to the north, above the canyon bottom, would include views of the south rim structure and conductors peripherally. Views to the south would become more naturalized because the existing structure would be removed and the area reclaimed (Photo 12c). Effects would be offset by removal of the existing structure upstream; effects would effectively move from one location to another. Tri-State would provide revised mapping and brochures for river users due to the change in transmission line location, because the existing structures and crossing are used as a frame of reference for river users. The existing transmission line is an expected component of the landscape.

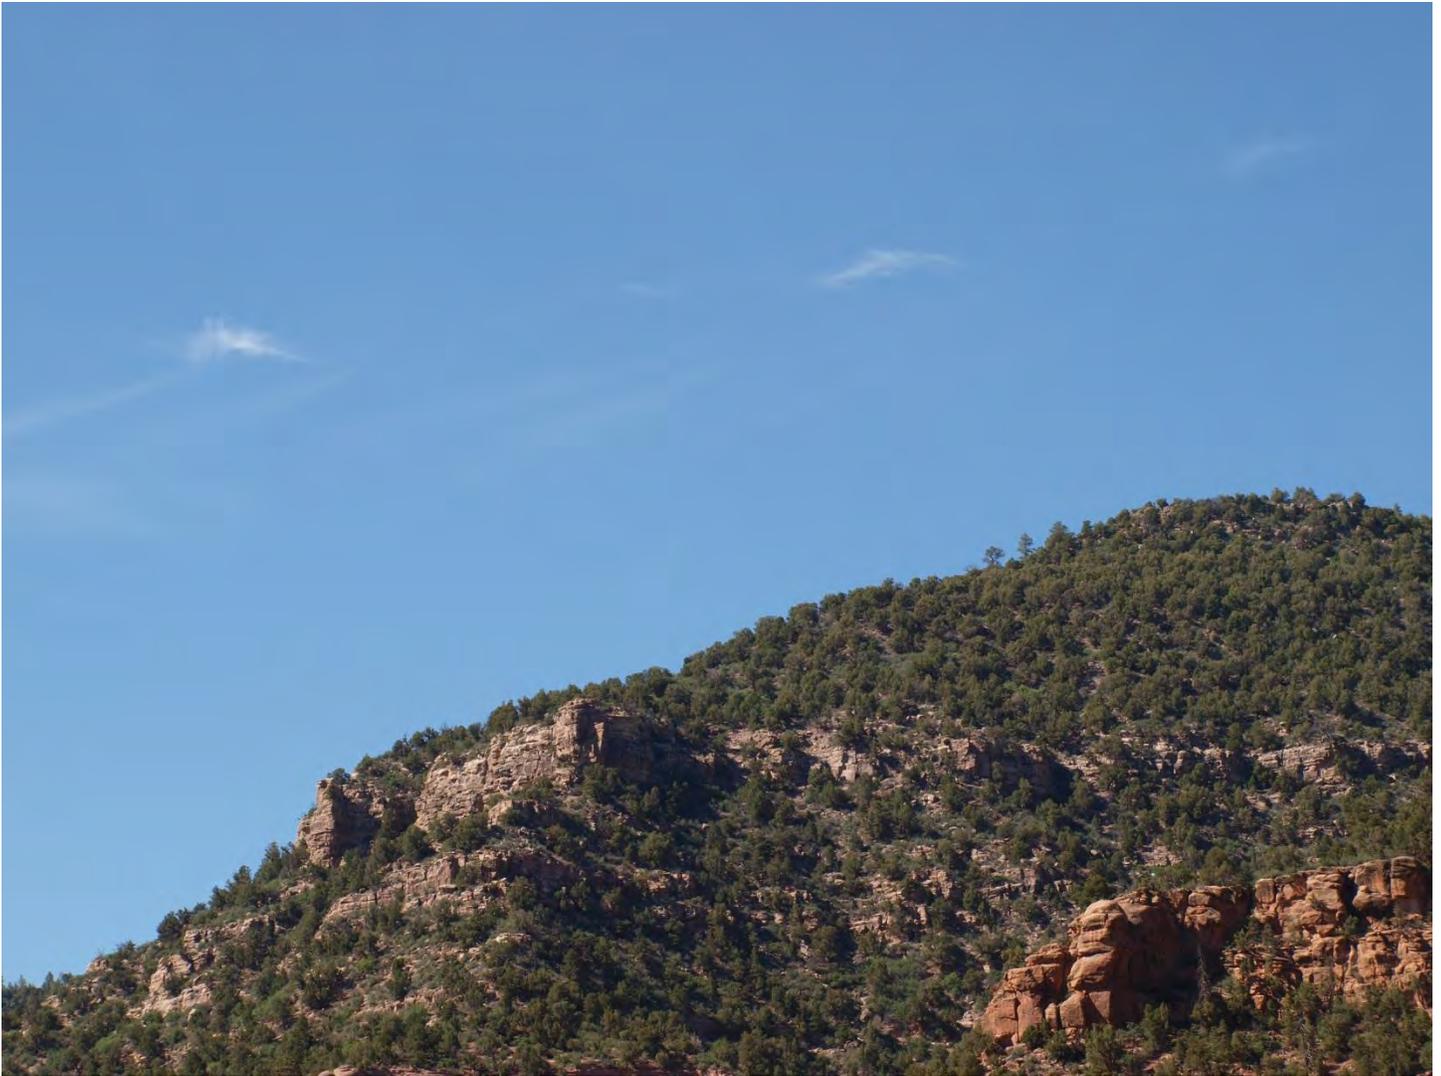
Photo 12b. KOP12, Alternative B and Alternative C: Combinations that include Dolores River Crossing Routing Option (Upgrade-in-Place) (View of the North Rim; the Existing Transmission Line is Behind the Viewer)

Alternative B: No Action (Photo 12b and 12d): Because the existing transmission line would remain unchanged, impacts to visual resources would be the same.

Alternative C: Combinations that include the Dolores River Crossing Routing Option (upgrade-in-place) (Photos 12b and 12e) Impacts to visual resources would be the same as in Alternative B in views to the north; there would be no visible structures. Views to the south (Photo 12e) indicate a larger structure moderate change in visibility. The structure is set back from the canyon rim slightly from the existing position. Effects are offset by the fact that the existing structures and crossing are used as a frame of reference for river users, and the transmission line is an expected component of the landscape.

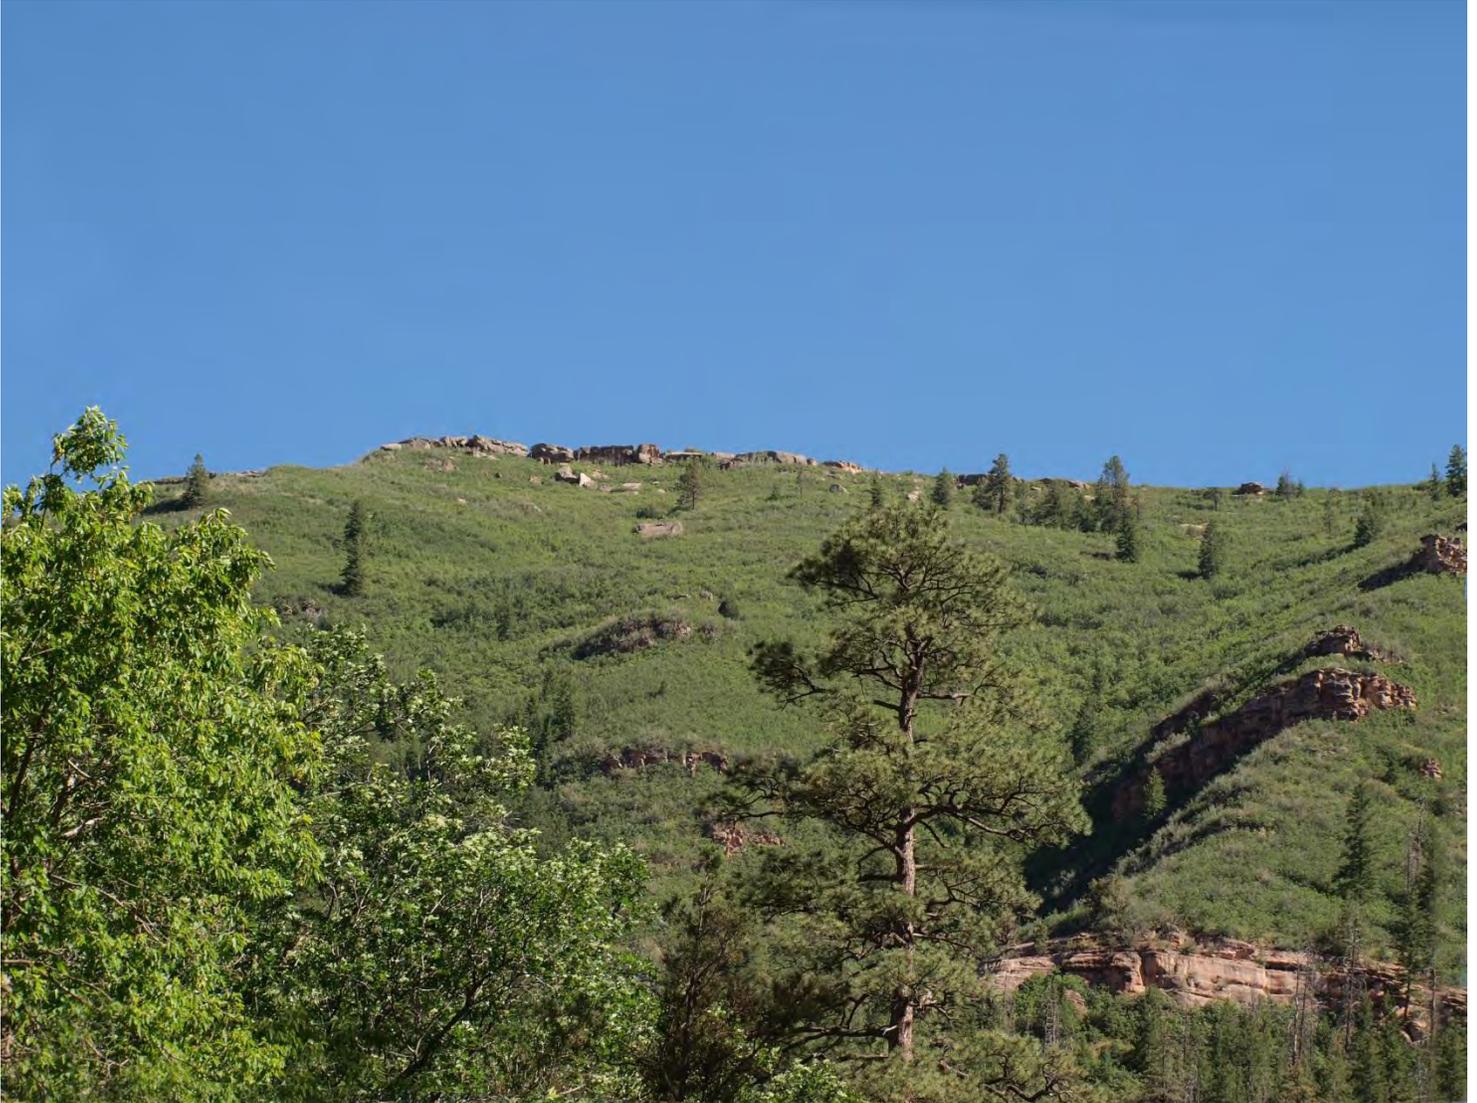
Photo 12c. KOP12, Alternatives A and C- Dolores River Crossing Realignment Option (View South)

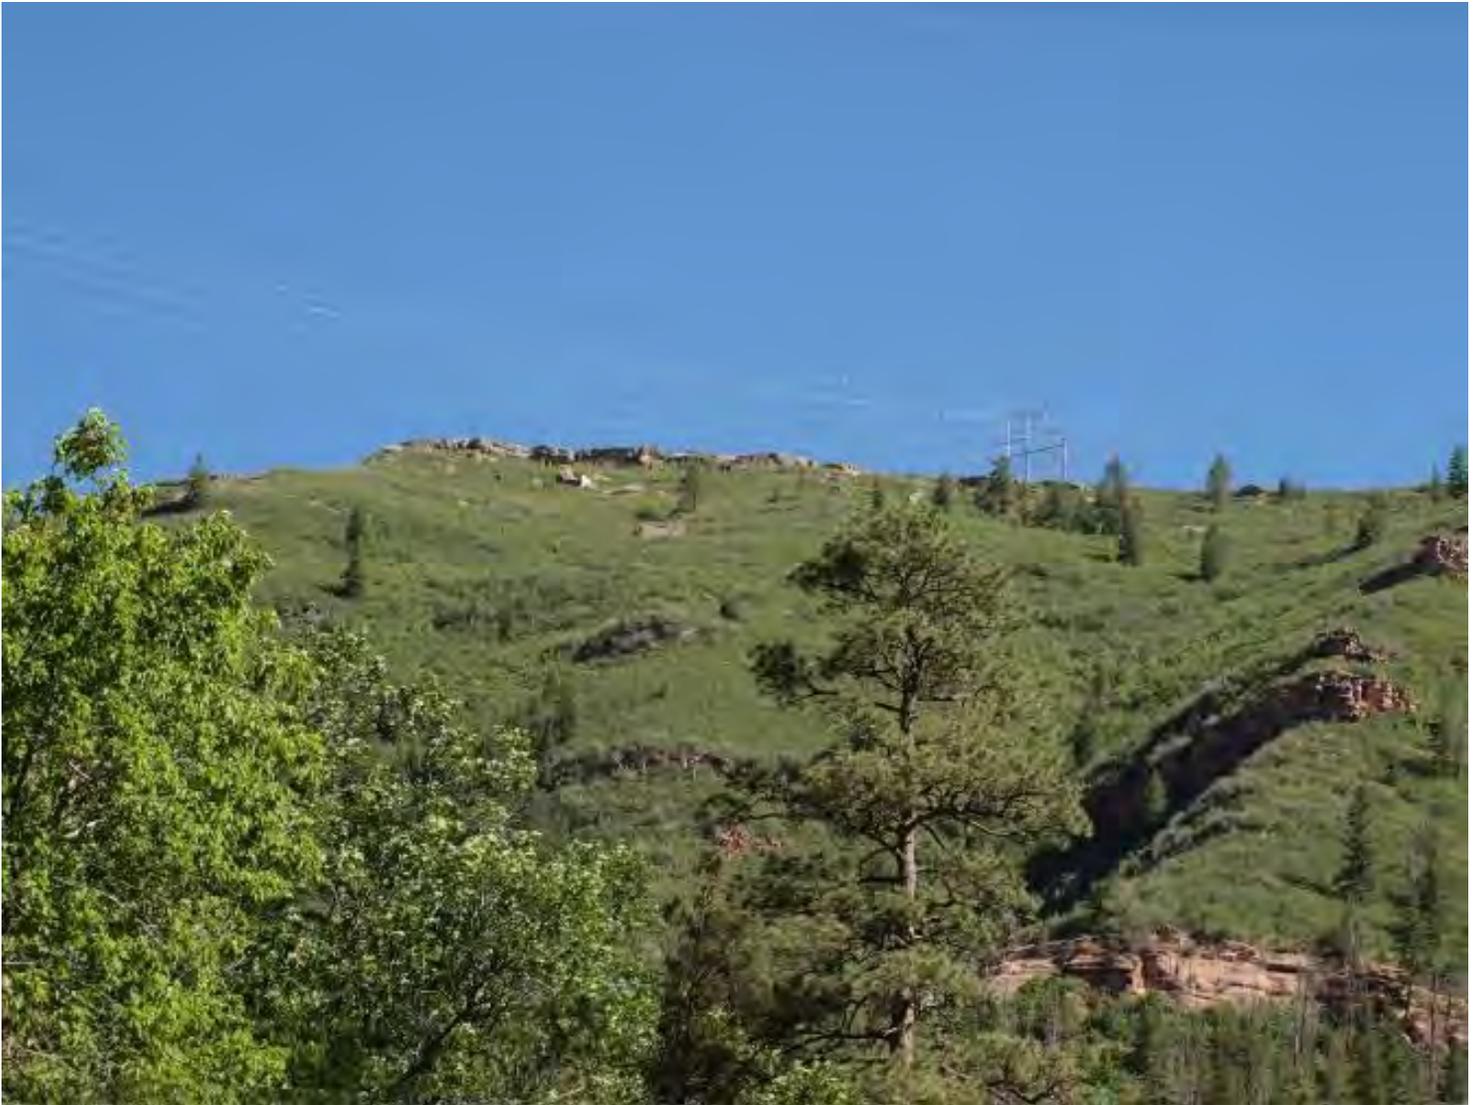
Photo 12d. KOP12, Alternative B (View South)
