Tri-State Montrose-Nucla-Cahone Transmission Line Improvement Project
Final Environmental Assessment
(*DOI-BLM-CO-S000-2013-0001*)

Appendix C. Draft Visual Resources Report

**VISUAL ASSESSMENT REPORT
FOR THE TRI-STATE MONTROSE-NUCLA-CAHONE
TRANSMISSION LINE IMPROVEMENT PROJECT
SOUTHWEST COLORADO**

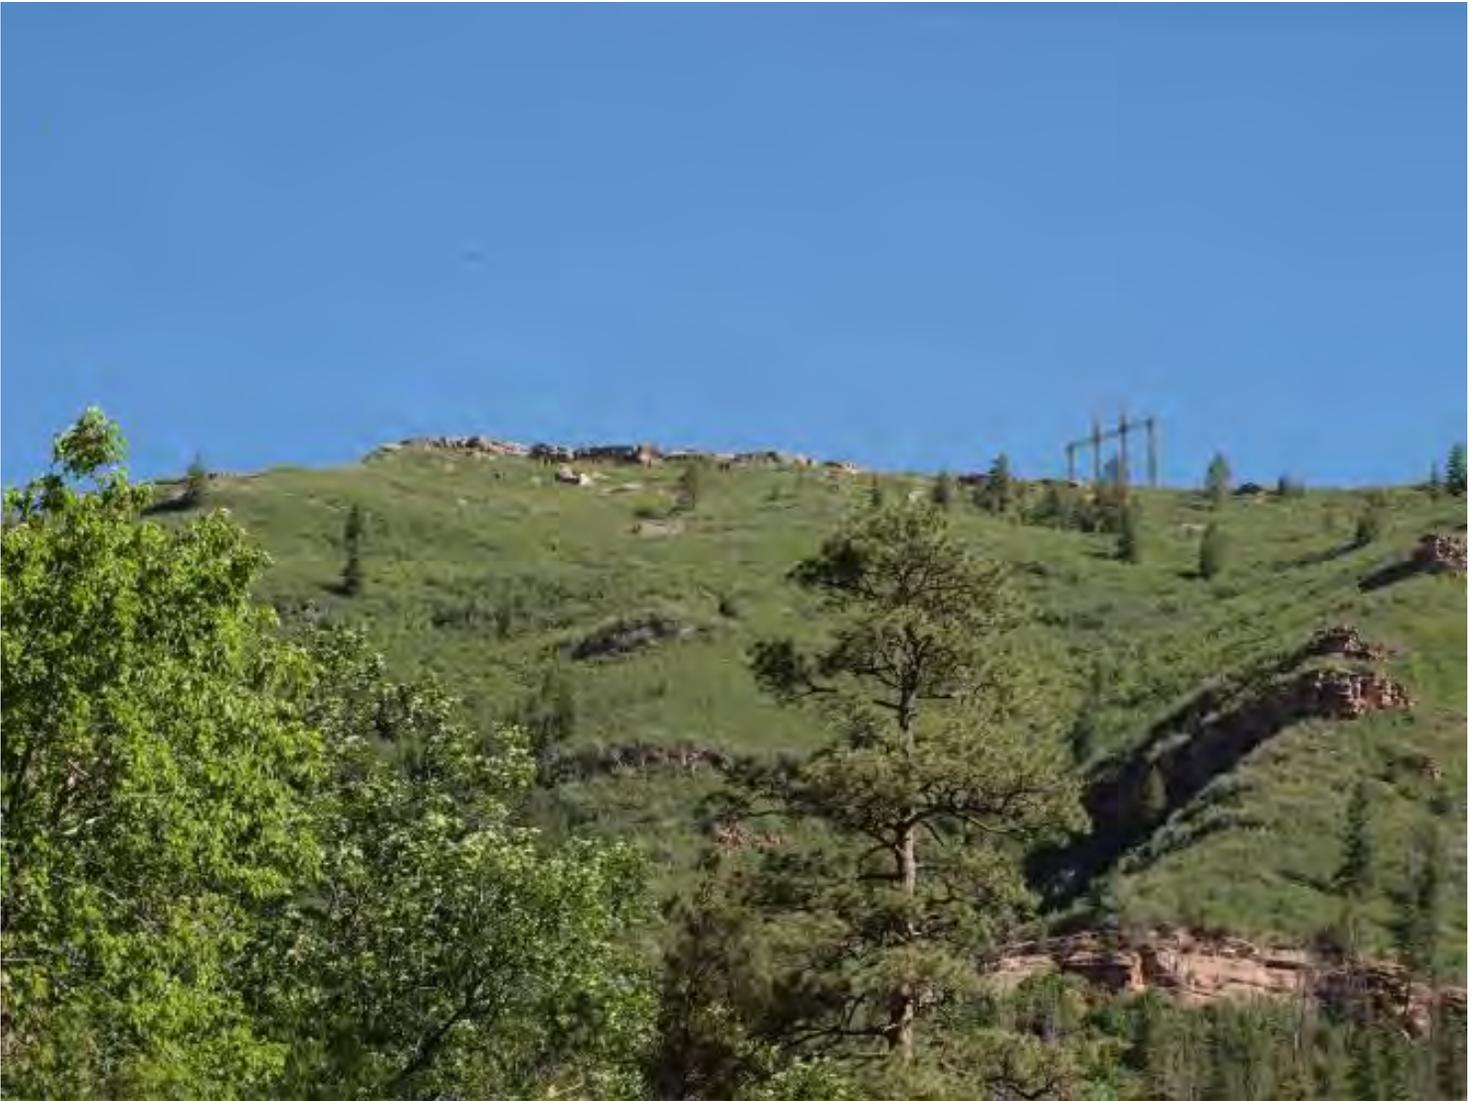
Photo 12e. KOP12, Alternative C: Combinations that include Dolores River Crossing Routing Option (Upgrade-in-Place) (View South)

Note: Structure type would resemble the type shown in Photo 12a simulation

Alternative C: Combinations that include the Dolores River Crossing Routing Option (upgrade-in-place) (Photos 12b and 12e) Impacts to visual resources would be the same as in Alternative B in views to the north; there would be no visible structures. Views to the south (Photo 12e) indicate a larger structure moderate change in visibility. The structure is set back from the canyon rim slightly from the existing position. Effects are offset by the fact that the existing structures and crossing are used as a frame of reference for river users, and the transmission line is an expected component of the landscape.

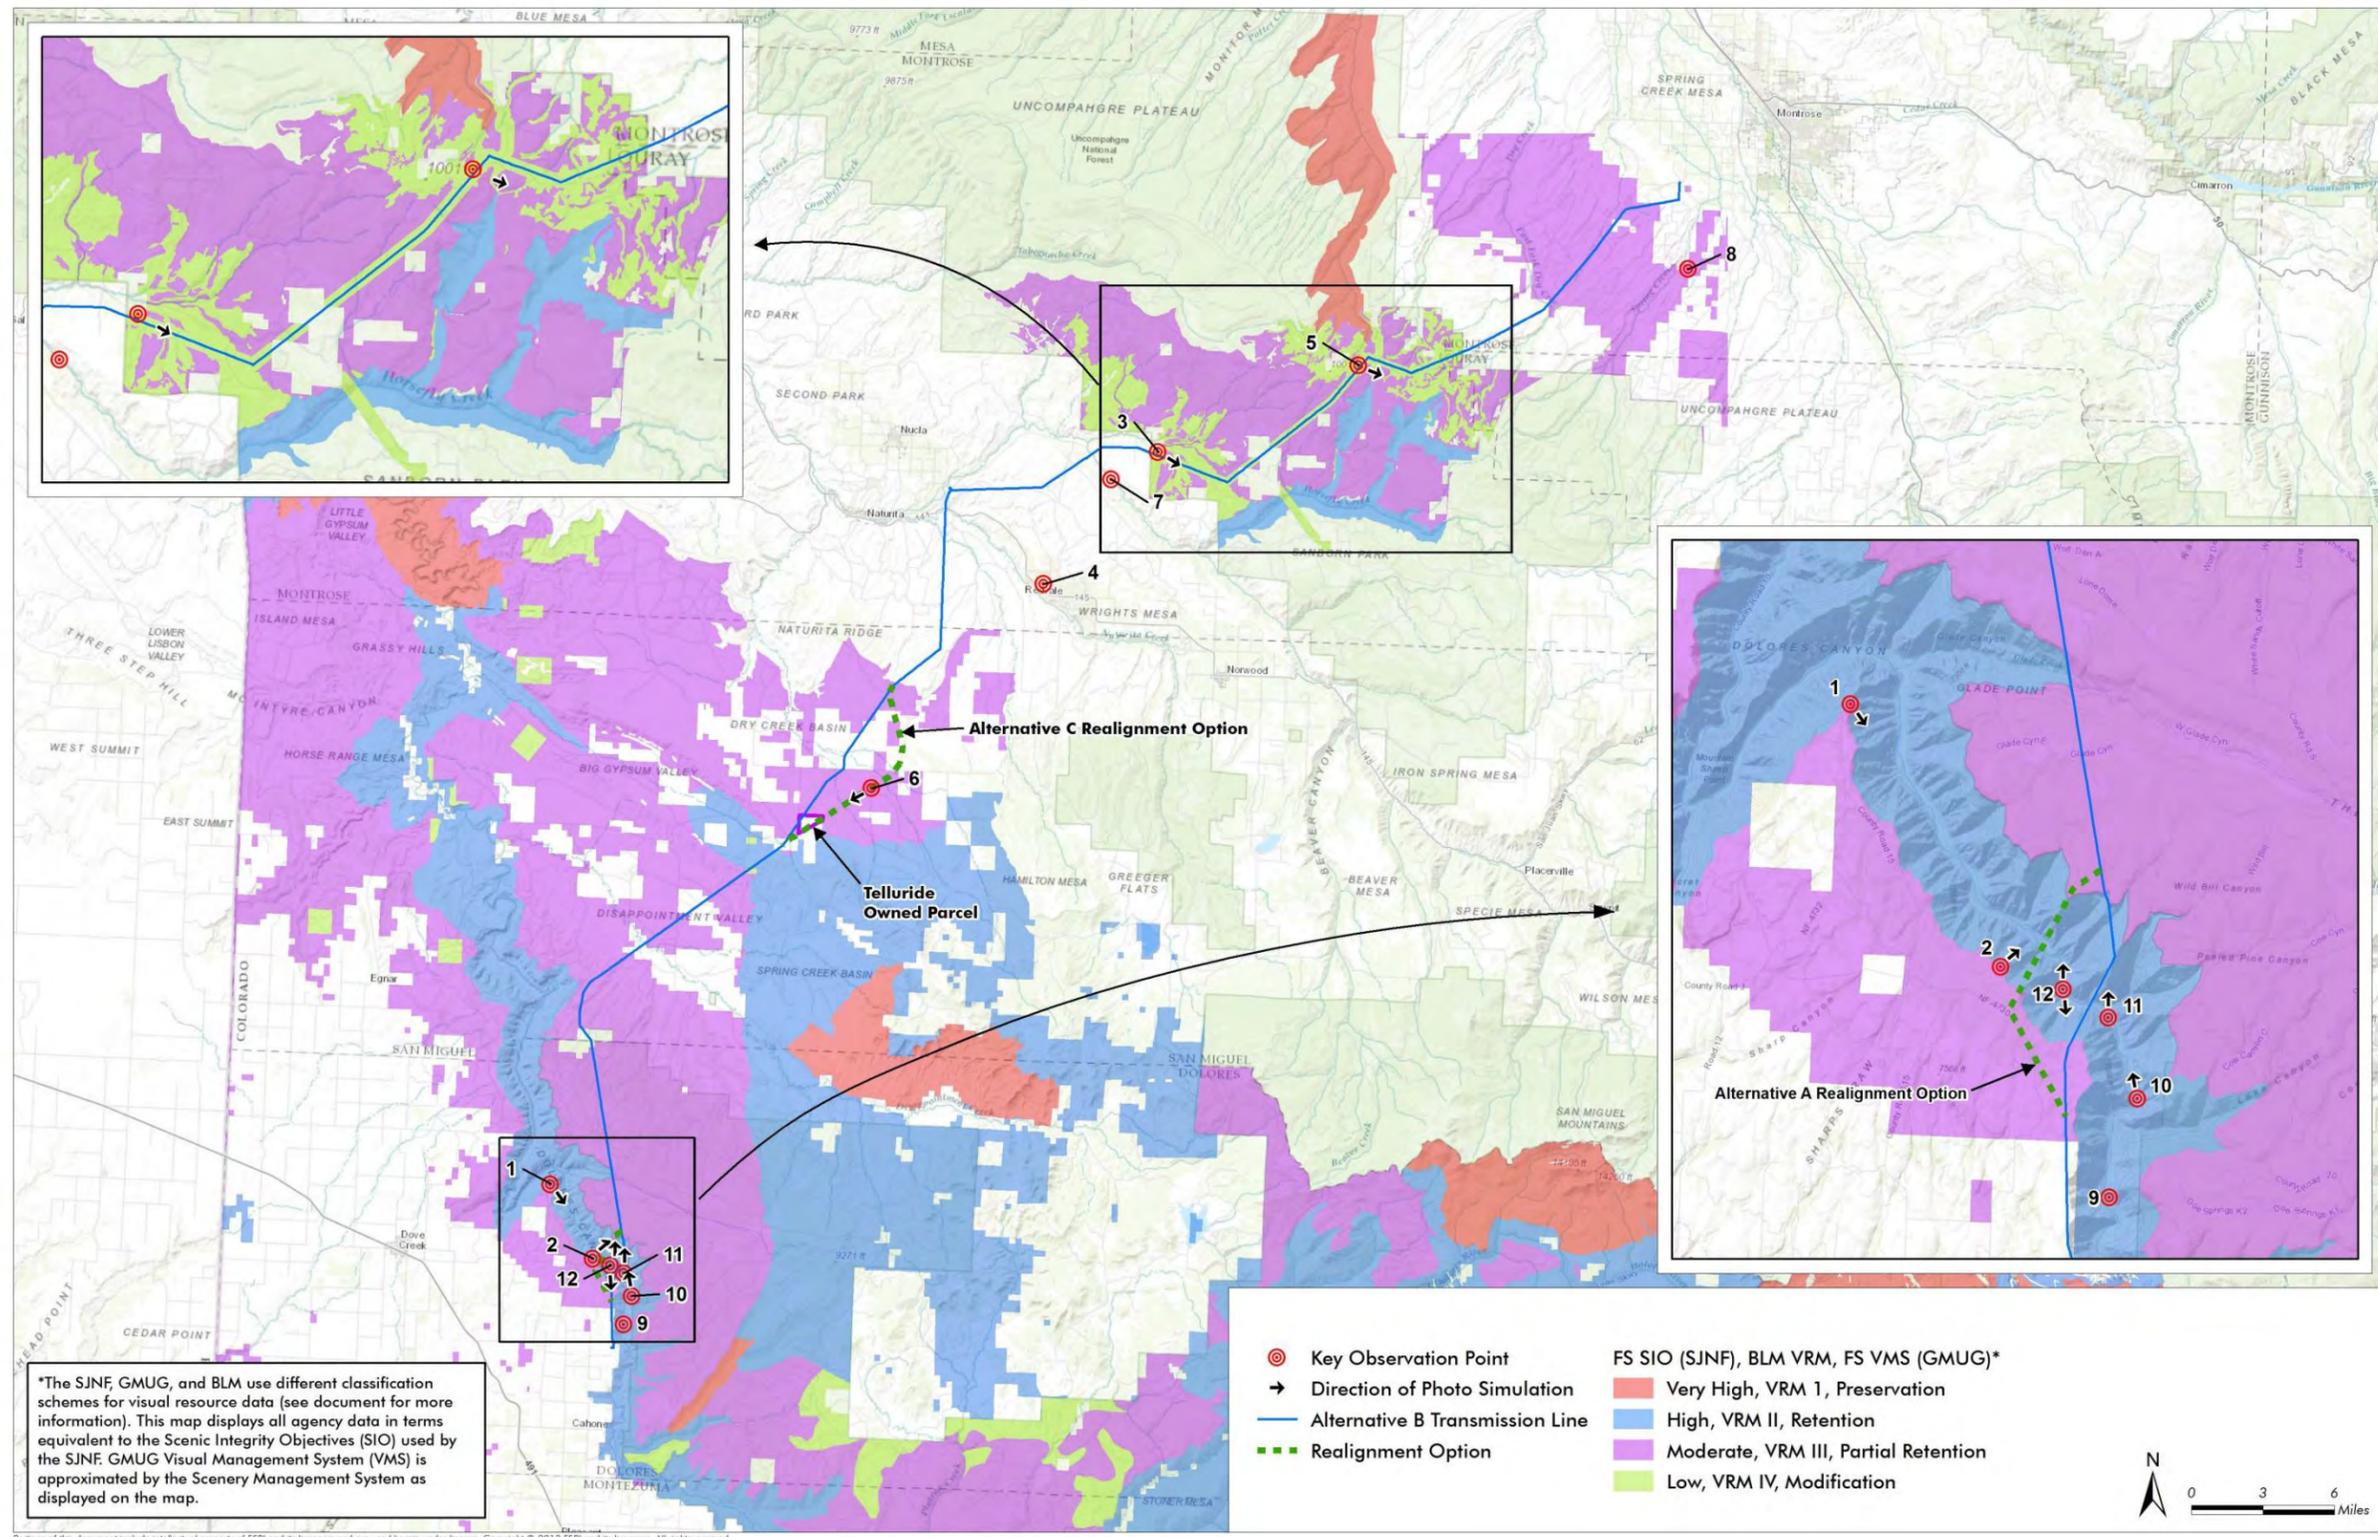
FIGURE 2. KEY OBSERVATION POINTS, DIRECTION OF PHOTO SIMULATION, AND VISUAL RESOURCE MANAGEMENT CLASSIFICATION

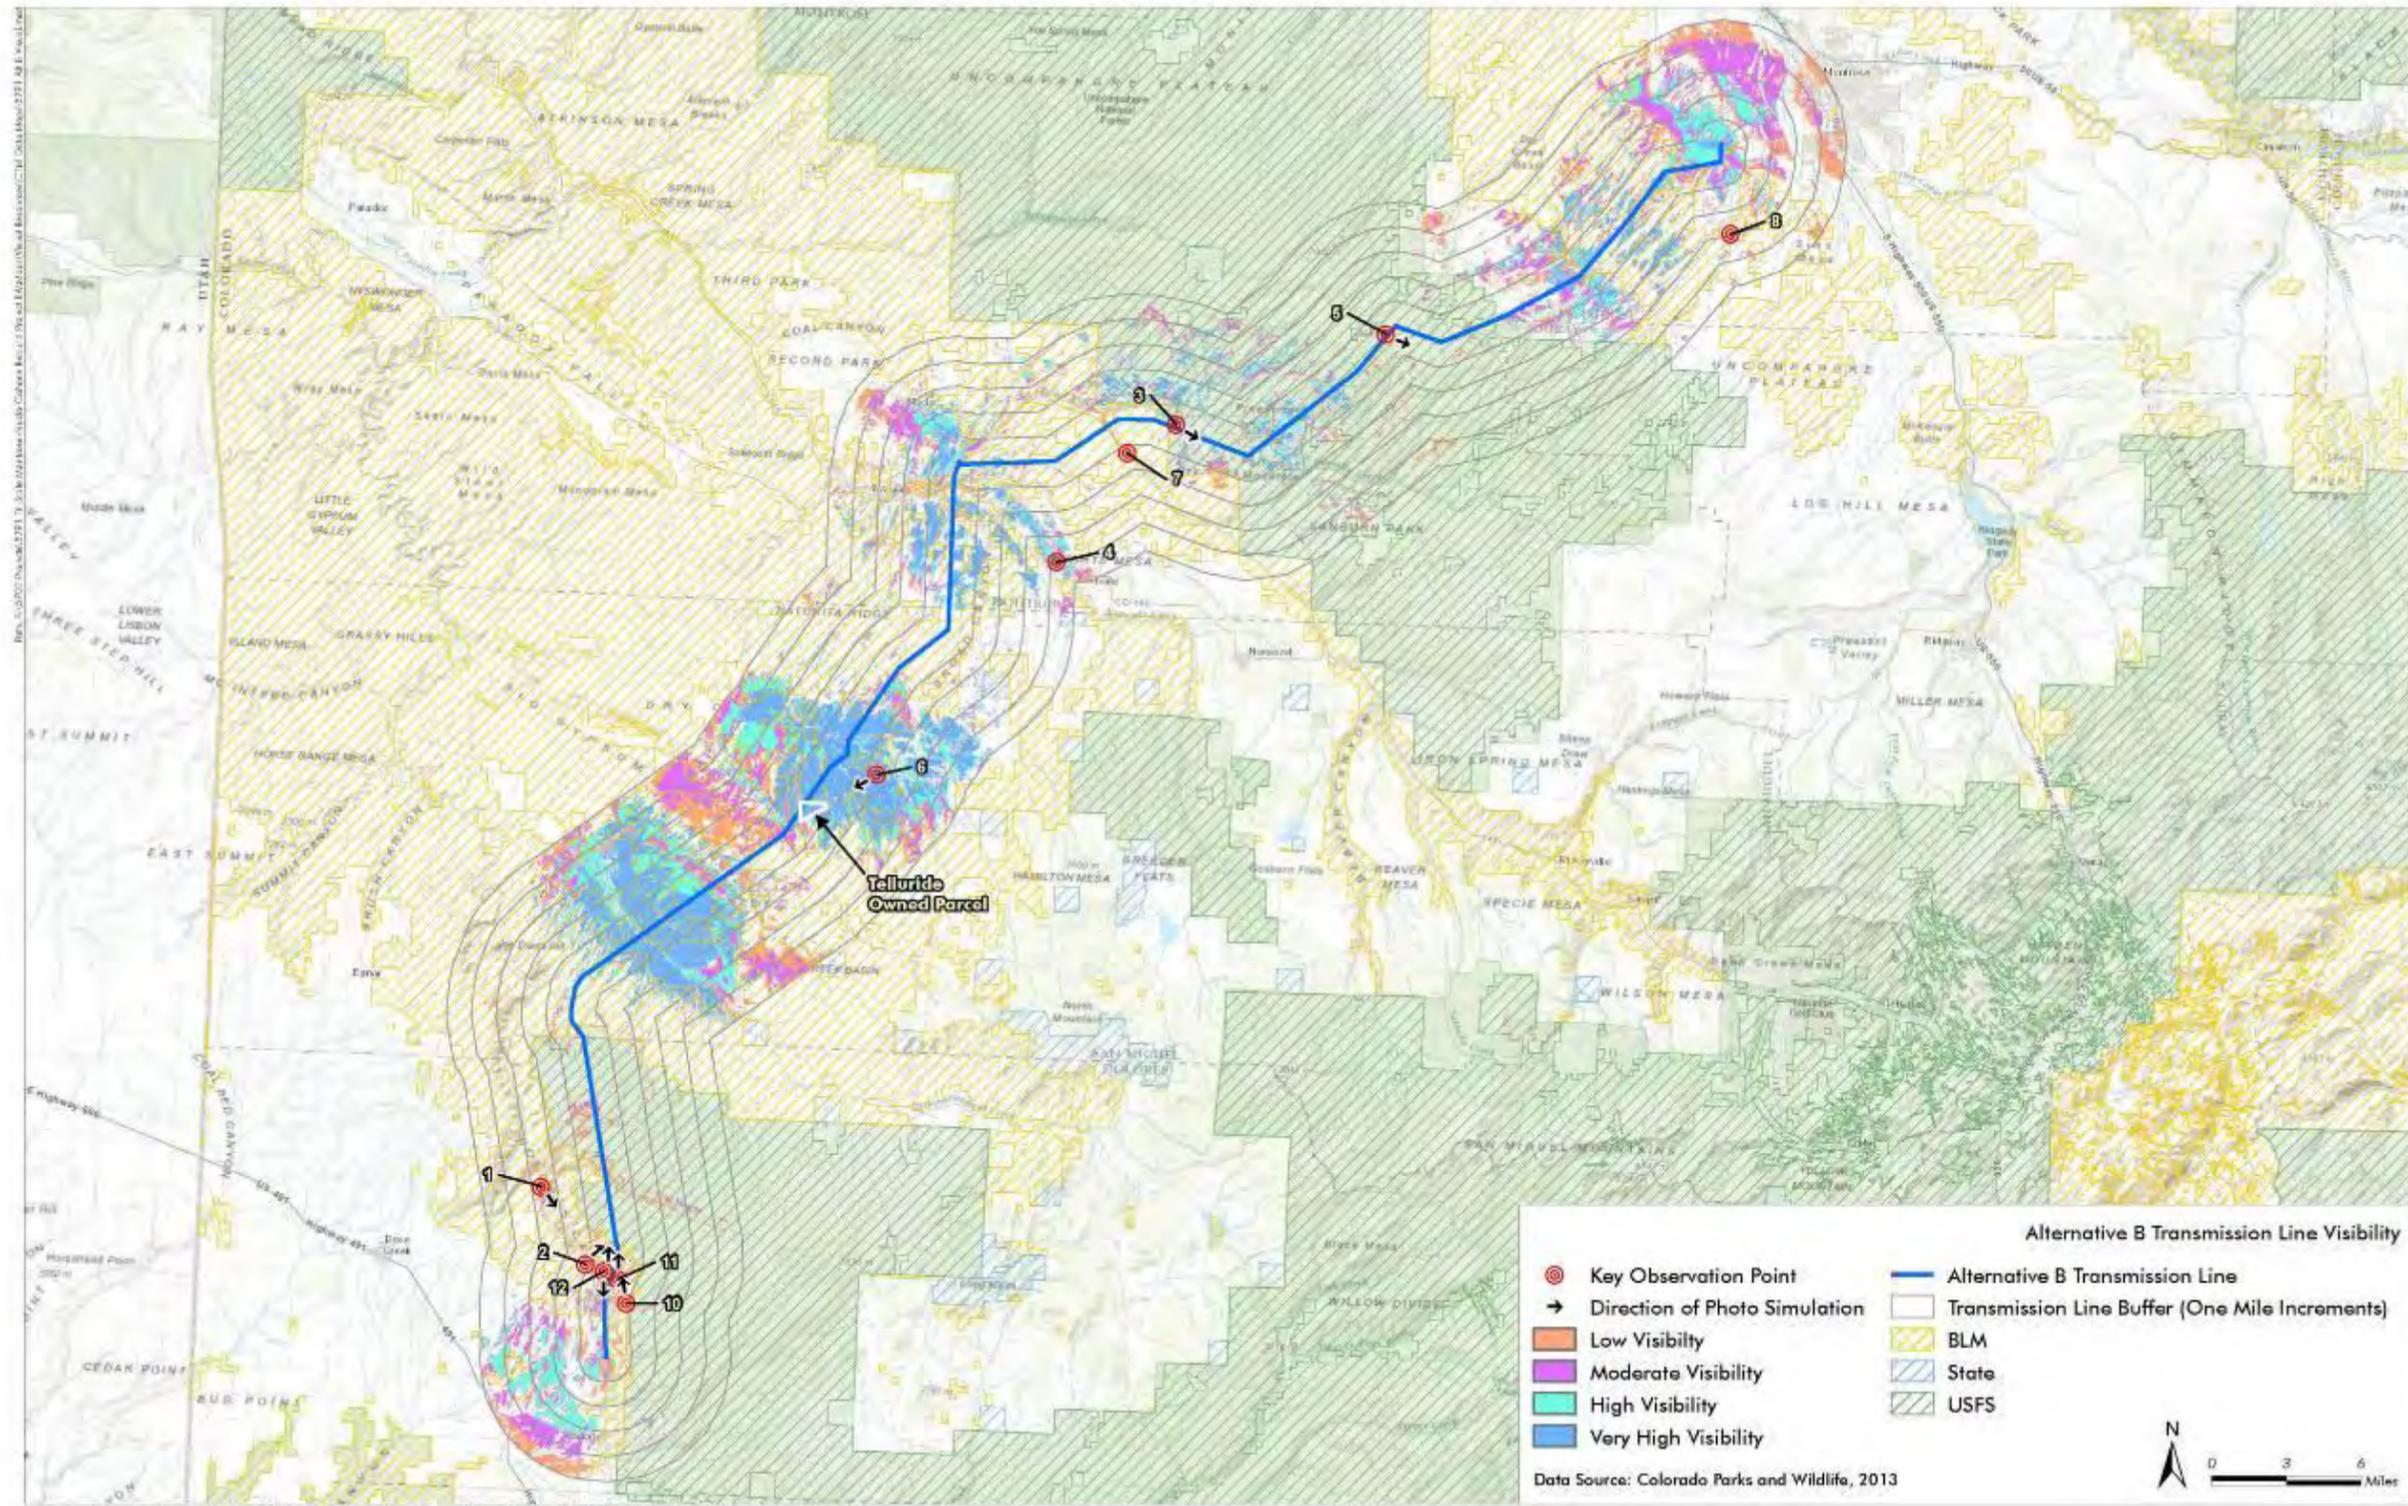
FIGURE 3. EXISTING VISIBILITY OF TRANSMISSION LINE/ALTERNATIVE - NO ACTION ALTERNATIVE

Areas with visibility of the transmission line alternatives were identified by two digital viewshed analyses. One viewshed analysis was performed from the existing transmission line (Figure 3), and the other analysis from the proposed line and alternatives (Figures 4 and 5). The digital viewshed analysis program for this project was written to use the transmission line structure tops for observation points. Therefore, the top of each connects direct lines of sight to the modified digital terrain model in all directions and at multiple elevations, within a distance of 5 miles from each structure. Tree coverage was included in the analysis by adding an average tree height to the digital terrain model. Digital polygons were created to represent the shape of the tree clearing areas required for the lines, structures, and access roads. The digital viewshed analyses were used to accurately calculate the length of each transmission line alternative visible from each KOP. The total length of

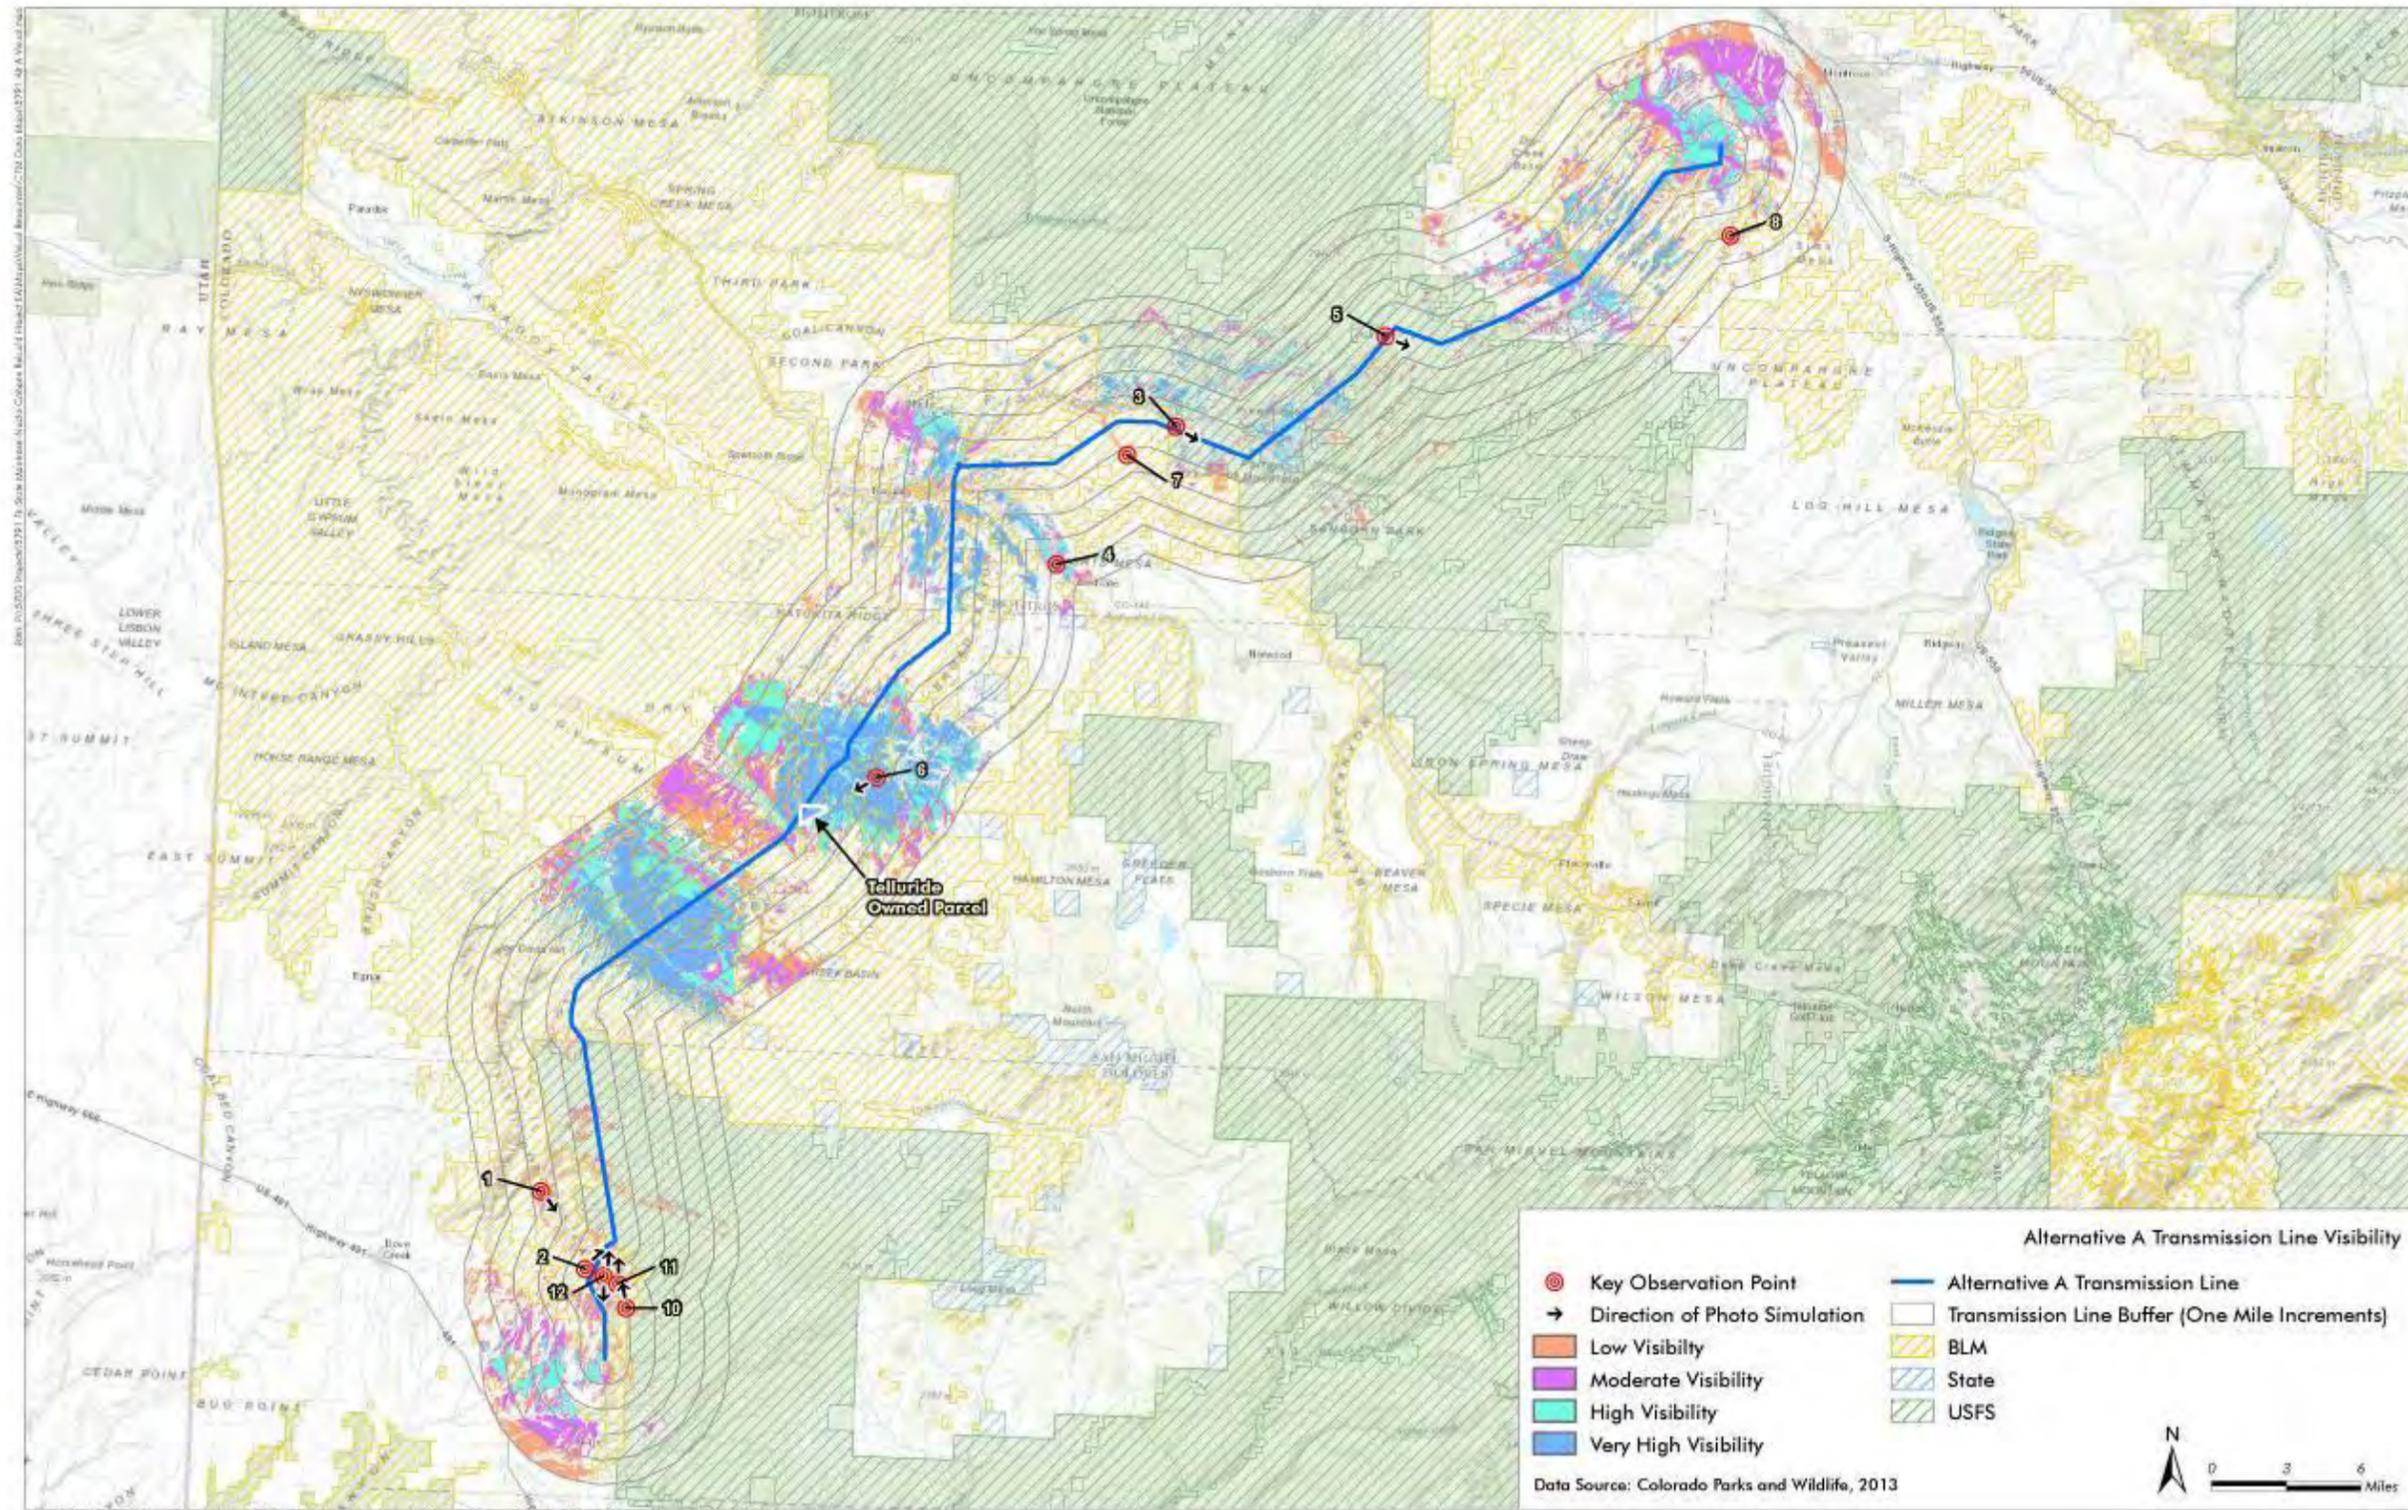
FIGURE 4. VISIBILITY OF TRANSMISSION LINE FROM ALTERNATIVE A - PROPOSED ACTION ALTERNATIVE

Figure 4. Visibility of Transmission Line from Alternative A - Proposed Action Alternative

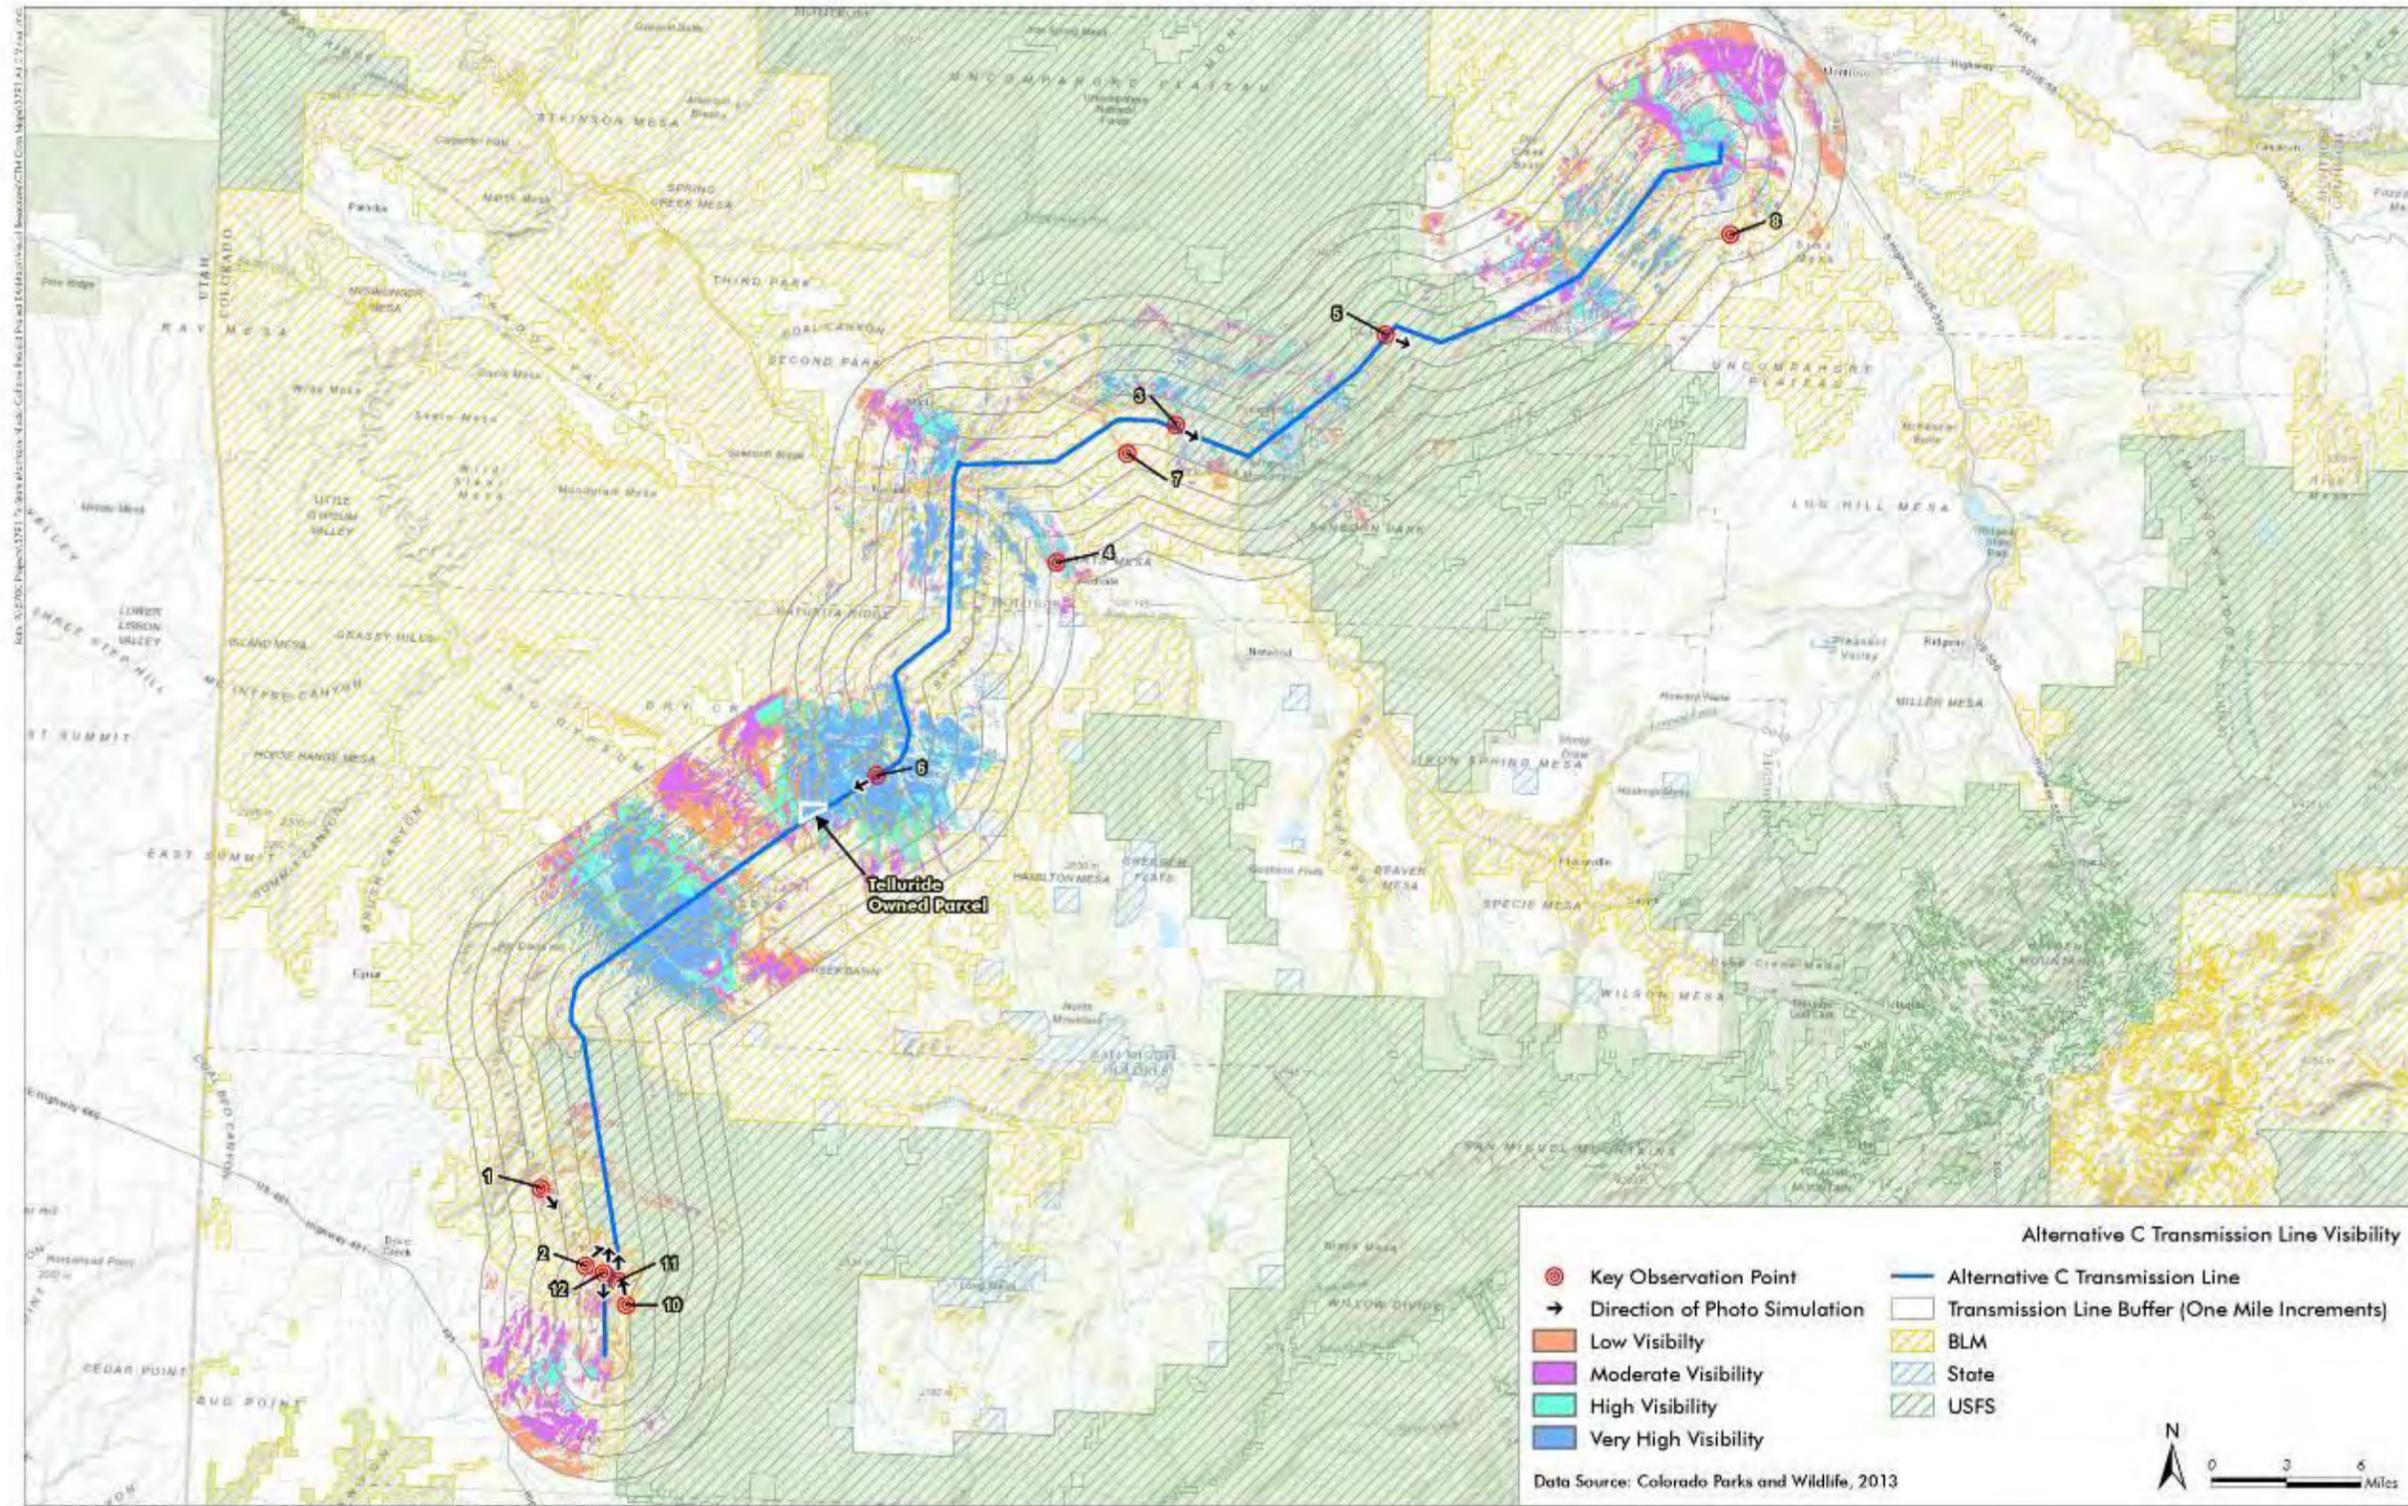
FIGURE 5. VISIBILITY OF TRANSMISSION LINE FROM ALTERNATIVE C – OTHER ACTION ALTERNATIVE

Figure 5. Visibility of Transmission Line from Alternative C – Other Action Alternative (BLM routing options)
