# Winecup-Gamble Complex Draft Land Health Assessment

June 2020

### DRAFT LAND HEALTH ASSESSMENT DOCUMENT Winecup-Gamble Complex

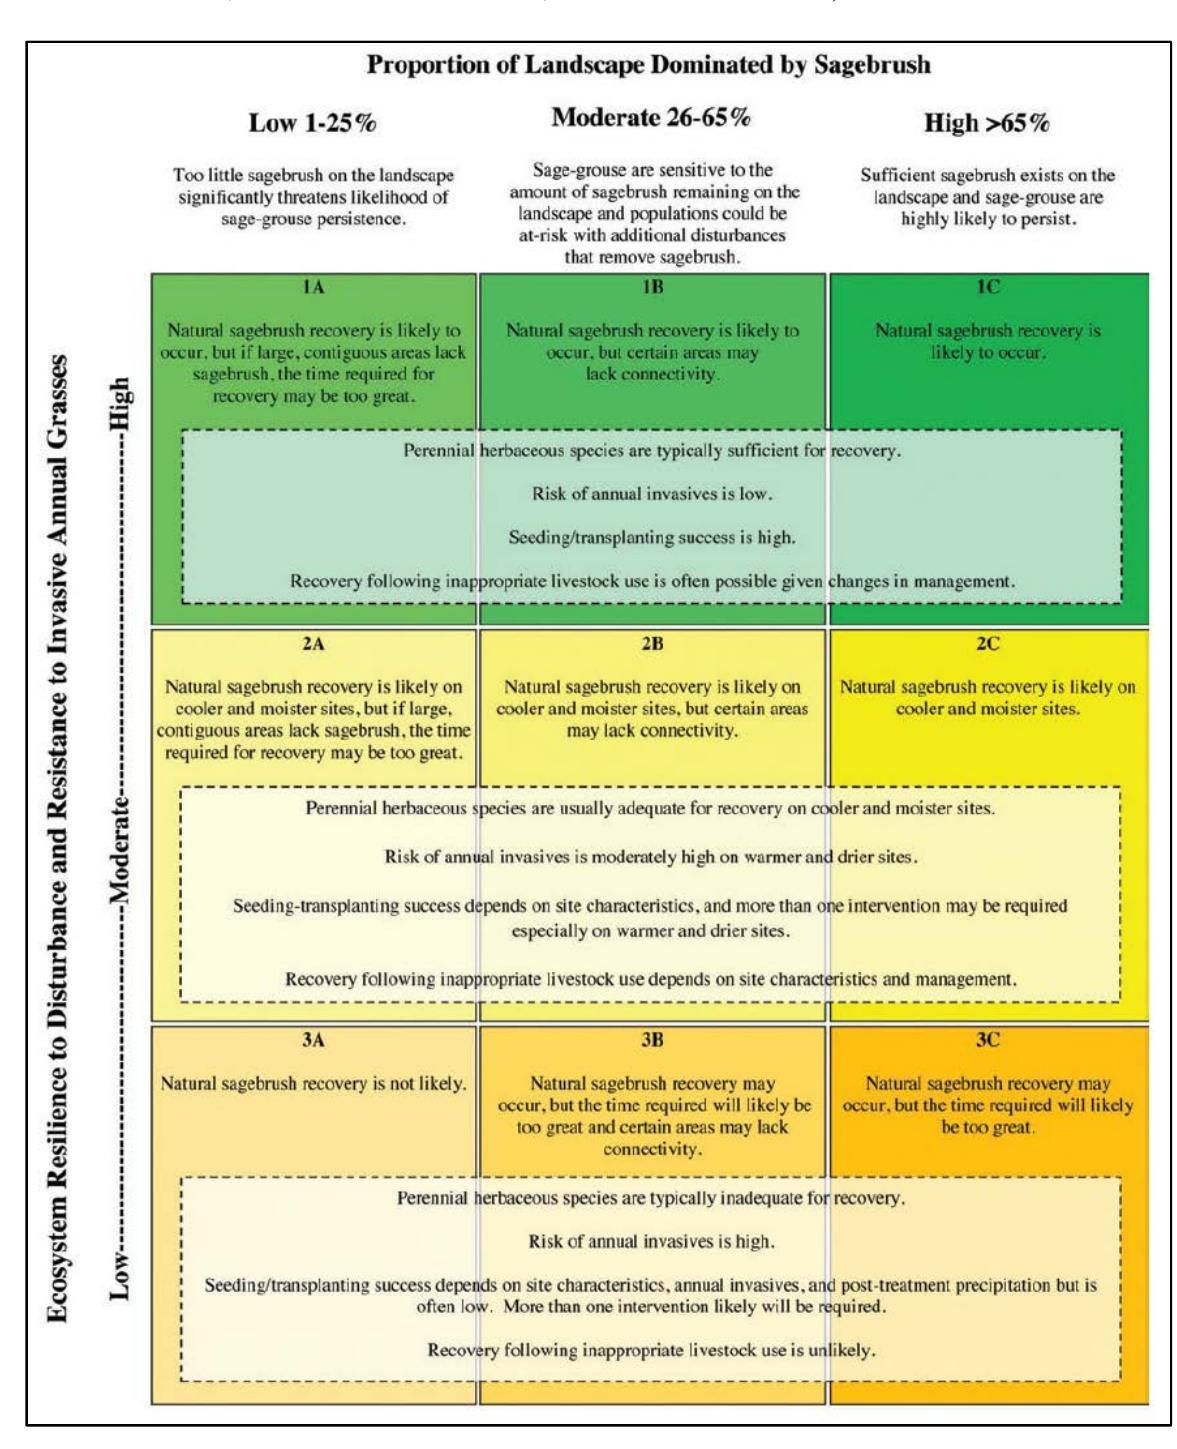
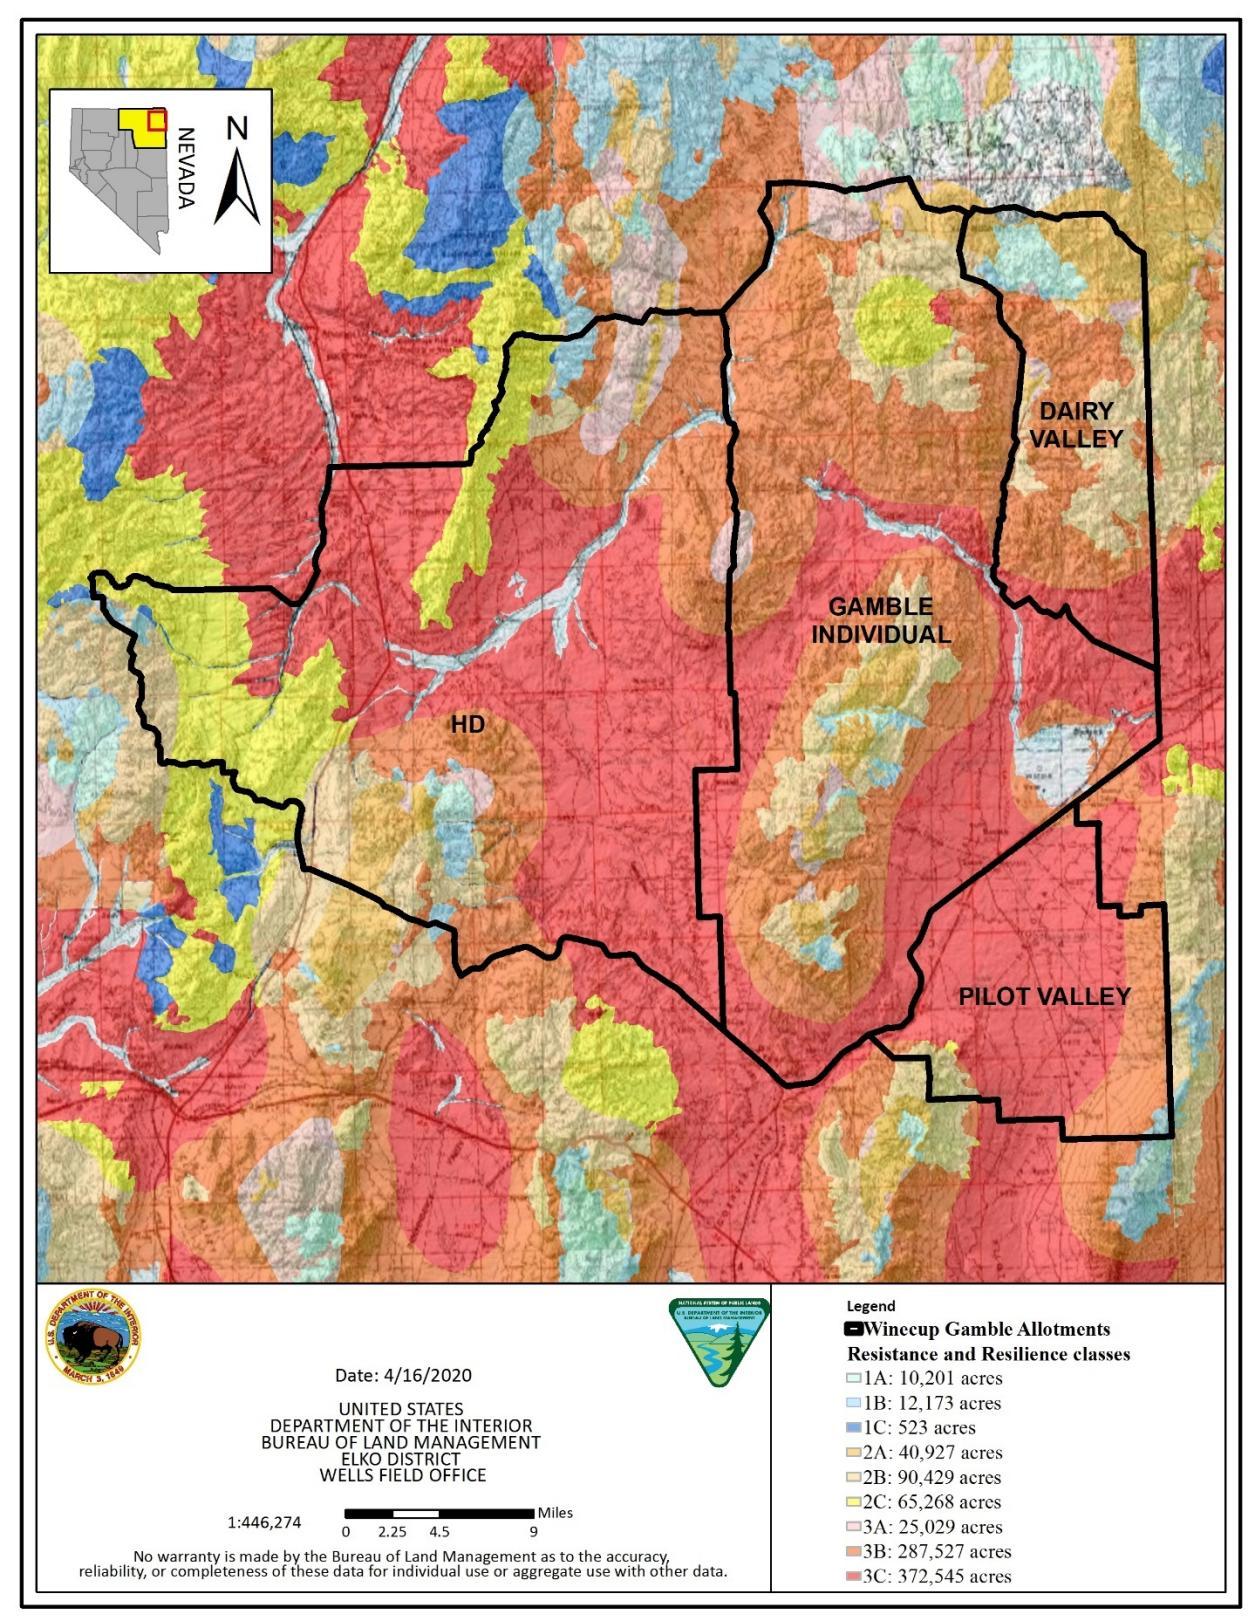
**Figure 1**. Relative Resilience to disturbance and Resistance to annual invasive grass species within and adjacent to the Winecup-Gamble Ranch. See Table 3 for class definitions.

Riparian corridors primarily along Thousand Springs Creek were not classified in terms of resistance/resilience. However, of 904,622 acres classified within the WGR, 76% were low R&R, 22% moderate R&R and 3% high R&R. The large amount of low R&R classification across the WGR indicates that disturbance within these areas has or is likely to result in sagebrush communities depauperate in sagebrush and perennial herbaceous species, high in prevalence of annual grasses and exhibiting long-lasting impacts of inappropriate historic livestock grazing, including increased shrub dominance and decreased amounts of deep-rooted perennial grasses.

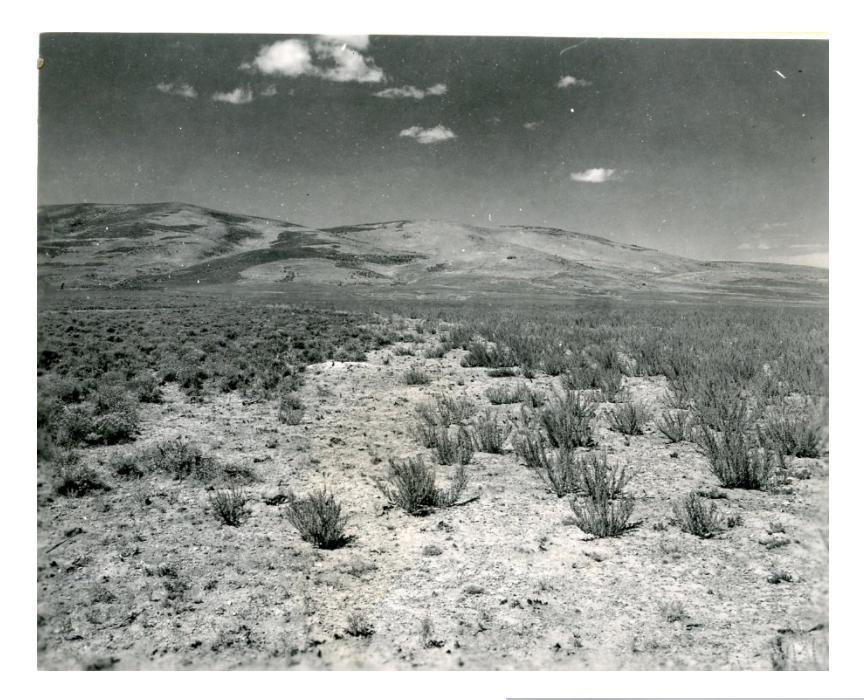
**Figures 2 and 3**. Figure 2 above shows the edge of a fire scar in the Red Point Pasture of the HD Allotment on 27 August 1950 showing prevalence of halogeton in the burned area. Figure 3 is a repeat of the same view in October 2019 showing the same area seeded to a crested wheatgrass and sagebrush dominated plan community.

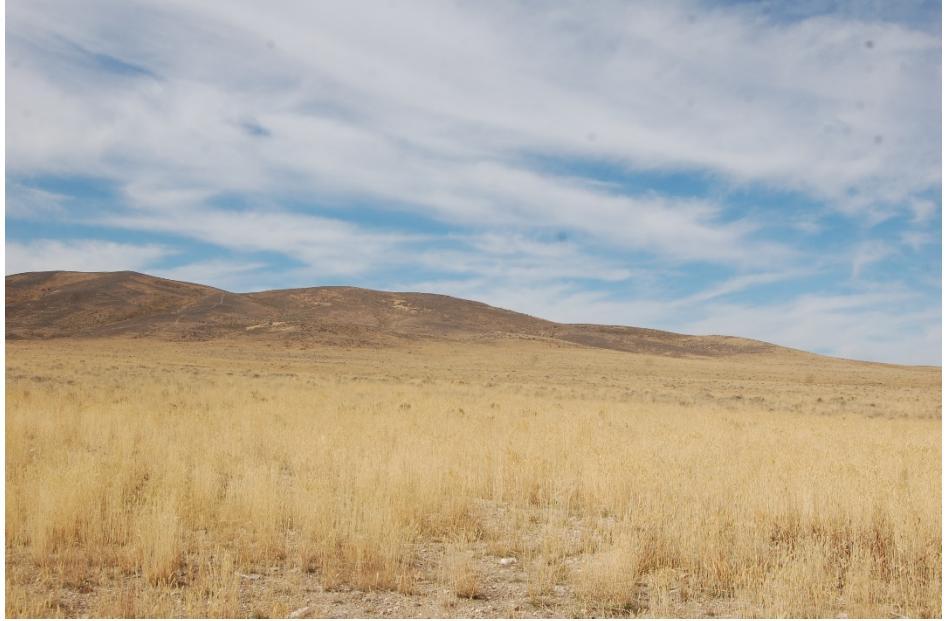
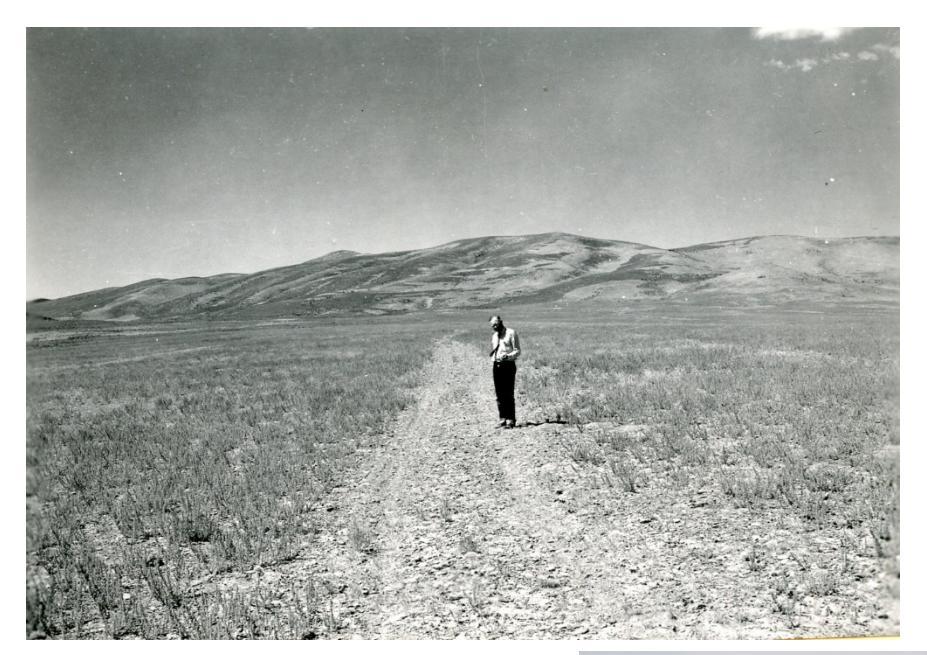
**Figures 4 and 5.** Figures 4 and 5 are another 1950 to 2019 repeat view in the Red Point Pasture of the HD Allotment. Figure 4 above is dated 27 August 1950 and shows absence of halogeton in a drill-width strip seeded to crested wheatgrass in 1947 while the adjacent unseeded areas are infested with halogeton. Figure 5 at right shows a repeat view of the same area in 2019 showing a crested wheatgrass-sagebrush dominated plant community.

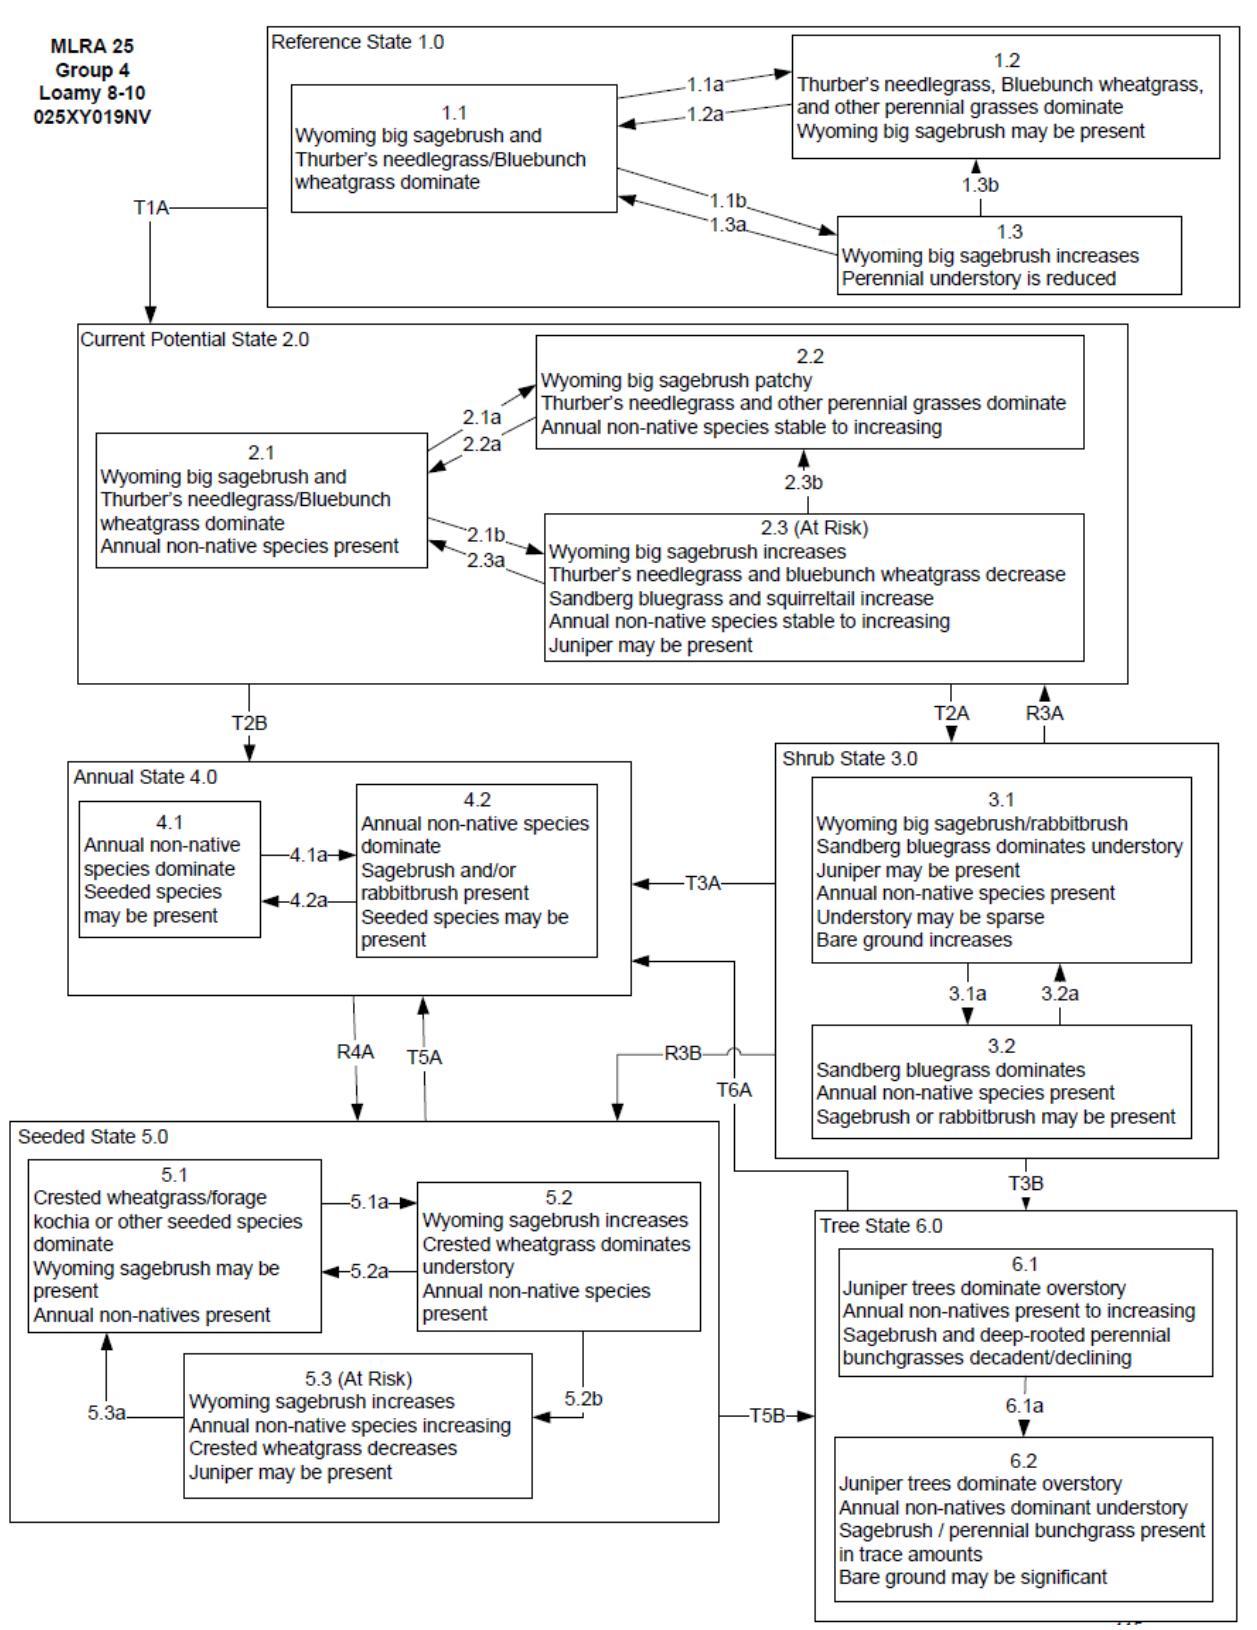
Figure 6. State and Transition Model developed for the 025XY019NV Ecological Site.

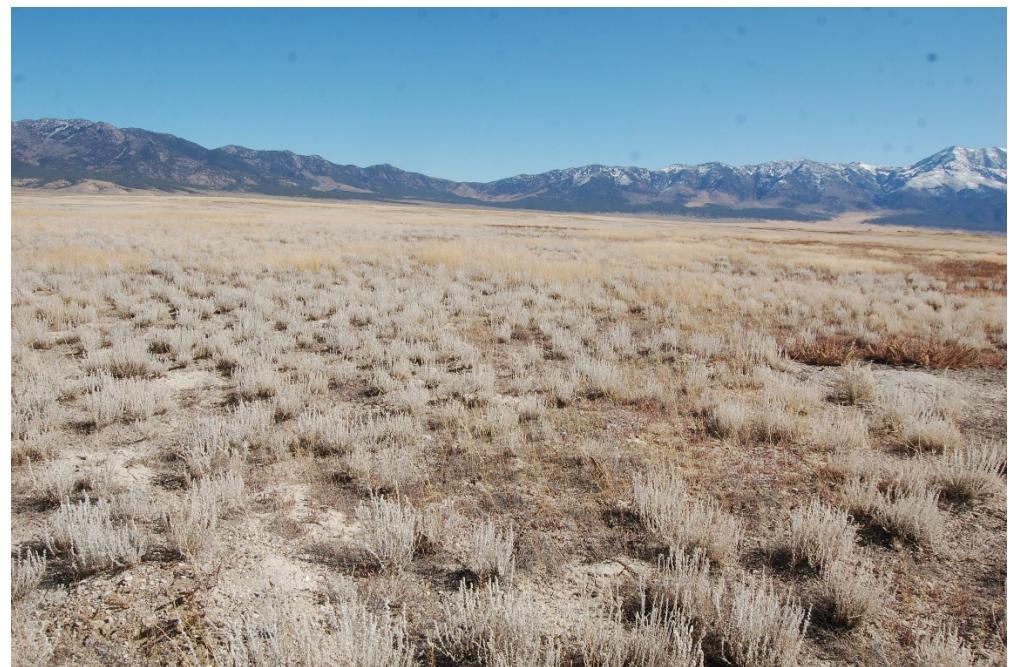
**Figure 7.** Photo in the Pilot Valley Allotment showing intact White Sage communities in the foreground intermingled with areas dominated by annual invasives such as cheatgrass, tumble mustard, and halogeton in the background. 3 October 2019.

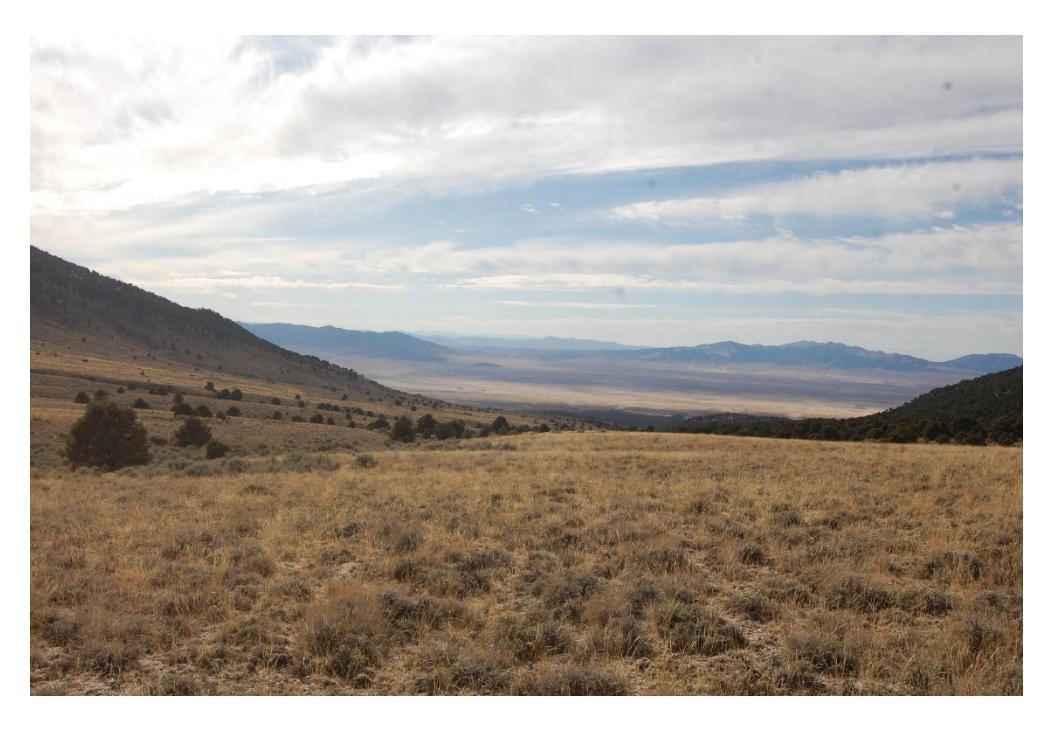
**Figure 8.** Intact sagebrush-bunchgrass communities typical of the highest elevations in the Pilot Valley Allotment. Photo taken from Patterson Pass looking west into Pilot Valley on 3 October 2019.

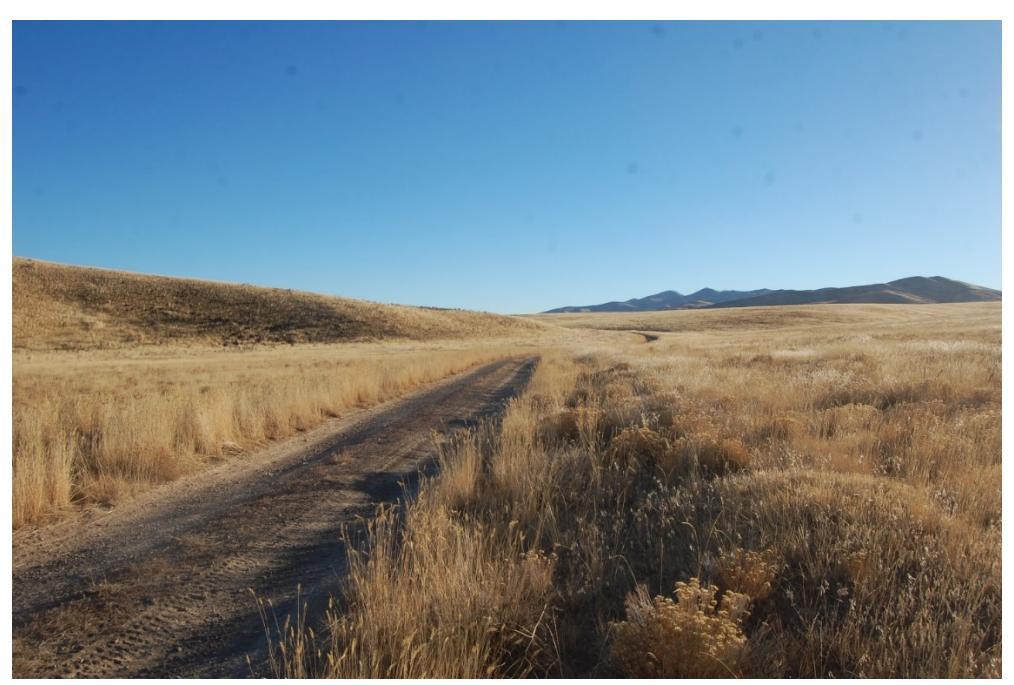
**Figure 9.** Signboard Pasture on 20 November 2018 showing a mixture of seeded species planted along the road, cheatgrass, rabbitbrush re-sprouting after the fire, and native perennial bunchgrasses.
