BLM CARSON CITY DISTRICT RMP PLANNING FACT SHEET *Riparian and Wetlands*

8.3—Riparian and Wetlands

Current Riparian Conditions

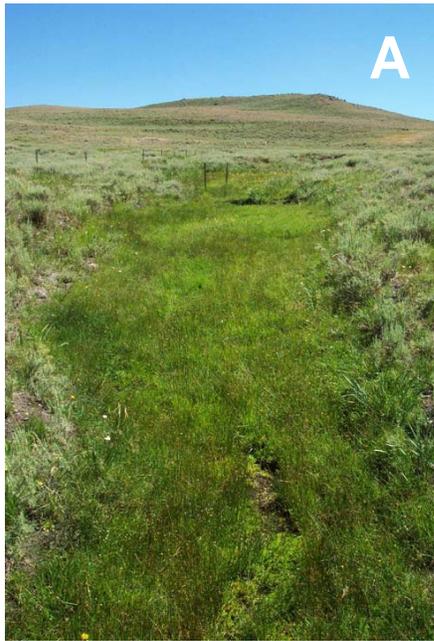
In photos A and B on the right: the channel in photo A is within a fence enclosure and appears to be recovering from past erosion events that created a wide shallow channel. It is covered by vegetation and appears stable. Downstream of the enclosure, photo B, shows bare ground on the stream banks and active head cuts in the channel. The riparian characteristics noted in photo A are missing in photo B.
