PROJECT DESCRIPTION
DUNCAN CREEK SPRING RESERVOIR MAINTENANCE – T 11S, R 03E, SEC 24 (#306214)

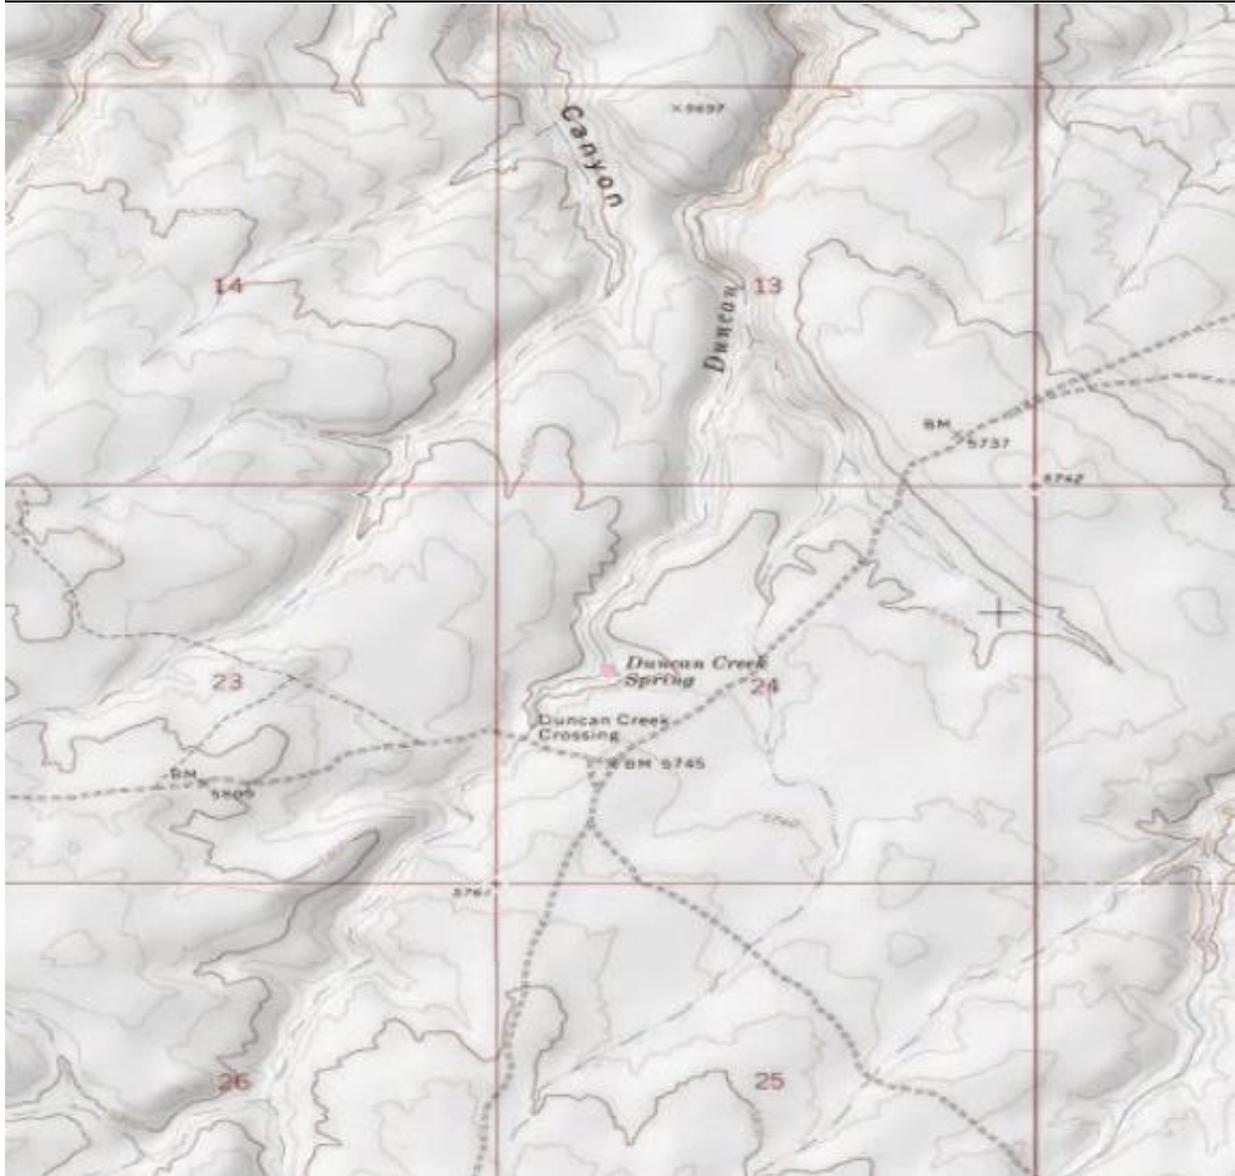
Figure 3. Reservoir Maintenance Location and Access Overview

Maintenance work would be done at the existing reservoir located in the Southwest of the Northwest quarter of Section 24, Township 11 South, Range 3 East. The project map depicts the location of the reservoir and access route. The equipment operator could access the reservoir along the 2-track way from the east, and walk the dozer in from an unloading point on the main road.

Work would be performed with a bulldozer (Figure 5). Equipment would access the reservoir along an existing but unmapped route from the Wickahoney Road to the east (Figure 1). The bulldozer would be transported on a low boy trailer to a staging area along the Wickahoney Road. The operator would then drive the bulldozer along the remainder of the route to the reservoir. The probable area of surface disturbance at the reservoir maintenance site at the base of the dam would total approximately 1 acre. The dimensions of the finished project would retain up to 0.5 acre feet per year of surface water, per the terms of the claimed water right.

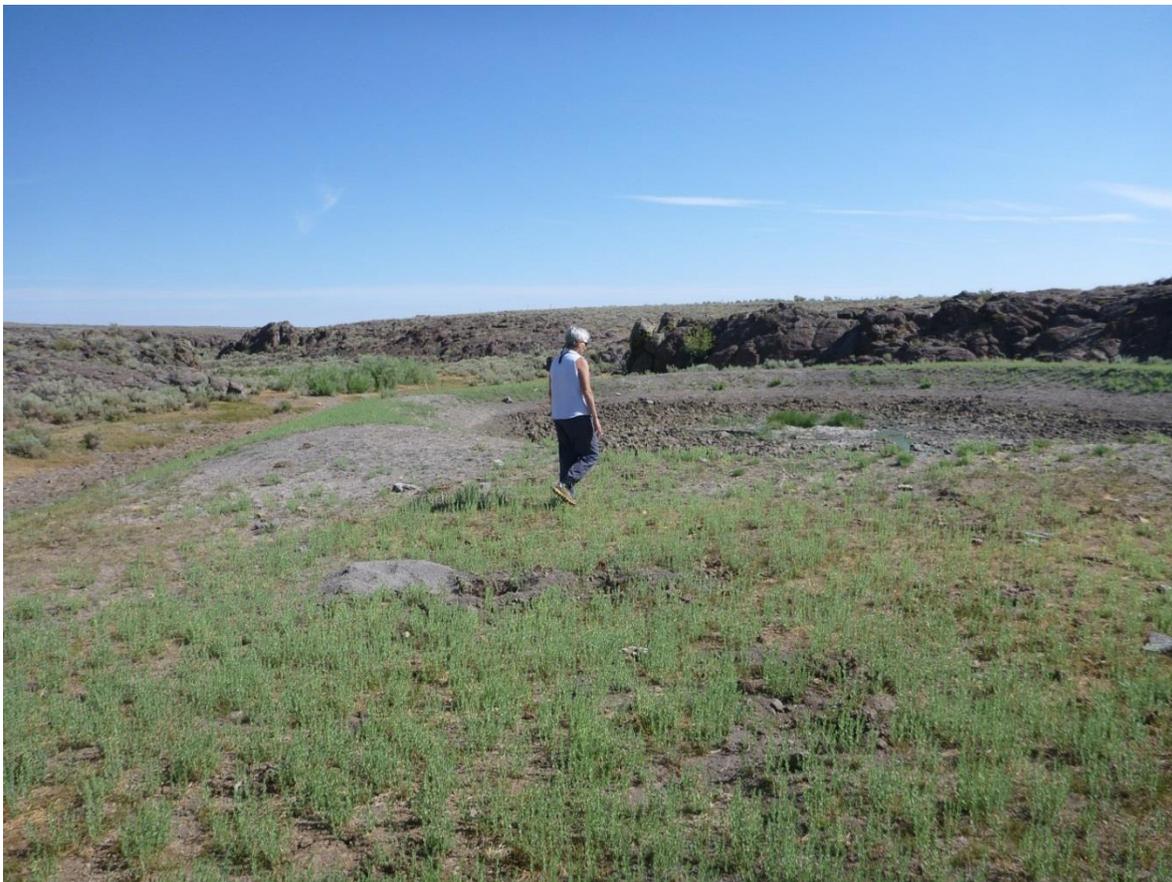
Figure 2. Duncan Creek Spring Reservoir on July 23, 2013. 2nd year of low snowpack.

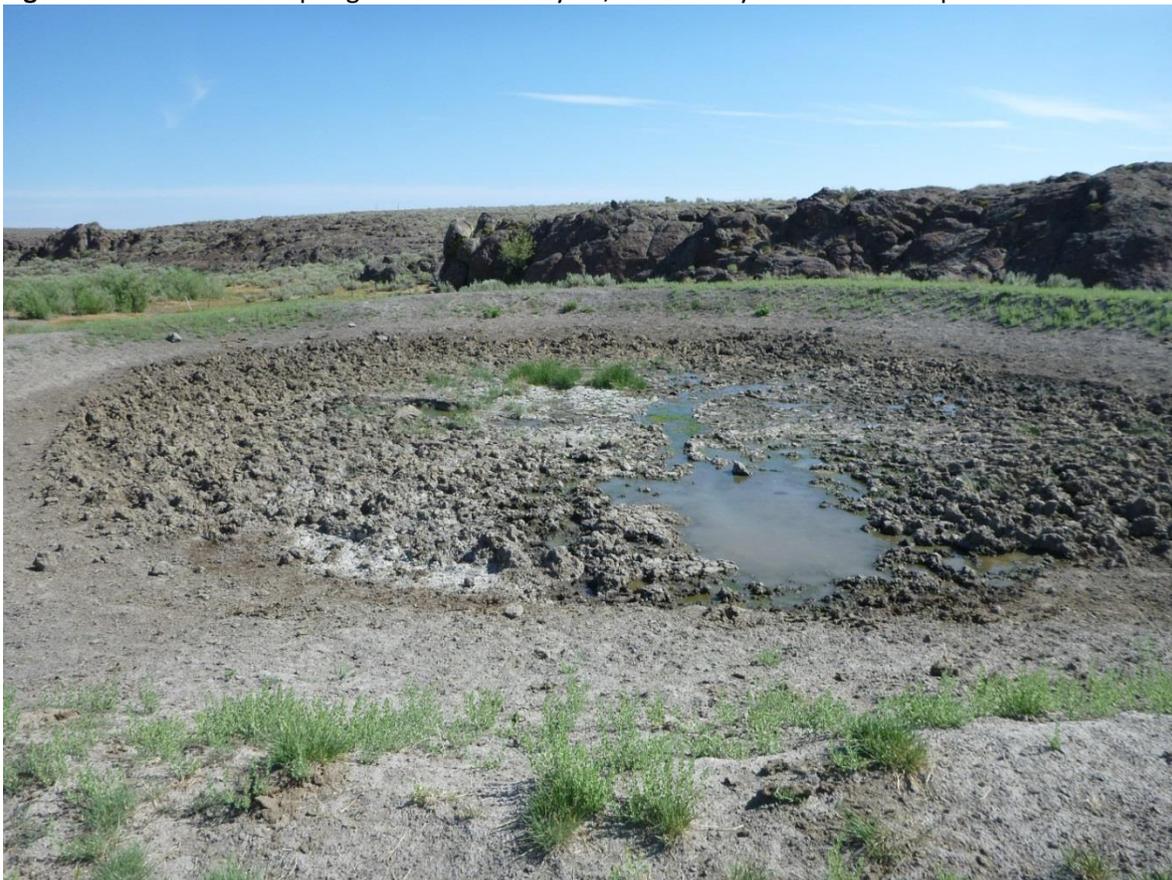
Figure 3. Duncan Creek Spring Reservoir on July 23, 2013. Small amount of water stored, mostly gone before scheduled use.

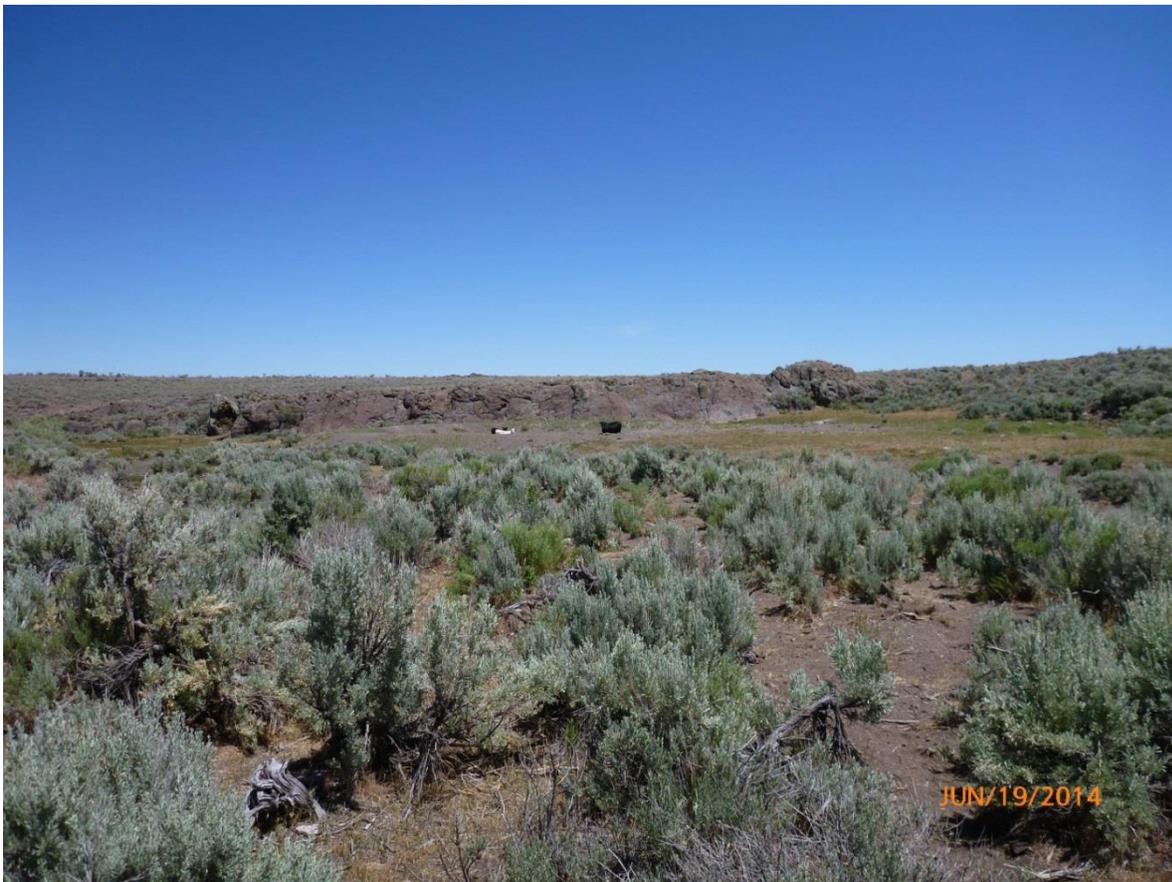
Figure 4. Duncan Creek Spring Reservoir on June 19, 2014. Lack of water forced very short use period for this pasture, focused around private springs on Harvey Place.

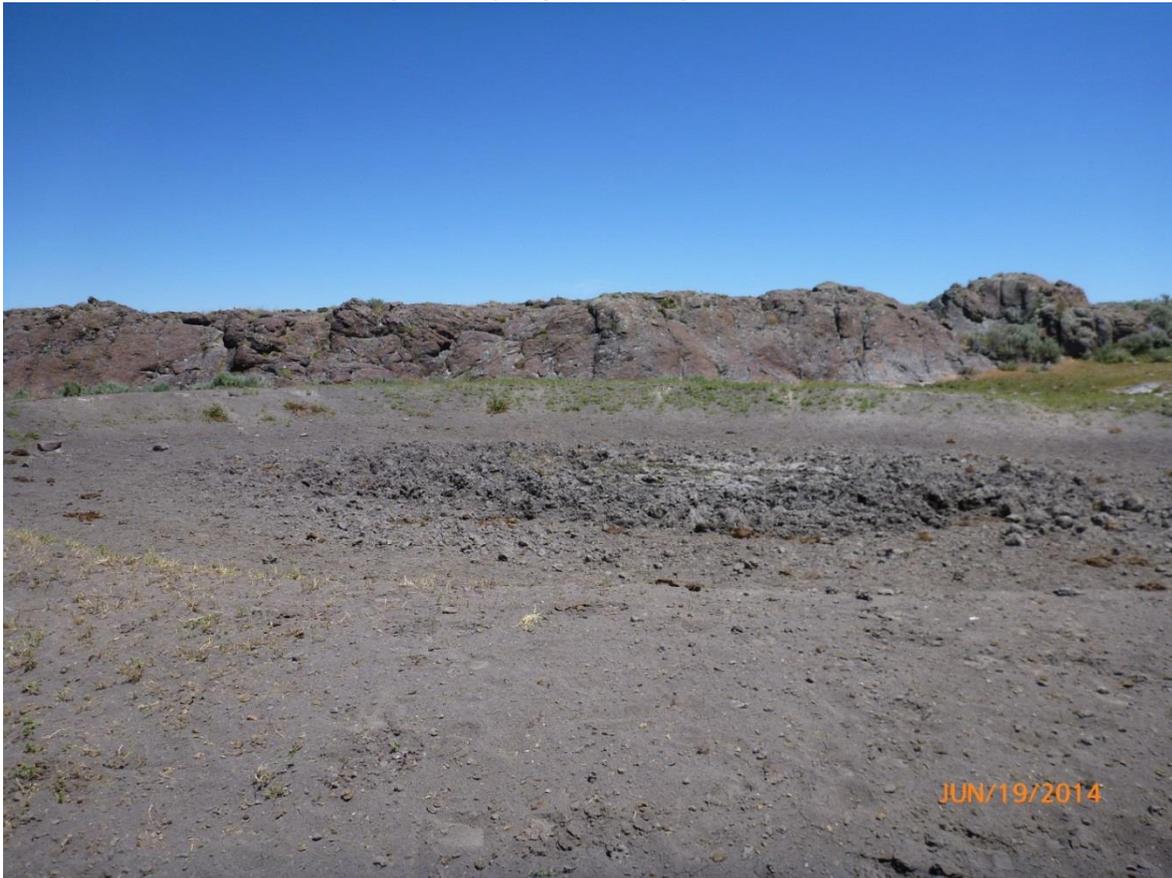
Figure 4. Duncan Creek Spring Reservoir. Pond captures flow of spring at rimrock base.

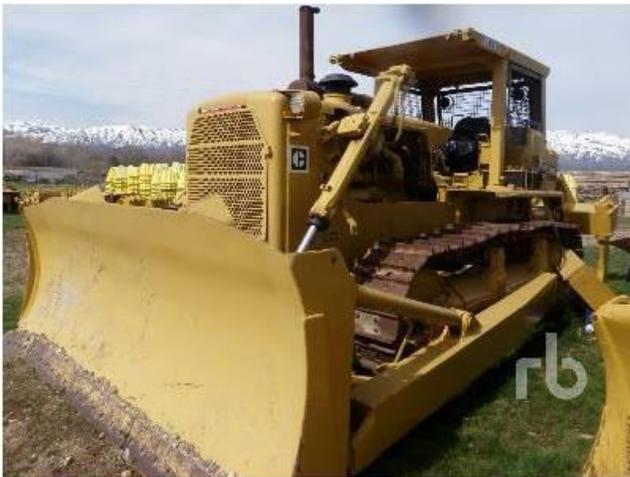
Figure 5. Example of Bulldozer (D8)
