**Visual Resource Management
Visual Resource Inventory Polygons**

Visual Resource Management Key Observation Points

VISUAL CONTRAST RATING WORKSHEET

| Project: Cotton Peak R.O.W. EA | Date: 11/26/14 |

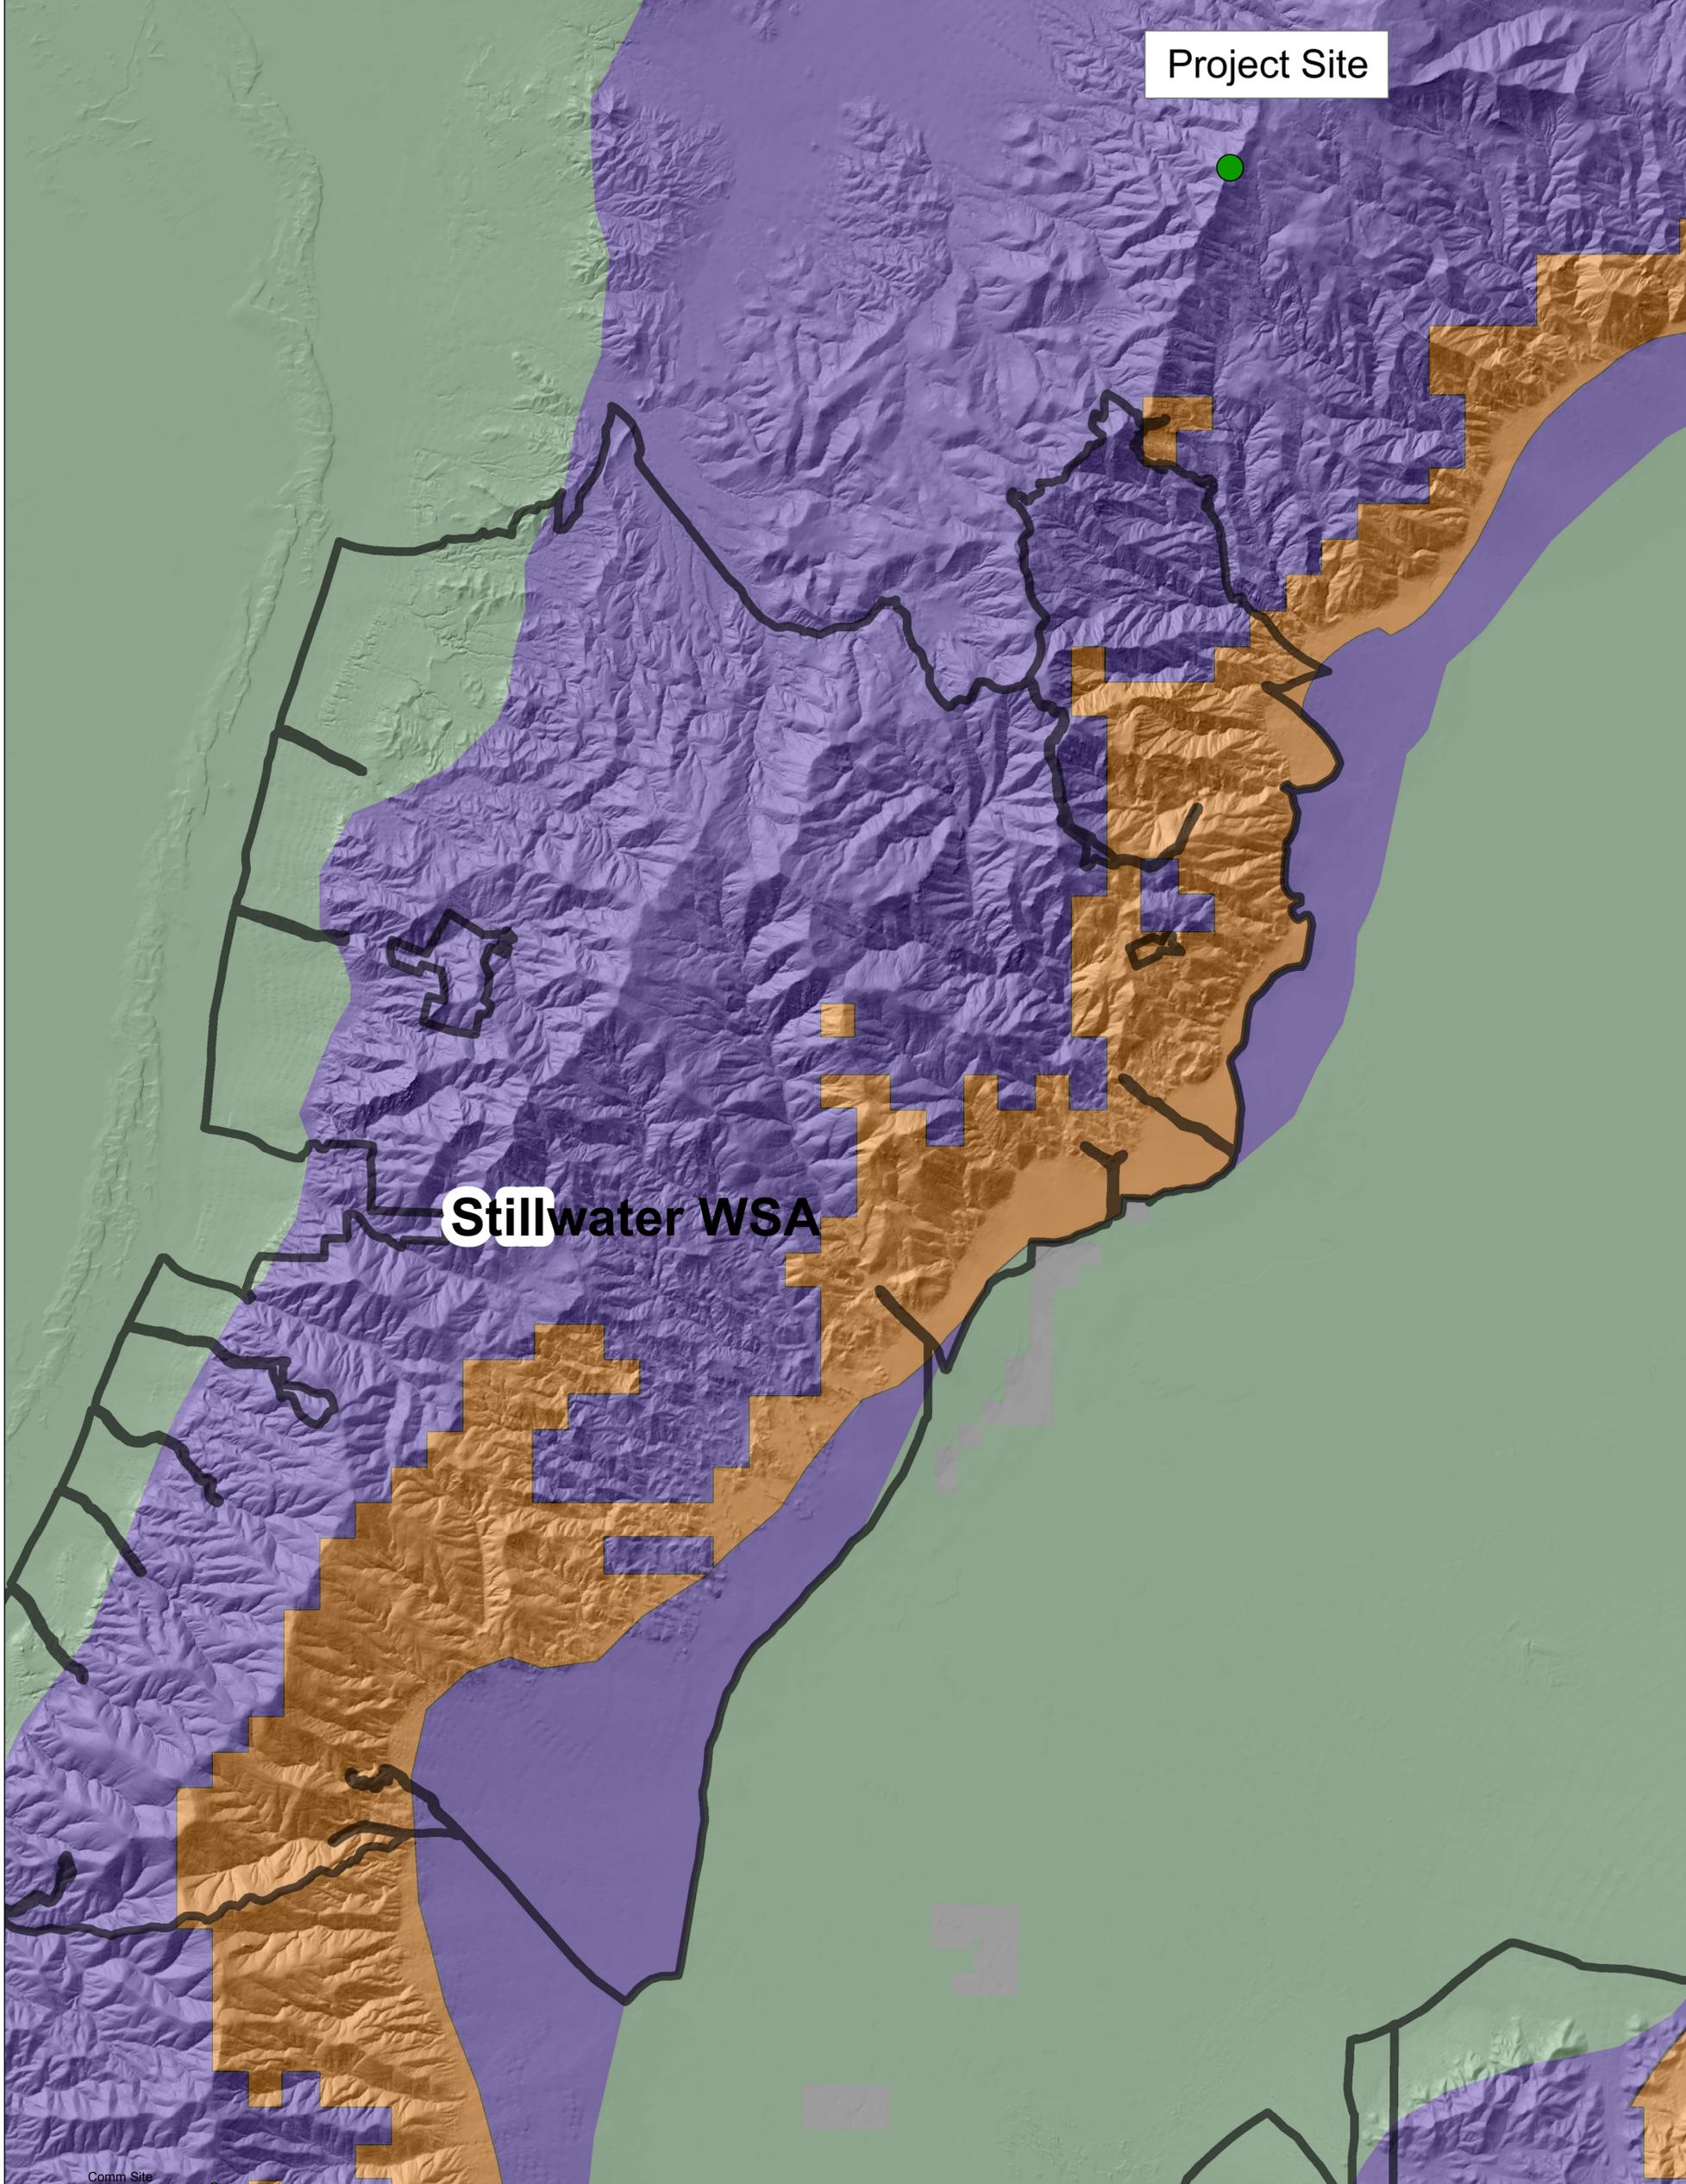
- VRI Class I
- VRI Class II
- VRI Class III
- VRI Class IV

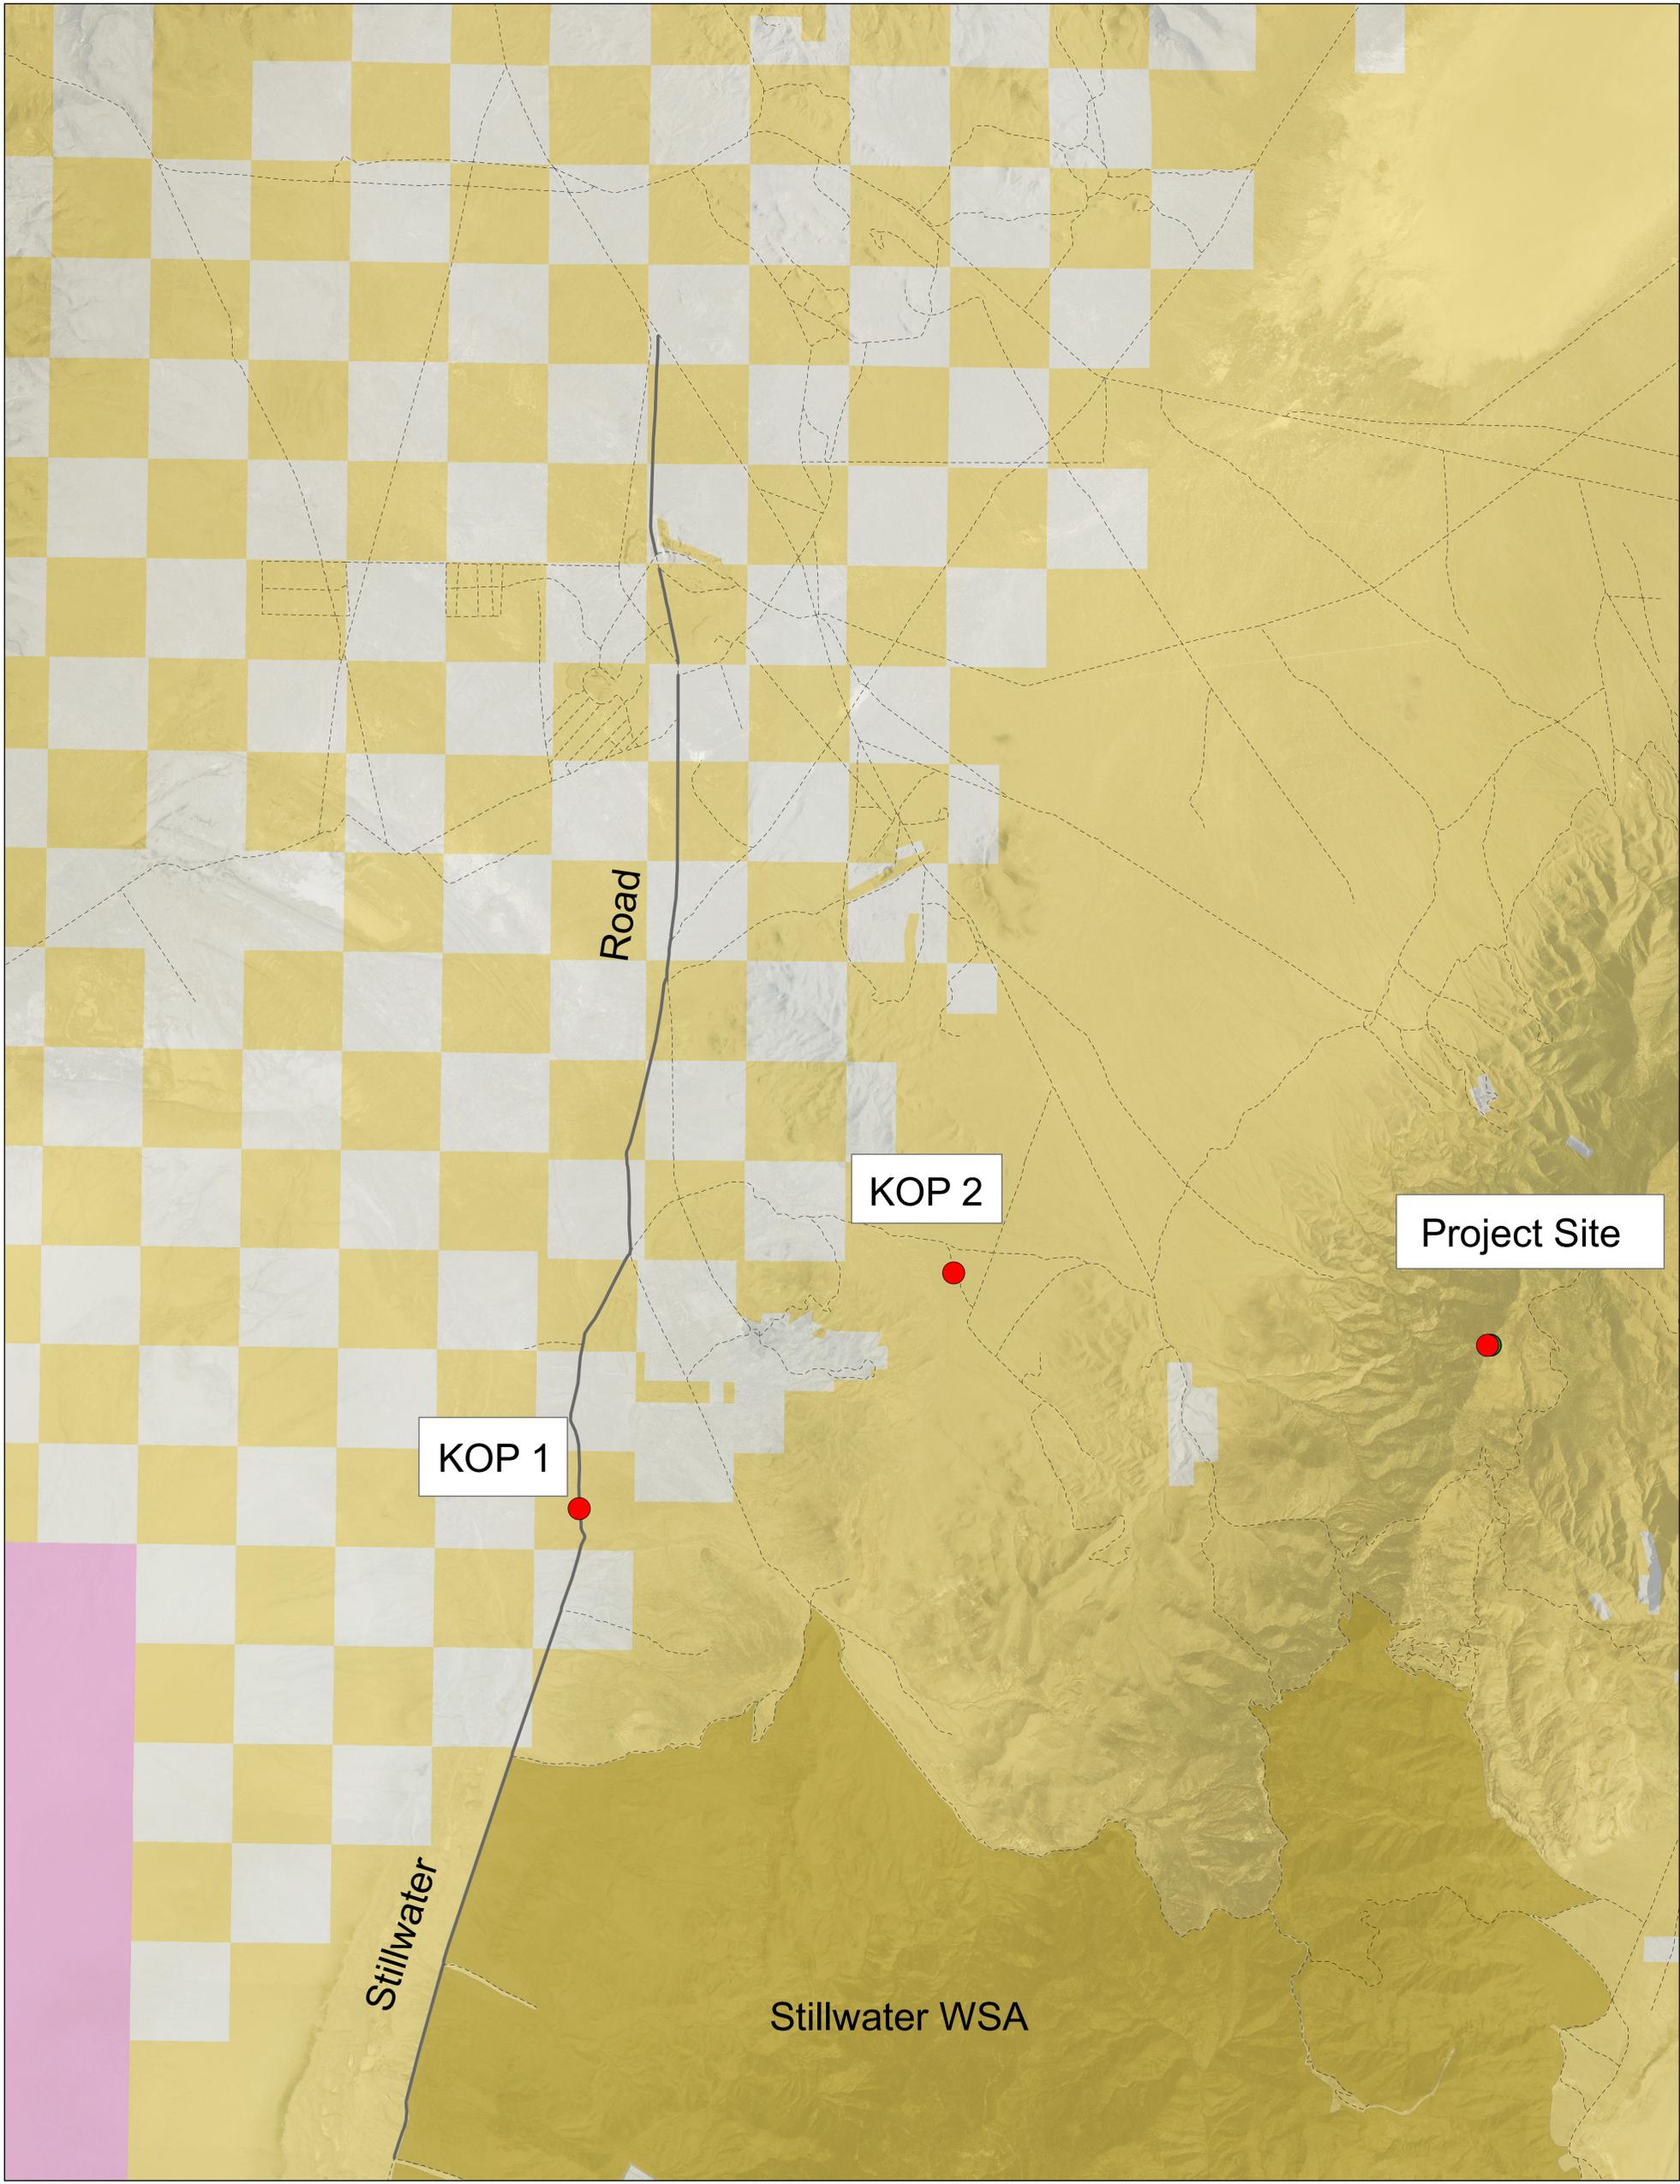
- Cotton Peak Tower
- KOPs

- BLM
- BR
- DOD
- PVT

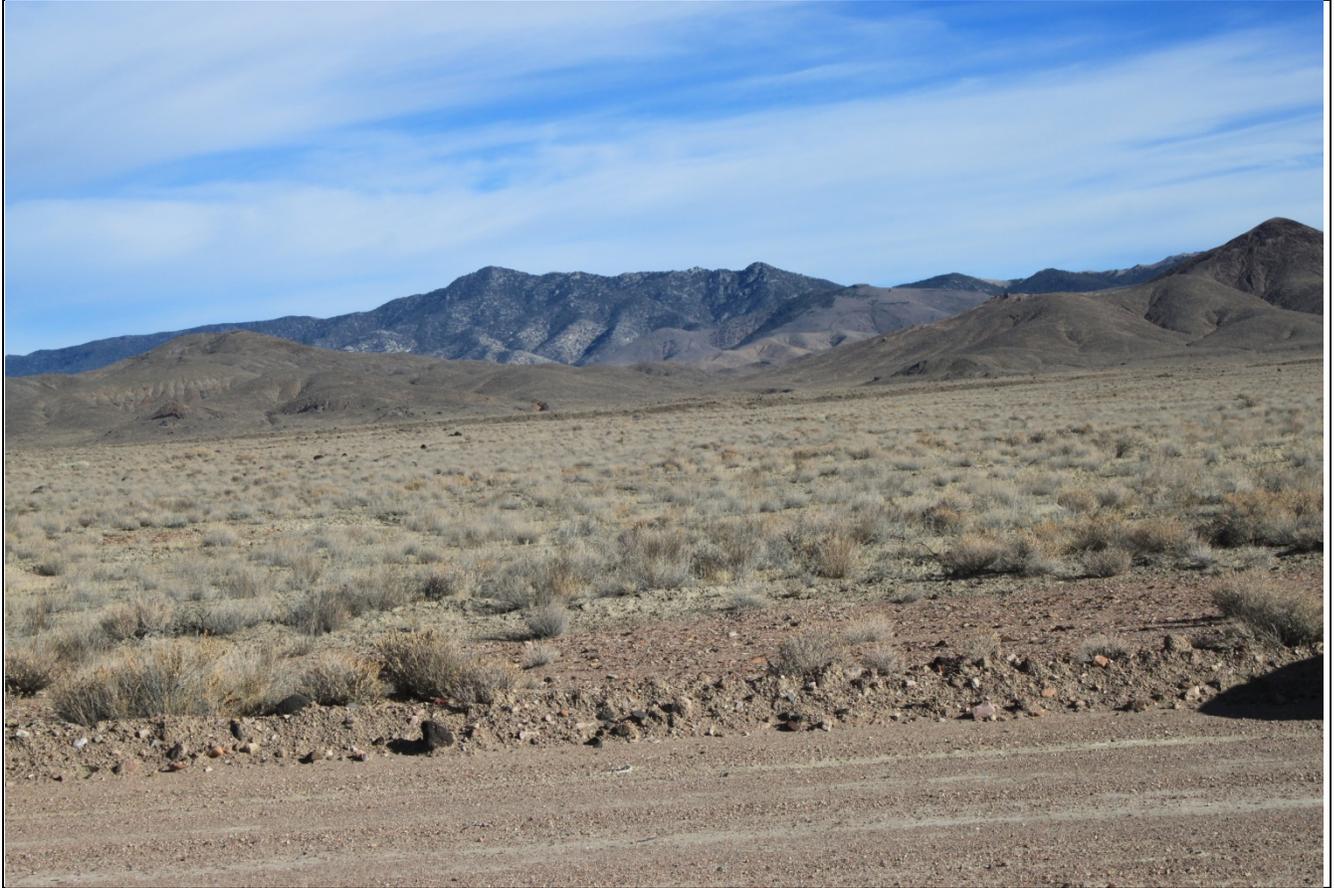
| Location ID: KOP 1 | Lens Focal Length: 50 mm |

Proposed site of tower as viewed from Stillwater Road, an infrequently driven graded road which connects Fallon and Lovelock. This is the most likely road to be traveled by the general public and the most viewable location of the project site along this road. The existing tower is not visible even with the aid of 10X binoculars from this location. Viewability of the site from the north will be obscured by the peak, and viewability on the eastern side of the Stillwater Range from Dixie Valley Road is low due to distance from the road.

From this Key Observation Point (KOP) the viewshed can be divided into three distinct boundaries: the foreground, middle ground and background. The foreground consists of flat sandy soils sparsely populated with salt desert scrub with predominate colors of yellow, and light tans. The middle ground is comprised of rolling hills covered with cheat grass with a smooth texture and yellow and tan colors. The background consists of rugged terrain comprised of small ridges and canyons that provide dark and light contrasts from shadows with predominant colors of dark greens and grays

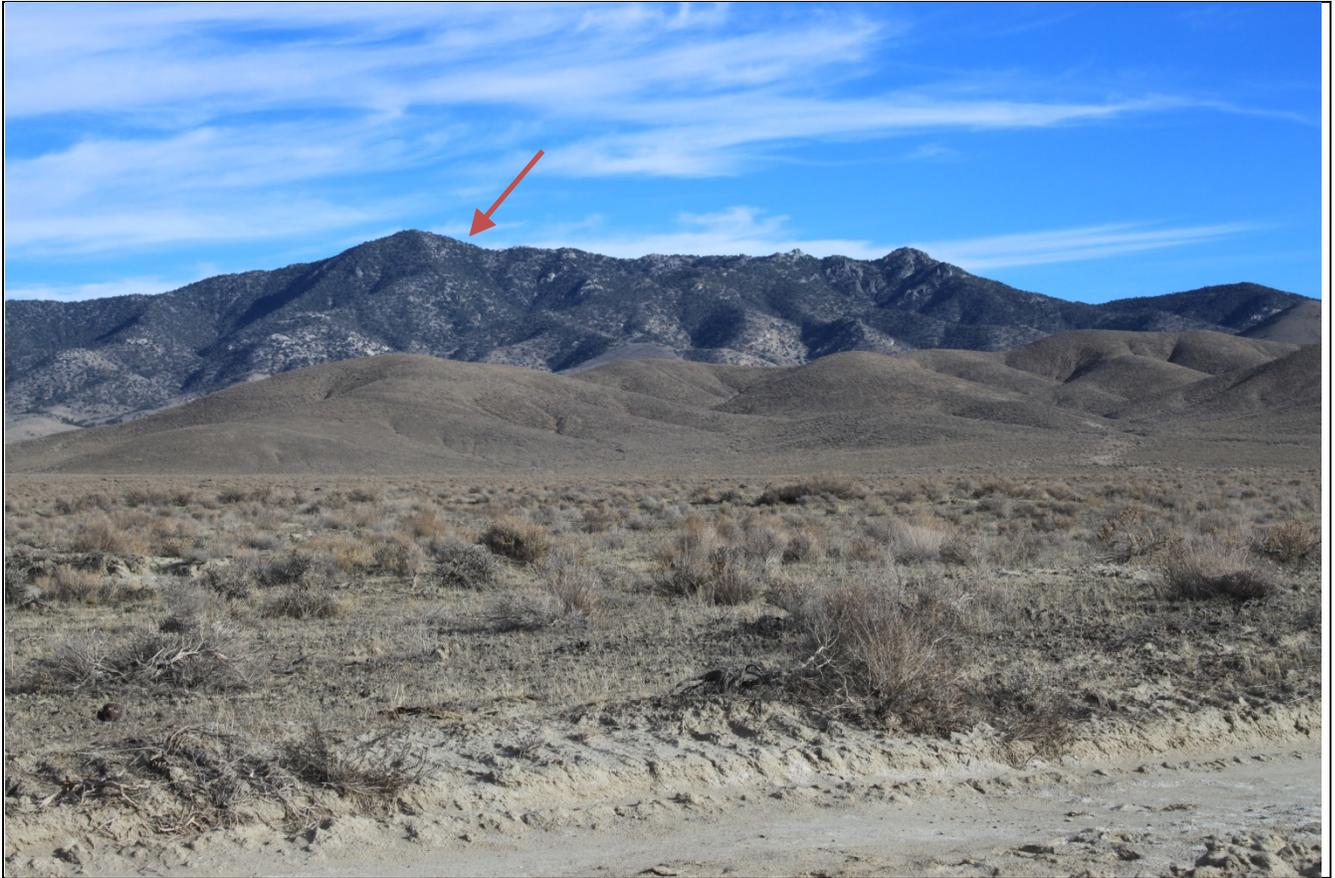
| Location ID: KOP 2 | Lens Focal Length: 50 mm |

Proposed site of tower as viewed from unnamed dirt road 5.4 linear miles from project site. The top of the existing tower is marginally visible with the aid of 10X binoculars from this location. The general public would not likely be travelling on this or any other 4WD road in this area.

From this Key Observation Point (KOP) the viewshed can be divided into three distinct boundaries: the foreground, middle ground and background. The foreground consists of flat sandy soils sparsely populated with salt desert scrub with predominate colors of yellow, and light tans. The middle ground is comprised of rolling hills covered with cheat grass with a smooth texture and yellow and tan colors. The background consists of rugged terrain comprised of small ridges and canyons that provide dark and light contrasts from shadows with predominant colors of dark greens and grays.
