**BUREAU OF LAND MANAGEMENT**

**RELIEF CANYON MINE PROJECT**

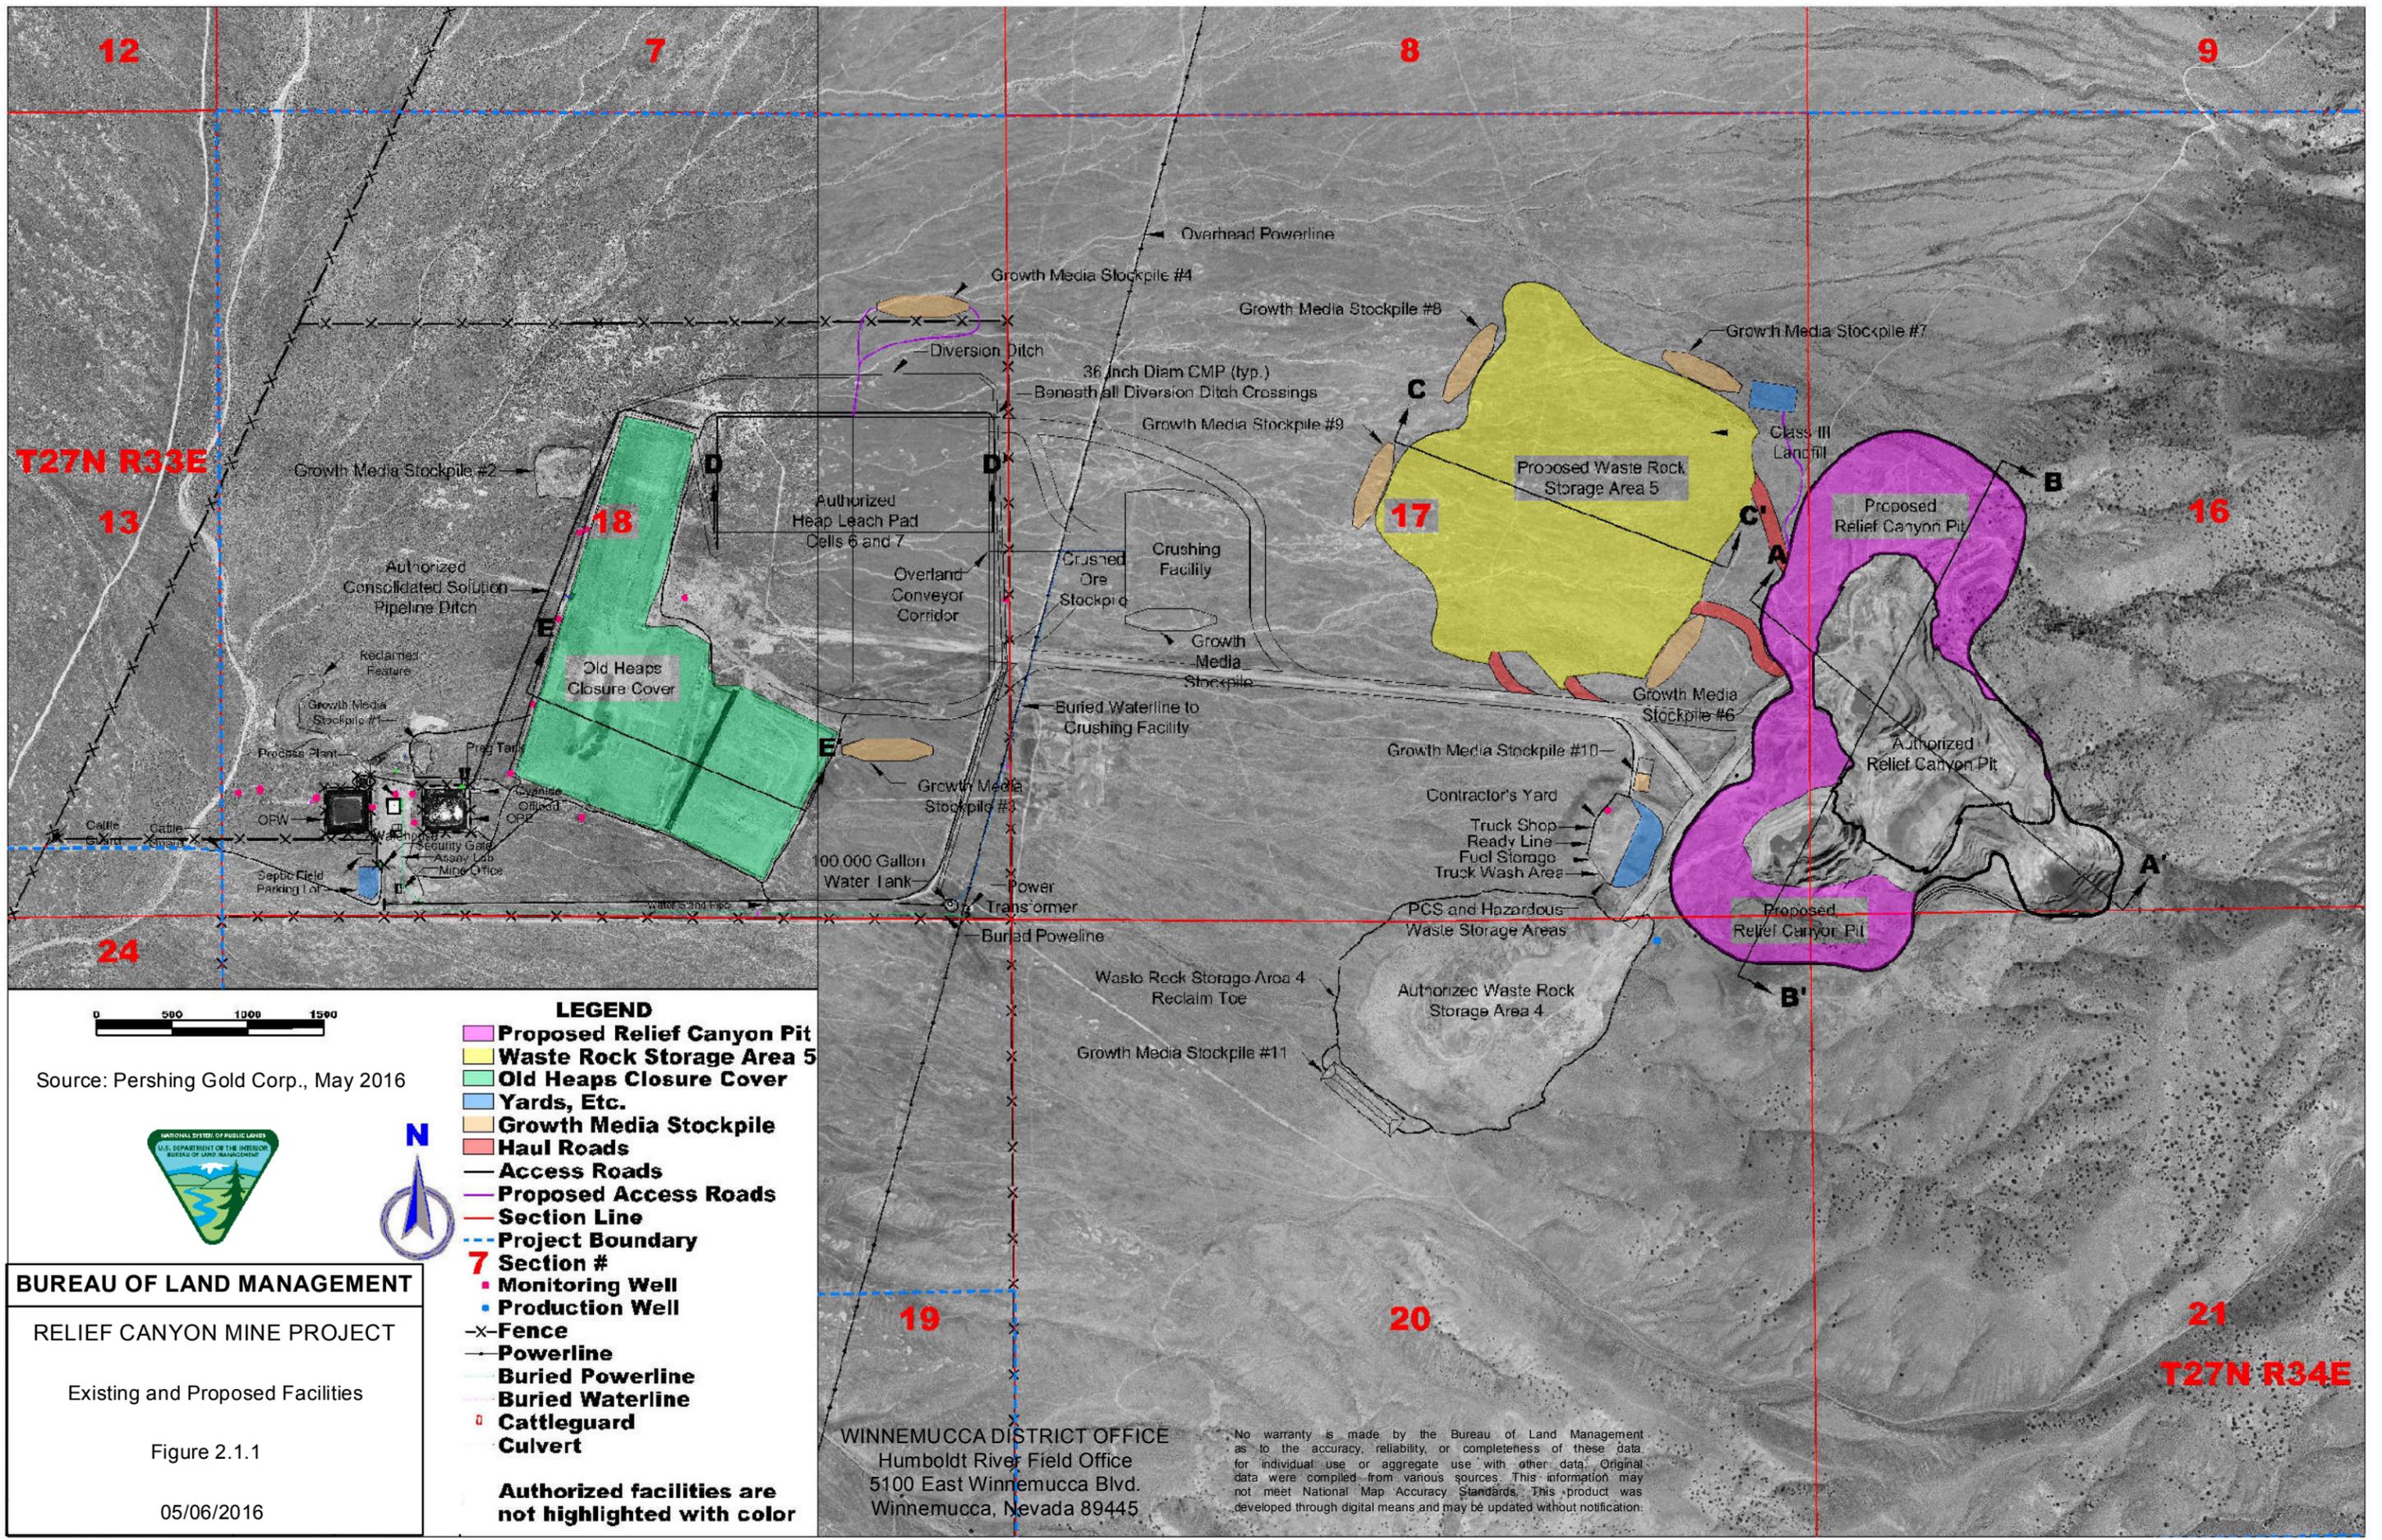
Figure 2.1.1

Existing and Proposed Facilities

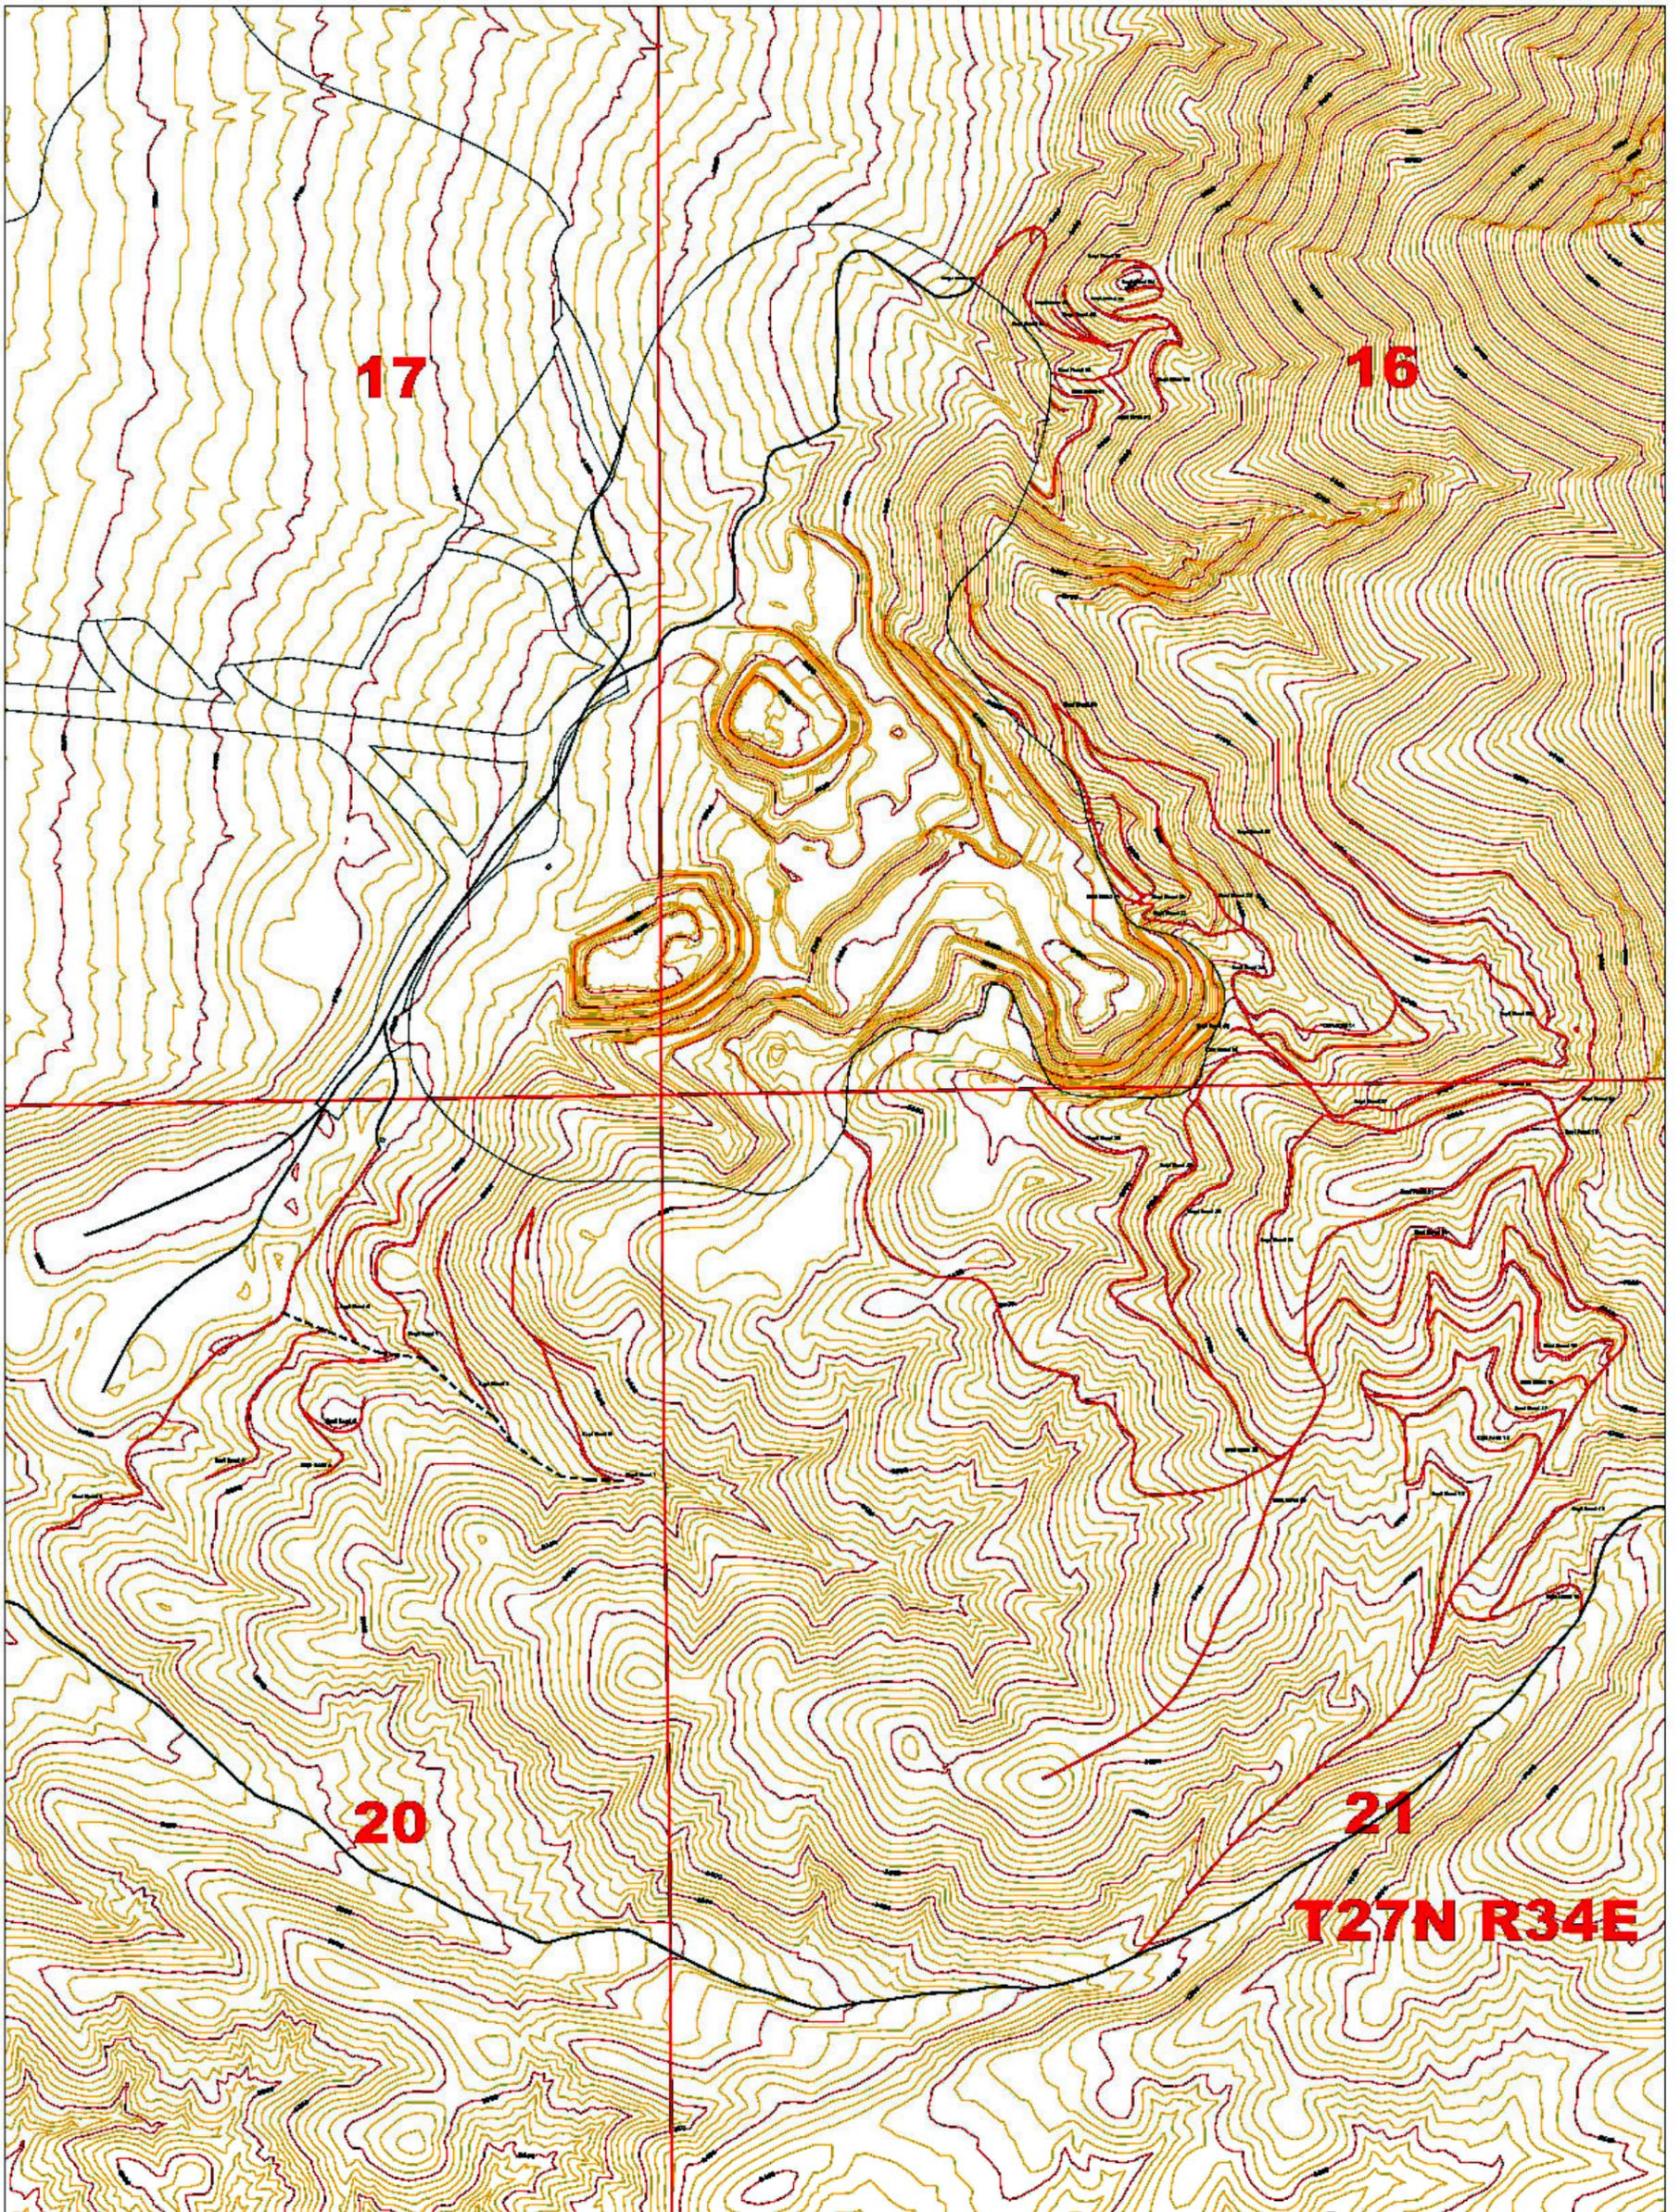
Figure 2.1.2

Proposed Exploration Roads

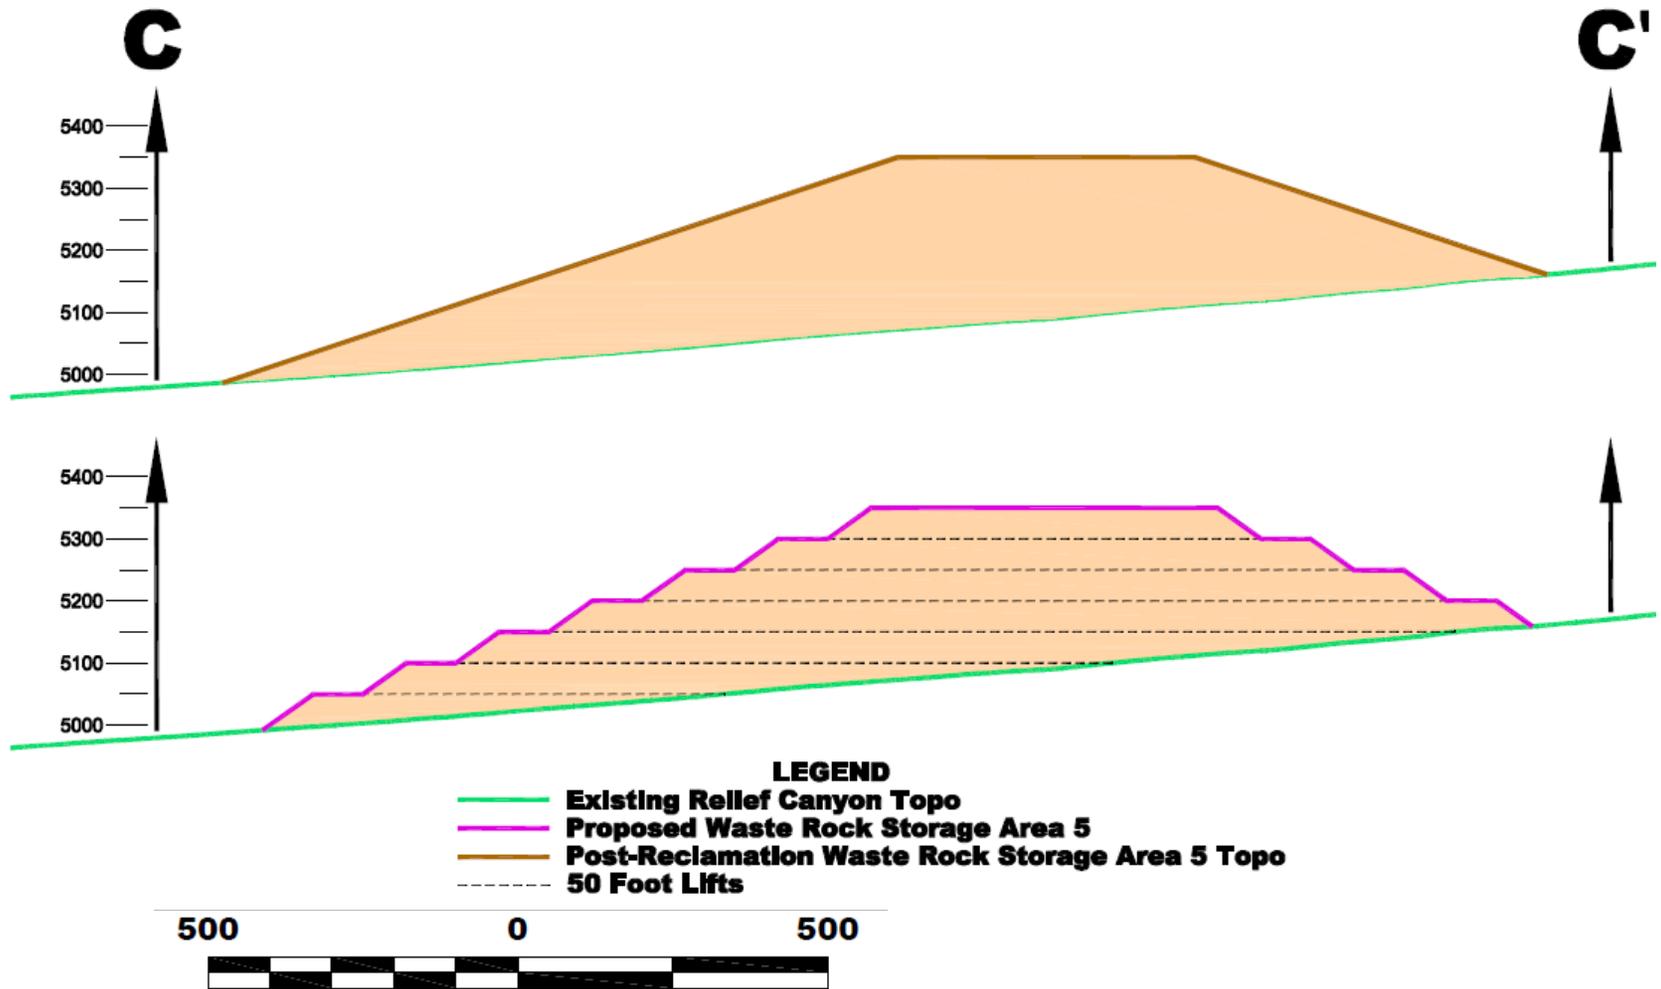
Figure 2.1.3

Cross Section of  
Waste Rock Storage Area

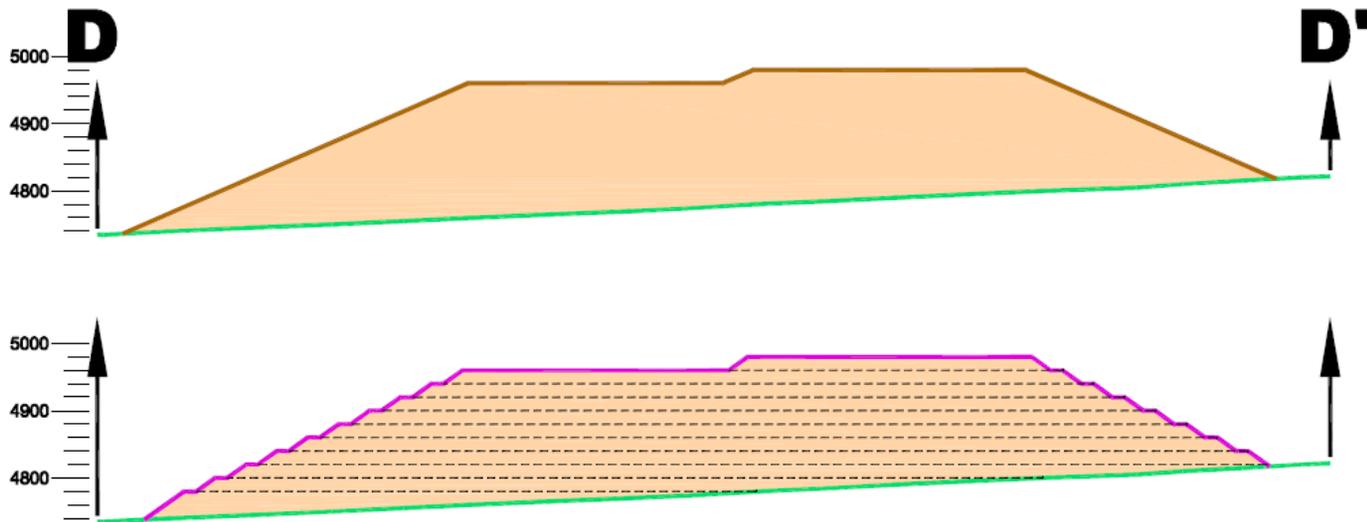
Figure 2.1.4

- LEGEND**
- Existing Relief Canyon Top
  - Planned Heap Cells 6 and 7 as Designed and Authorized
  - Post-Reclamation Heap Leach Pad Top
  - - - 20 Foot nominal thickness lift thickness shown, may vary up to 40 feet.

Generalized Cross Section of  
 New Heap Leach Pad

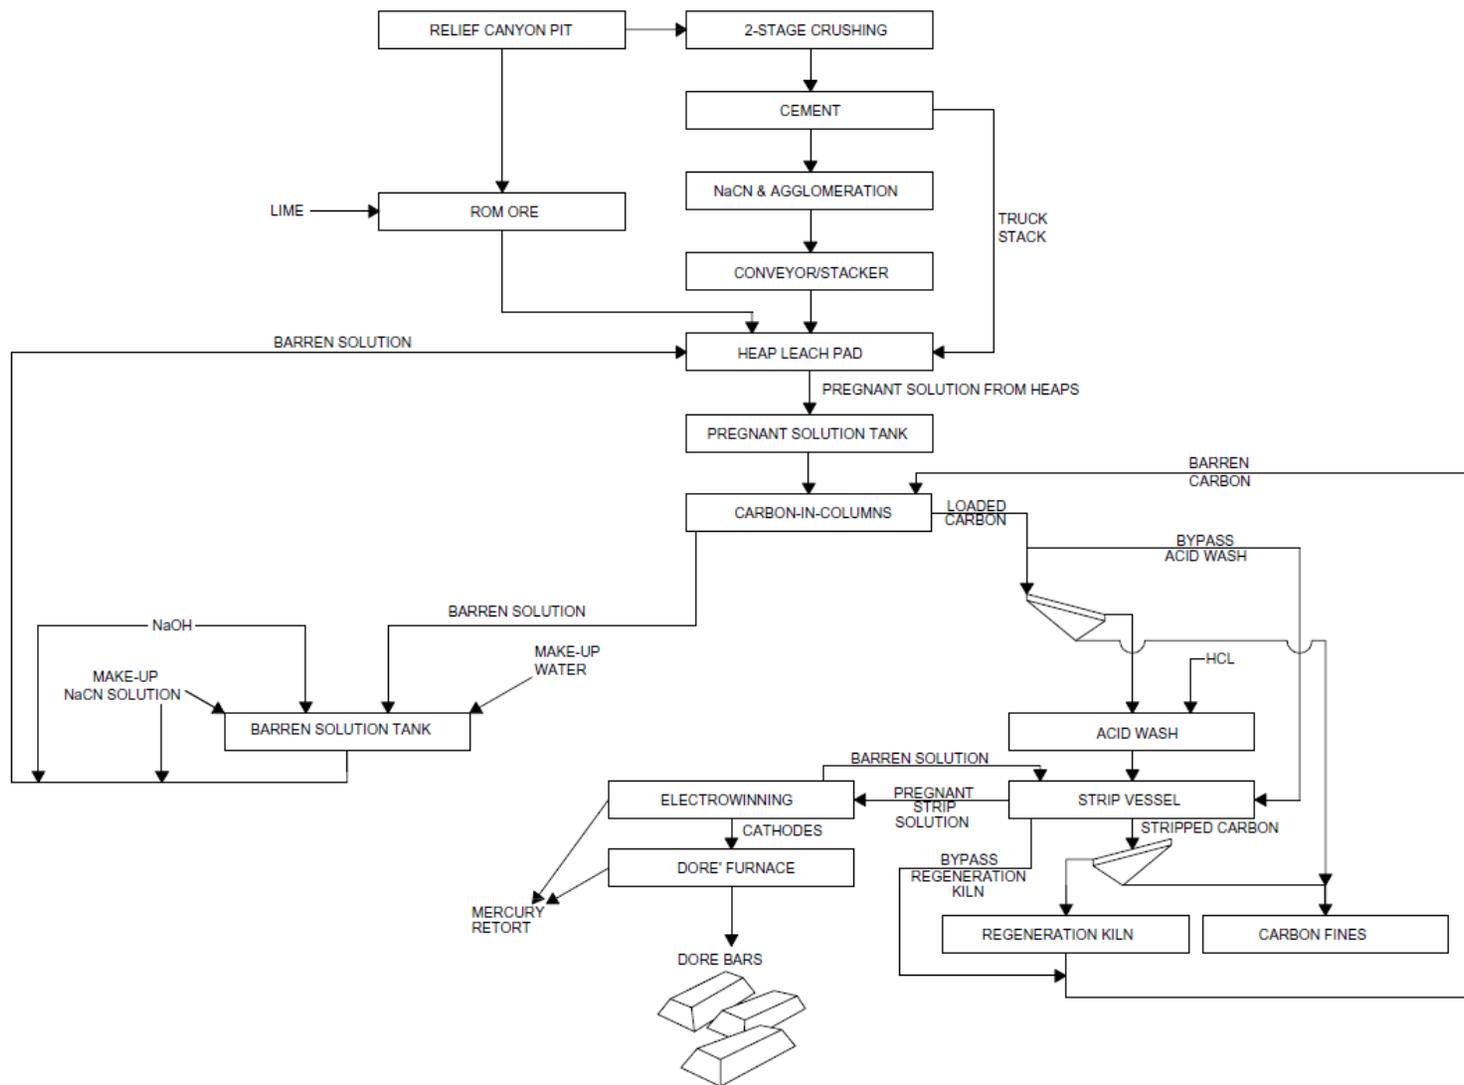
Figure 2.1.5

Process Flow Sheet

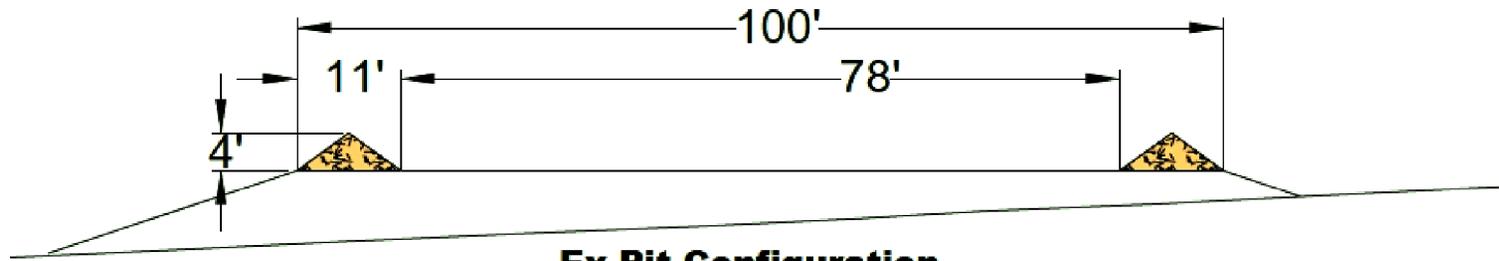
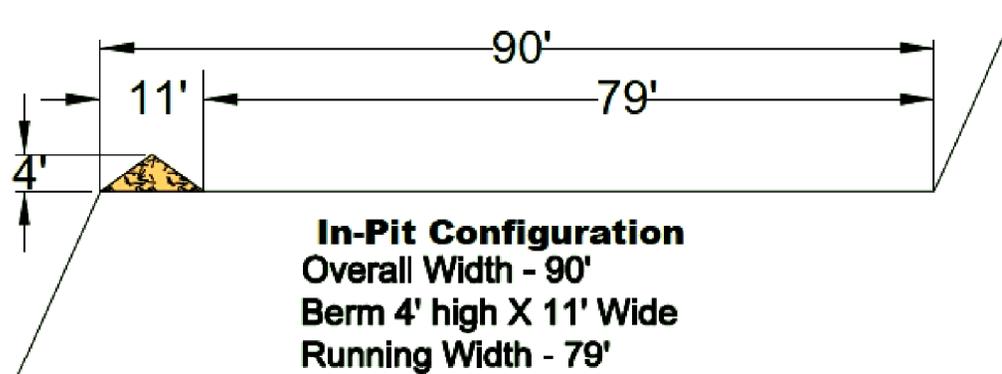
Figure 2.1.6

**Ex-Pit Configuration**  
 Overall Width - 100'  
 2@ Berms 4' high X 11' Wide  
 Running Width - 78'

**In-Pit Configuration**  
 Overall Width - 90'  
 Berm 4' high X 11' Wide  
 Running Width - 79'

Typical Haul Road Cross Section

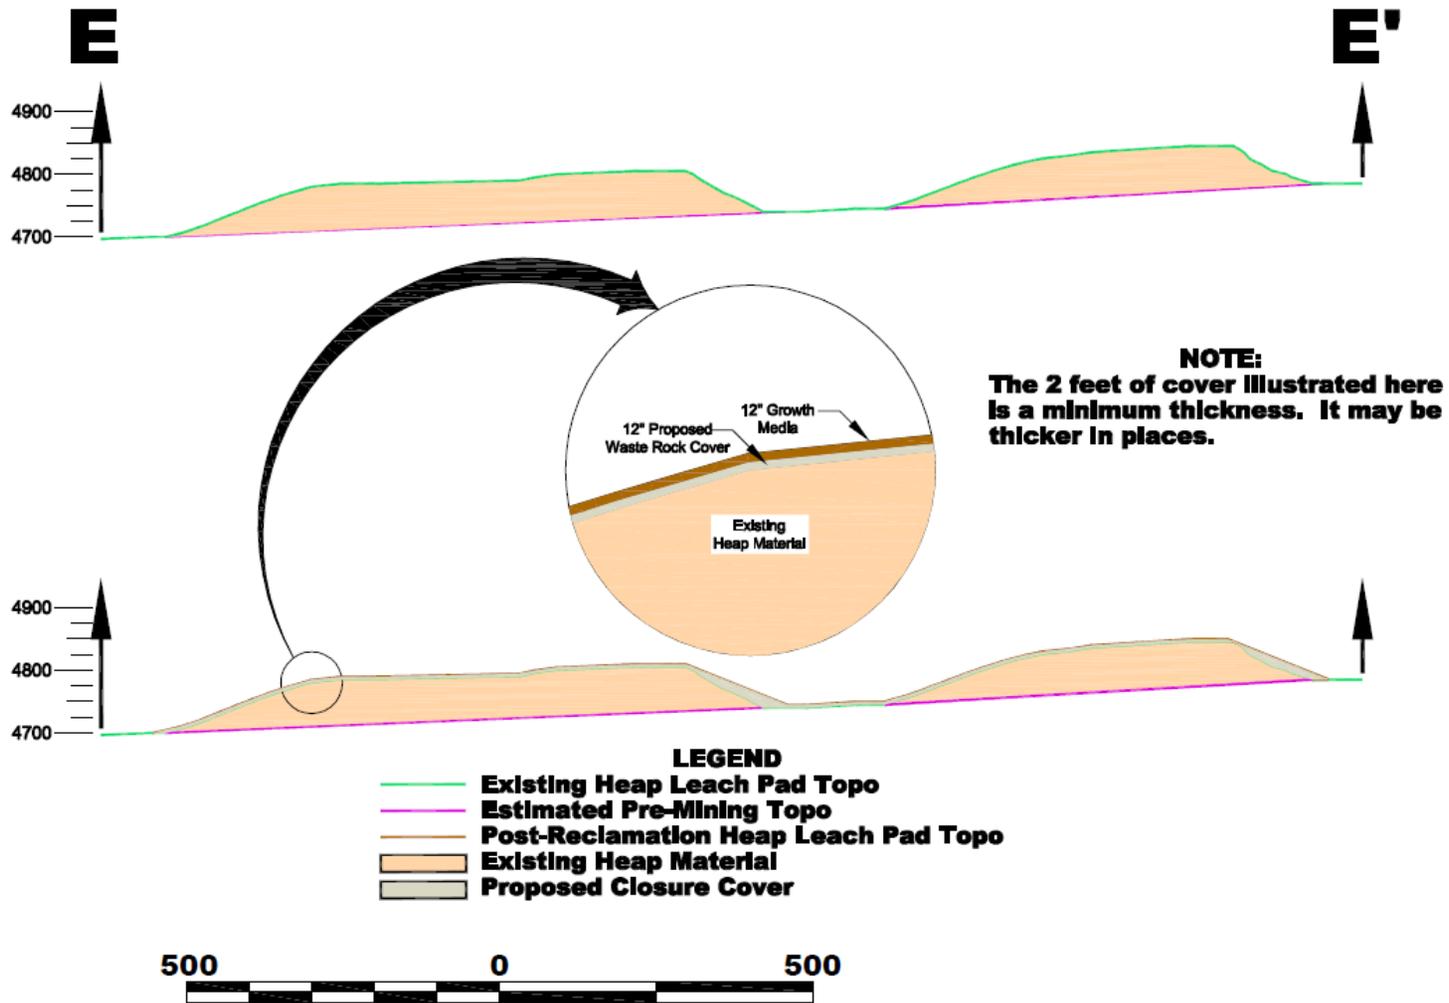
Figure 2.1.7

RELIEF CANYON MINE PROJECT  
 Cross Section of  
 Reclaimed Old Heap Leach Pads

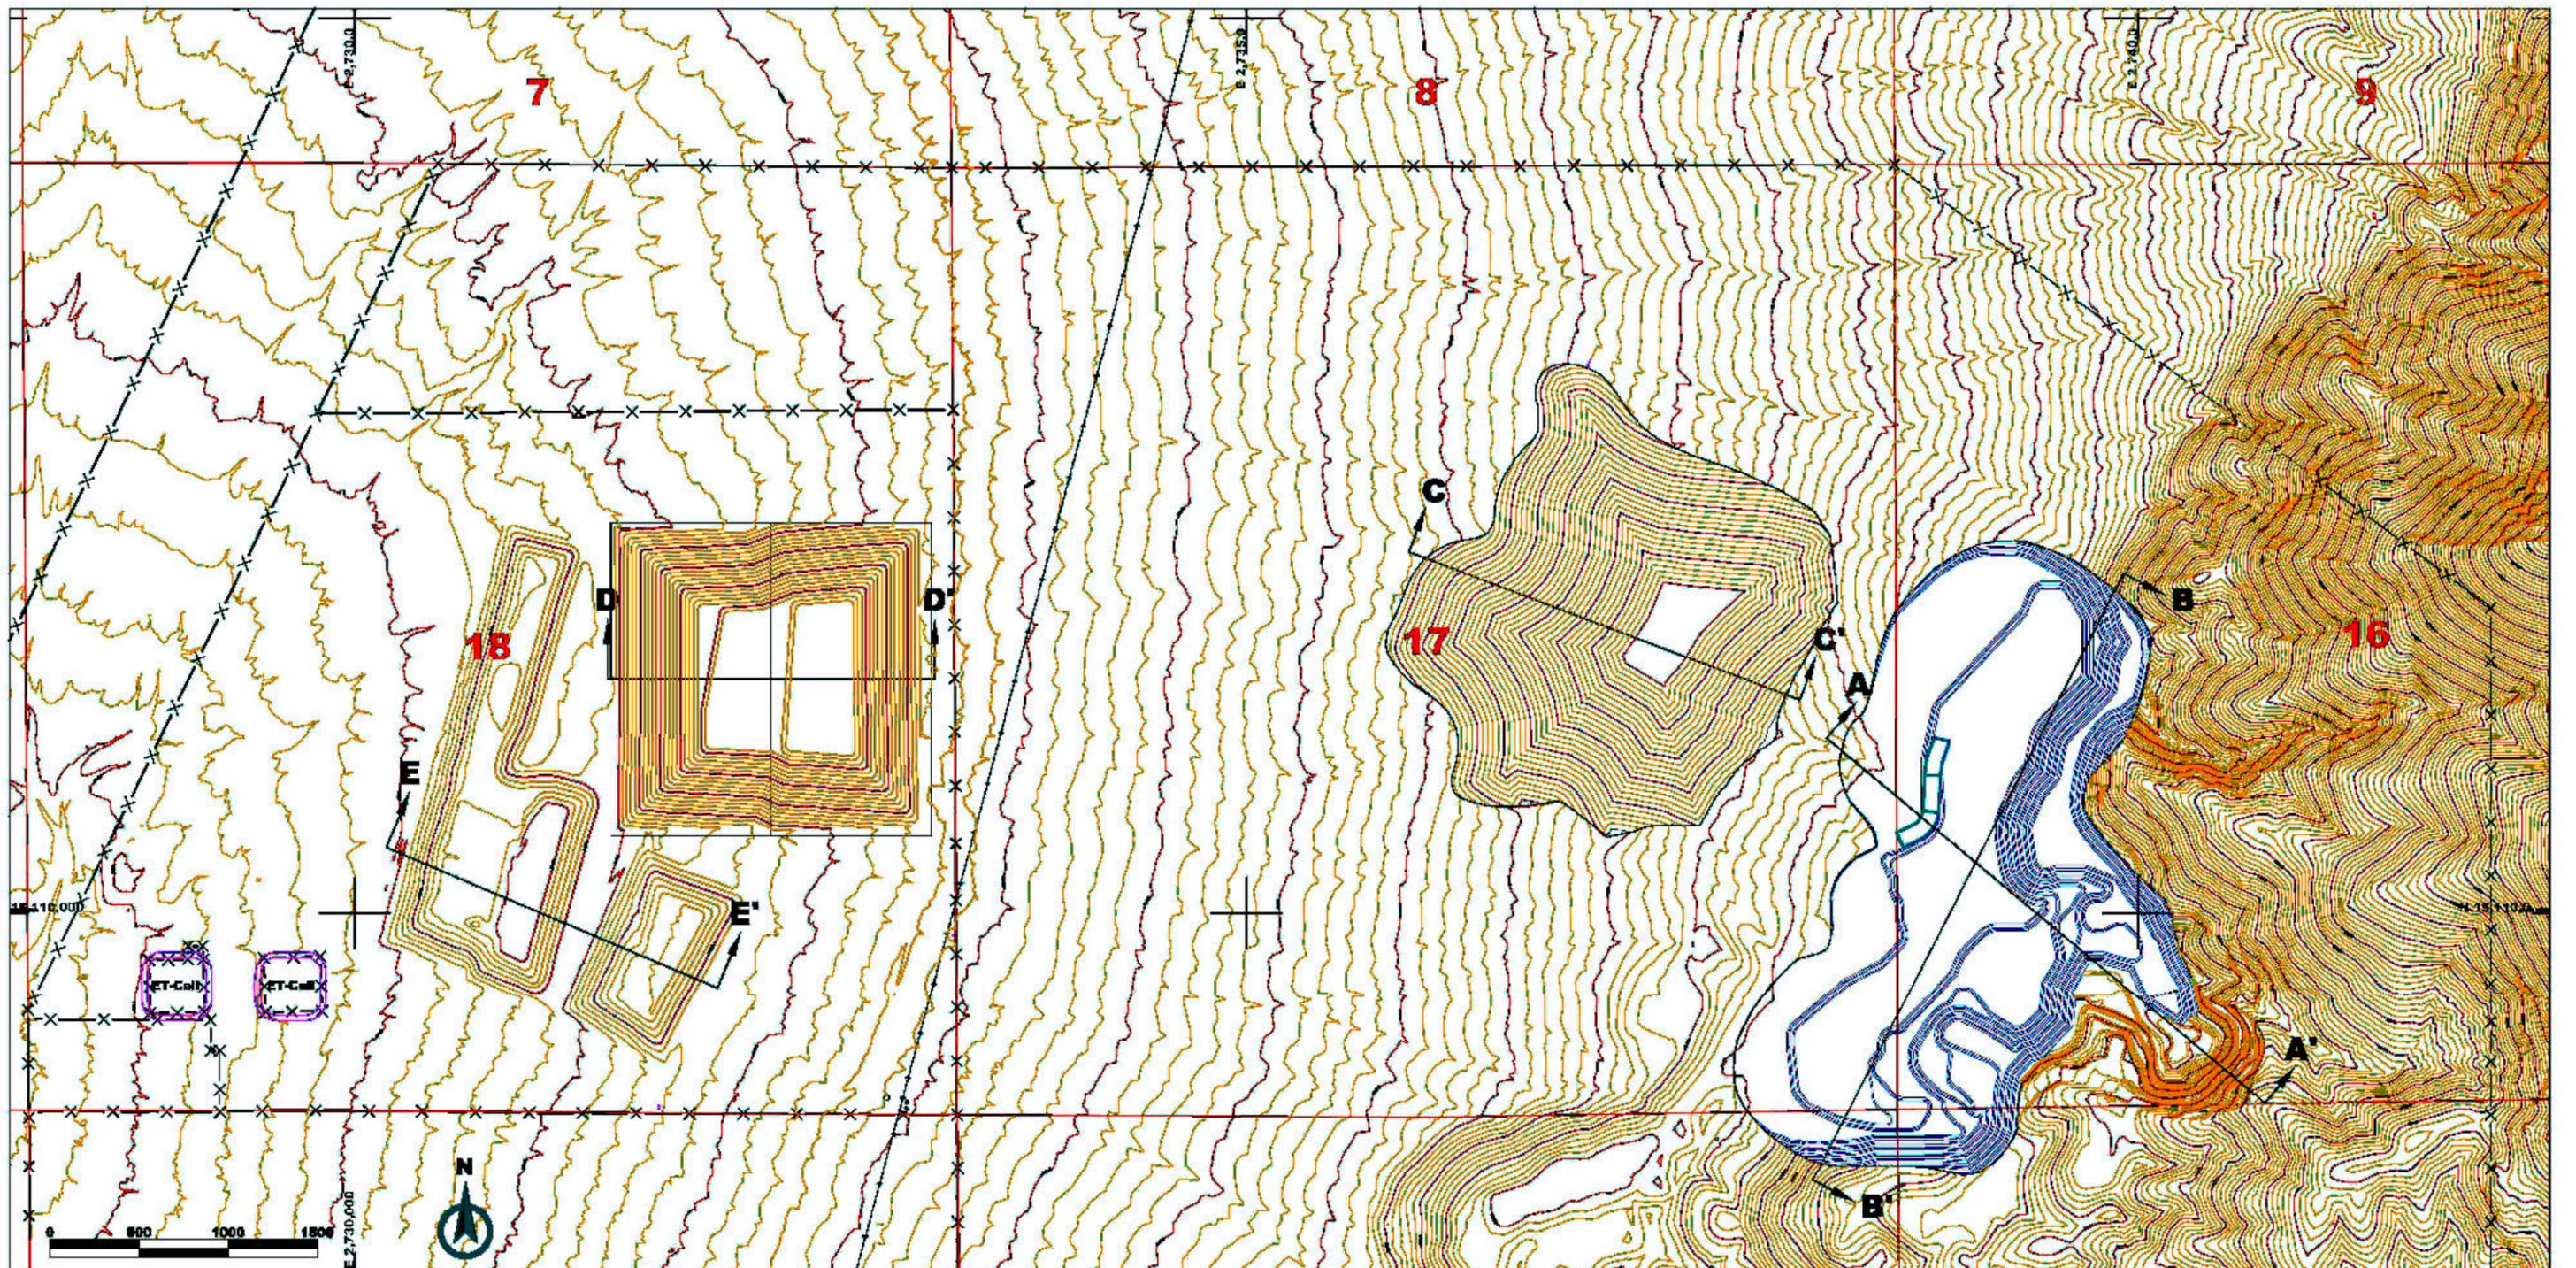
Figure 2.1.8

Post-Mining Topography
