VISUAL CONTRAST RATING WORKSHEET

TRANSWEST EXPRESS TRANSMISSION PROJECT

KOP Rich-2
Skyline Road
(northbound)
(Segment 310)

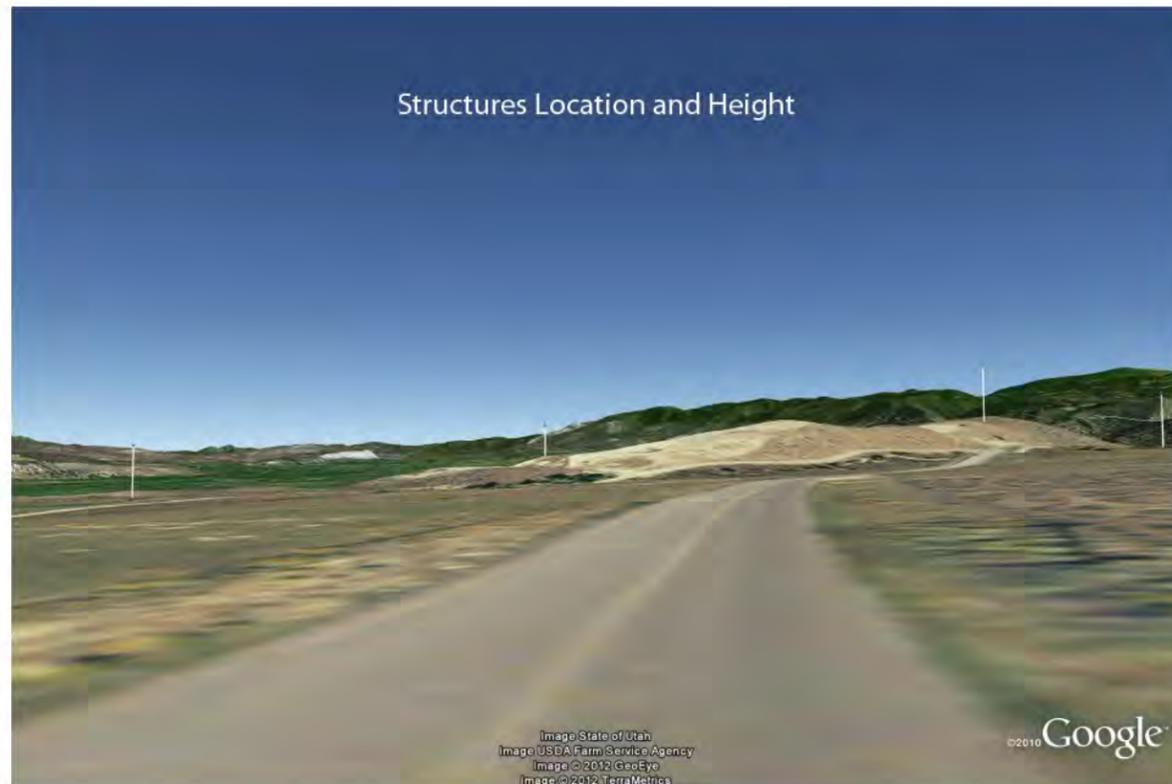
Structures Location and Height

1. LAND/WATER	2. VEGETATION	3. STRUCTURES
FORM			Pyramidal steel lattice structures and guys, and tubular conductors.
LINE			Vertical steel lattice structures, angular guys, and curvilinear conductors.
COLOR			Light silver to dark grey steel lattice structures, guys, and conductors.
TEXTURE			Coarse steel lattice structures, and smooth guys and conductors.

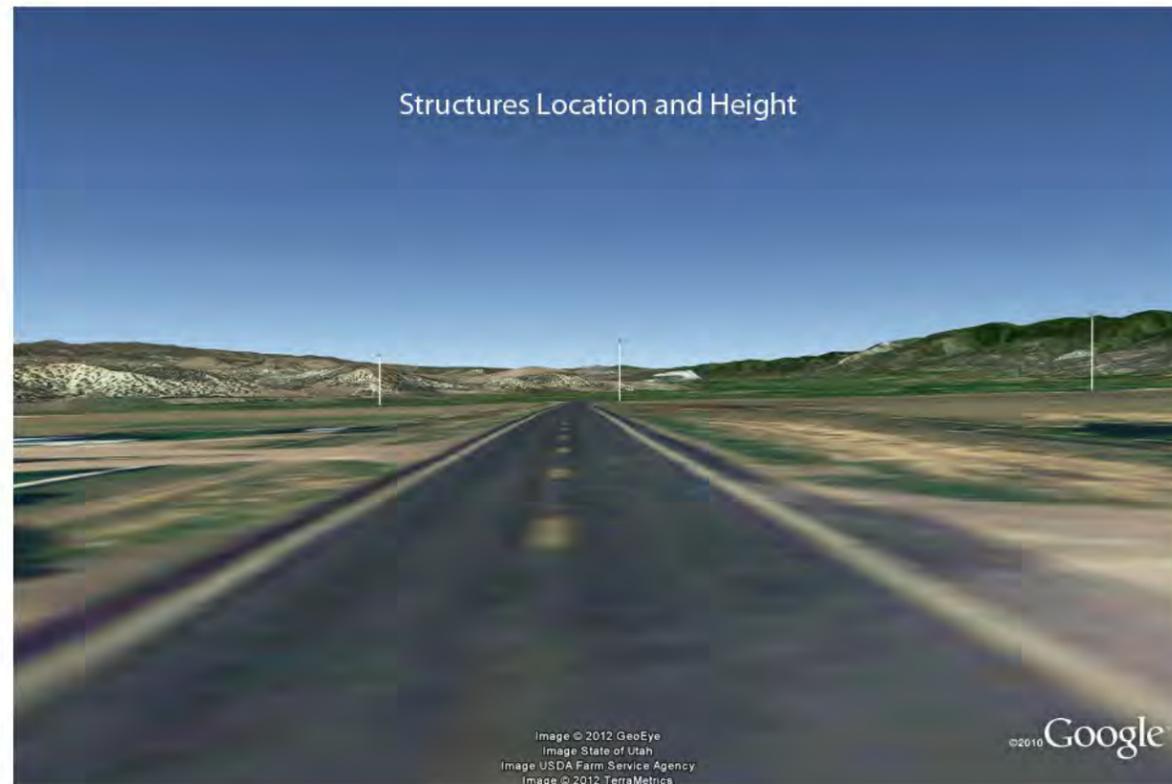
Structures Location and Height

1. LAND/WATER	2. VEGETATION	3. STRUCTURES
FORM			Pyramidal steel lattice structures and guys, and tubular conductors.
LINE			Vertical steel lattice structures, angular guys, and curvilinear conductors.
COLOR			Light silver to dark grey steel lattice structures, guys, and conductors.
TEXTURE			Coarse steel lattice structures, and smooth guys and conductors.

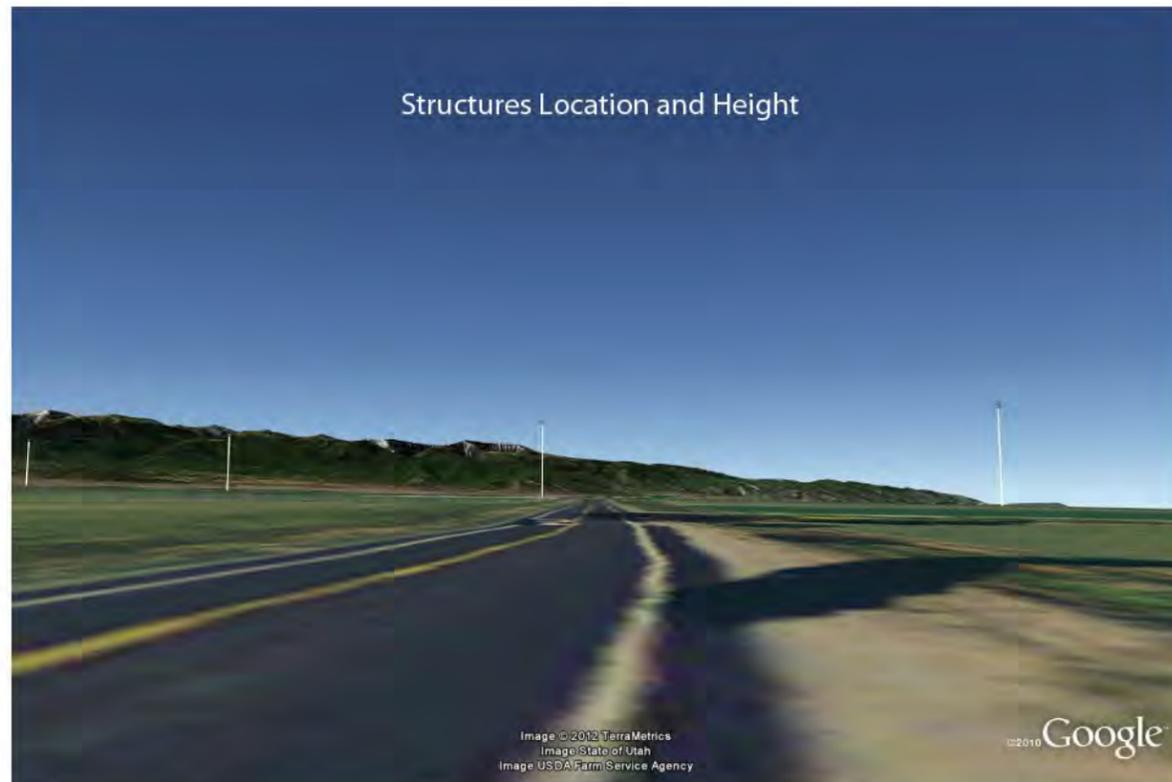
Structures Location and Height

1. LAND/WATER	2. VEGETATION	3. STRUCTURES
FORM			Pyramidal steel lattice structures and guys, and tubular conductors.
LINE			Vertical steel lattice structures, angular guys, and curvilinear conductors.
COLOR			Light silver to dark grey steel lattice structures, guys, and conductors.
TEXTURE			Coarse steel lattice structures, and smooth guys and conductors.
