**UNITED STATES DEPARTMENT OF THE INTERIOR
BLM, BOISE DISTRICT**

EA # DOI-BLM-ID-B010-2011-0010-EA - Wilson Road RoW

Applicant (if any): Adams County, BLM Action		Proposed Action: Issue a Adams County a Road Right- of-Way (IDI 36963)		EA No. DOI-BLM-ID-B010-2011-0010- EA
State: Idaho	County: Adams	District: Boise	Field Office: Four Rivers	Authority: FLPMA
Prepared By: Four Rivers Field Office Interdisciplinary Team		Title: Wilson Road RoW		Report Date: March 2, 2012

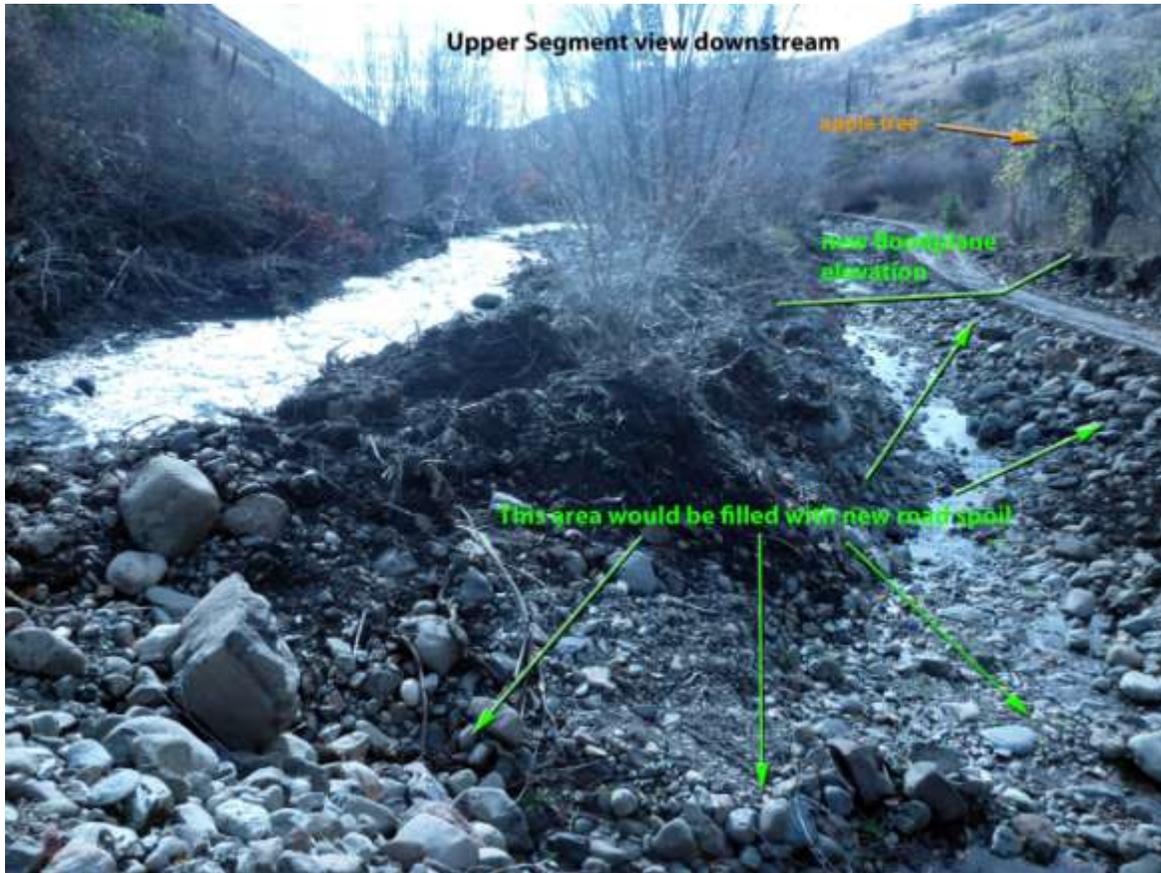
Figure 1. Old incised roadbed and temporary road would be back-filled with excavated road spoil to reestablish a floodplain.

The Goodrich Creek stream channel, at its upper segment (Figure 1), was temporarily diverted back to the pre-flood channel by Adams County Road and Bridge personnel during post-flood emergency road repair; however, the diversion was only temporary. The stream segment remains unstable and would eventually re-route back to the old roadbed in future years if not fully stabilized.

Using a trackhoe and/or dozer, the stream’s upper segment would be reinforced with native materials, i.e., boulders, logs, and woody debris, to prevent diversion back to the roadbed. The entrenched old roadbed, about 160 linear feet, would then be back-filled with soil and rocks excavated from the new roadway (figure 1). The repaired/filled roadbed would correspond to the level of the natural floodplain. Temporary flow diversion, time lapses to allow water to clear, and minimal mechanical disturbance in the streambed would occur during construction. To provide long-term stability, the fill area would be planted with riparian and upland vegetation after construction.

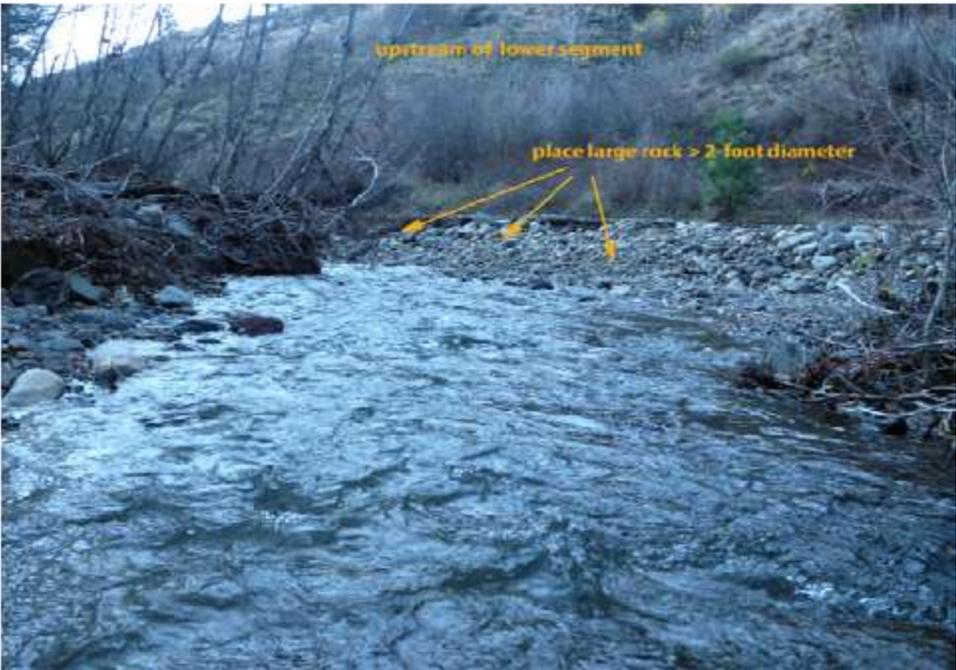
Figure 2. Rip-rap would be placed at areas indicated to protect the streambank from impinging flows.

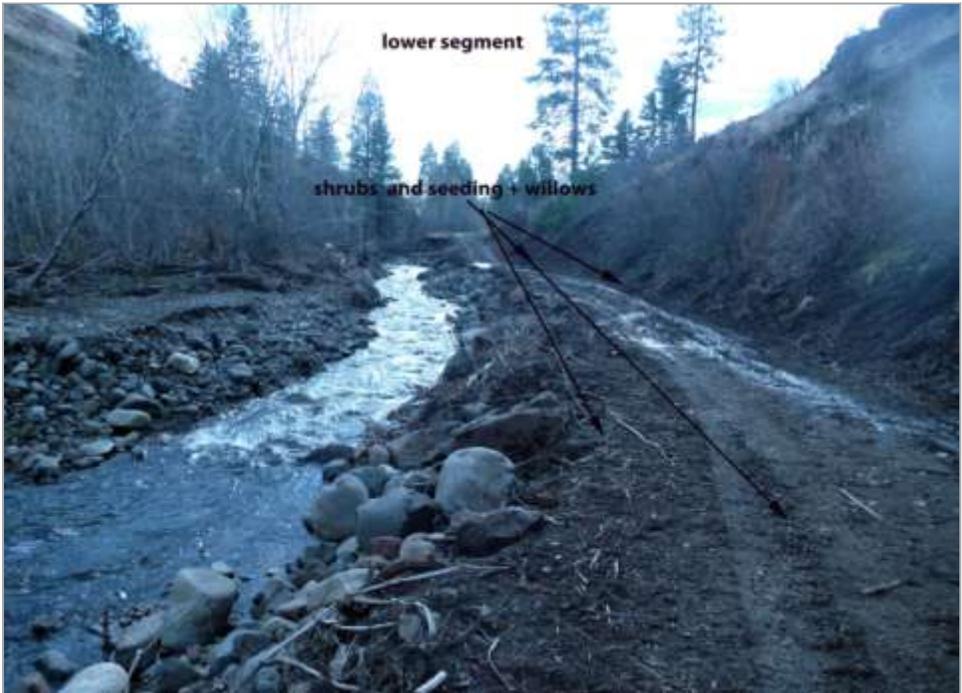
Figure 3. The temporary road would be scarified, and barren areas re-vegetated with native shrubs, grasses, and forbs.

The lower segment stream channel would remain incised into the old roadbed (Figure 3) because re-routing Goodrich Creek back to its previous flow path would require extensive streambed modifications and disturbance, and would be prohibitively expensive to restore. Treatment of this area would include placing large diameter rip-rap at the segment's upstream end to protect the streambank from impinging flows (Figure 2). The temporary road bed would be re-contoured along the western streambank to establish a functional floodplain, followed by planting of native shrubs and other vegetation (Figure 3).

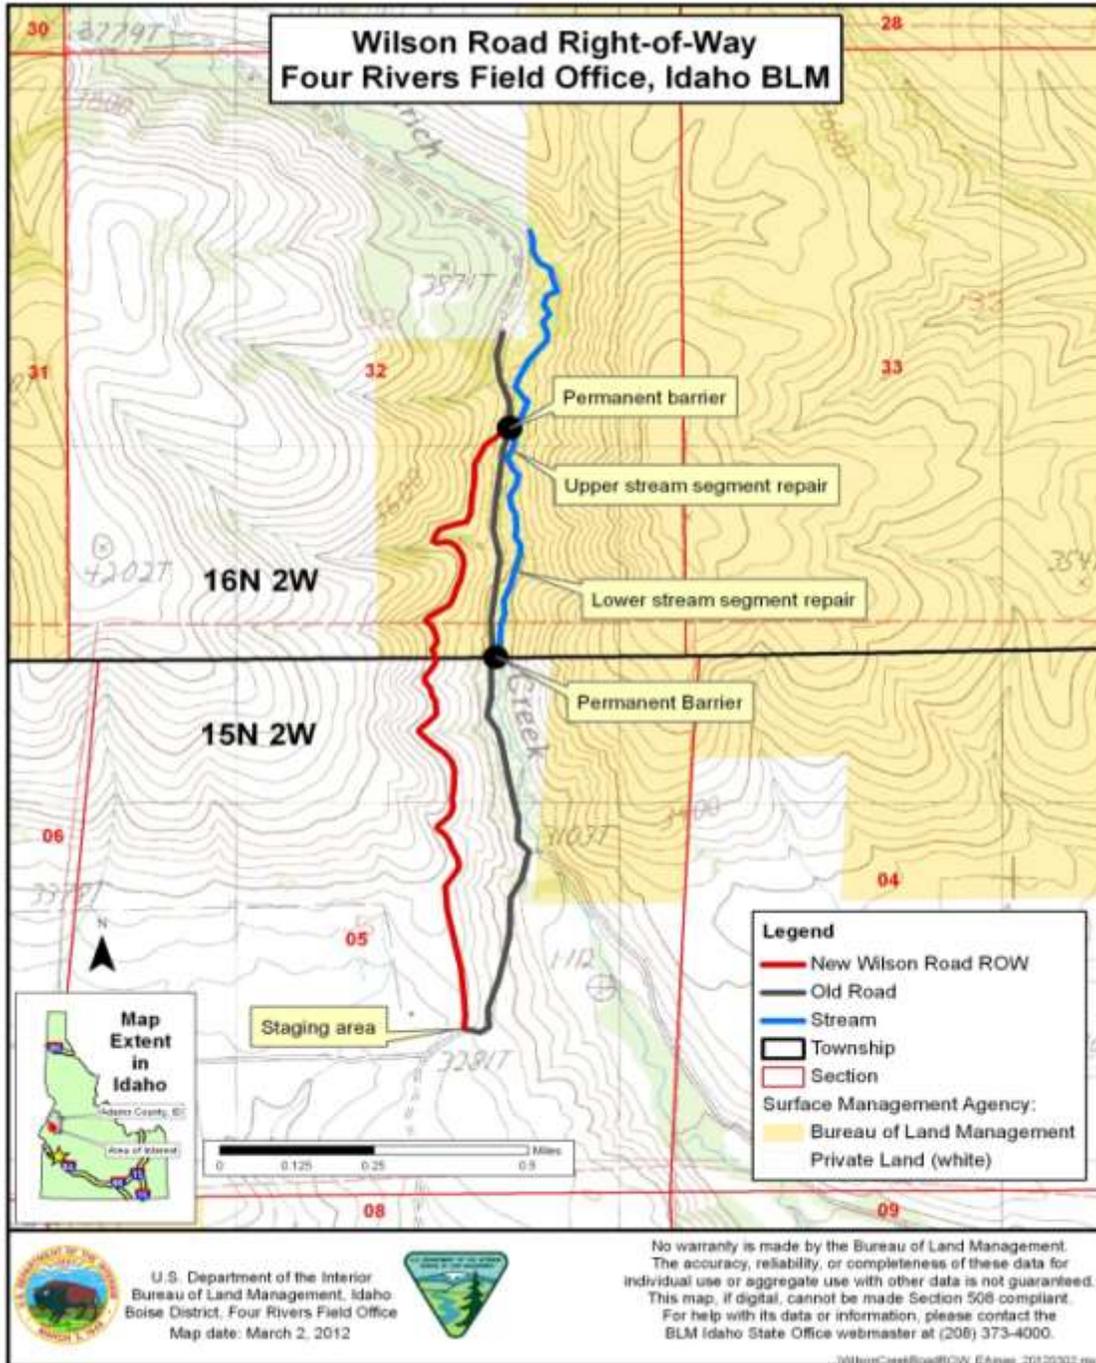
Map 1. Wilson Road RoW showing land status, new Wilson Road RoW route, road closure areas, route of road to be decommissioned, and stream segments to be repaired along Goodrich Creek
